**UT to BILLY'S CREEK
FINAL MONITORING REPORT
YEAR 2 OF 5
2007**

**EEP Project # 36
Franklin County, North Carolina**

**UNNAMED TRIBUTARY TO BILLY’S CREEK STREAM RESTORATION
YEAR 2 MONITORING REPORT**

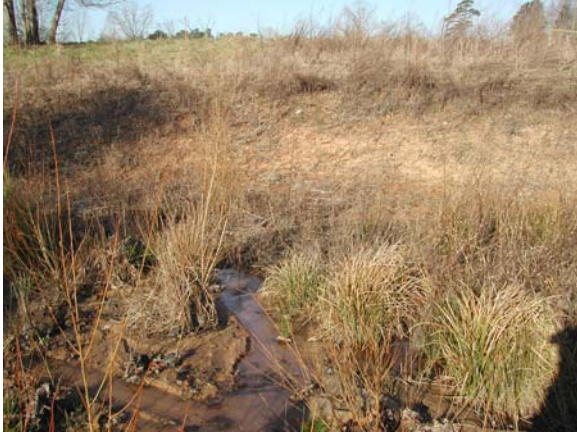
Photo 1. Representative bare floodplain problem area (Station 10+50 along plan view).

Feature/Issue	Station # / Range	Probable Cause	Photo #
Bare Floodplain	10+00 to 11+00 (RIGHT)	Possible past cattle damage and or poor soil attributes (i.e. reduced germination/survival rates).	1
	11+60 to 11+90 (RIGHT)	Possible past cattle damage and or poor soil attributes (i.e. reduced germination/survival rates).	
Bare Bank	16+75 to 17+10 (RIGHT)	Remnant cattle trail; has not fully recovered since total removal of cattle access.	
	17+30 to 17+60 (RIGHT)	Remnant cattle trail; has not fully recovered since total removal of cattle access.	
	21+00 to 21+15 (BOTH BANKS)	Remnant cattle trail; has not fully recovered since total removal of cattle access.	
	23+05 to 23+20 (RIGHT)	Remnant cattle trail; has not fully recovered since total removal of cattle access.	
	23+35 to 23+75 (RIGHT)	Remnant cattle trail; has not fully recovered since total removal of cattle access.	
	23+90 to 25+00 (RIGHT)	Remnant cattle trail; has not fully recovered since total removal of cattle access.

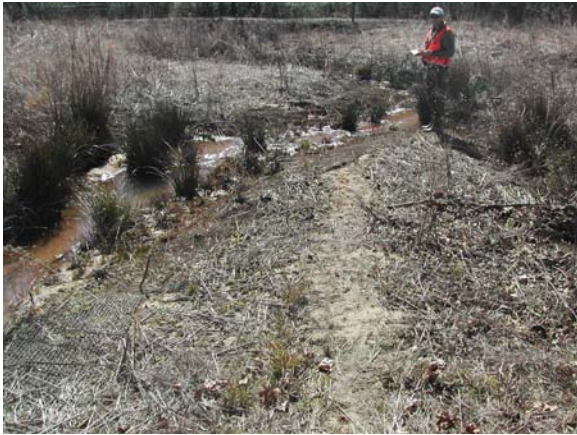
Photo 2. Representative bare bank problem area (Station 29+25 along plan view).

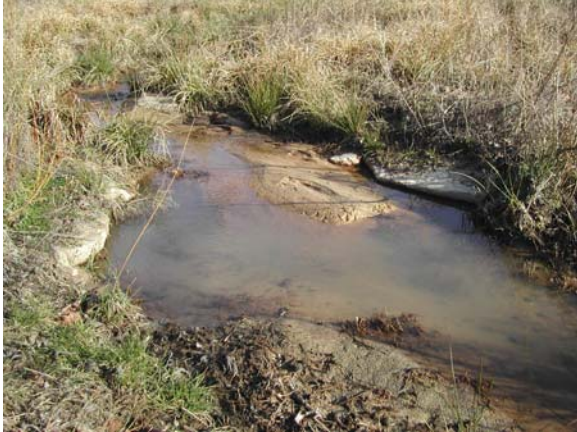
Photo 1: Representative sand/gravel aggradation and bar formation problem area (Station 14+43 along plan view).

UT Billys Creek			
Feature Issue	Station numbers	Suspected Cause	Photo number
Aggradation	10+00	An upstream source has deposited significant amounts of fine sediment (i.e. sand) during high flow events, resulting in long sections of fine sediment aggradation.	
	13+73		
Bar Formation	14+43	Excess fine sediment from an upstream source deposited during high flow event.	Photo 1
	14+58		
Stone Step Structure	15+90	Piping/scour around right side of structure.	Photo 4
Bank Erosion (left bank)	18+44	Inadequate bank protection from rootwad, soil instability/bank angle, and/or lack of protective vegetation.	
	18+54		
Bank Erosion (right bank)	18+69	Inadequate bank protection from rootwad, soil stability/bank angle, and/or lack of protective vegetation.	
	18+78		
Bank Erosion (both banks, severe)	18+82	Major slumping, possibly due to lack of protective vegetation and/or soil instability. Also exposure/undercutting of matting.	Photo 3

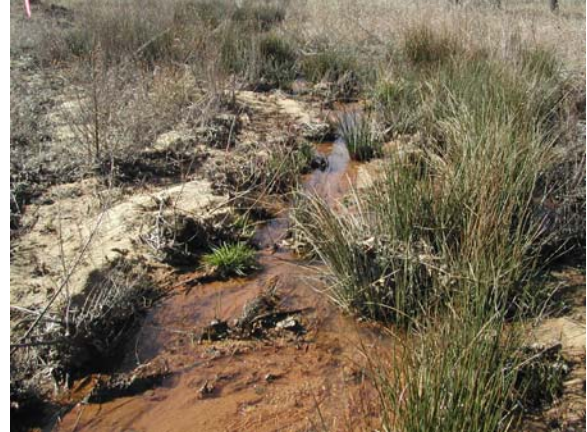
Photo 2: Representative sand and rush aggradation problem area (Station 27+05 along plan view).

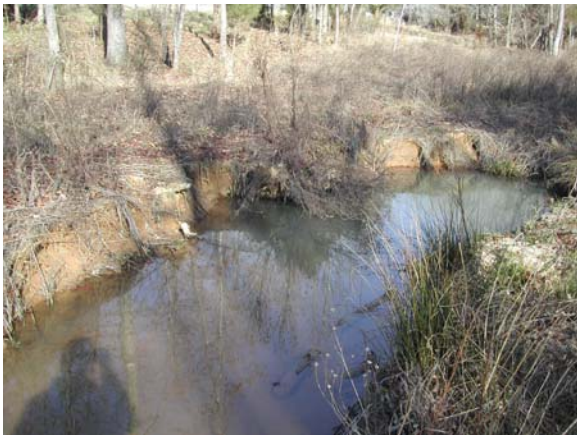
Photo 3: Representative bank erosion problem area (Station 18+82 along plan view).

19+12		
Bank Erosion (right bank)	19+33	Soil instability or lack of protective vegetation.	
	19+43		
Bank Erosion (both banks, severe)	20+18	Major slumping, possibly due to lack of protective vegetation and/or soil instability. Also exposure/undercutting of matting.	
	20+26		
Undercut Bank (right bank)	20+55	Inadequate protection at toe on outside of meander, however rooted vegetation is holding bank in place to prevent erosion.	
	20+74		
Bank Erosion (left bank)	20+75	Soil instability or lack of protective vegetation.	
	20+84		
Bank Erosion (right bank)	21+12	Soil instability or lack of protective vegetation.	
	21+16		
Aggradation/Bar Formation	23+37	An upstream source has deposited significant amounts of fine sediment (i.e. sand) during high flow events, resulting in long sections of fine sediment aggradation.	
	26+09		
Aggradation	26+41	An upstream source has deposited significant amounts of fine sediment (i.e. sand) during high flow events, resulting in long sections of fine sediment aggradation.

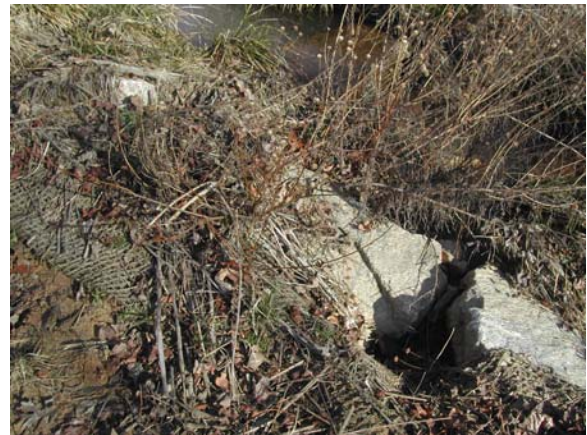
Photo 4: Representative problem rock step structure (Station 15+90 along plan view).

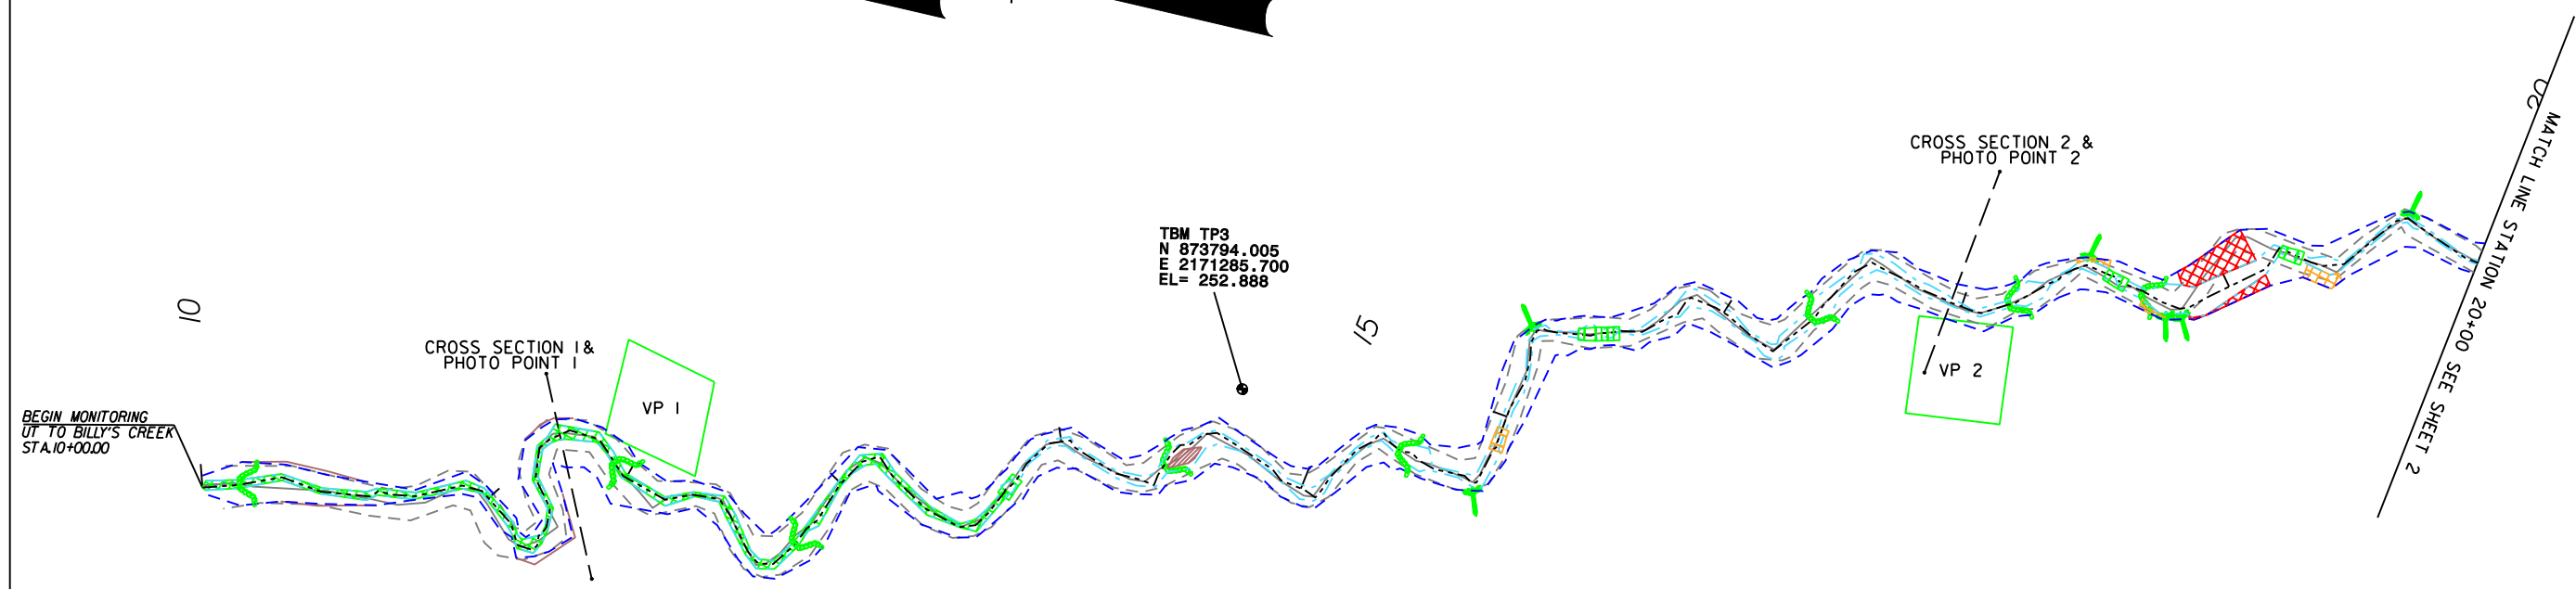
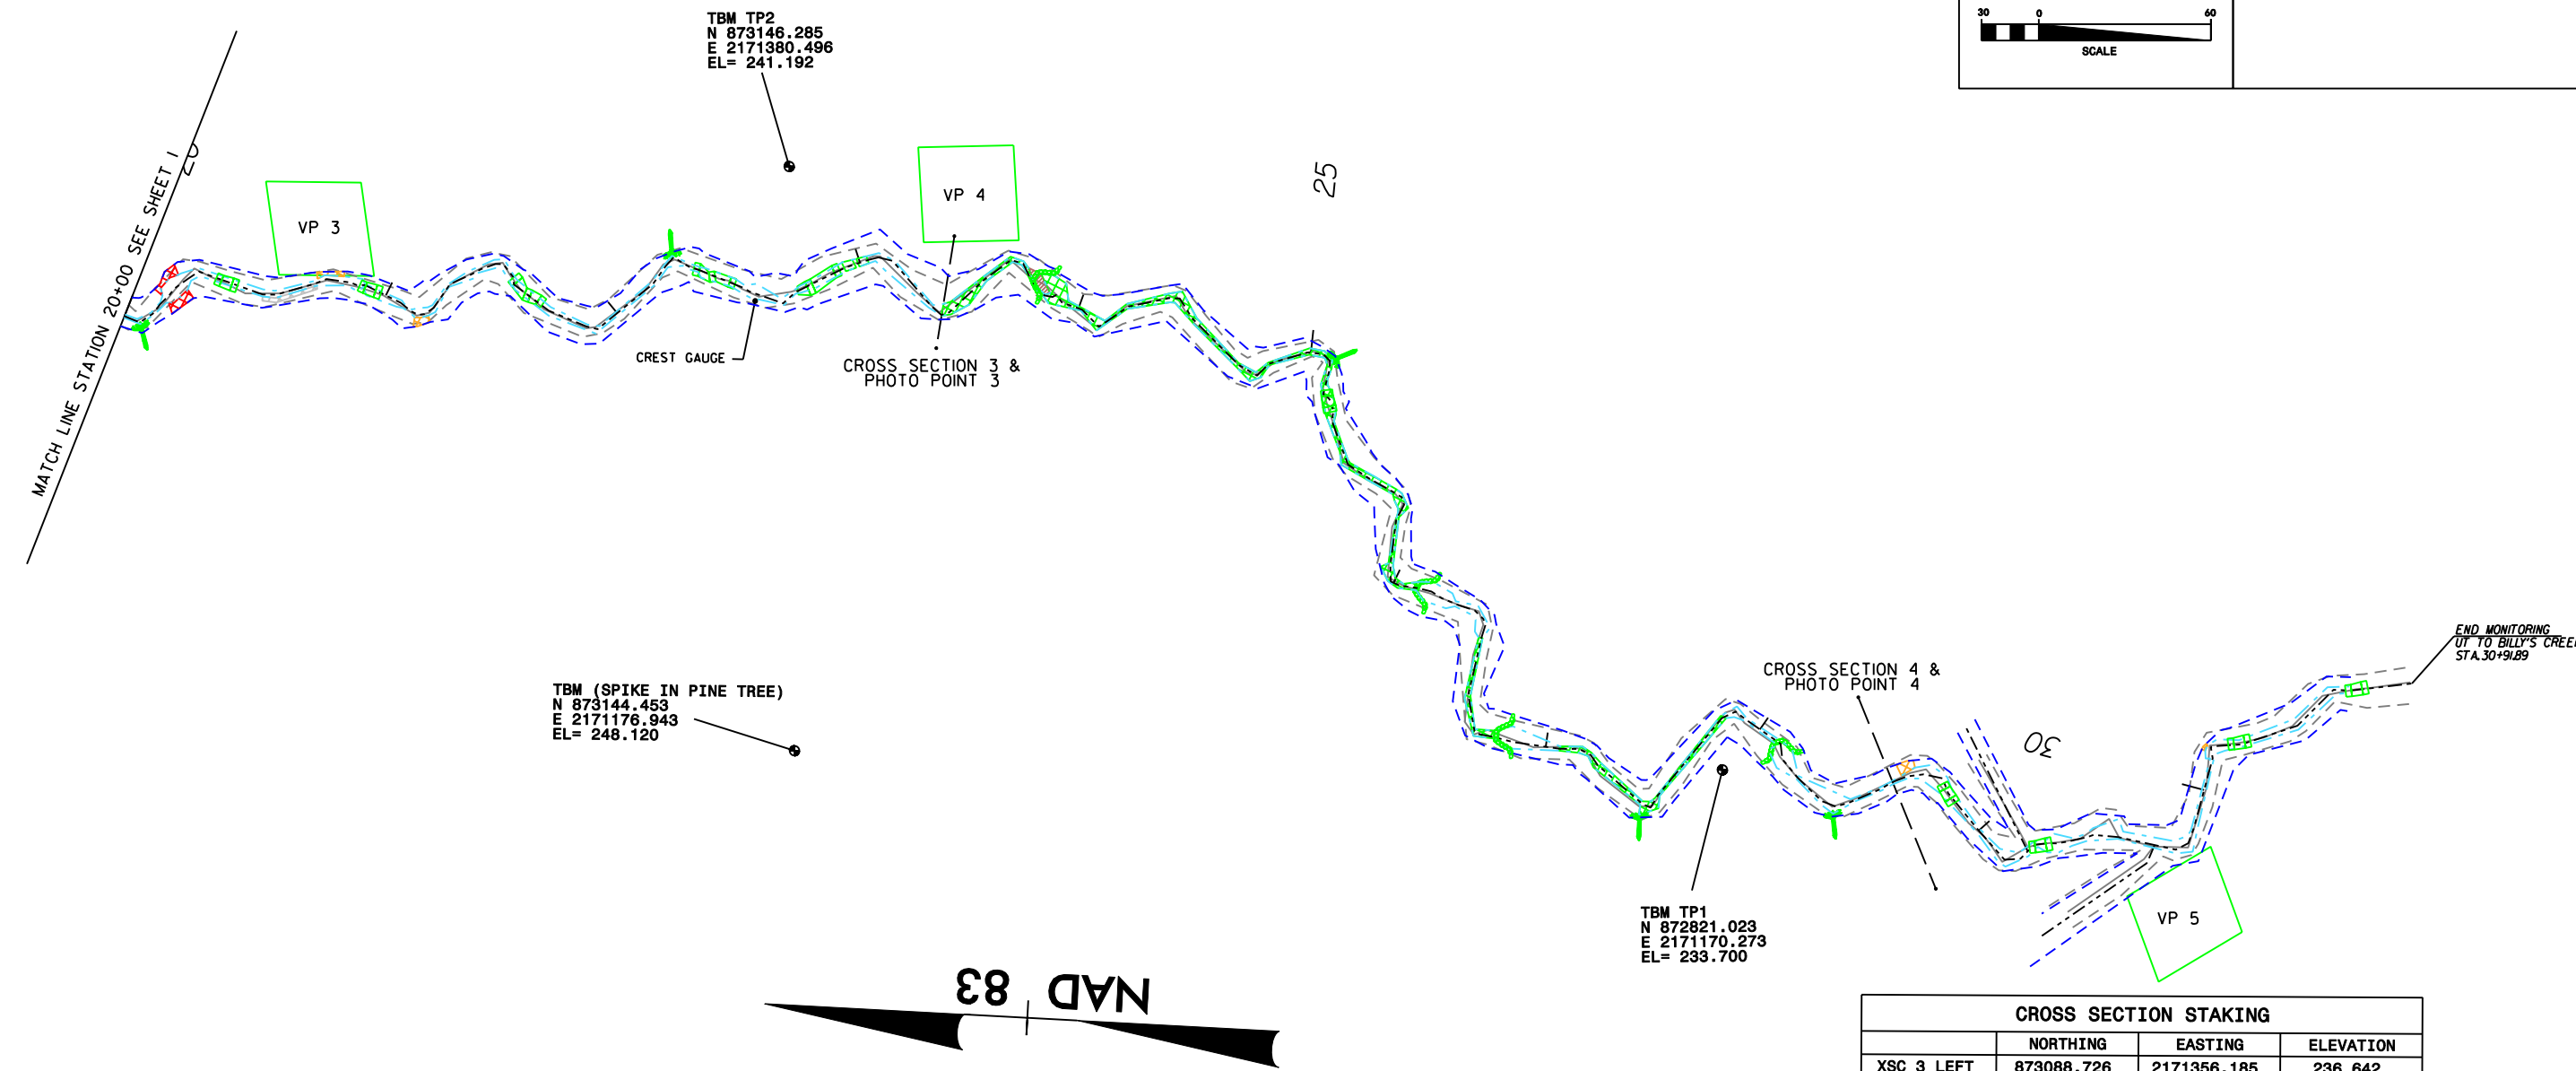
LOCATION: UT TO BILLY'S CREEK STREAM MONITORING - YEAR 2 STREAM PROBLEM AREAS	
PROJ #: 36	COUNTY: FRANKLIN
PREPARED BY: IPJ	
CHECKED BY: PDB	DATE: 7/20/07

Sand deposition (noted as aggradation on the problem area plan view) has “blanketed” the entire upper quarter of the project reach and has impacted several large sections of the rest of the reach, essentially having the effect of homogenizing channel units into long run sections. Soft rush has “choked” the entire channel in these areas, making it very difficult to even locate channel features. In fact, these areas now look much more like linear wetland than stream channel. The sediment source is presumably upstream of the project. This conclusion is based on the fact that the sediment deposition starts at the culvert outlet at the head of the reach (station 10+00). There are several bank erosion areas as noted on the problem area plan views (Appendix C) and, although bank erosion does not appear to be a major problem of concern in the reach (bank condition of 97% in the Visual Morphological Stability Estimate), there are two specific erosion areas rated severe that should be watched closely in the future. These two areas, located at Station 18+82 and at Station 20+18 along the thalweg, have major slumping of both banks and are probably in need of repair as soon as possible. The most common causes for bank erosion along the reach were inadequate bank protection or soil instability. All structures appeared to be in good physical condition, except for one stone grade control structure, located at Station 15+90 along the thalweg, that had water piping around the right side causing some bank scour.

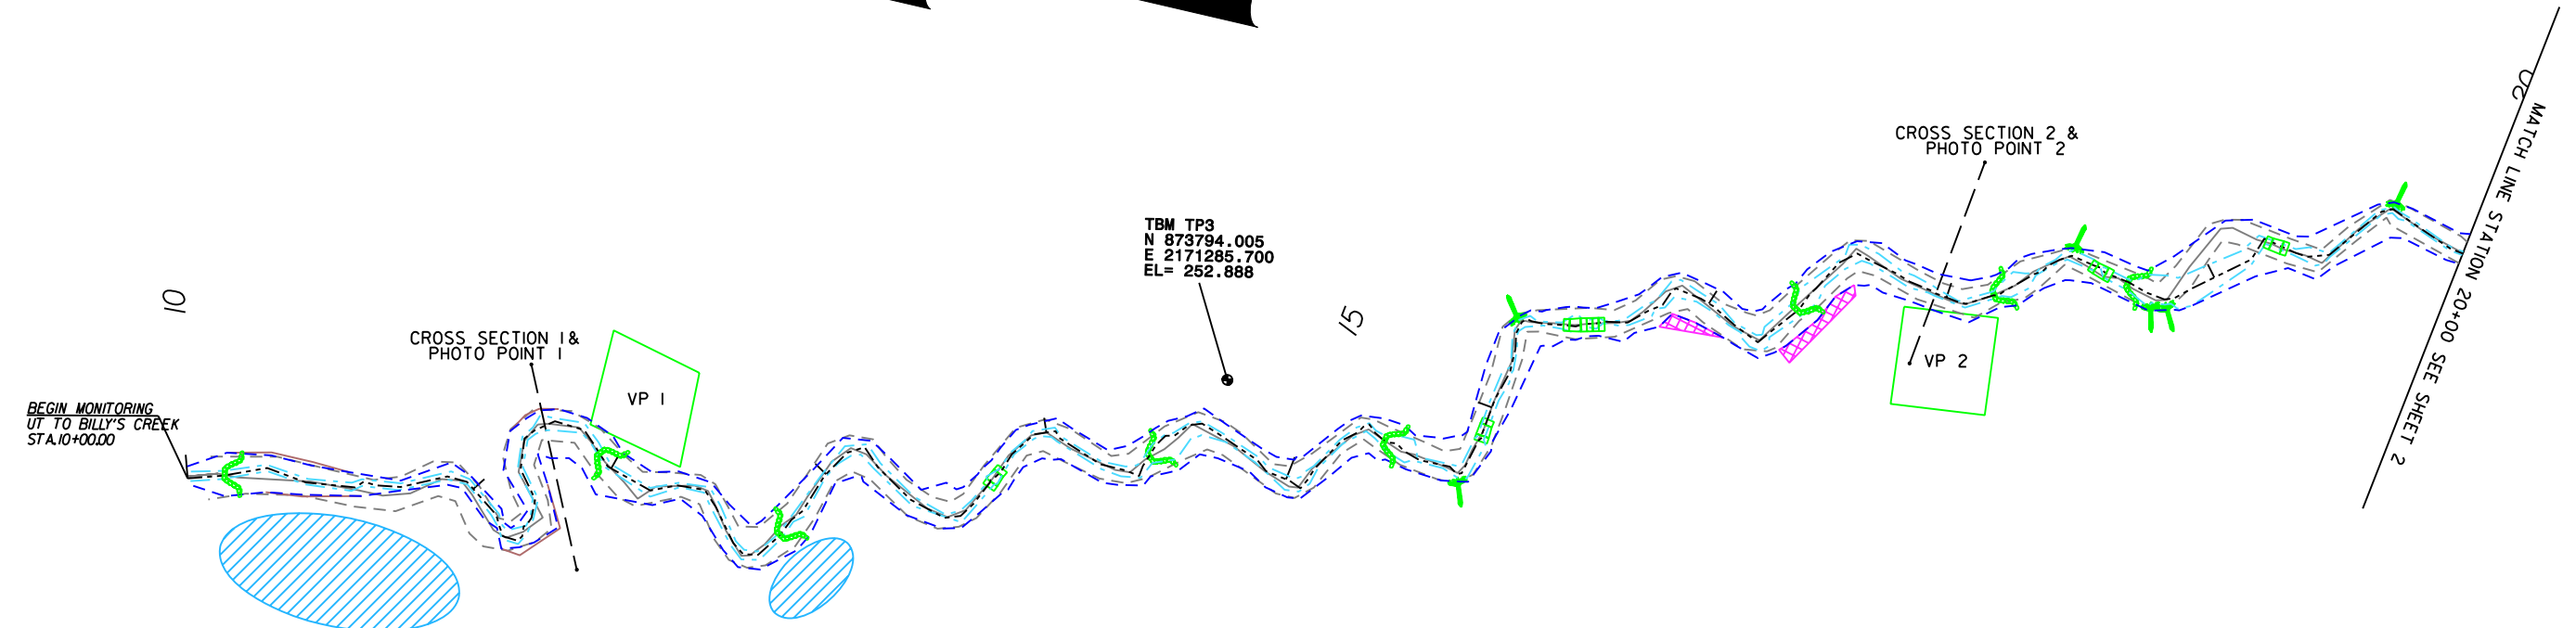
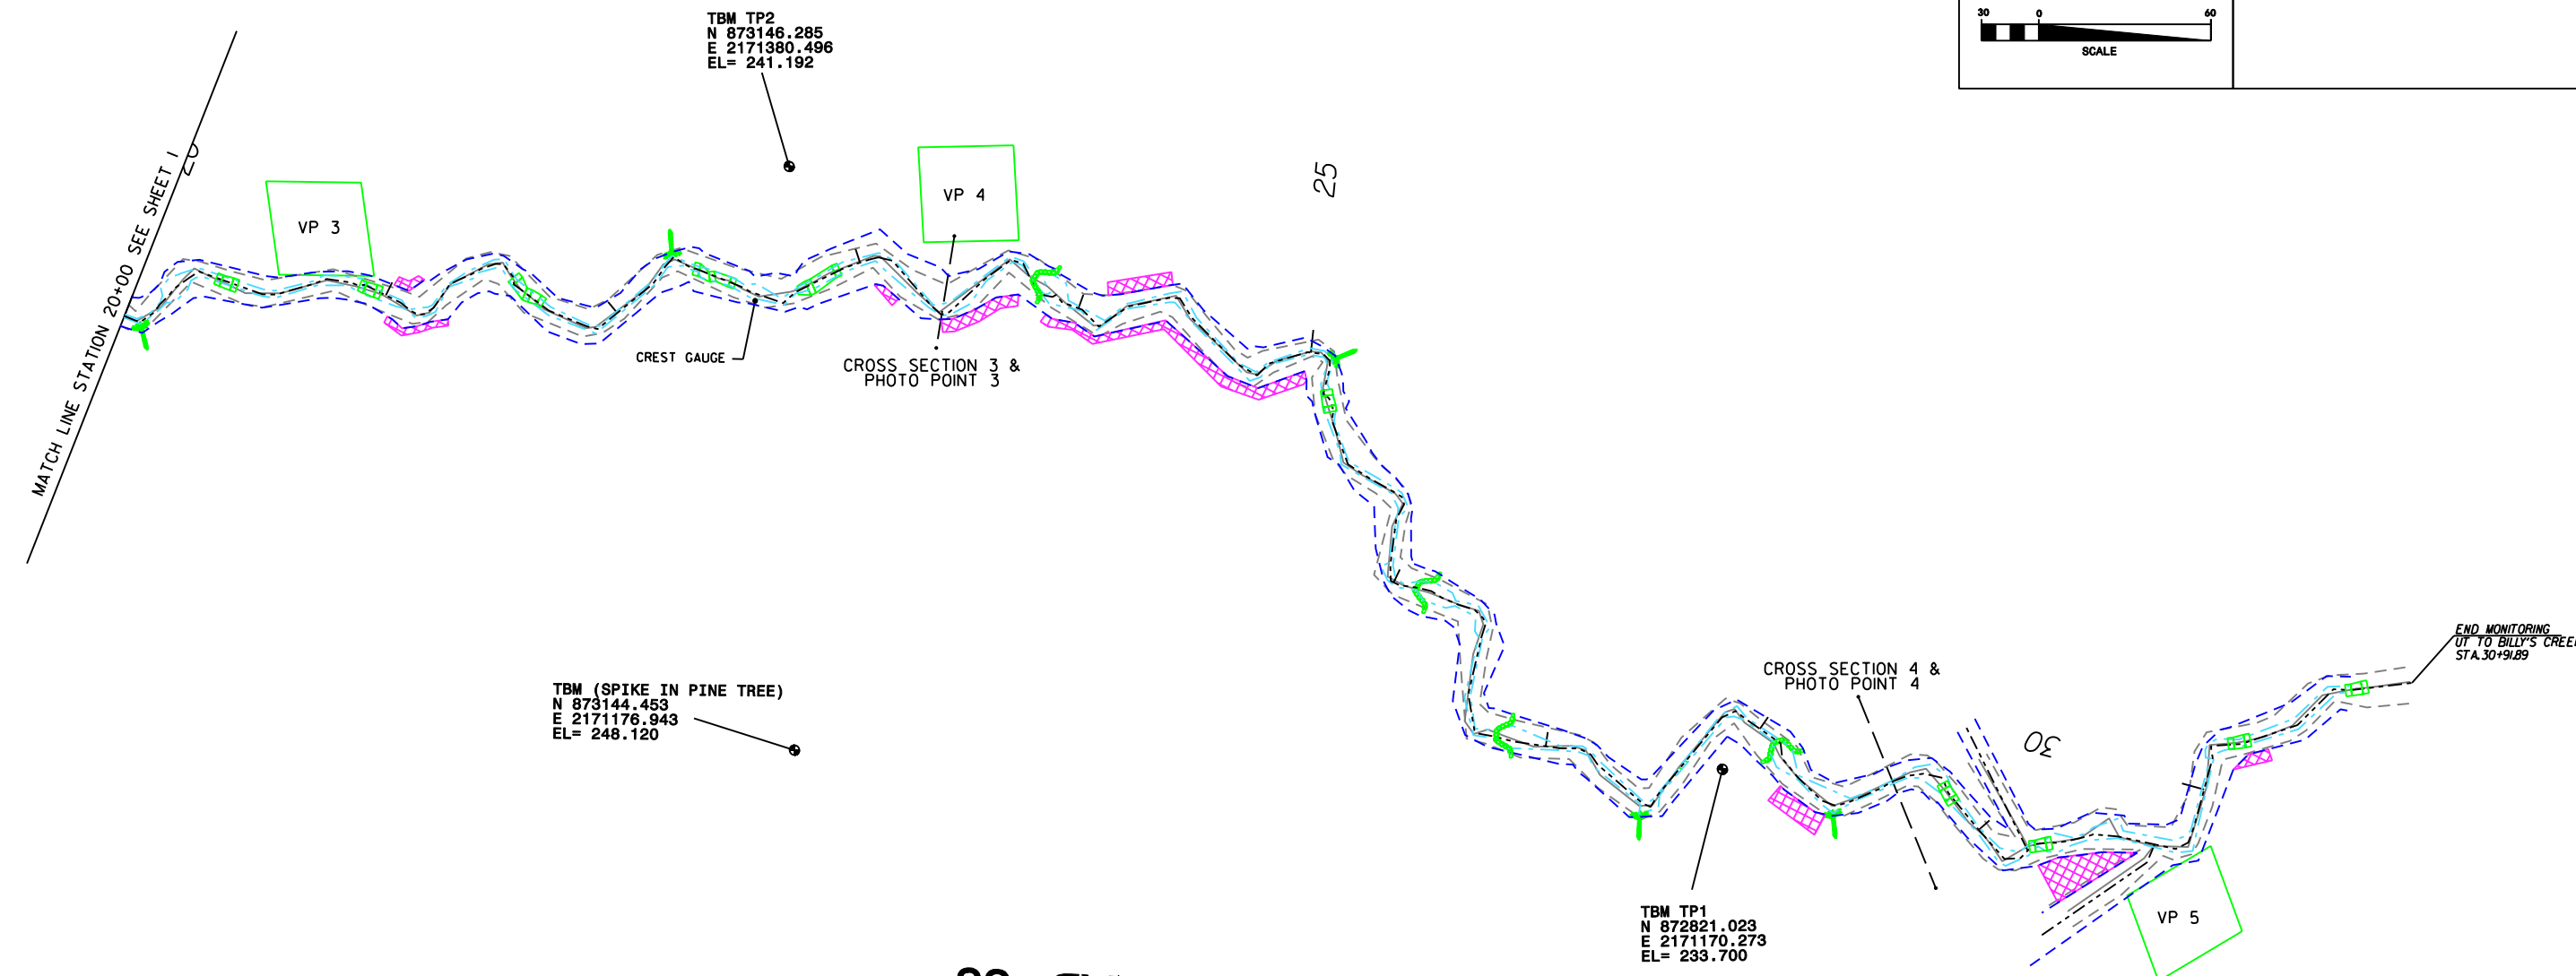
LOCATION: UT TO BILLY'S CREEK	
STREAM MONITORING - YEAR 2	
VEGETATION PROBLEM AREAS	
PROJ #: 36	COUNTY: FRANKLIN
PREPARED BY: IPJ	
CHECKED BY: PDB	DATE: 7/20/07

Overall, there appears to be good vegetation along the stream channel. There were some areas of bare floodplain where the vegetation has not rooted as vigorously as elsewhere in the project. In addition, there were several areas bare bank where vegetation is still sparse along the streambank. However, these areas have recovered notably since Monitoring Year 1. The bare floodplain and bare bank areas are noted on the vegetation problem area plan view and problem area list.
