**UT to BILLY'S CREEK  
FINAL MONITORING REPORT  
YEAR 3  
2008**

EEP Project # 36  
Franklin County, North Carolina

## **Executive Summary**

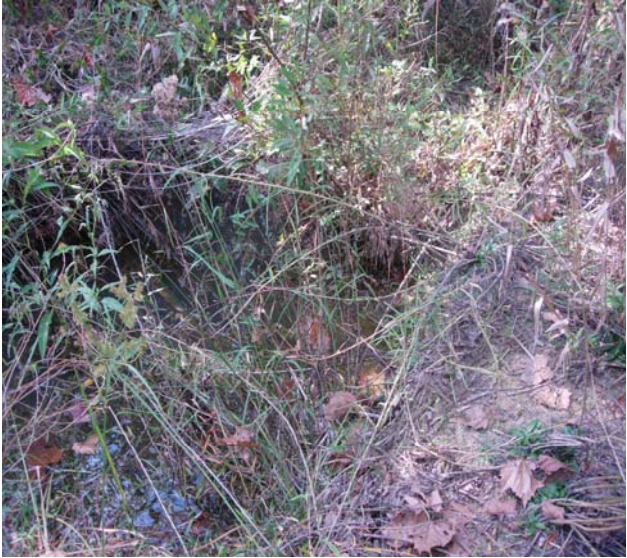
Overall, there appears to be good vegetation along the stream channel. There were some areas of bare floodplain and bare bank identified in the first two monitoring years where the vegetation was sparse. Several of these areas were listed again in Monitoring Year 3, however it should be noted that these areas are starting to fill in with vegetation as the project matures. The bare floodplain and bare bank areas are noted on the vegetation problem area plan view and problem area list.

Photo 1. Representative bare bank problem area (Station No. 21+02; view from left bank; 9-14-2008).

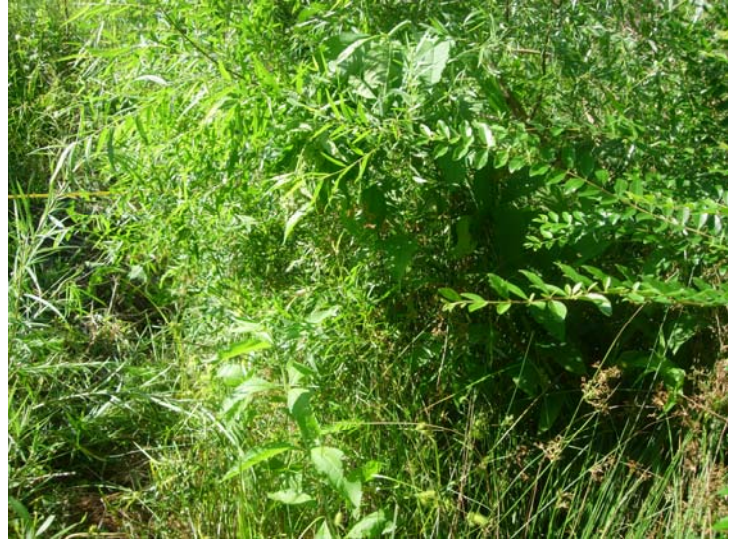
Several populations of invasive *Ligustrum sinense* (Chinese privet) were noted along the project corridor during Monitoring Year 3. These areas occur along the length of the project and are noted on the problem area plan view as well as the vegetative problem area list. There is a small population of *Microstegium virmineum* that was discovered during Monitoring Year 3 (Station 13+75 to 15+13). Although not considered a ‘problem,’ it should be noted that cattails, which are sometimes considered to be invasive, were noted near the upper end of the reach.

Photo2. Representative Chinese privet (*Ligustrum sinense*) growth (Station No. 27+34; view from left bank; 9-14-2008).

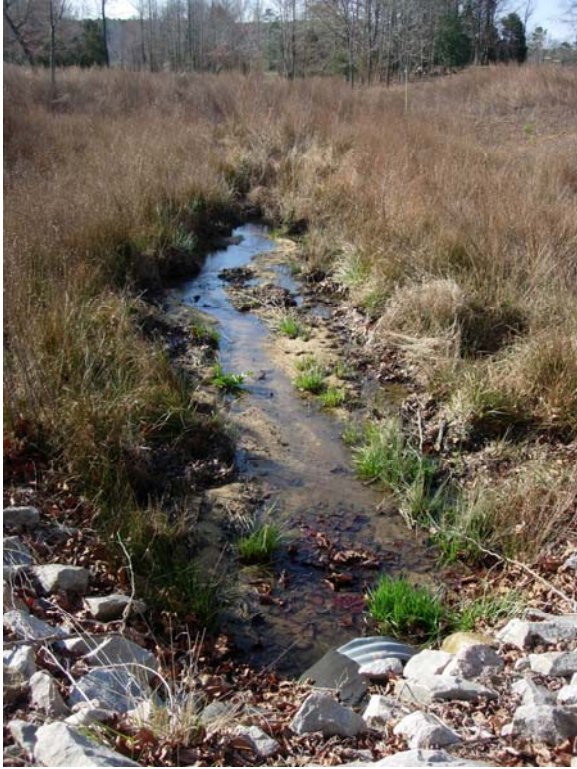
Sand deposition (noted as aggradation on the problem area plan view) has “blanketed” the entire upper quarter of the project reach effect of homogenizing channel units into long run sections. Soft rush has “choked” the entire channel in this area, making it very difficult to locate channel features. These areas now look much more like linear wetland than stream channel. The sediment source is presumably upstream of the project. There are three bank erosion areas to keep an eye on, as noted on the problem area plan views (Appendix C). Although bank erosion does not appear to be a major problem of concern (bank condition of 98% in the Visual Morphological Stability Estimate), there are two specific erosion areas rated severe that should be watched closely in the future. These two areas, located at Station 18+72 and at Station 20+19 along the thalweg, have major slumping of both banks. Repair assessment may be warranted at these locations. All structures appeared to be in good physical condition, except for one stone grade control structure, located at Station 15+90 along the thalweg, that had water piping around the right side that caused some bank scour.

Photo 1: Representative sand/gravel aggradation and bar formation problem area (Station No. 10+00; view downstream; 2-27-2008).

<b>UT Billys Creek</b>			
<b>Feature Issue</b>	<b>Station numbers</b>	<b>Suspected Cause</b>	<b>Photo number</b>
<b>Aggradation</b>	10+00	An upstream source has deposited significant amounts of fine sediment (i.e. sand) during high flow events, resulting in long sections of fine sediment aggradation.	1
	15+40.55		
<b>Cross Vane</b>	10+12.50	Buried under sediment; cannot find; not forming pool.	
<b>Cross Vane</b>	12+02.37	Buried under sediment; cannot find; not forming pool.	
<b>Cross Vane</b>	14+53.42	Buried under sediment; not forming pool.	2
<b>Central Bar Formation</b>	14+53.52	Sediment aggradatio has filled in pool.	2
	14+67.58		
<b>Stone Step Structure</b>	15+90	Piping/scour around right side of structure.	
<b>Bank Erosion (both banks, severe)</b>	18+72	Major slumping, possibly due to lack of protective vegetation and/or soil instability. Also exposure/undercutting of matting.	4
	19+05		
<b>Central Bar Formation</b>	19+05.5	Sediment aggradatio has filled in pool.

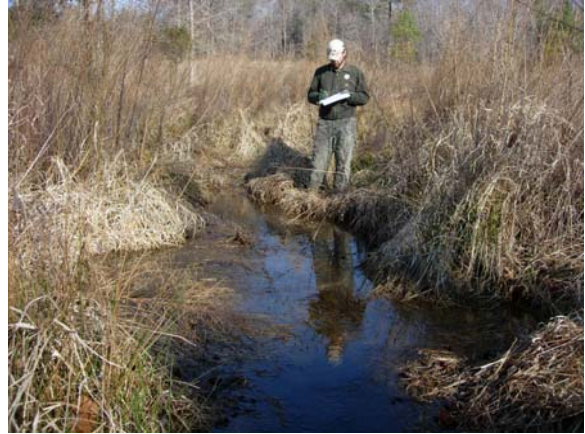
Photo 2: Representative crossvane problem area (Station No. 14+53; view upstream; crossvane is covered in photo; 2-27-2008).

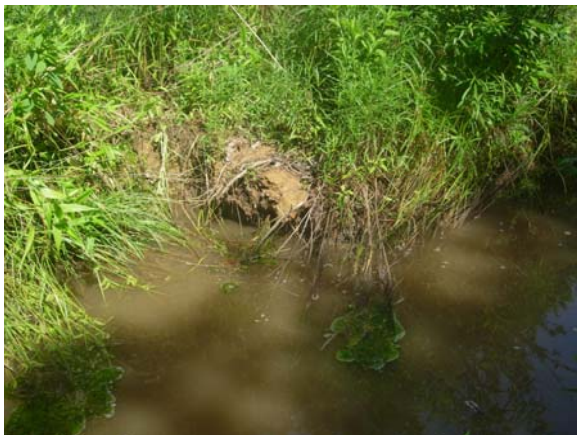
Photo 3: Representative bank erosion problem area (Station No. 18+72; view of right bank; 6-30-2008).

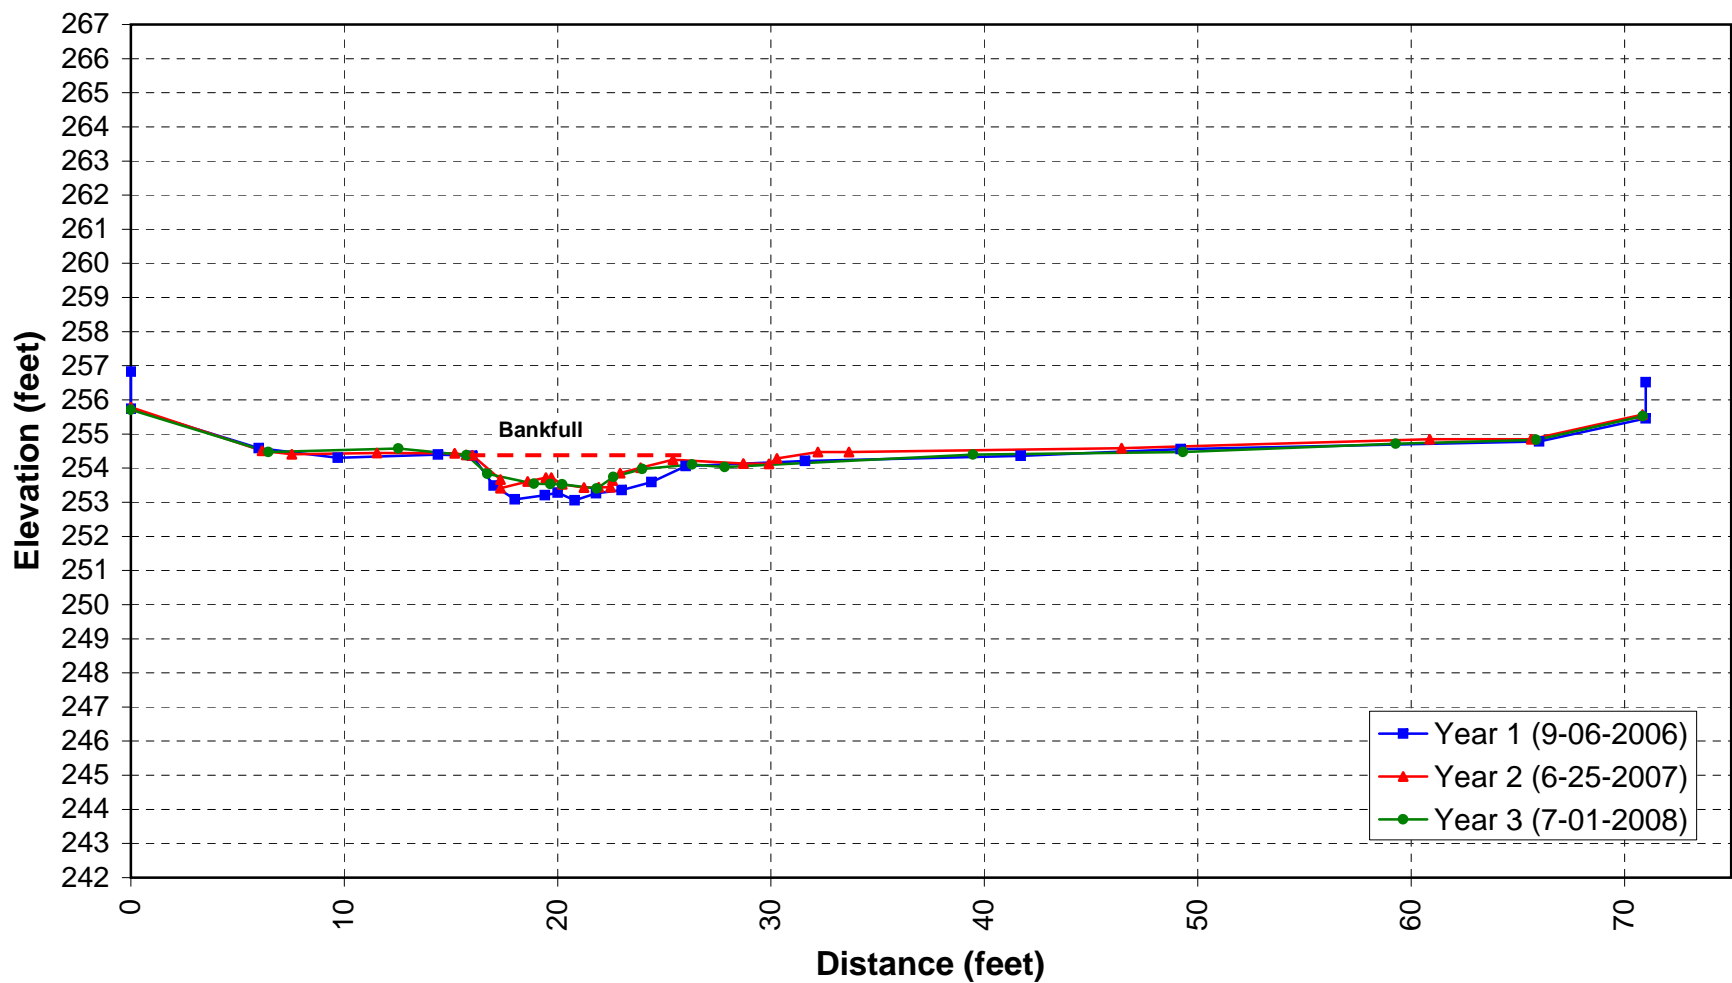
**Cross Section Overlay (Years 1-3)**  
**UT to Billy's Creek**  
**Cross Section #1 - Pool**

The widespread deposition along the upper end of the project is apparent in cross section #1, where the stream bottom has risen during each consecutive monitoring year. However, the rate of aggradation may be slowing down as the rise of the streambed this monitoring year was less than the rise observed between Monitoring Years 1 and 2. There is evidence that this problem may be spreading downstream as far as cross section #3, Cross section #2 displayed a larger rise in the streambed elevations than cross section #1, and although cross section three did not show as much of a rise in streambed during the current monitoring year, the streambed has risen significantly at this location since construction. This aggradation problem area was not documented as extending all the way to cross section #2 during this years' on-site observations because the deposition is not as visually apparent downstream of the current documented limits. Nevertheless, this trend represents evidence that this depositional area needs close attention during Monitoring Year 4 so that the limits are accurately reported. Alternatively, very little change in dimension was observed between Monitoring Years 2 and 3 on cross sections 3 and 4. Aggradation of the streambed was observed during Monitoring Year 2 at cross section 3, but it is apparent that this has stabilized for as no change was observed during Monitoring Year 3.
