**UT to BILLY'S CREEK  
FINAL MONITORING REPORT**

**YEAR 5 OF 5**

**2010**

EEP Project #36

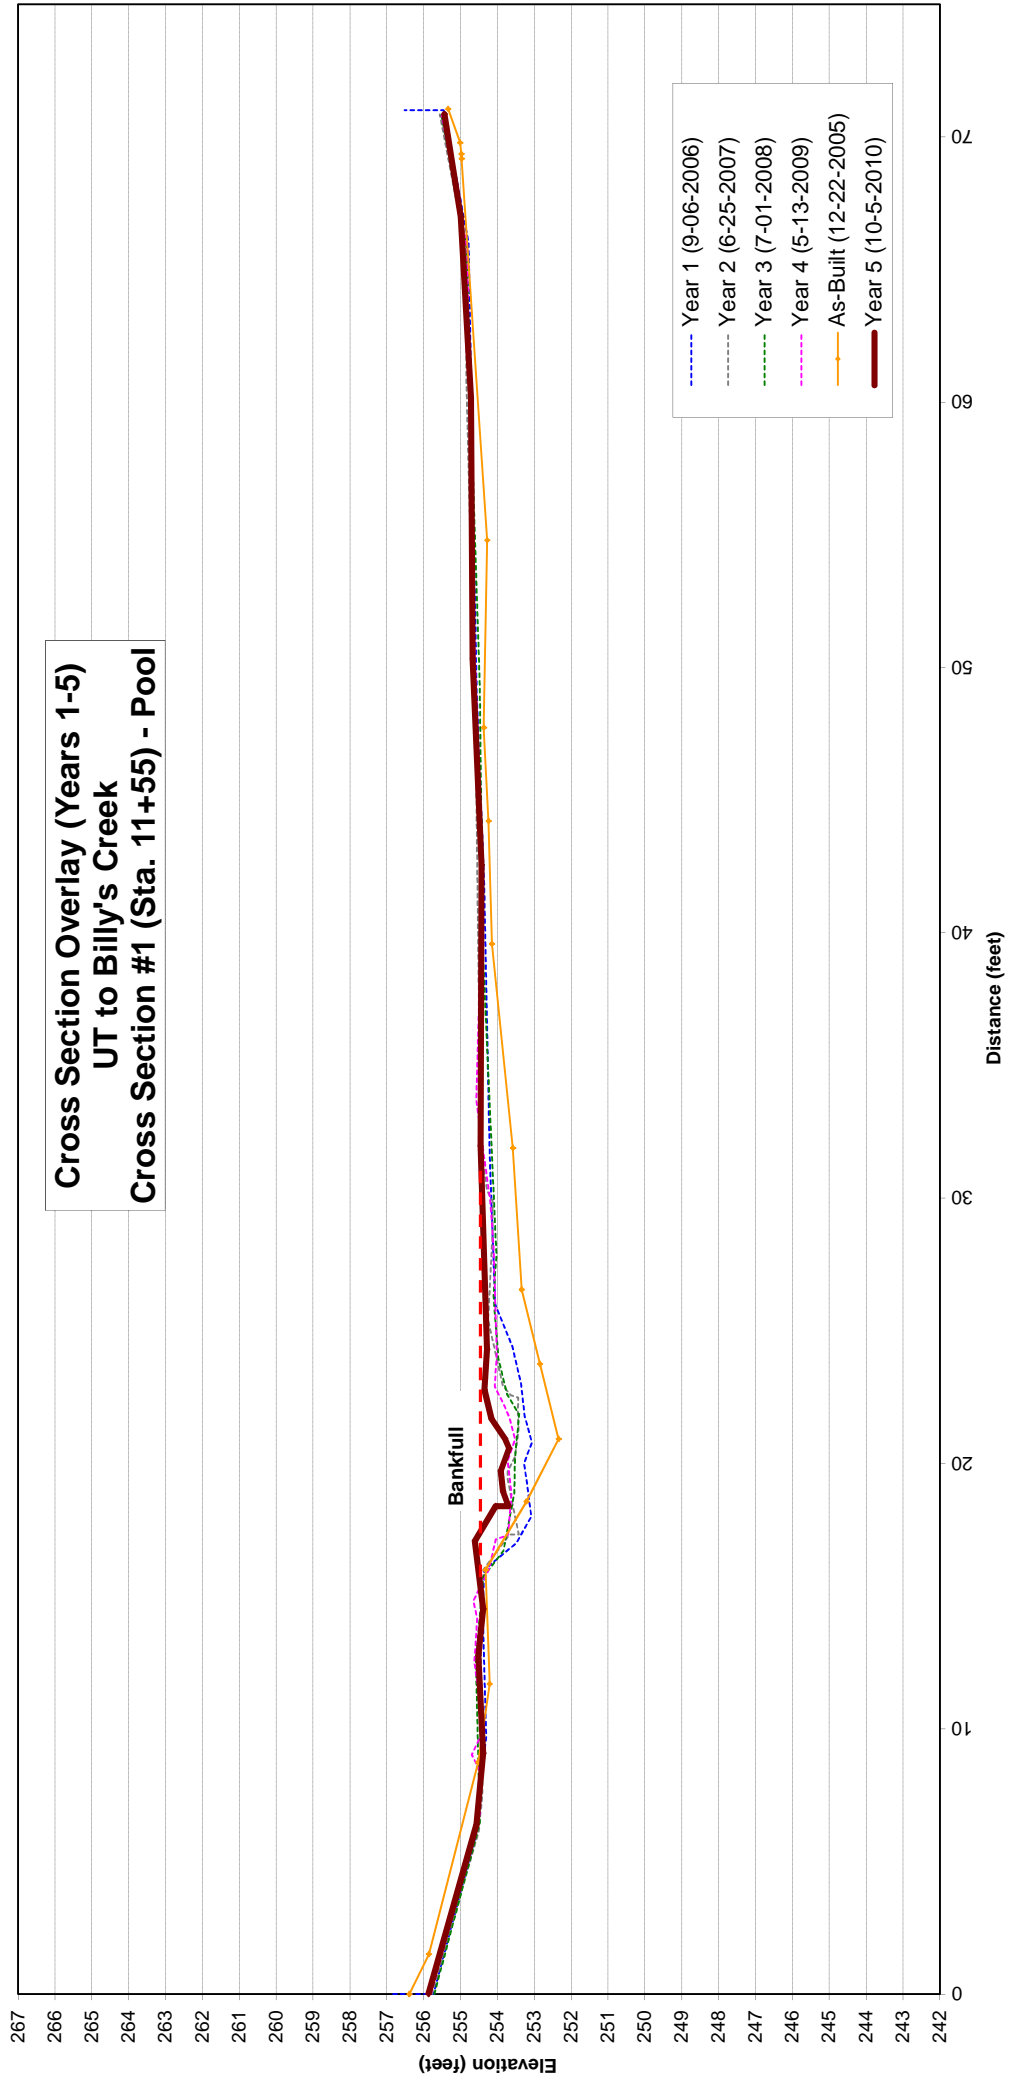
**Cross Section Overlay (Years 1-5)  
 UT to Billy's Creek  
 Cross Section #1 (Sta. 11+55) - Pool**

The majority of the UT Billy's Creek restoration reach remained stable through Monitoring Year 5 with the exception of a 384 foot section of sand deposition at the upstream end of the reach (Station 10+00 to 13+84). Excess sand deposition has completely filled the channel and blanketed out over the floodplain making it very difficult to locate the main channel in the upstream-most 150 feet due to braiding. This deposition has changed the channel dimension and profile significantly over the monitoring period. Cross Section 1 (Station 11+55) clearly shows a steady streambed elevation rise through Monitoring Year 5 that is likely correlated with this deposition. Furthermore, the Monitoring Year 5 bankfull cross sectional area of Cross Section 1 was the lowest documented compared to the four previous monitoring years. Approximately 15% of the channel has aggraded (primarily the upper section) or has significant bed deposition
