Blair Creek Stream Mitigation Project

Year 1 (2022) Monitoring Report FINAL

Clay County, North Carolina

DMS Project ID No. 100047

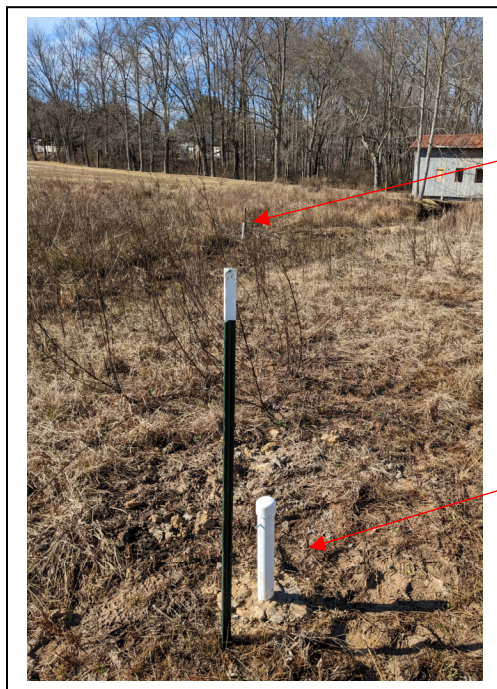
- It was noted in MY0 that GW-1 was installed in a non-representative area for the surrounding wetland reestablishment area. Baker committed to moving the gauge approximately 15-20' farther away from the channel. The gauge location shown on the CCPV appears to be the original location. Please verify that the gauge was moved and update the CCPV accordingly.

RESPONSE: GW-1 was not moved; however, an additional well (GW11) was installed in a more representative location during MY1. The installation did not take place until late in the 2022 growing season, therefore data was not reported in MY1. All future monitoring years will include GW1 and GW11 data. The location of GW11 is shown on the CCPV. The photo below shows GW11 and GW1 is visible in the background.
