Blair Creek Stream Mitigation Project

Year 2 (2023) Monitoring Report FINAL

Clay County, North Carolina

DMS Project ID No. 100047

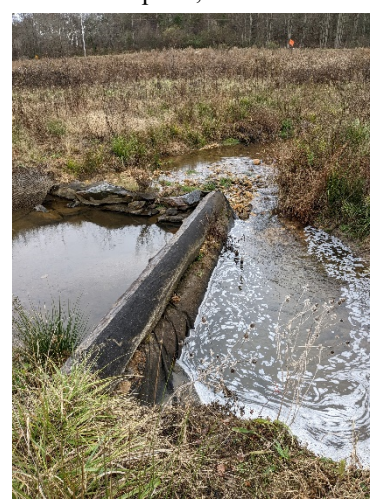
SPA1 (MY1) Before Repair. Photo
Taken November 11, 2022 (MY2)

- SPA1 and SPA2 were repaired in July 2023. Please call out the location of these two repaired areas on the CCPV and update Table 2 to include the repair.

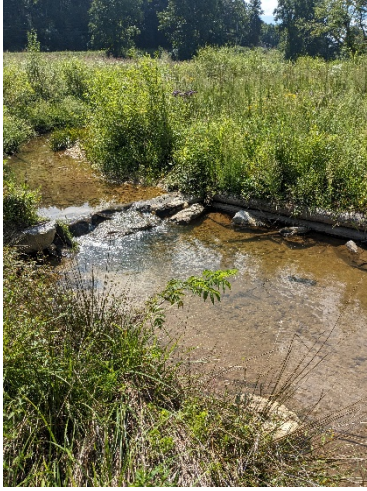
SPA1 (MY1) After Repair. Photo
Taken September 19, 2023 (MY2)

The Year 2 monitoring survey data of the fifteen permanent cross-sections indicates that the stream transects are geomorphically stable and in-stream structures are performing as designed. Minor fluctuations to vertical and lateral constraints are expected as the channel evolves; however, all reaches are stable and performing as designed. XS-14 may have experienced some hydraulic changes due to the scour created from Stream Problem Area 1, although this scour has since been repaired and XS-14 will be monitored closely during MY3 for stability. Stream Problem Areas (SPA1 and SPA2) were repaired in July 2023 and are functioning as intended.

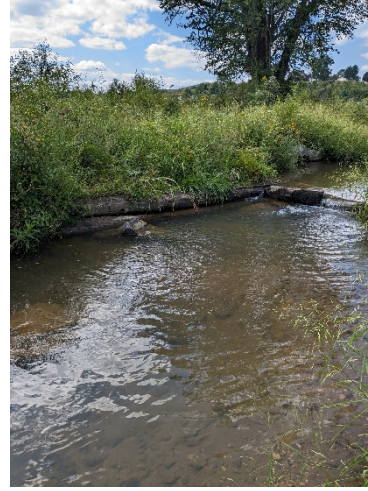
SPA2(MY1) After Repair. Photo
Taken September 19, 2023 (MY2)
