Blockhouse Creek Restoration Project

Year 1 Monitoring Report

Polk County, North Carolina

Date Submitted: November 2009

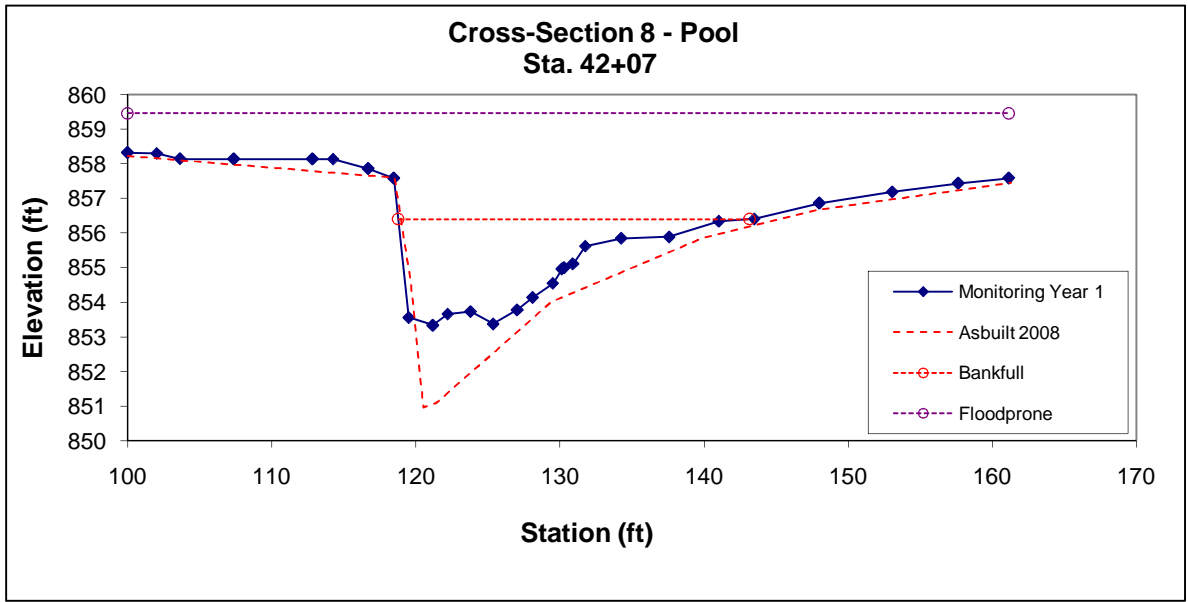
Photo 26: XS-8 facing right bank

A concern that was located at a specific point is at cross-section 8 in Reach 4 of Blockhouse Creek. The bank behind a rootwad located in one of the last meanders of the project area required some minor repair work due to soil subsidence. The loss of bank occurred due to stream flow under the rootwad eroding soil from around the trunk of the rootwad creating a “sinkhole” in an area of approximately 5 feet by 5 feet. Loss of soil at the base of the rootwad and overland flow resulted in a small “sinkhole” being created behind the rootwad. To remedy the problem, 10 to 14 inch rock was placed at the base of the hole and this was covered with a geotextile, backfilled, re-seeded and the area was mated.

Bank repair work was performed on one isolated section in Reach 4 of Blockhouse Creek where soil subsidence had created a “sink hole” behind rootwads near cross-section 8. The unstable area, was approximately 5 feet in length, and was the result of soil erosion beneath a rootwad that was previously installed. Bank repairs were minor and consisted of placing rock in the base of the hole, covering this with a geotextile, backfilling, re-seeding and matting the area.
