Blockhouse Creek Mitigation Project

Year 2 Monitoring Report-Final

Polk County, North Carolina

Date Submitted: October 2010

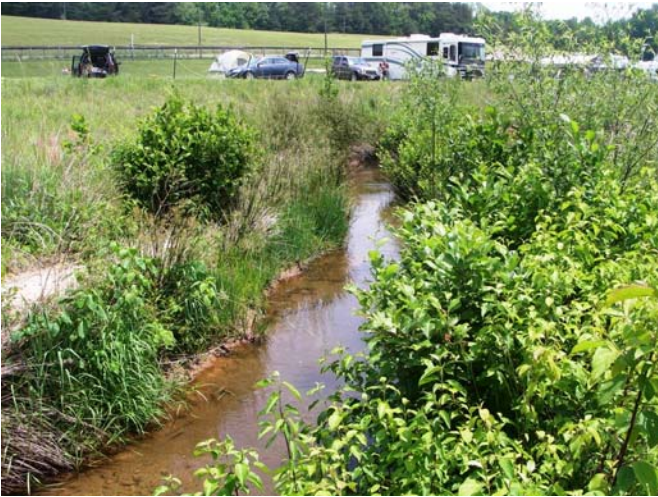
Photo Point 1: facing downstream-past large shrub at photo pt.
