# Blockhouse Creek Mitigation Project

## Year 4 Monitoring Report

### Polk County, North Carolina

Contract Number: D06027-A, NCEEP Project #92516

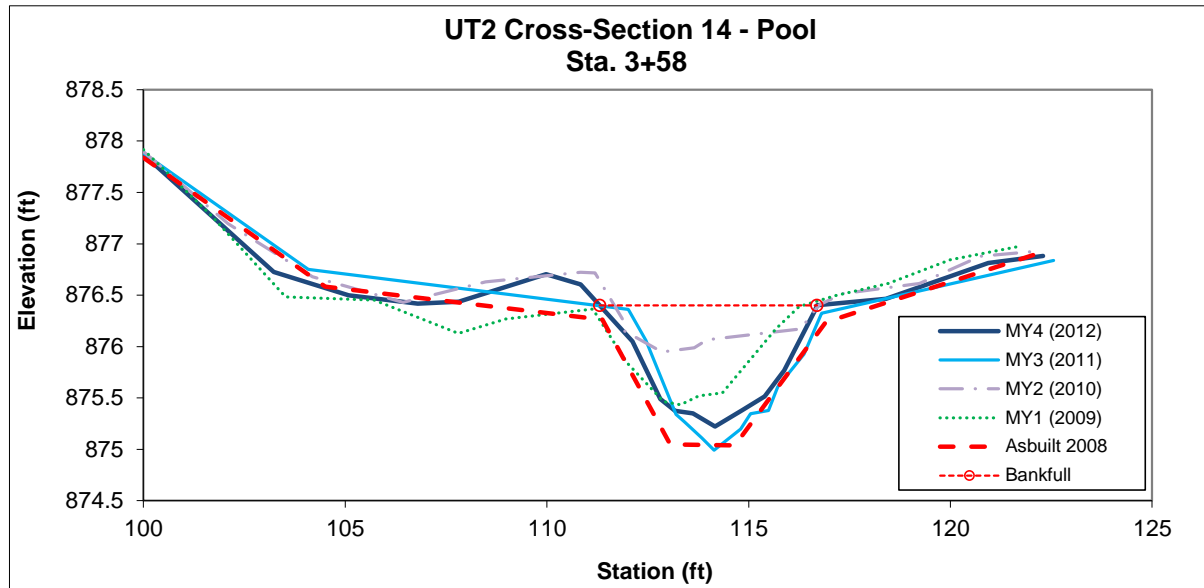
Photo 53: XS-14 facing right bank

Sometime between the as-built survey and Year 2 monitoring, a tree came down at Cross-section 14 on UT2, contributing to local aggradation along this subreach of UT2. The tree was removed during Year 2 monitoring and the aggraded material was transported downstream on high flows, returning the channel to dimensions that are similar to the As-built condition. The last cross-section on UT2, Cross-section 16, shows deposition on the inside of a meander as a result of bankfull conditions experienced at the Site over the course of the monitoring period. This has developed a nice, vegetated point bar on this meander. Cross-sections surveyed during Year 4 monitoring did not indicate any notable changes in dimension compared to Year 3 monitoring conditions and appeared to be stable due to properly constructed dimensions, in-stream structures, adequate bank sloping and developing vegetation.
