FINAL
YEAR 1 (2016) ANNUAL
MONITORING REPORT

BOBS CREEK
STREAM MITIGATION SITE

NCDMS Project No. 92879
Contract No. D09023S
USACE Action ID No. SAW-2009-917 & NCDWR Project No. 10-0122
SCO No. 08-07308-01
McDowell County, North Carolina

Data Collection: May-November 2016
Submission: January 2017

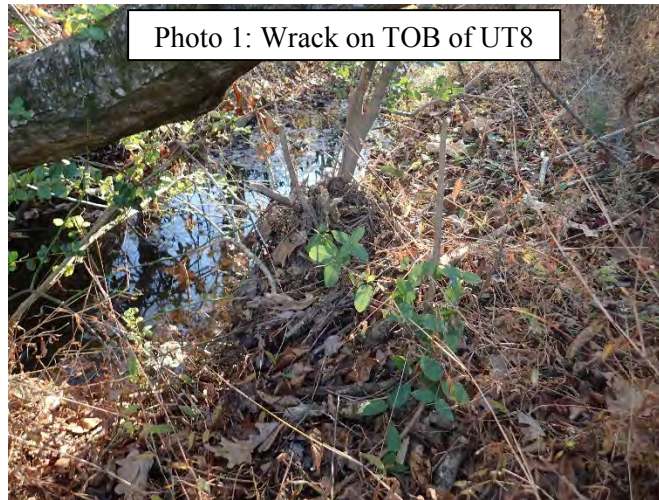
Date of Data Collection	Date of Occurrence	Method	Photo (if available)
August 17, 2016	July 4, 2016	Crest gauge data along with wrack observed on the TOB of UT8 indicate a bankfull event after approximately 1.88 inches of rain documented* in one day.	1
