**FINAL**  
**YEAR 3 (2018) ANNUAL**  
**MONITORING REPORT**

**BOBS CREEK**  
**STREAM MITIGATION SITE**

NCDMS Project No. 92879  
Contract No. D09023S  
USACE Action ID No. SAW-2009-917 & NCDWR Project No. 10-0122  
SCO No. 08-07308-01  
McDowell County, North Carolina

Data Collection: May-November 2018  
Submission: November 2018

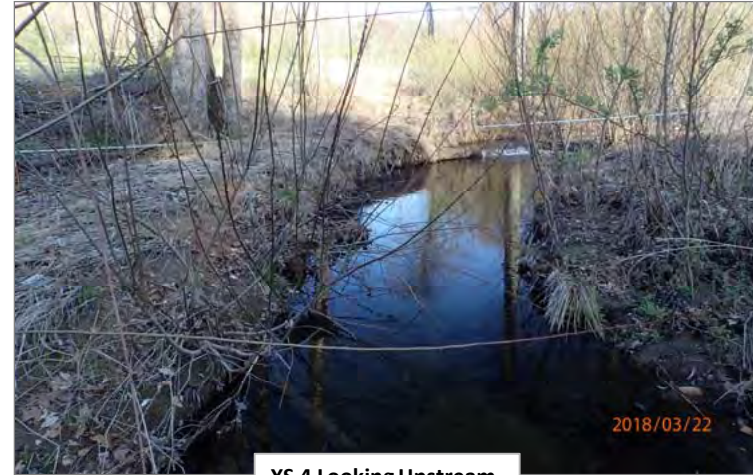
XS 4 Looking Upstream

SUMMARY DATA	
<b>Bankfull Elevation:</b>	1231.5
<b>Bankfull Cross-Sectional Area:</b>	20.7
<b>Bankfull Width:</b>	12.6
<b>Flood Prone Area Elevation:</b>	1233.9
<b>Flood Prone Width:</b>	150.0
<b>Max Depth at Bankfull:</b>	2.4
<b>Low Bank Height:</b>	2.9
<b>Mean Depth at Bankfull:</b>	1.6
<b>W / D Ratio:</b>	7.7
<b>Entrenchment Ratio:</b>	11.9
<b>Bank Height Ratio:</b>	1.2

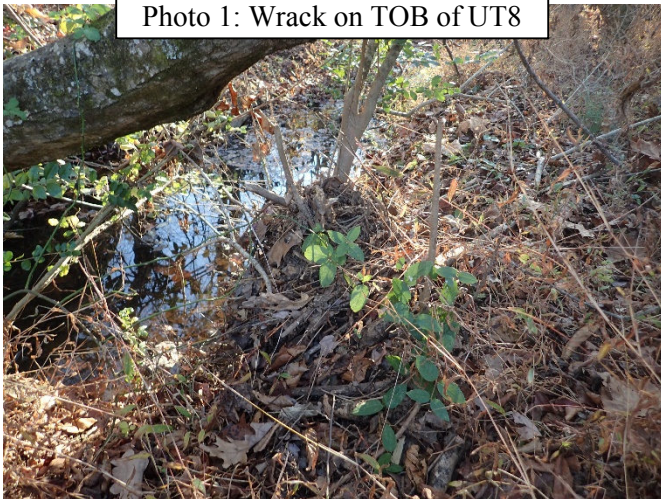
Date of Data Collection	Date of Occurrence	Method	Photo (if available)
August 17, 2016	July 4, 2016	Crest gauge data along with wrack observed on the TOB of UT8 indicate a bankfull event after approximately 1.88 inches of rain documented* in one day.	1
May 17, 2017	April 23, 2017	Crest gauge data indicates a bankfull event after approximately 1.76 inches of rain documented* in one day.	--
May 9, 2018	April 24, 2018	Crest gauge data along with wrack observed on the floodplain of UT8 indicate a bankfull event after 3.89 inches of rain documented** over two days.	2
September 25, 2018	September 16, 2018	Crest gauge data indicates a bankfull event after 2.42 inches of rain** resulting from the remnants of Hurricane Florence.	--
November 8, 2018	October 11, 2018	Crest gauge data indicates a bankfull event after 2.79 inches of rain** resulting from the remnants of Hurricane Michael.	--

Photo 1: Wrack on TOB of UT8

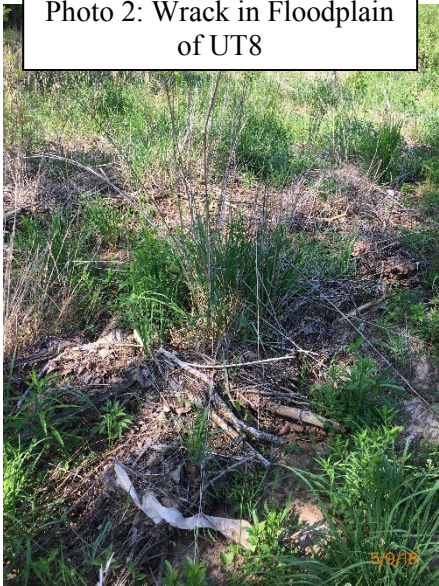
Photo 2: Wrack in Floodplain of UT8
