FINAL
YEAR 4 (2019) ANNUAL
MONITORING REPORT

BOBS CREEK
STREAM MITIGATION SITE

NCDMS Project No. 92879
Contract No. D09023S
USACE Action ID No. SAW-2009-917 & NCDWR Project No. 10-0122
SCO No. 08-07308-01
McDowell County, North Carolina

Data Collection: May-November 2019
Submission: January 2020

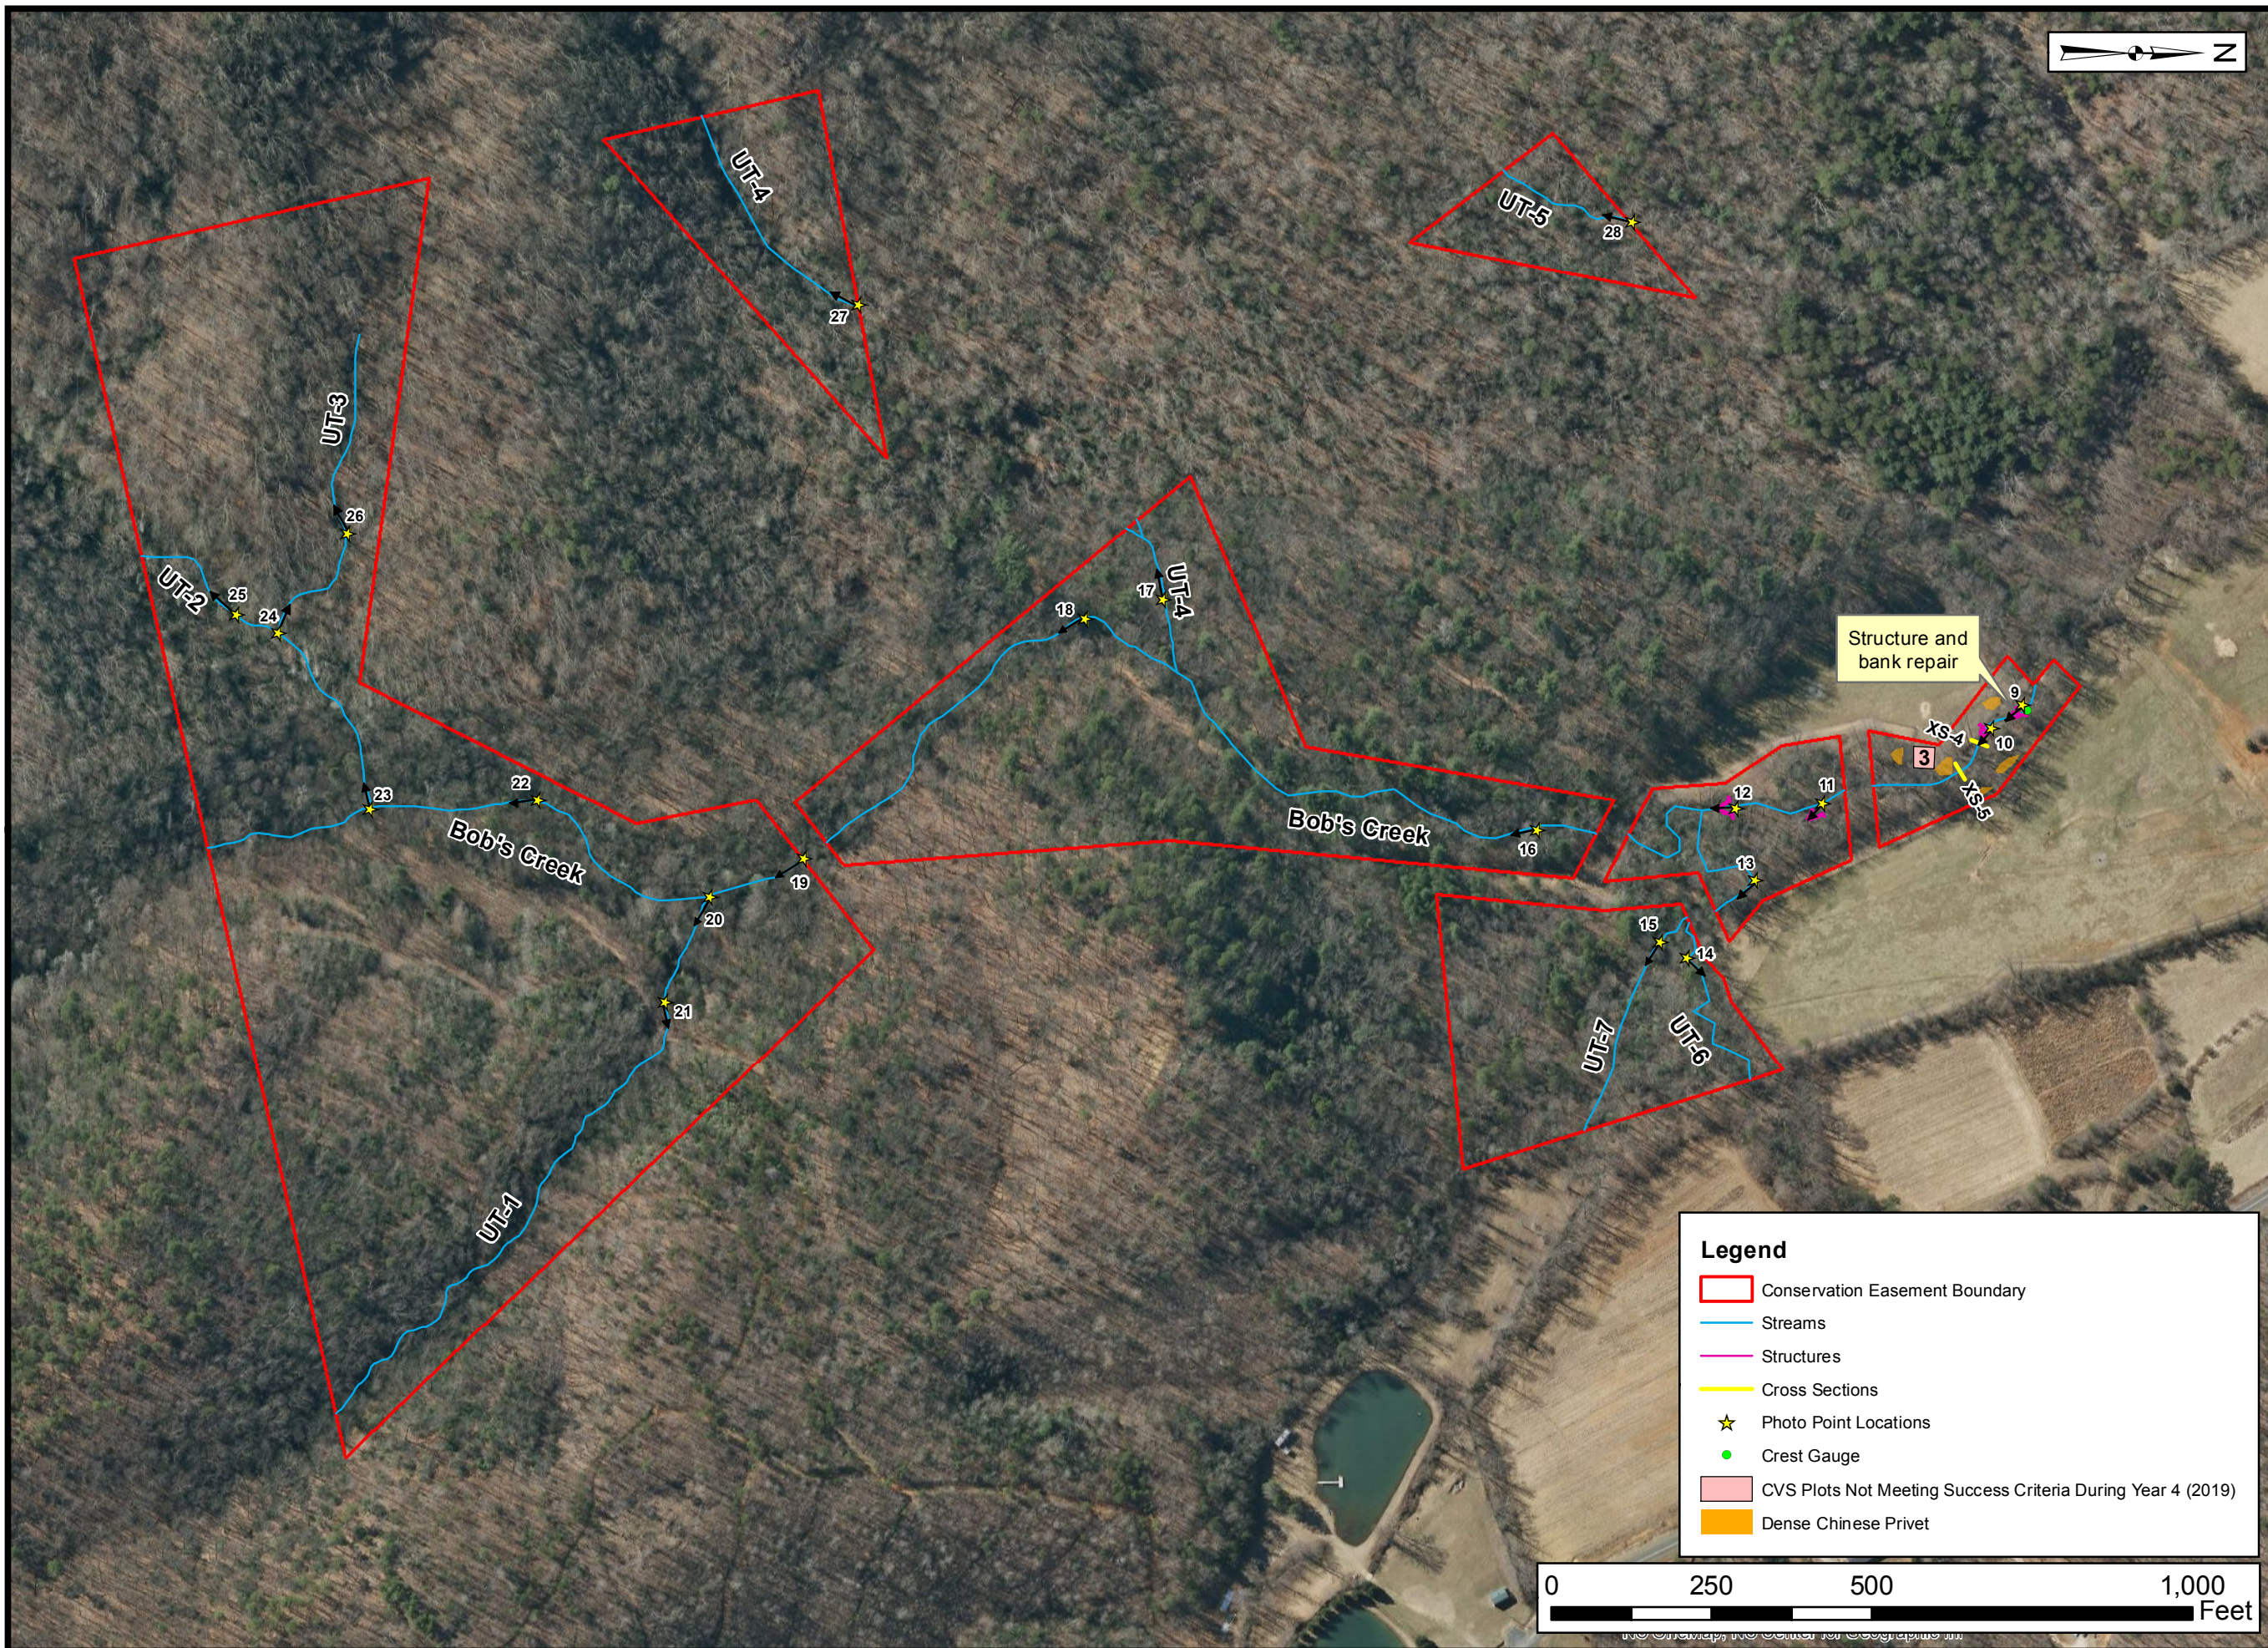
One stream area of concern was observed during year 4 (2019) monitoring. A log cross vane on the downstream reach of UT-8 to Bobs Creek is compromised and appears to be piping (Area of Concern #1). This currently does not appear to be an immediate threat to stream stability, but it is not functioning as designed. This stream area of concern is depicted on Figure 2A (Appendix B). Year 4 (2019) stream measurements indicate that site streams are meeting success criteria.

- CCPV: Please add location of repaired structure to CCPV and callout (see attached map)
A callout was added to point out the repaired structure on figure 2B.

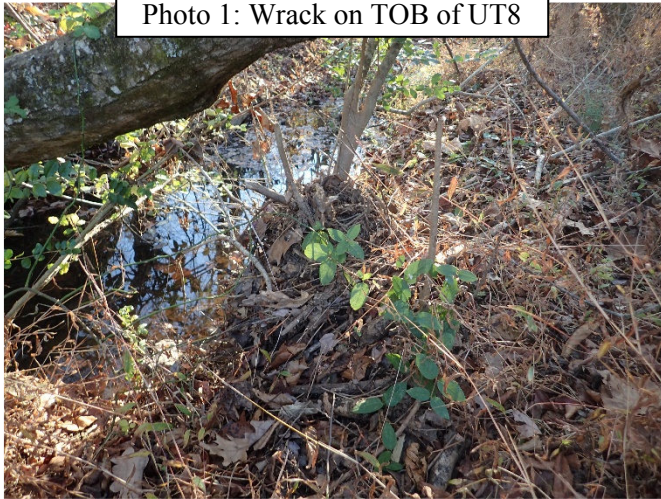
Photo 1: Wrack on TOB of UT8

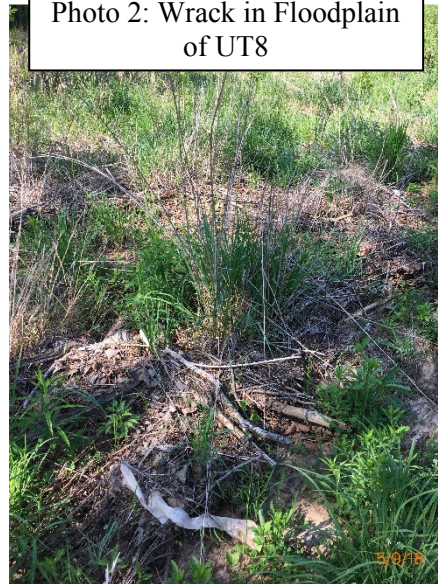
Photo 2: Wrack in Floodplain of UT8

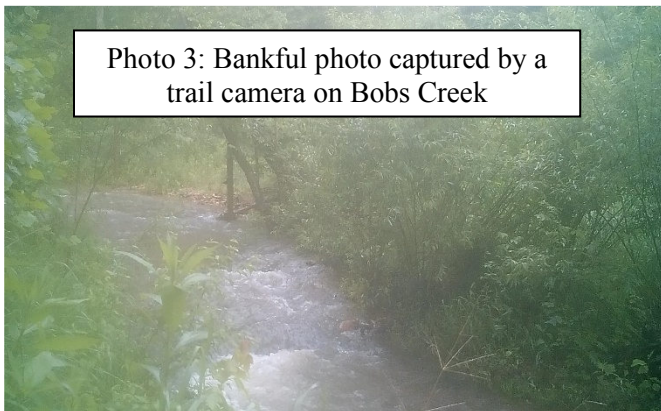
Photo 3: Bankful photo captured by a trail camera on Bobs Creek
