**FINAL**  
**YEAR 5 (2020) ANNUAL**  
**MONITORING REPORT**

**BOBS CREEK**  
**STREAM MITIGATION SITE**

NCDMS Project No. 92879  
Contract No. D09023S  
USACE Action ID No. SAW-2009-917 & NCDWR Project No. 10-0122  
SCO No. 08-07308-01  
McDowell County, North Carolina

Data Collection: May-November 2020  
Submission: January 2021

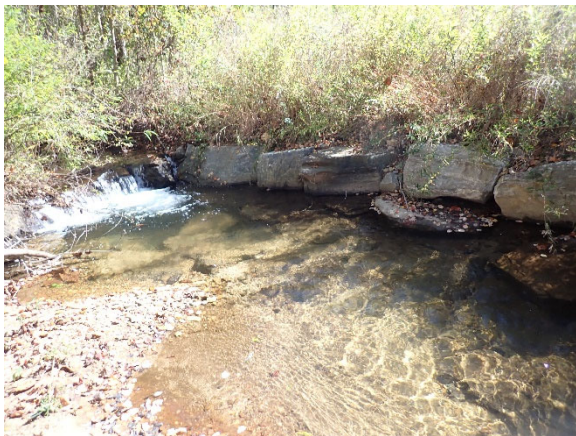
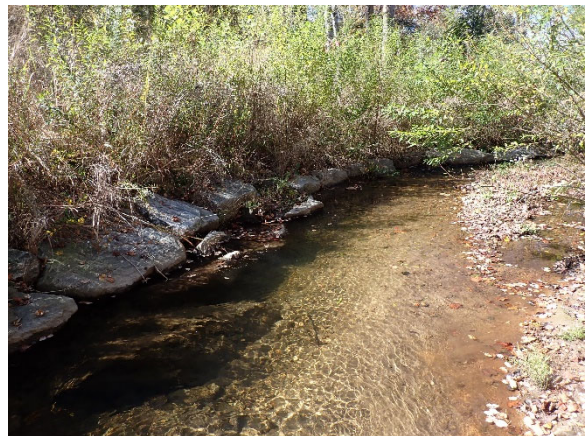
Early in Year 1 (2016), several structures were damaged and surrounding streambanks were eroded by significant storm events that occurred shortly after Site construction. Warranty repair work was completed in October 2016 to address these issues. Additionally, during year 3 (2018), approximately 60 feet of an outer bend on the downstream reach of Bobs Creek had become heavily eroded, and several boulders from a rock cross-vane structure had become dislodged and had fallen into the stream. This area was repaired by NCDMS during March of 2019. The repaired structure and bank appear stable and well-vegetated during years 4-5 (2019-2020) (see photos below).

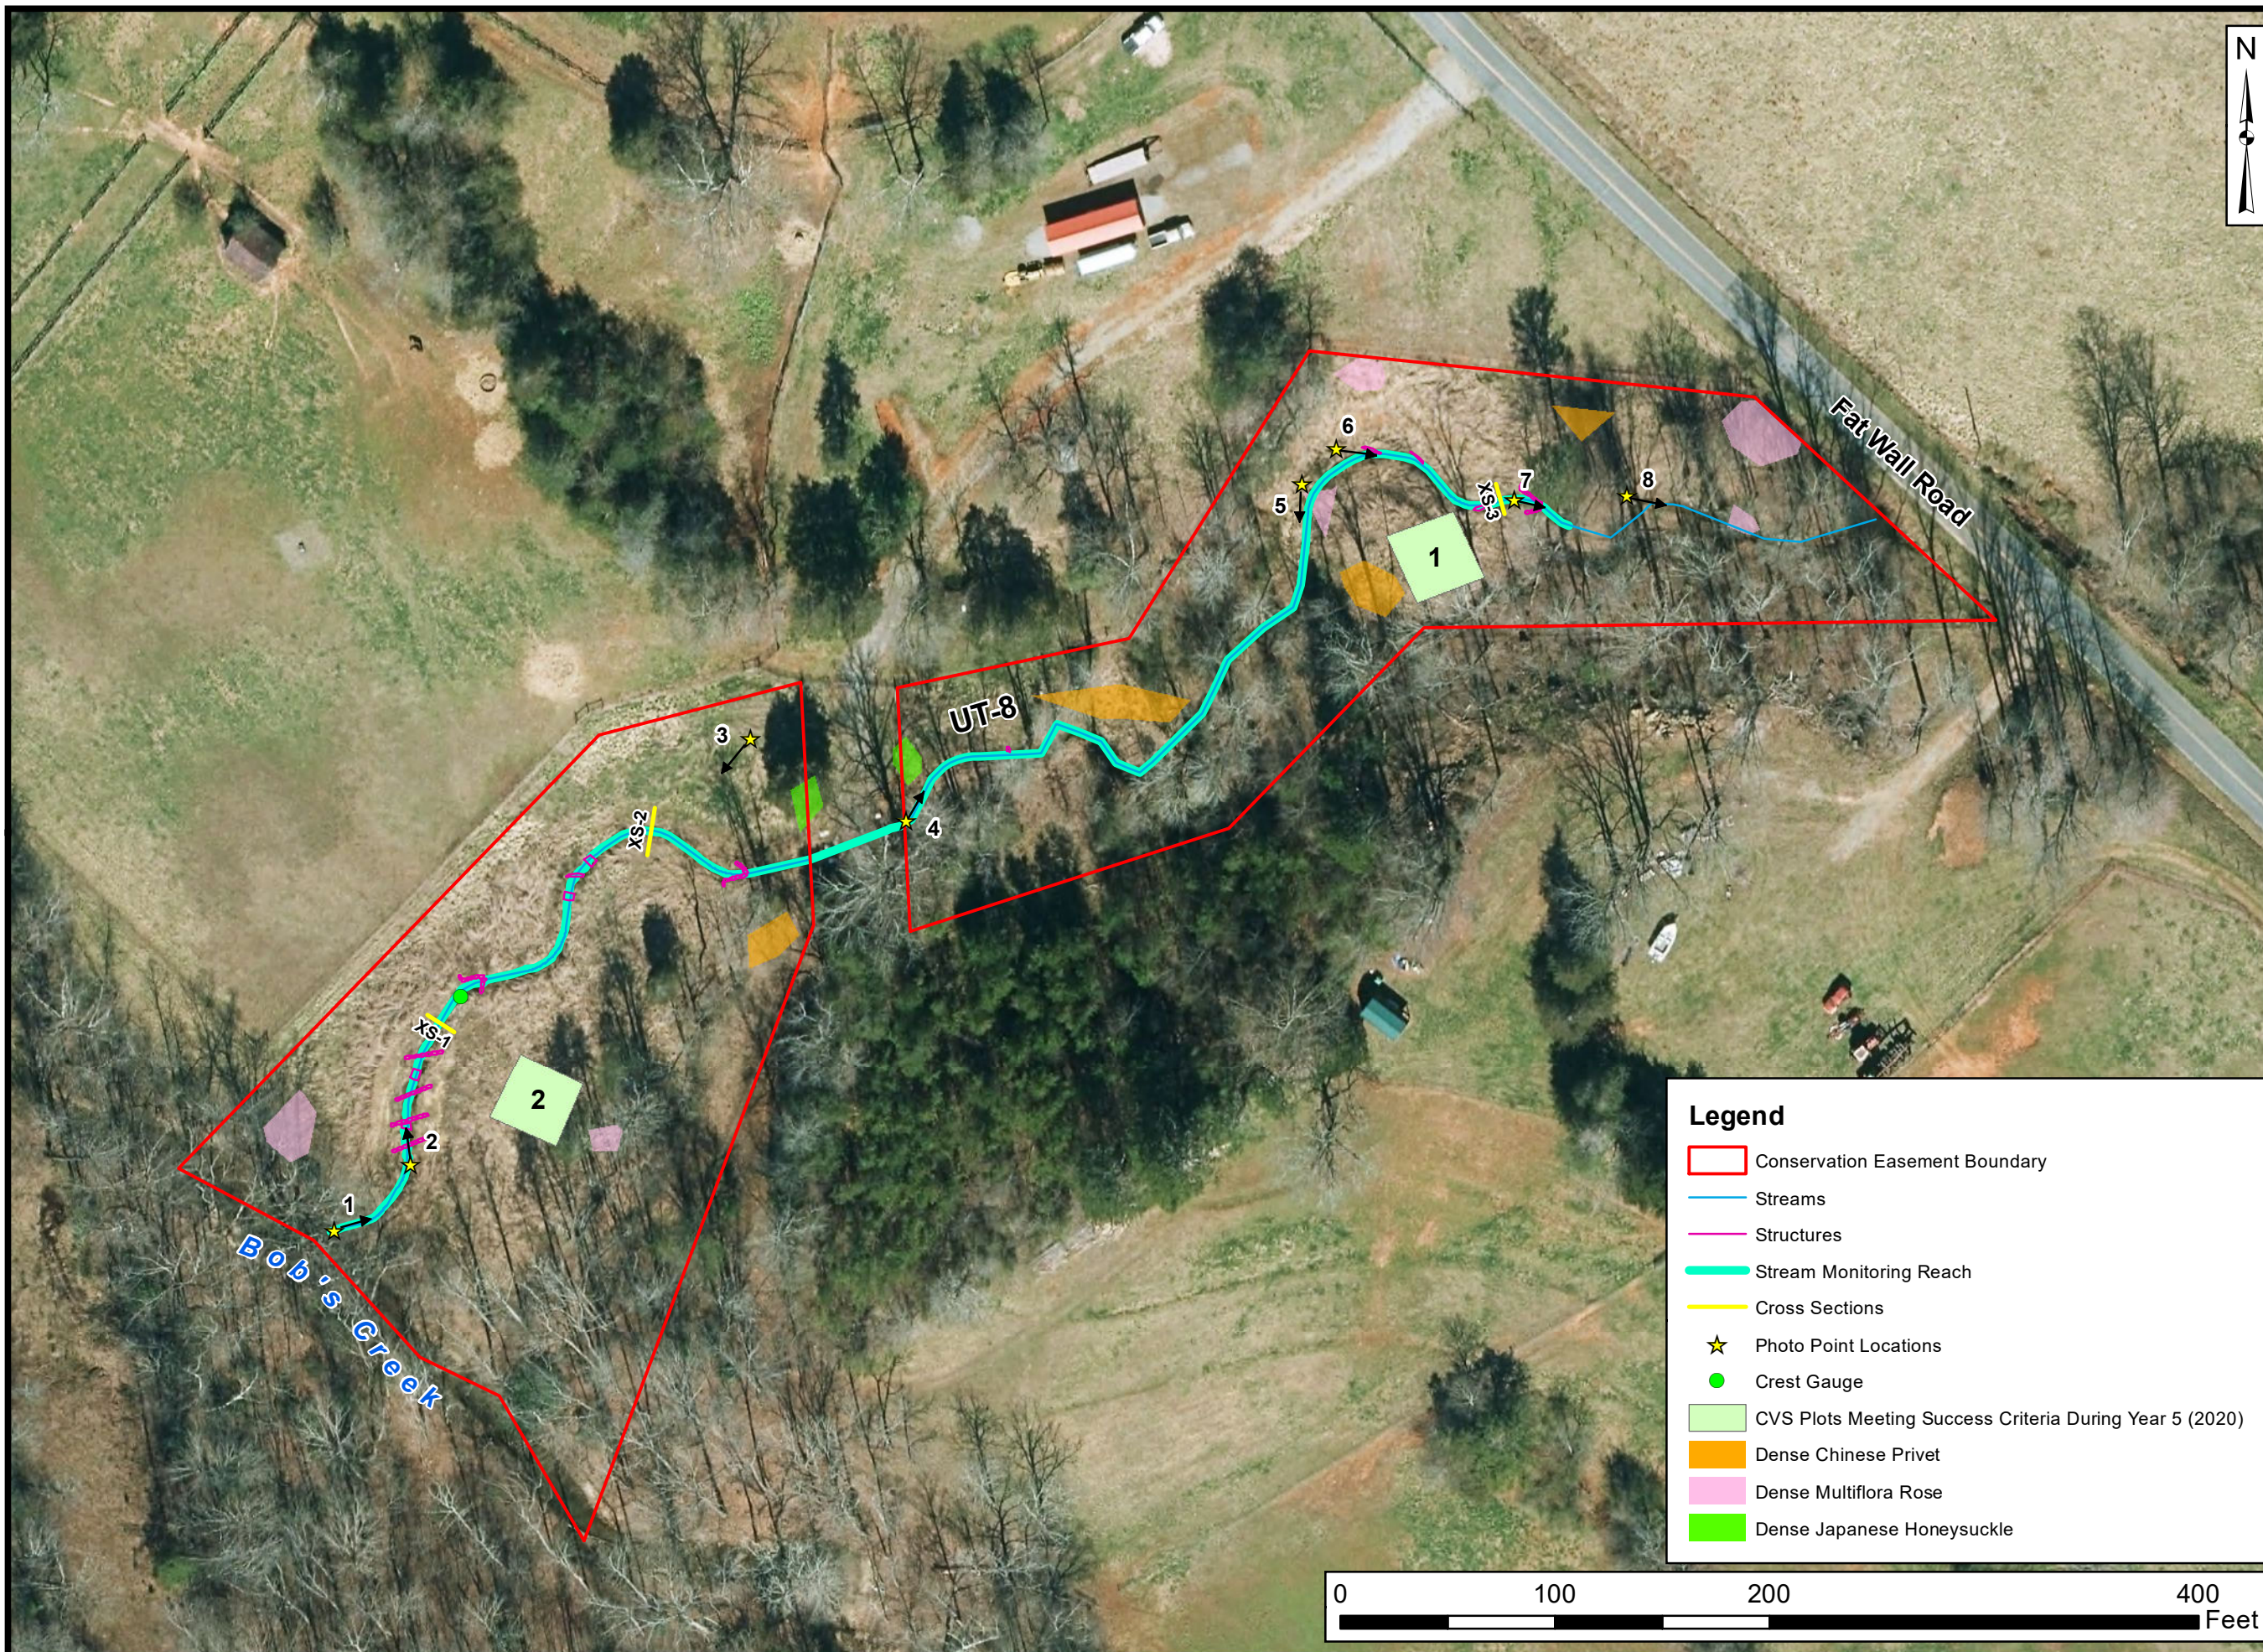
FIGURE  
**2A**

Efforts to address invasive species throughout restoration reaches have been very effective, however, several small but dense populations remain. Nine populations of Chinese privet (*Ligustrum sinense*) were observed onsite; four along the upper portion of UT-8, and five along the lower portion of Bobs Creek. Additionally, nine populations of multiflora rose (*Rosa multiflora*), six along UT-8 and three along Bobs Creek; and two populations of Japanese honeysuckle (*Lonicera japonica*) were observed along UT-8 (Figures 2A-B, Appendix B). A few additional stems of privet and multiflora rose were observed scattered throughout Site restoration reaches in quantities below mapping thresholds. NCDMS has implemented an invasive management plan that will continue through closeout. The report summarizing the treatment methods has been included in Appendix F.

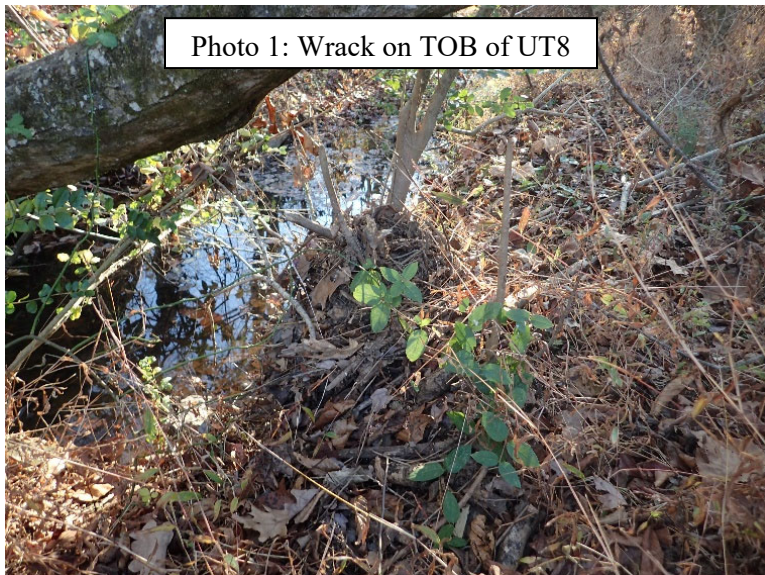
Photo 1: Wrack on TOB of UT8

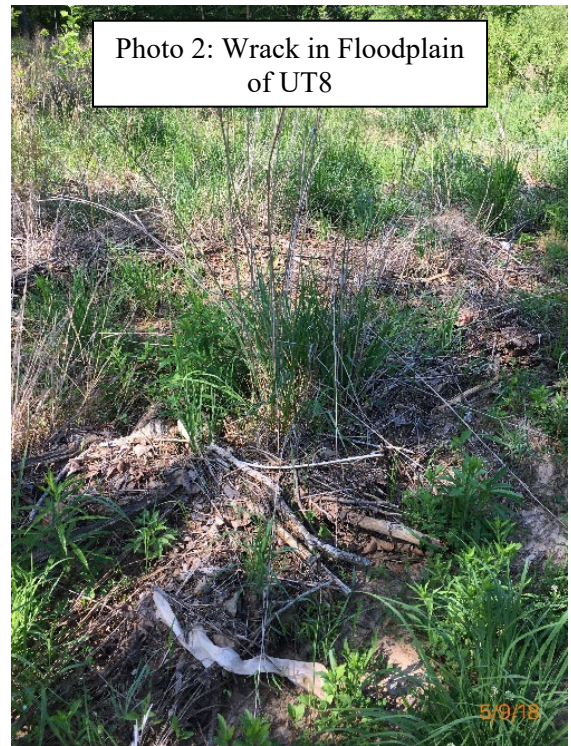
Photo 2: Wrack in Floodplain of UT8

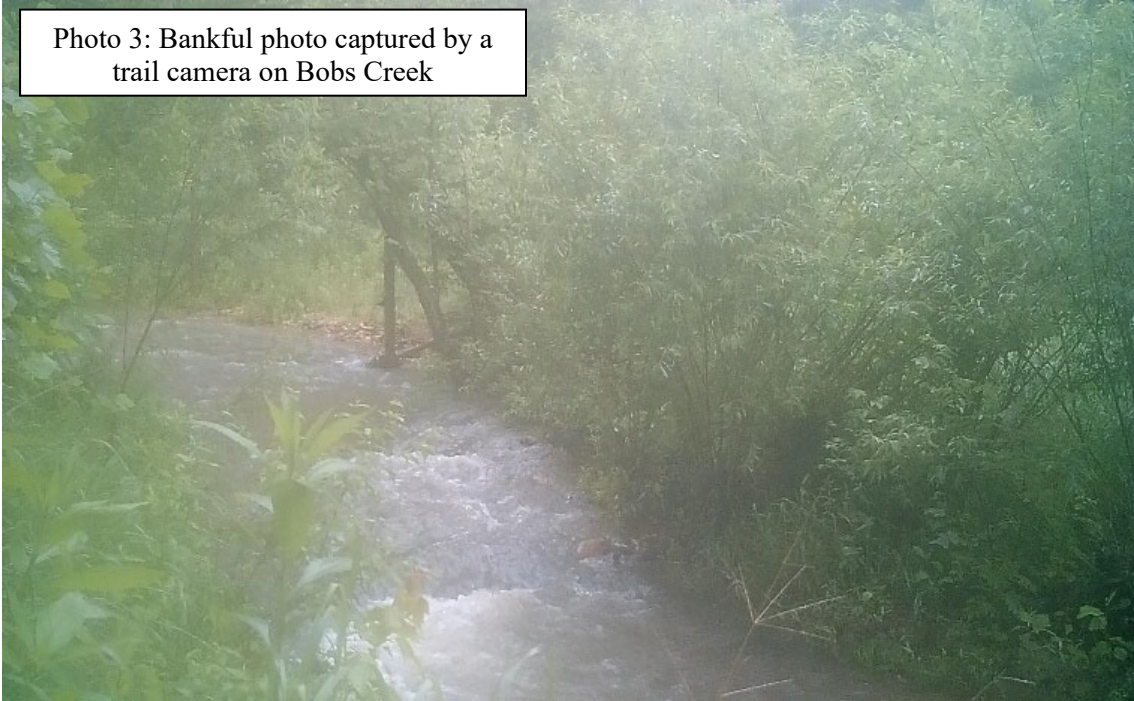
Photo 3: Bankful photo captured by a trail camera on Bobs Creek

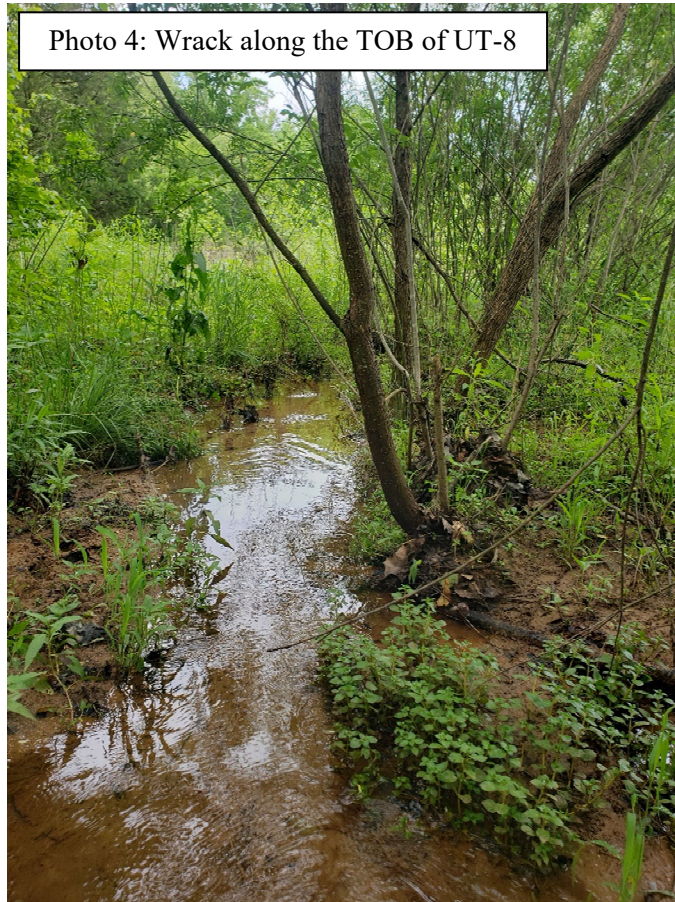
Photo 4: Wrack along the TOB of UT-8
