As-Built Baseline Monitoring Report

Bohemian Mitigation Project

DMS Project #: 100108 | Contract #: 7863 | DWR # 2019-1403 | RFP: 16-007703

Randolph & Guilford Counties, North Carolina
Cape Fear River Basin
Randleman Lake Watershed
HUC 03030003

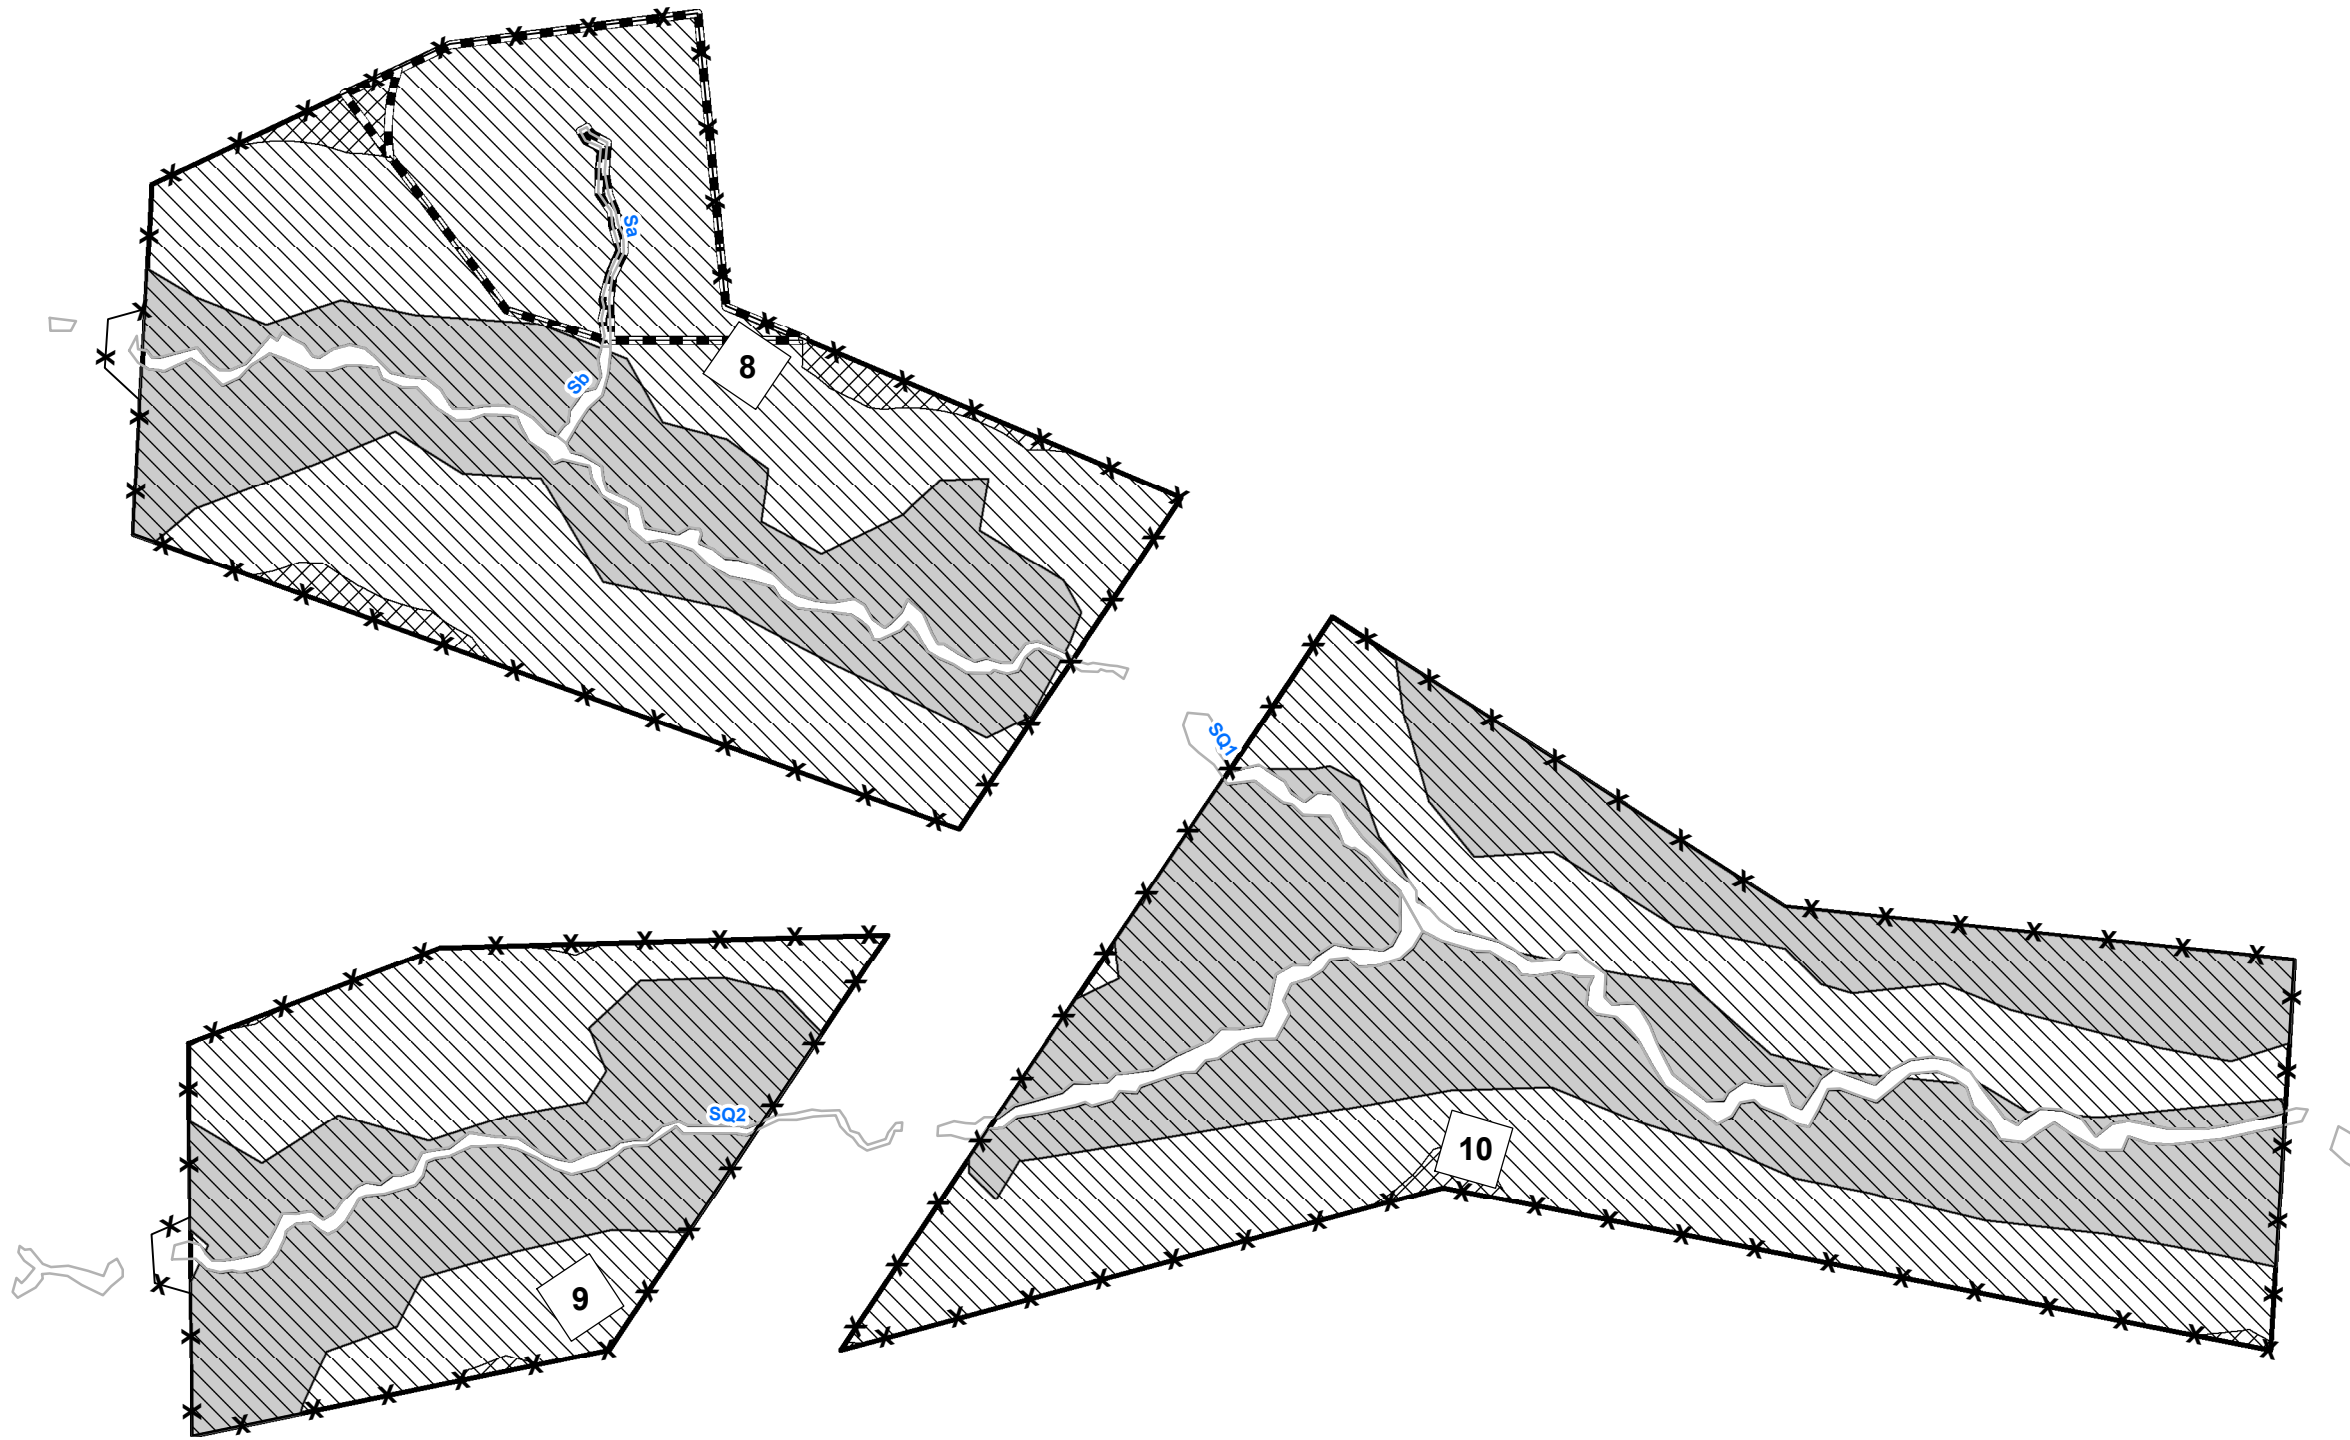
Figure 3b
As-Built Map (Bohemian East)
 MY0 2020
Bohemian Mitigation Project
 Guilford and Randolph Counties, North Carolina

4. Figure 3b – Any fencing installed at the site should be shown on the As-built Map.

[Done.](#)
