ANNUAL MONITORING REPORT BOLD RUN

STREAM AND BUFFER RESTORATION WAKE COUNTY, NORTH CAROLINA (EEP Project Number 439)

Monitoring Year 2 of 5 (2008)

December 2008

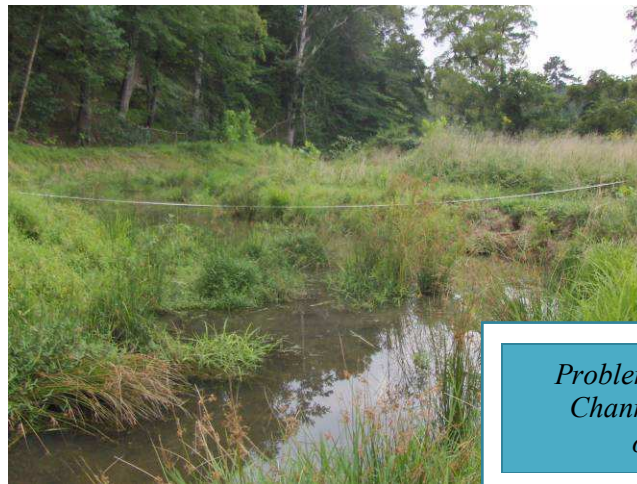
Feature Issue	Station Numbers	Suspected Cause	Photo
Outer bend bank erosion/channel widening	24+00	Lack of deep-rooted vegetation, downstream beaver activity	Problem Area Photos 1-2
Large beaver dam causing backwater effects	Immediately downstream of Site on Bold Run Creek	Beaver activity	Problem Area Photo 3

*Problem Area Photo 1-
Channel widening at
outerbend*

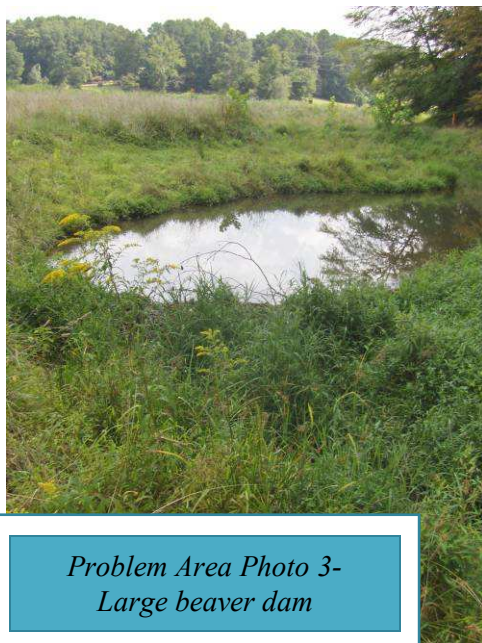
*Problem Area Photo 3-
Large beaver dam*

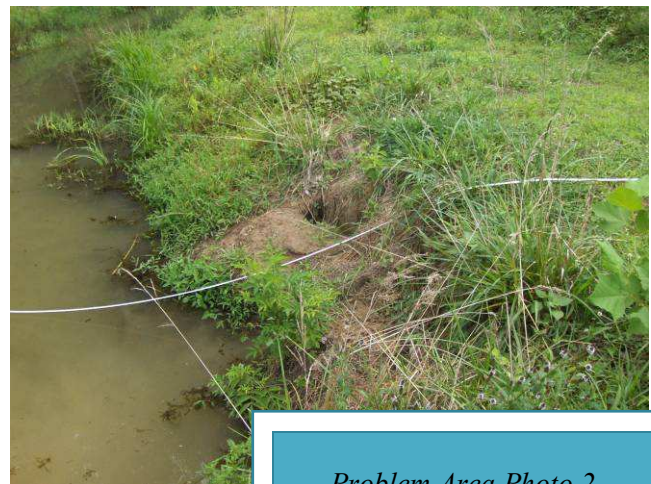
*Problem Area Photo 2-
Bank erosion*
