ANNUAL MONITORING REPORT BOLD RUN

STREAM AND BUFFER RESTORATION WAKE COUNTY, NORTH CAROLINA (EEP Project Number 439)

Monitoring Year 4 of 5 (2010)

February 2011

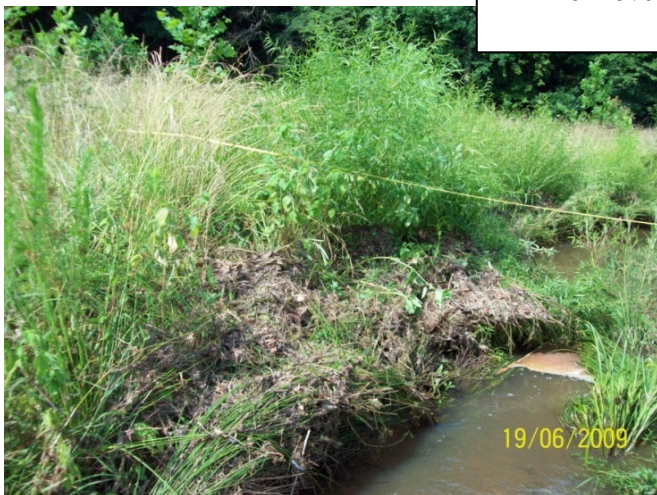
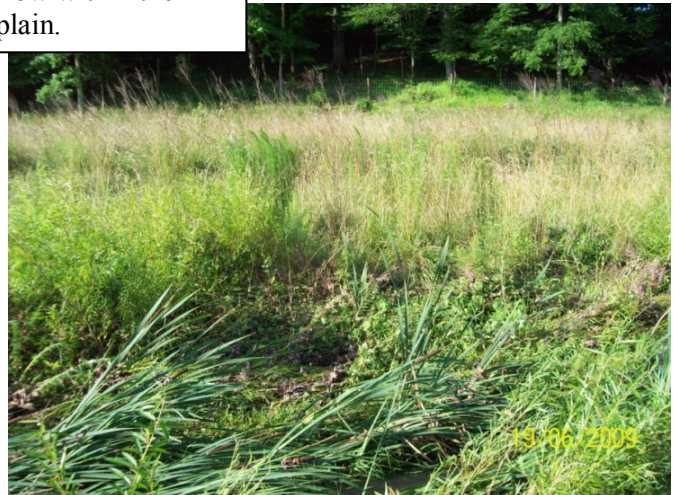
Bankfull Event Photos 1-2 showing evidence of overbank through wrack lines on banks and vegetation matted from overland flow within the floodplain.

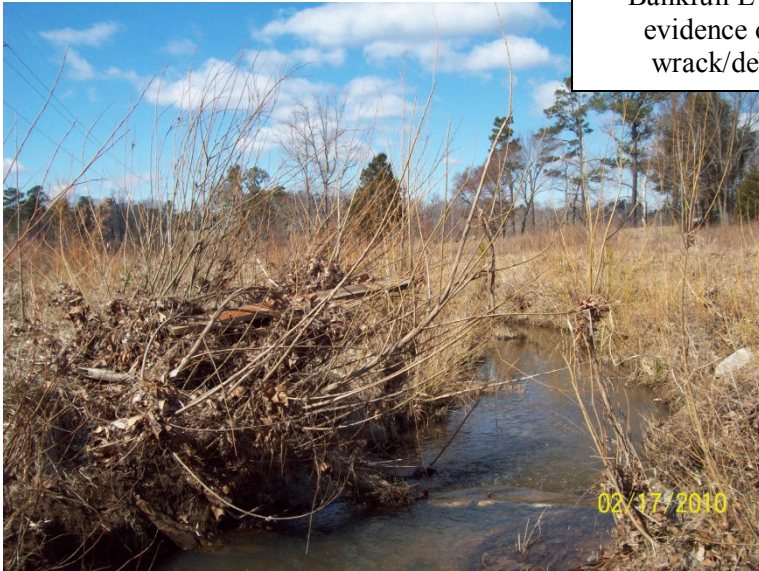
Bankfull Event Photo 3 showing evidence of overbank through wrack/debris lines on banks.

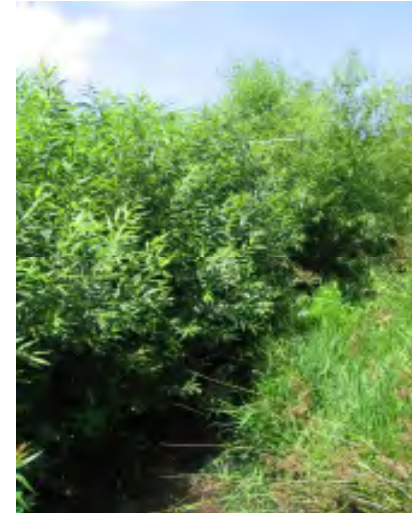
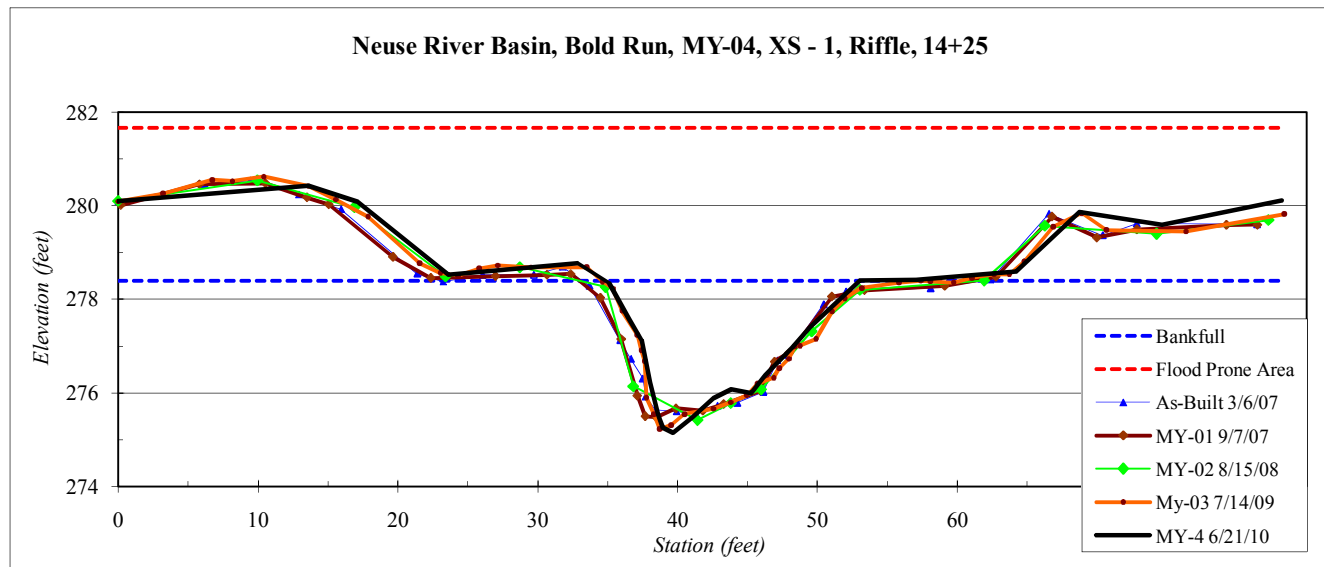
River Basin:	Neuse
Watershed:	Bold Run, MY-04
XS ID	XS - 1, Riffle, 14+25
Drainage Area (sq mi):	1.6
Date:	6/21/2010
Field Crew:	Dean, Perkinson

SUMMARY DATA	
Bankfull Elevation:	278.4
Bankfull Cross-Sectional Area:	31.1
Bankfull Width:	18.2
Flood Prone Area Elevation:	281.7
Flood Prone Width:	>80
Max Depth at Bankfull:	3.3
Mean Depth at Bankfull:	1.7
W / D Ratio:	10.7
Entrenchment Ratio:	>4
Bank Height Ratio:	1.0

Stream Type	E4
--------------------	----

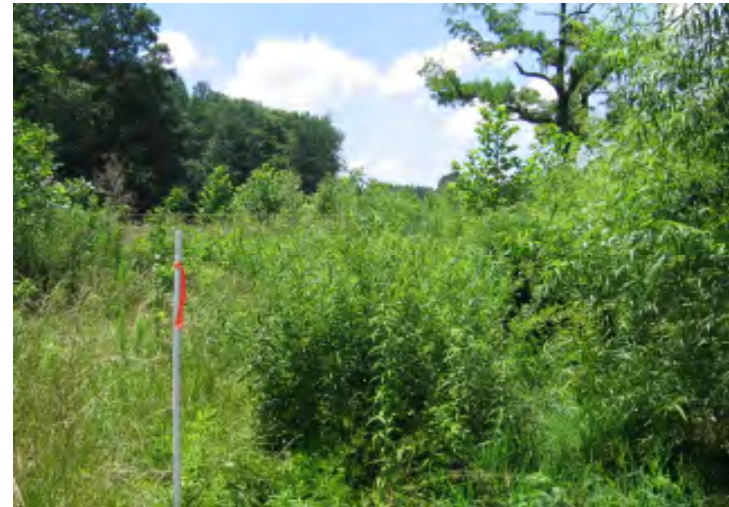
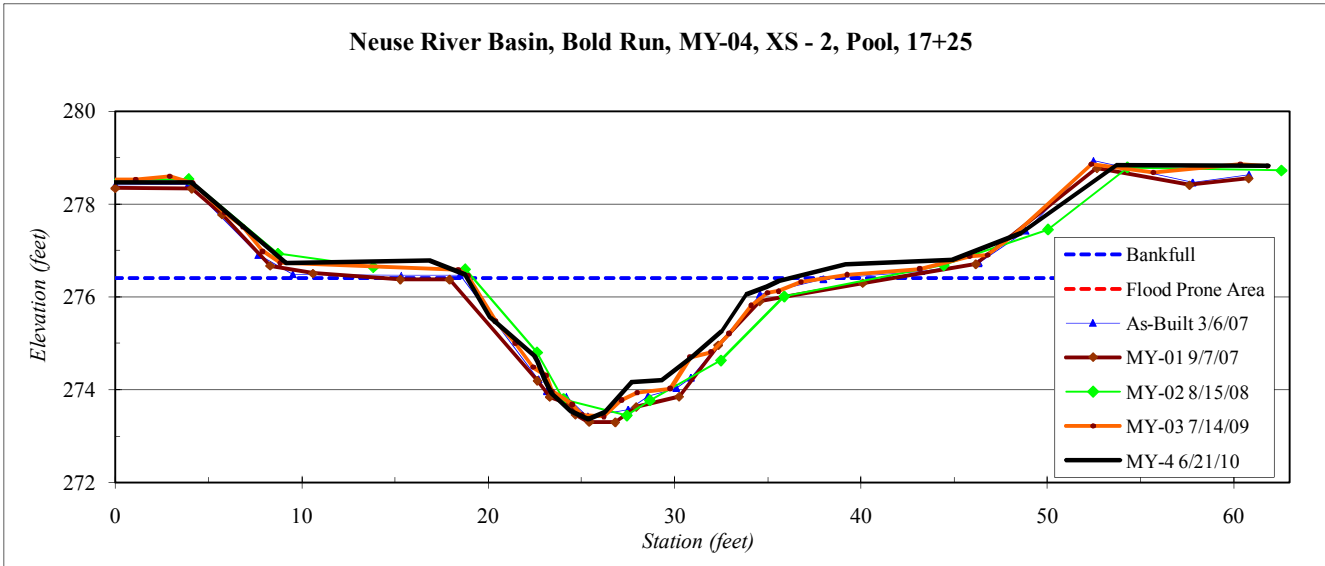
River Basin:	Neuse
Watershed:	Bold Run, MY-04
XS ID	XS - 2, Pool, 17+25
Drainage Area (sq mi):	1.6
Date:	6/21/2010
Field Crew:	Dean, Perkinson

Stream Type	E4
--------------------	----

SUMMARY DATA	
Bankfull Elevation:	276.4
Bankfull Cross-Sectional Area:	27.7
Bankfull Width:	17.4
Flood Prone Area Elevation:	-
Flood Prone Width:	-
Max Depth at Bankfull:	3.0
Mean Depth at Bankfull:	1.6
W / D Ratio:	-
Entrenchment Ratio:	-
Bank Height Ratio:	-

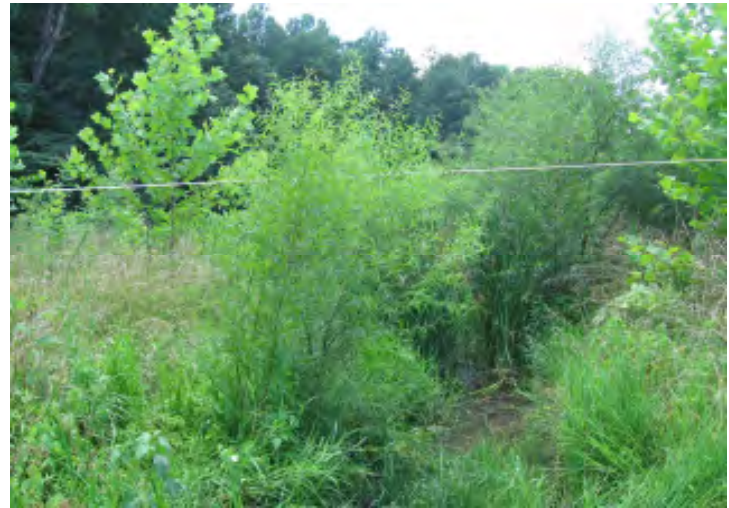
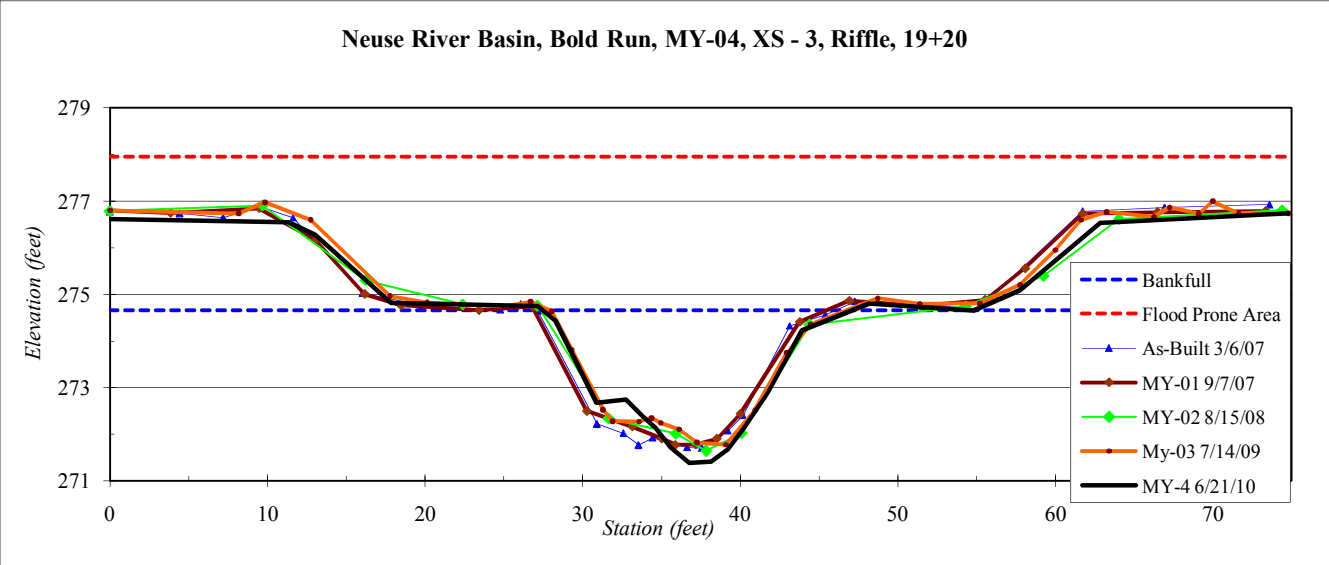
River Basin:	Neuse
Watershed:	Bold Run, MY-04
XS ID	XS - 3, Riffle, 19+20
Drainage Area (sq mi):	1.6
Date:	6/21/2010
Field Crew:	Dean, Perkinson

SUMMARY DATA	
Bankfull Elevation:	274.7
Bankfull Cross-Sectional Area:	34.0
Bankfull Width:	19.7
Flood Prone Area Elevation:	278.0
Flood Prone Width:	>74
Max Depth at Bankfull:	3.3
Mean Depth at Bankfull:	1.7
W / D Ratio:	11.4
Entrenchment Ratio:	>3
Bank Height Ratio:	1.0

Stream Type	E4
--------------------	----

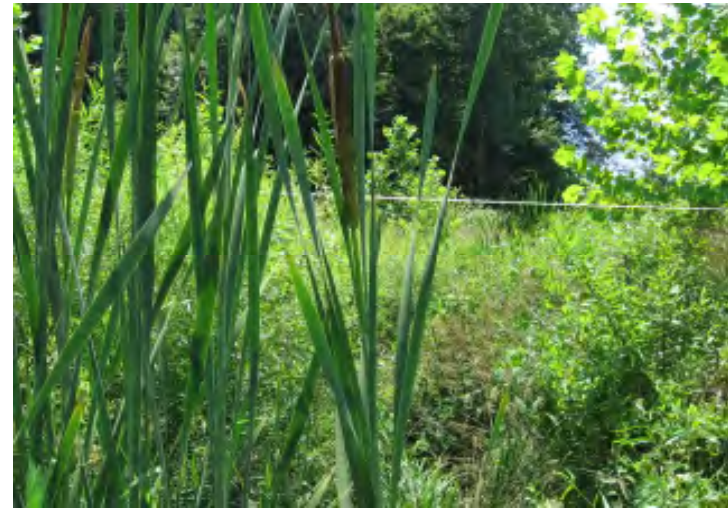
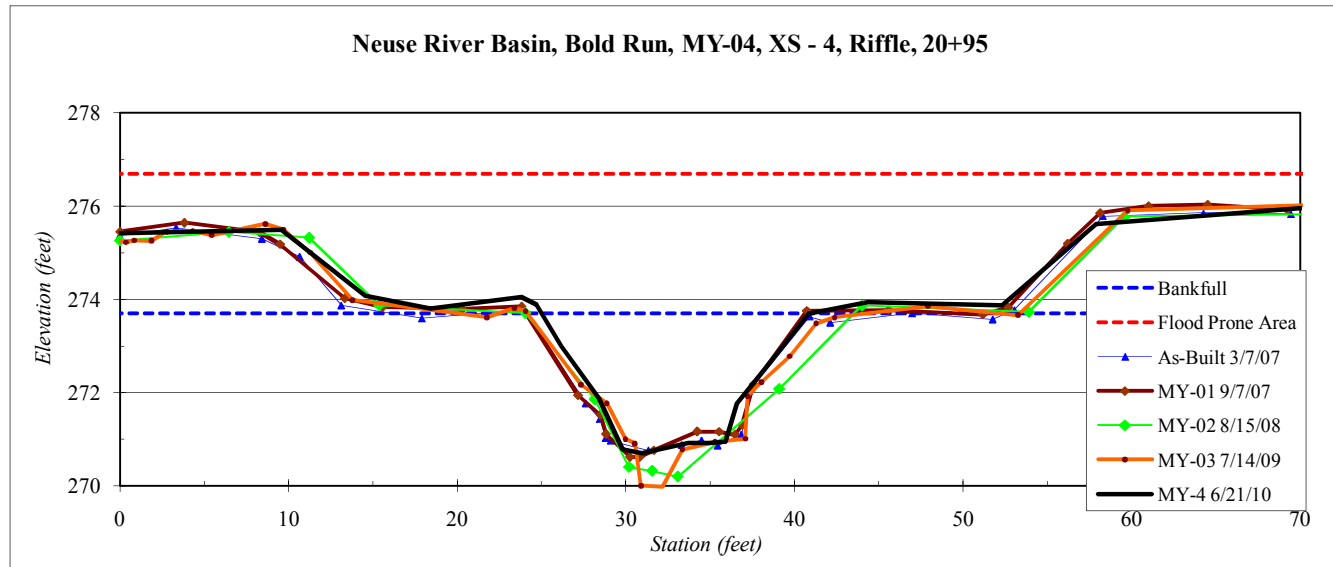
River Basin:	Neuse
Watershed:	Bold Run, MY-04
XS ID	XS - 4, Riffle, 20+95
Drainage Area (sq mi):	1.6
Date:	6/21/2010
Field Crew:	Dean, Perkinson

SUMMARY DATA	
Bankfull Elevation:	273.7
Bankfull Cross-Sectional Area:	29.7
Bankfull Width:	15.8
Flood Prone Area Elevation:	276.7
Flood Prone Width:	>70
Max Depth at Bankfull:	3.0
Mean Depth at Bankfull:	1.9
W / D Ratio:	8.4
Entrenchment Ratio:	>4
Bank Height Ratio:	1.0

Stream Type	E4
--------------------	----

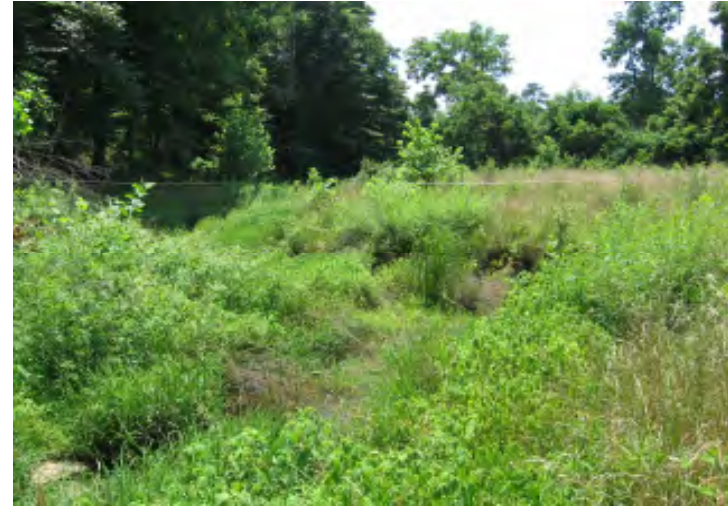
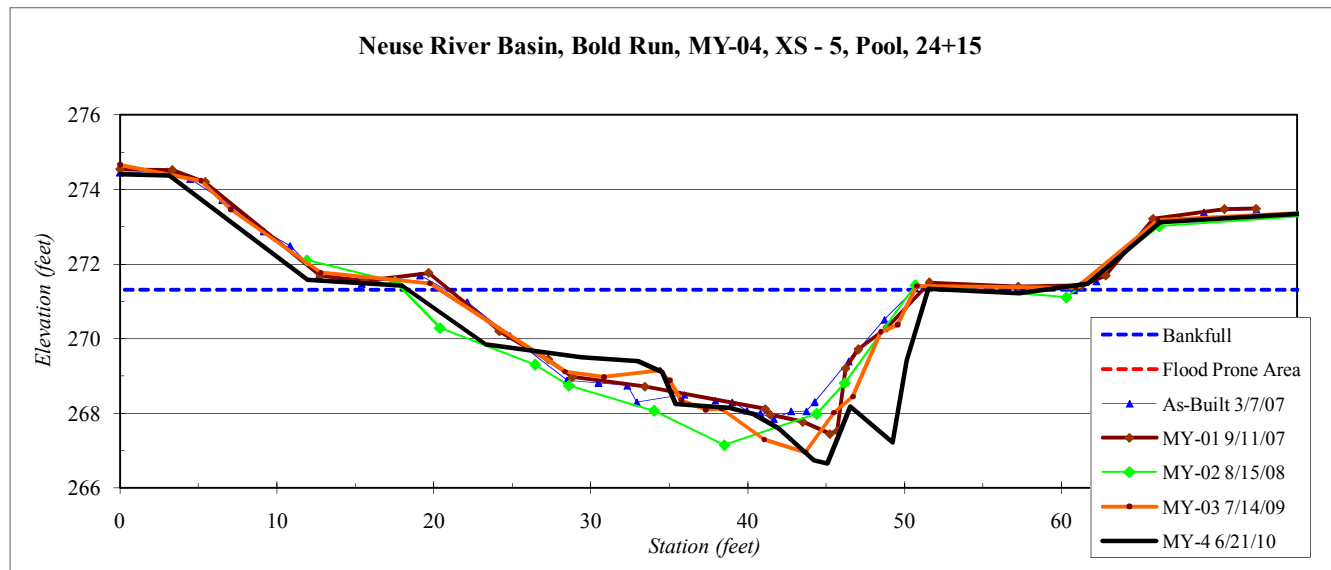
River Basin:	Neuse
Watershed:	Bold Run, MY-04
XS ID	XS - 5, Pool, 24+15
Drainage Area (sq mi):	1.6
Date:	6/21/2010
Field Crew:	Dean, Perkinson

Stream Type E4

SUMMARY DATA	
Bankfull Elevation:	271.3
Bankfull Cross-Sectional Area:	79.6
Bankfull Width:	33.1
Flood Prone Area Elevation:	-
Flood Prone Width:	-
Max Depth at Bankfull:	4.7
Mean Depth at Bankfull:	2.4
W / D Ratio:	-
Entrenchment Ratio:	-
Bank Height Ratio:	-
