**FINAL  
ANNUAL MONITORING REPORT  
BOLD RUN**

**STREAM AND BUFFER RESTORATION  
WAKE COUNTY, NORTH CAROLINA  
(EEP Project Number 439)**

Monitoring Year 5 of 5 (2011)

Prepared by:  
Axiom Environmental, Inc.  
218 Snow Avenue  
Raleigh, North Carolina 27603

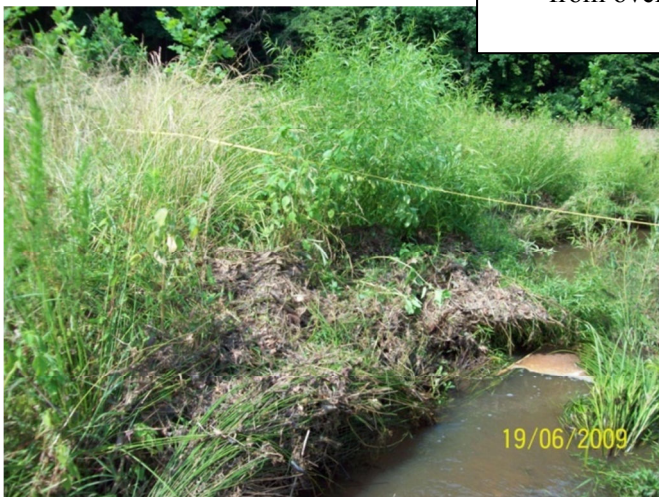
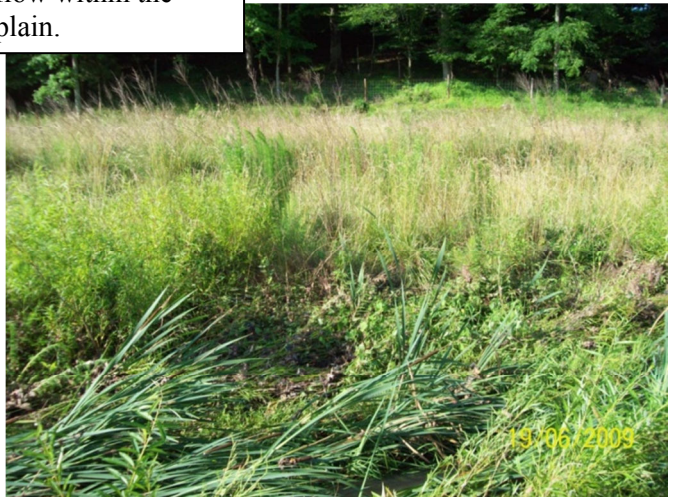
Bankfull Event Photos 1-2 showing evidence of overbank through wrack lines on banks and vegetation matted from overland flow within the floodplain.

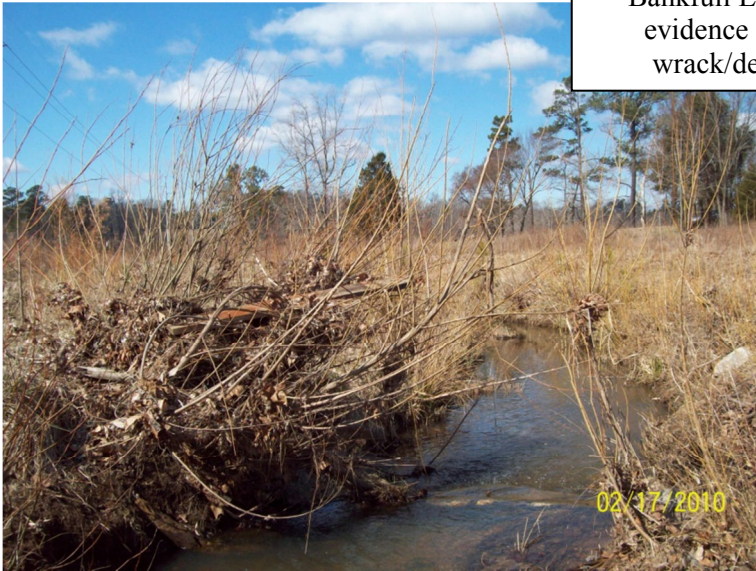
Bankfull Event Photo 3 showing evidence of overbank through wrack/debris lines on banks.
