**As-built Baseline Monitoring Report  
FINAL**

**Mt. Pleasant Creek Restoration Project  
Bowman Property  
DMS Project Number 44  
401: DWR 07-2252v2  
404: SAW-2008-01382**

**Randolph County, North Carolina**

**Monitoring Data Collected: March 2017  
Date Submitted: April 2017**

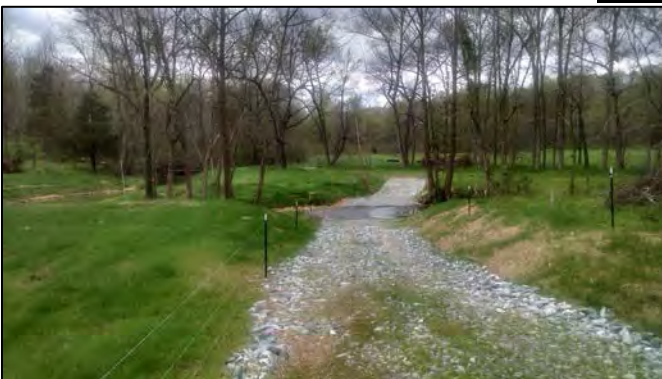
Fencing at stream crossing – MY-00 – 4/7/17

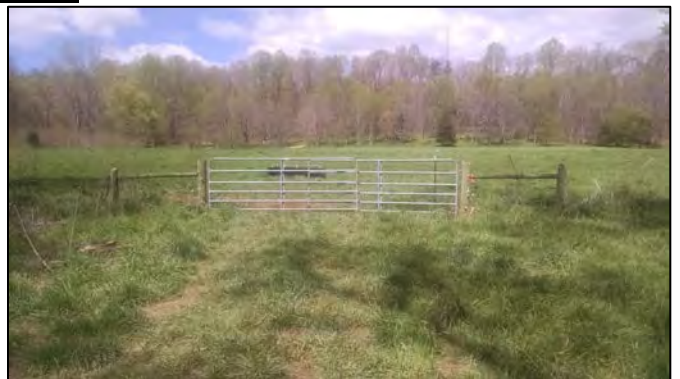
Fencing at stream crossing – MY-00 – 4/7/17

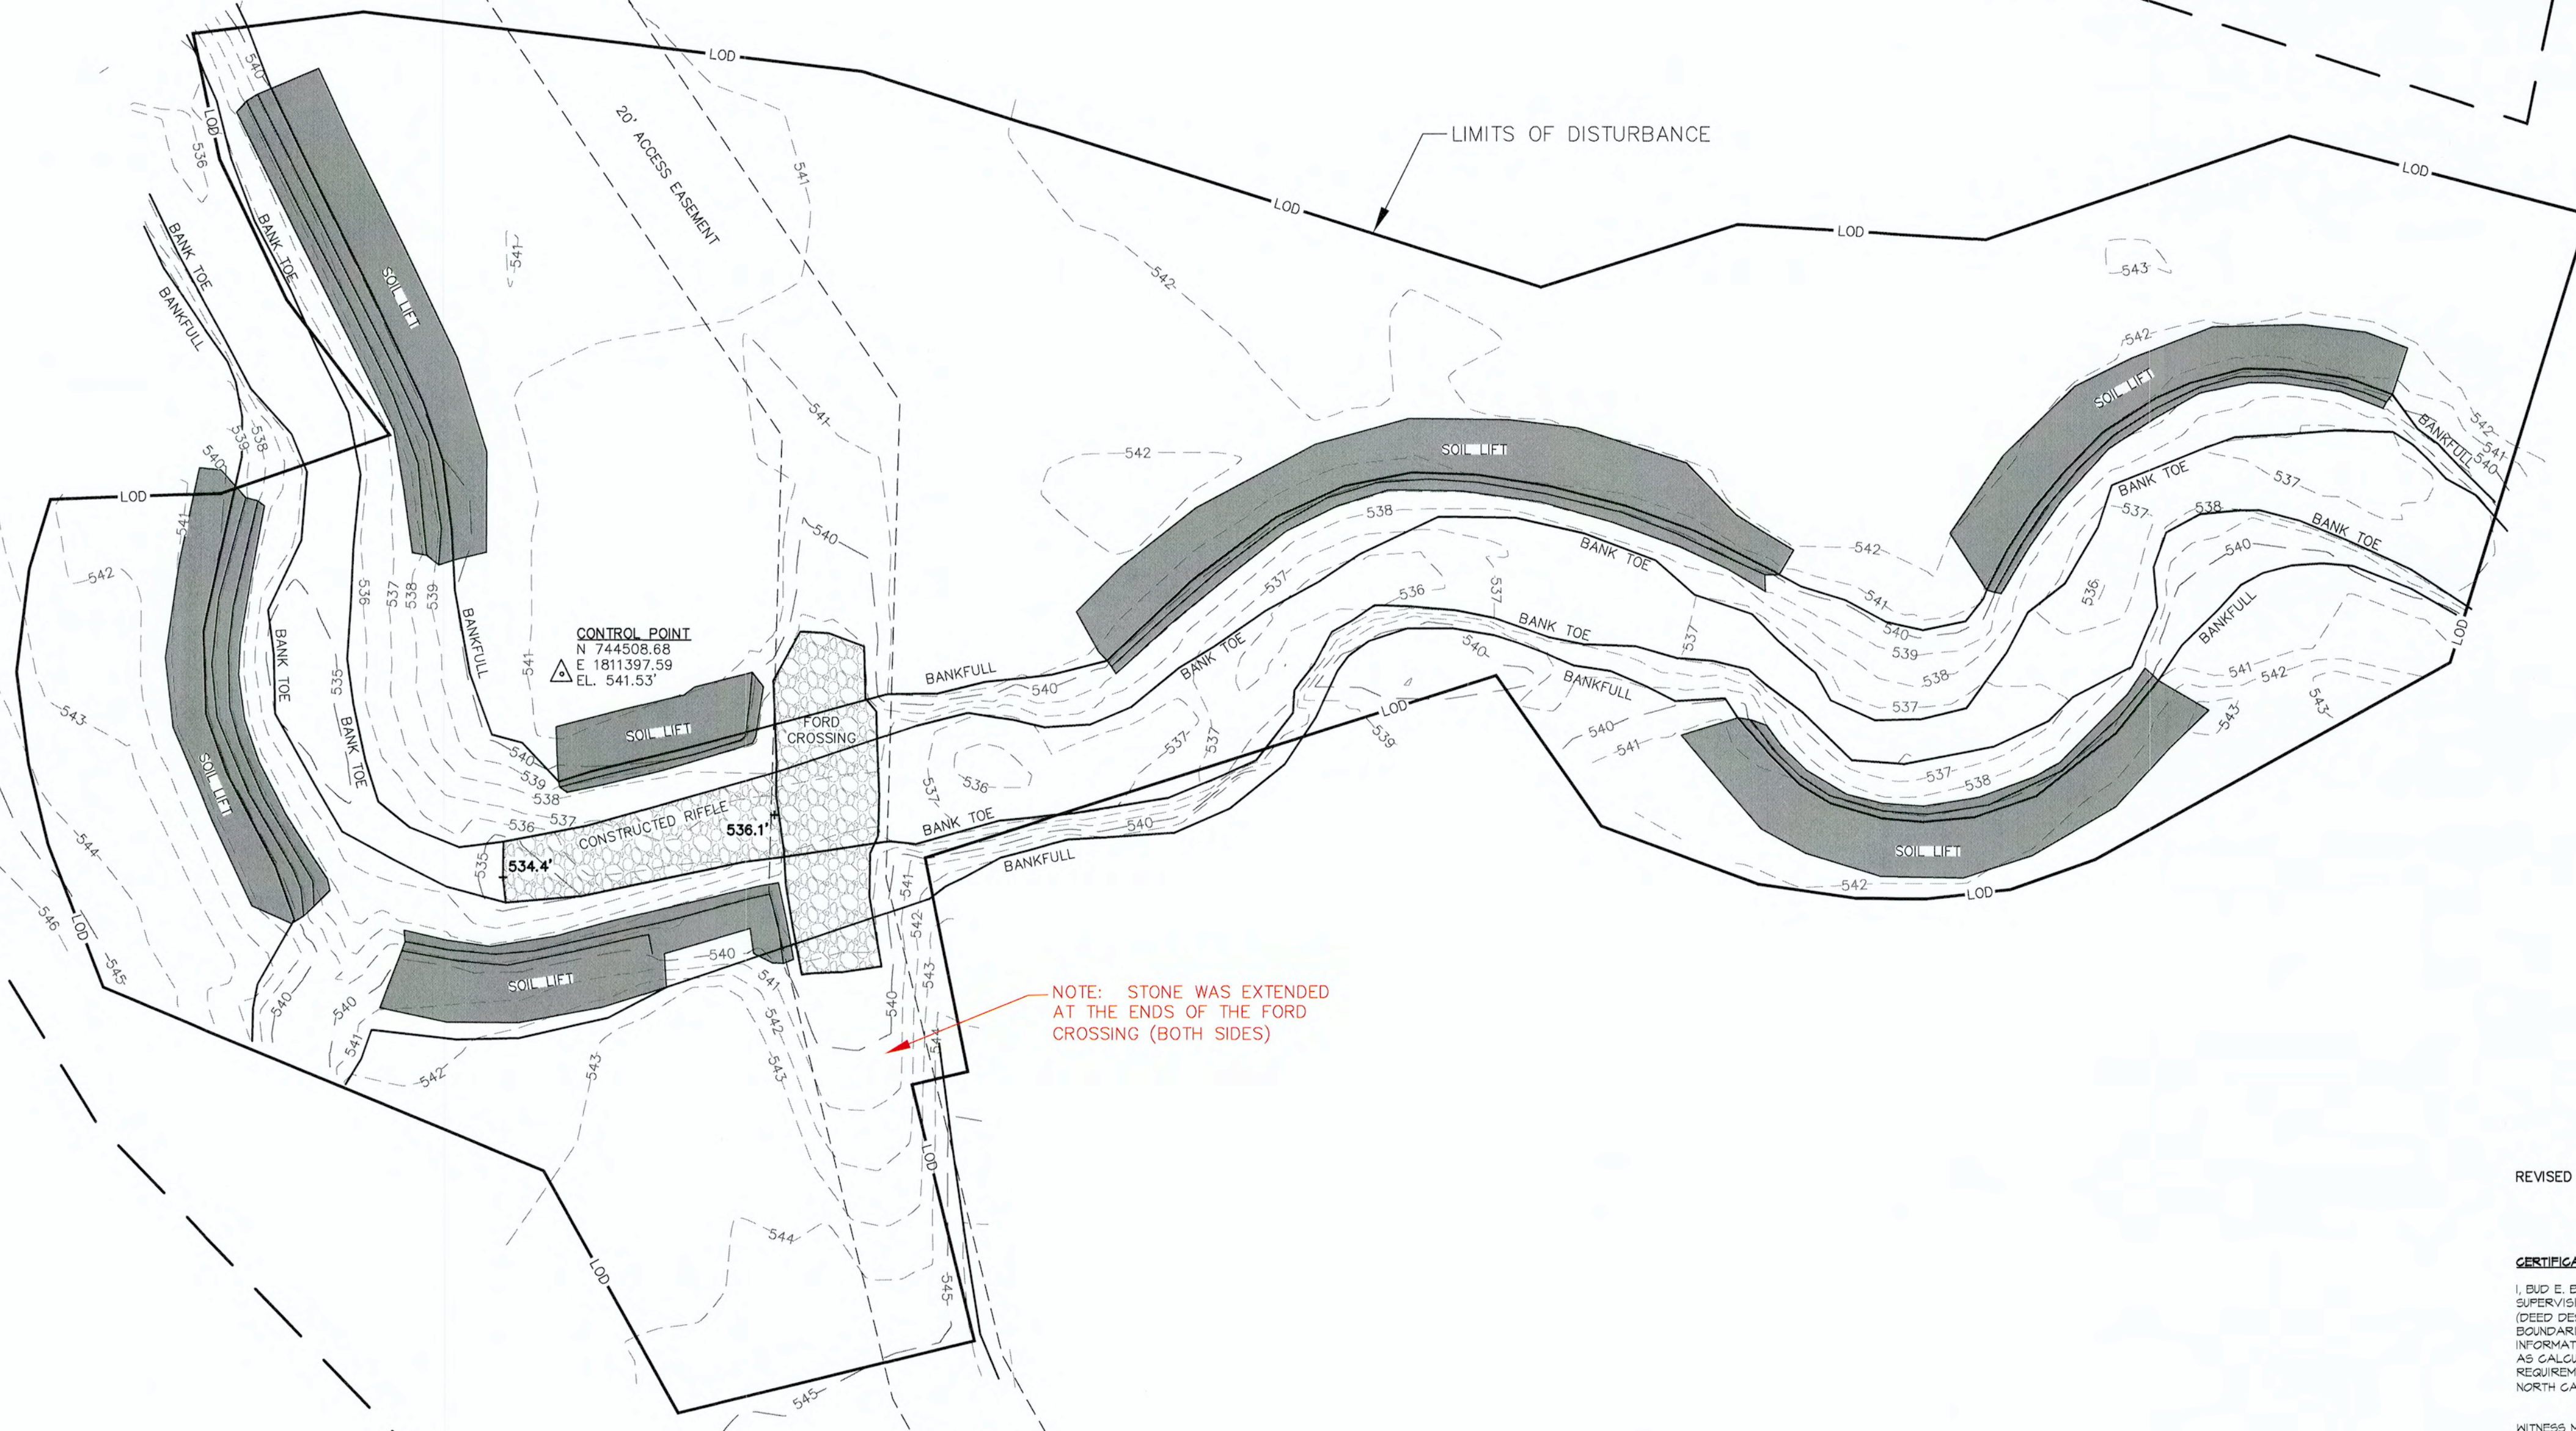
**AS-BUILT  
TOPOGRAPHIC SURVEY  
MT. PLEASANT CREEK  
RESTORATION  
PROJECT  
DMS #44  
RANDOLPH COUNTY  
NORTH CAROLINA**

To implement these objectives, project work was completed in February 2017 per the Mitigation Plan. The as-built and baseline surveys found that the stream was constructed as designed and all structures were installed as planned. Stream work included installation of 7 soil lifts fortified with live willow whips, a ford crossing, and constructed riffle in the Enhancement I credit area. Bio-engineering with live staking, temporary and permanent seeding occurred along all exposed banks, and sloped banks; and transplants were installed where possible. Invasive treatment occurred throughout the entire easement, using a stump herbicide treatment method. The site was constructed as designed. The only modification during construction was the extension of the stone on both sides of the ford crossing.

NOTE: STONE WAS EXTENDED  
AT THE ENDS OF THE FORD  
CROSSING (BOTH SIDES)
