Monitoring Report Year 1 FINAL

Bowman
(Mt. Pleasant Creek Restoration Project)
DMS Project Number 44
401: DWR 07-2252v2
404: SAW-2008-01382

Randolph County, North Carolina

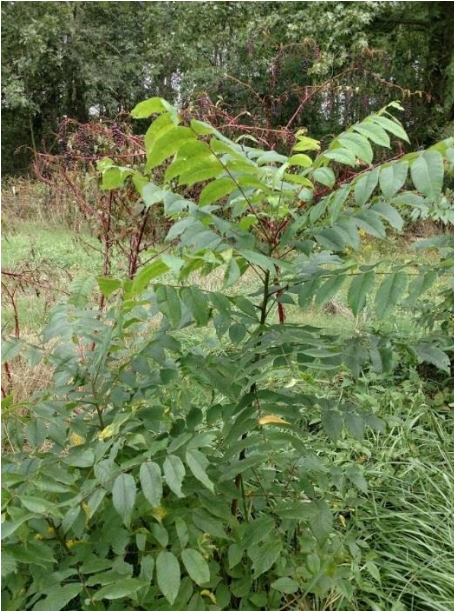
Willow volunteers are common in planted area.

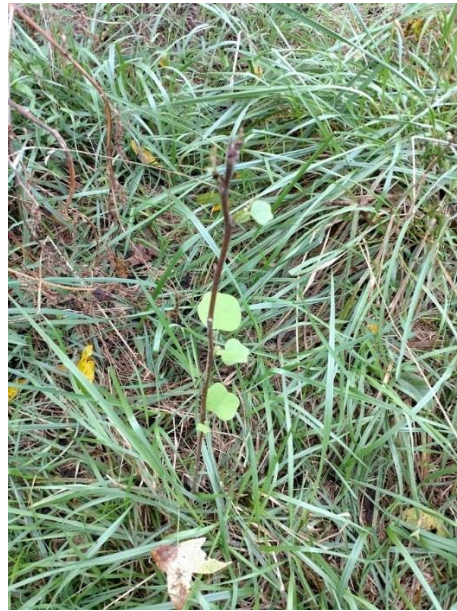
Deer browse present on planted stems, with re-sprout.

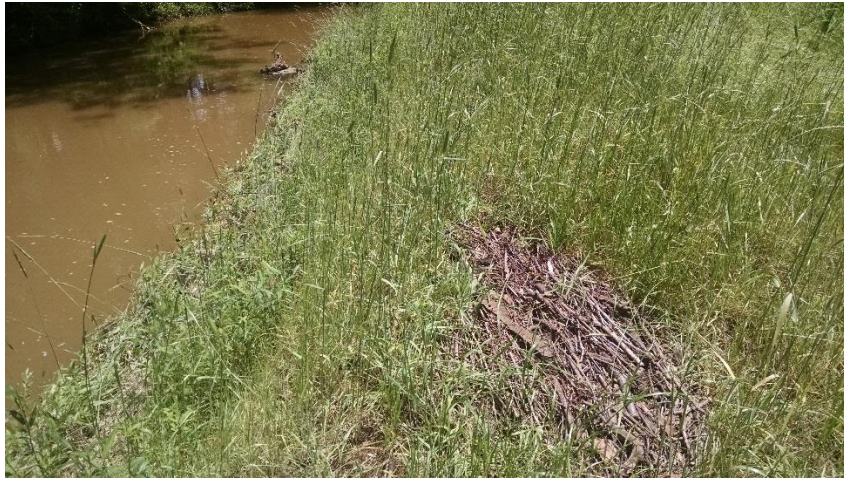
Evidence of wrack on the banks, 5/25/2017

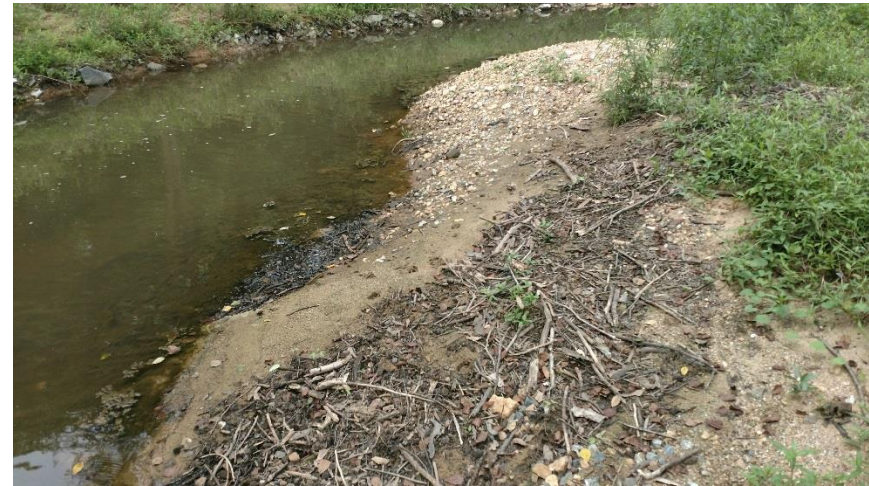
Sorting, deposition, and wrack lines from 6/27/17

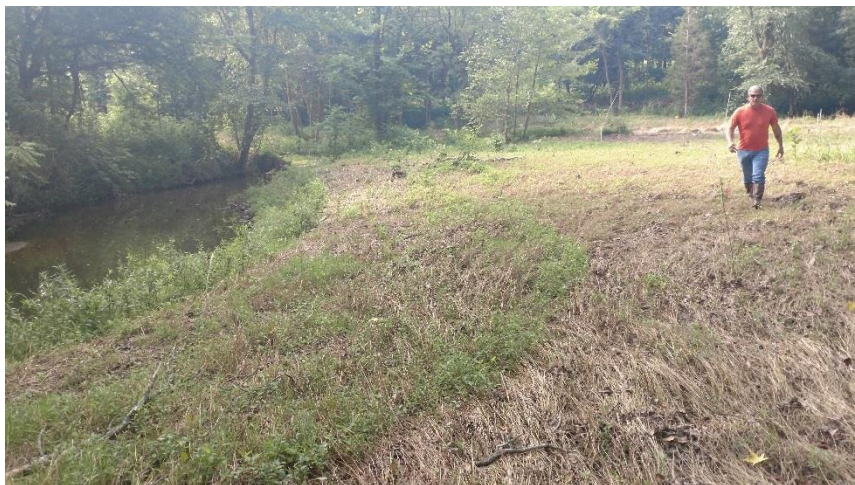
Evidence floodplain access in the form of preferential flow over grasses
Mt. Pleasant Creek Restoration Project-Bowman Property

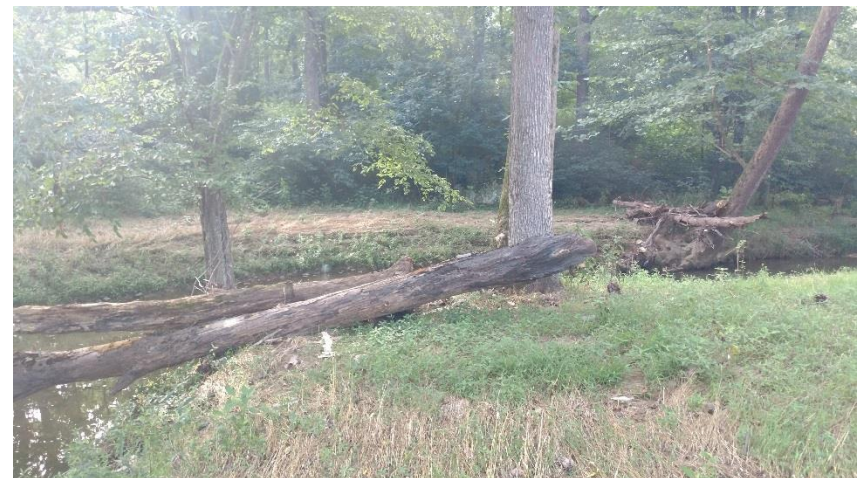
High flow lifted large woody debris into the floodplain as shown in the picture.
