# Monitoring Report Year 2

**Bowman**  
**(Mt. Pleasant Creek Restoration Project)**  
**DMS Project Number 44**  
**401: DWR 07-2252v2**  
**404: SAW-2008-01382**

**Randolph County, North Carolina**

**Monitoring Data Collected: July-October 2018**

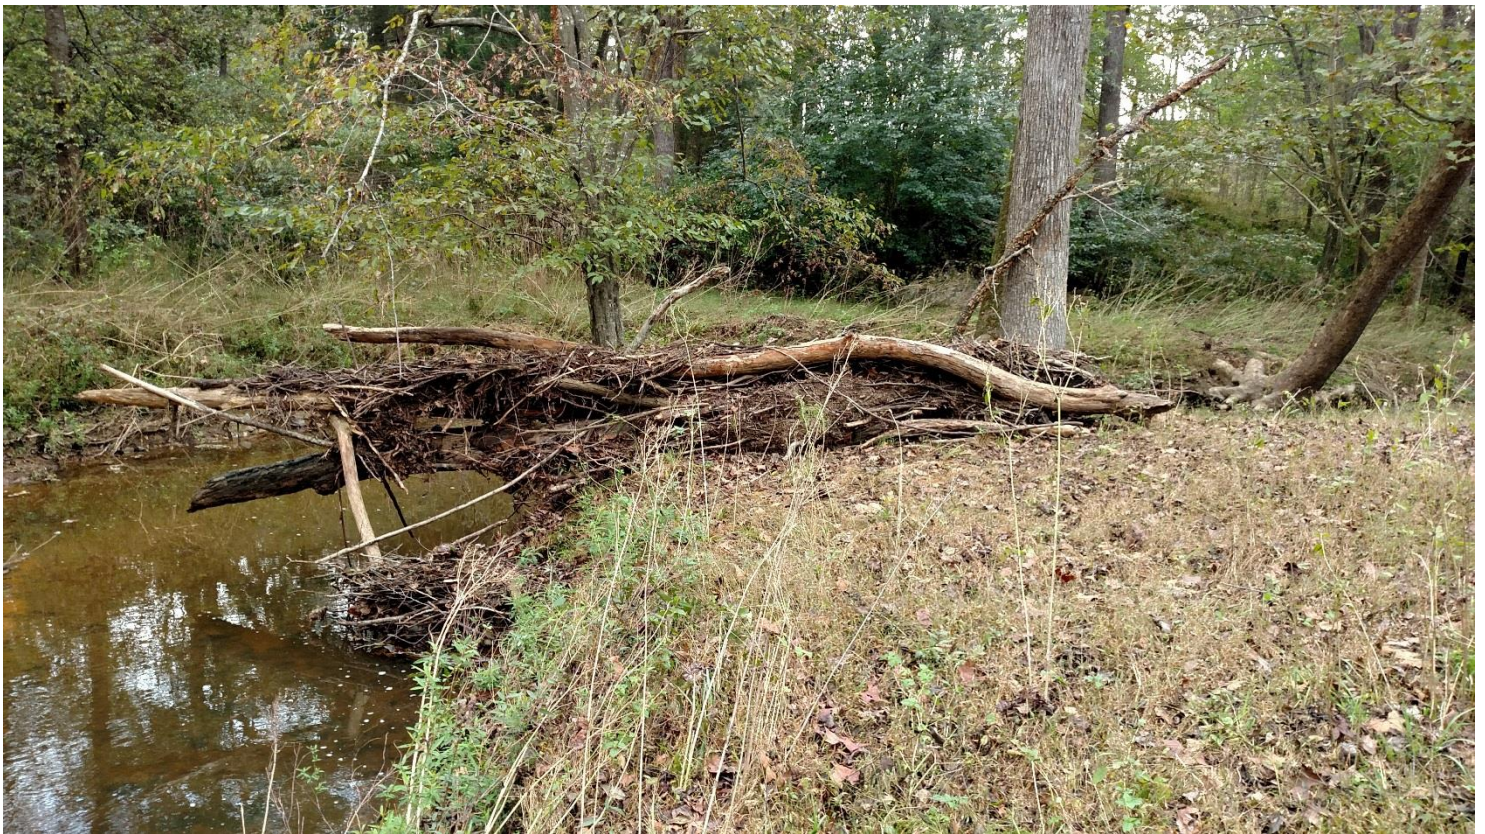
10/16/18. Large wood picked up during a storm and distributed on floodplain.

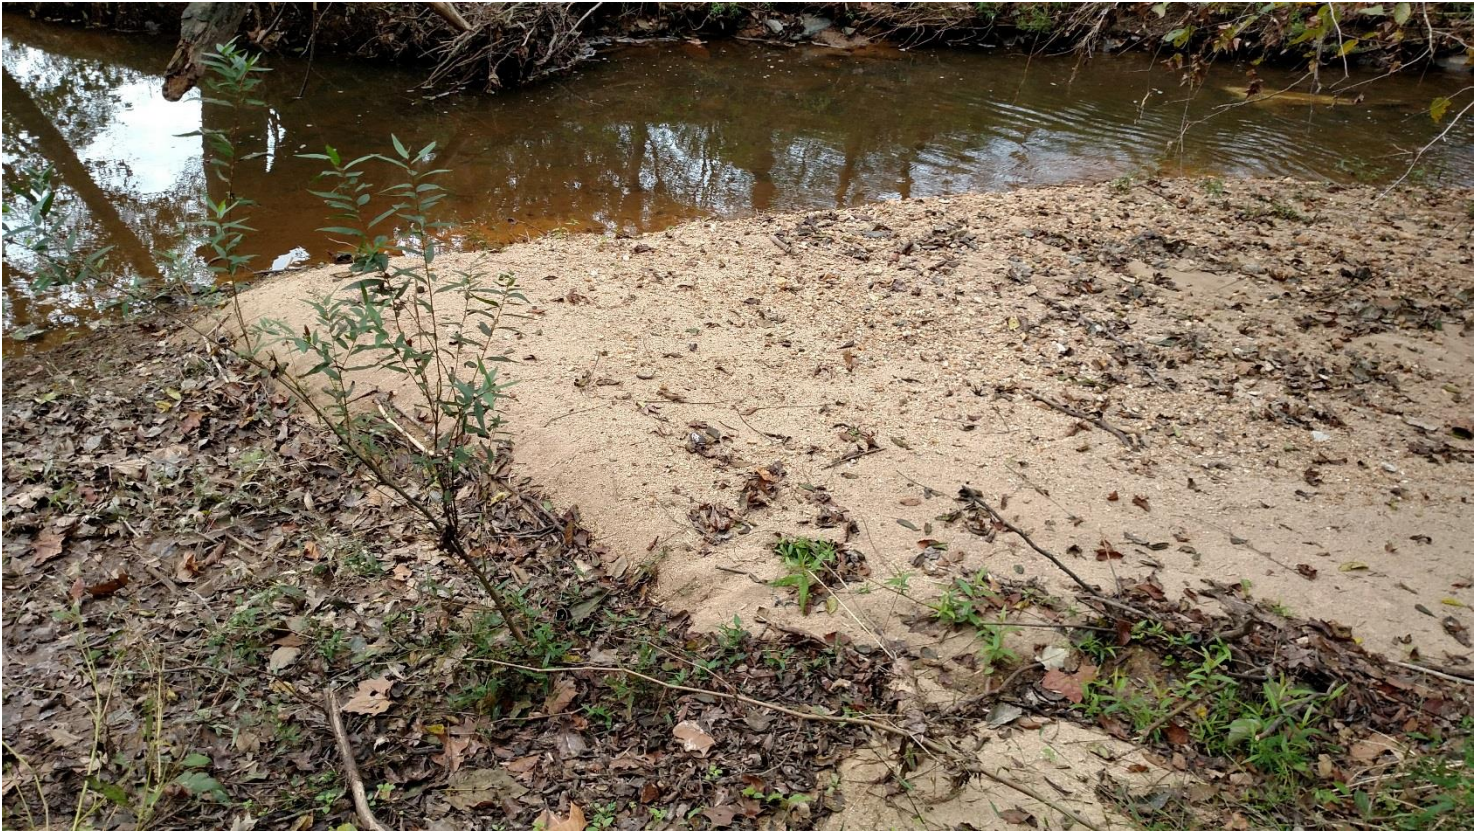
10/16/18. Depositional sediment bar forming in stream.

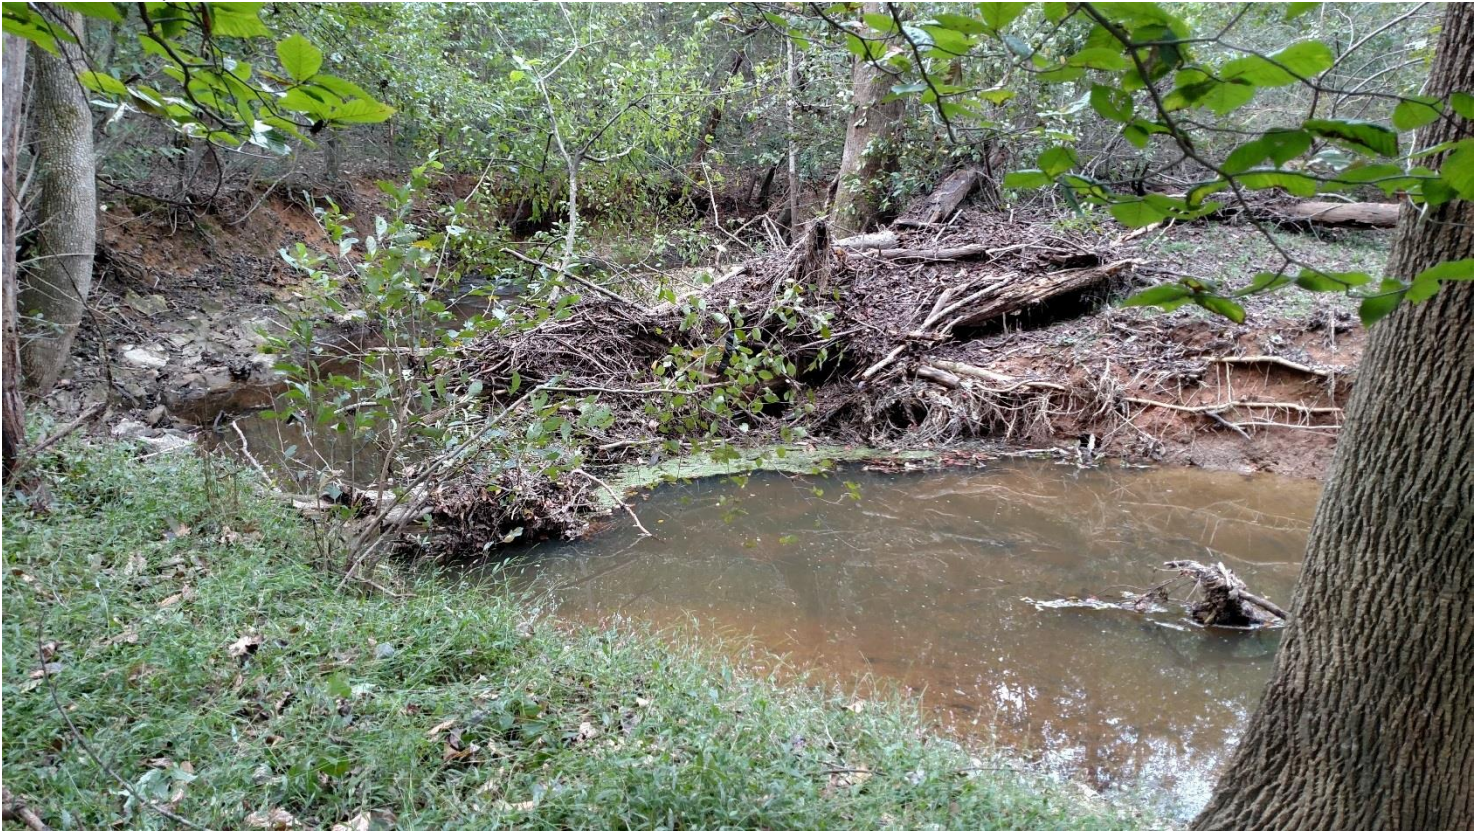
During the MY2 site visit, staff noticed some isolated areas of bank scour and mechanical failure in the enhancement II area, which may have previously been obscured by dense privet in these areas. Due to these concerns, staff resurveyed a stream cross-section and compared it to a 2007 survey (Cross-sections, page 23) and looked at pre-conditions. These comparisons showed no significant deviation from pre-conditions, and staff professionals think it likely due to the large drainage area and natural geomorphological processes, and that these banks looked like this all along.

10/16/18. Wrack piling up from storms. See background image of exposed bank as typical on Enhancement II section.

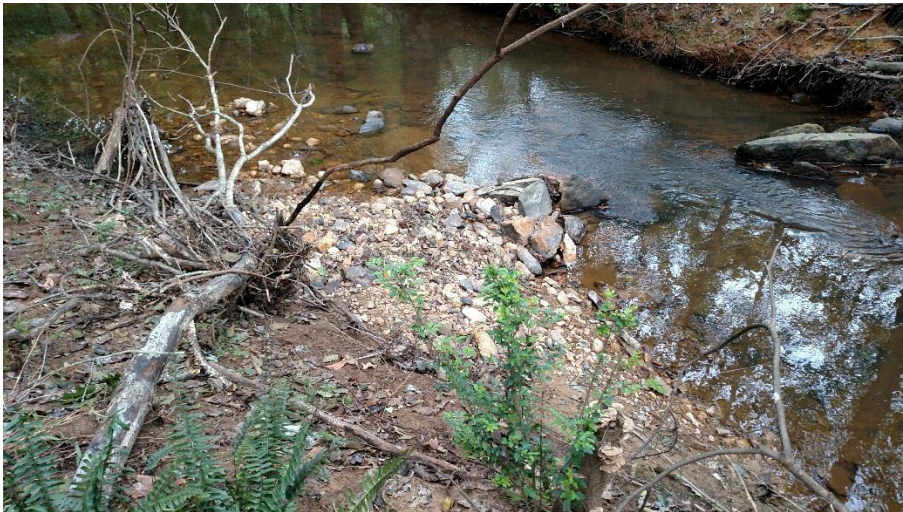
Evidence of wrack on the banks and sorting, 10/16/18
