Monitoring Report Year 3

Bowman
(Mt. Pleasant Creek Restoration Project)
DMS Project Number 44
401: DWR 07-2252v2
404: SAW-2008-01382

Randolph County, North Carolina

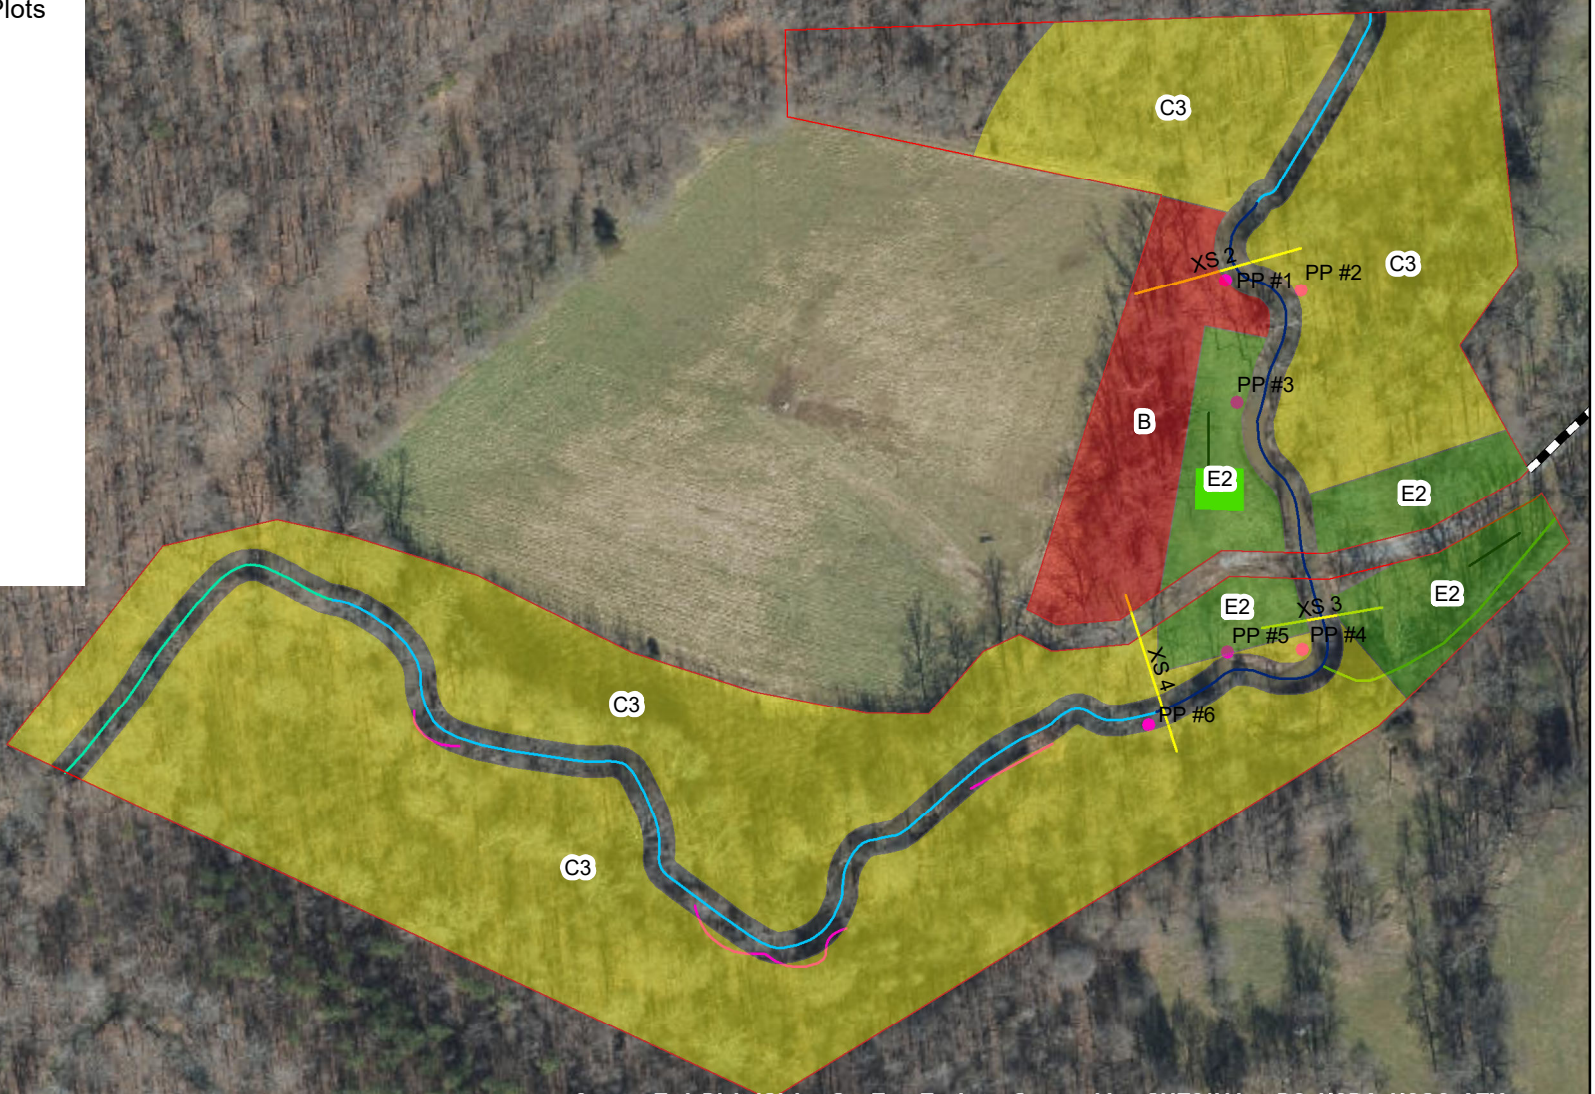
Current Condition Plan View

There were numerous bankfull events during 2019, at least visually documented twice in the monitoring year (Table 7). There were several very large trees lifted into the floodplain, evidence of significant rack and debris, and establishment of some benching. Stream banks area stable. Willow whip live stakes are vigorous and have established a strong bank foothold.

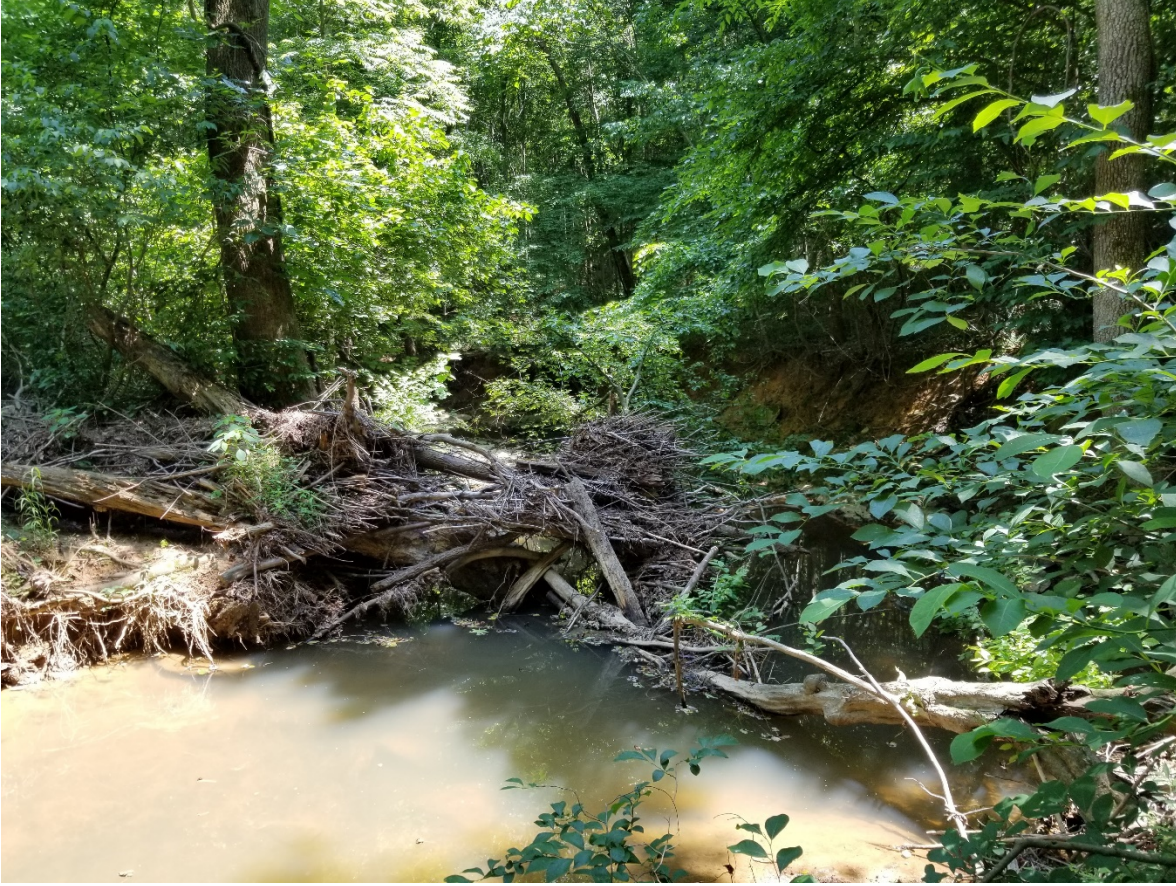
6/4/19. Bankfull debris deposited in stream.

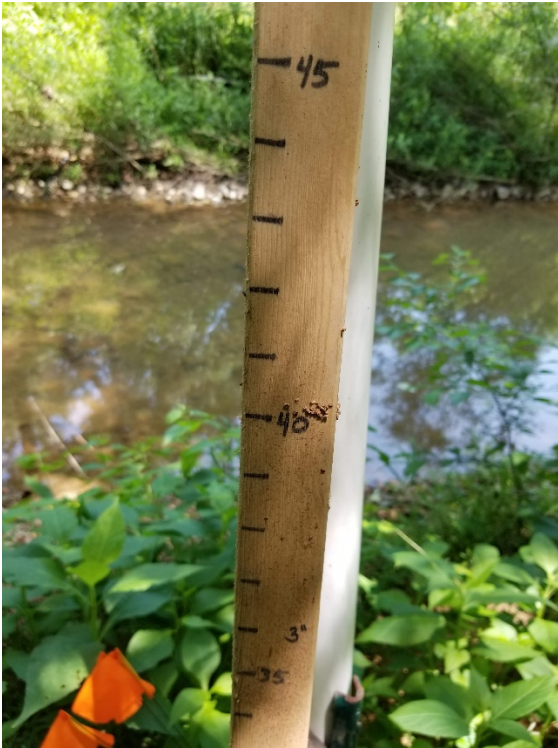
6/4/2019. Cork indicating stream flow reached 16" above bankfull flow (bankfull is at 24").

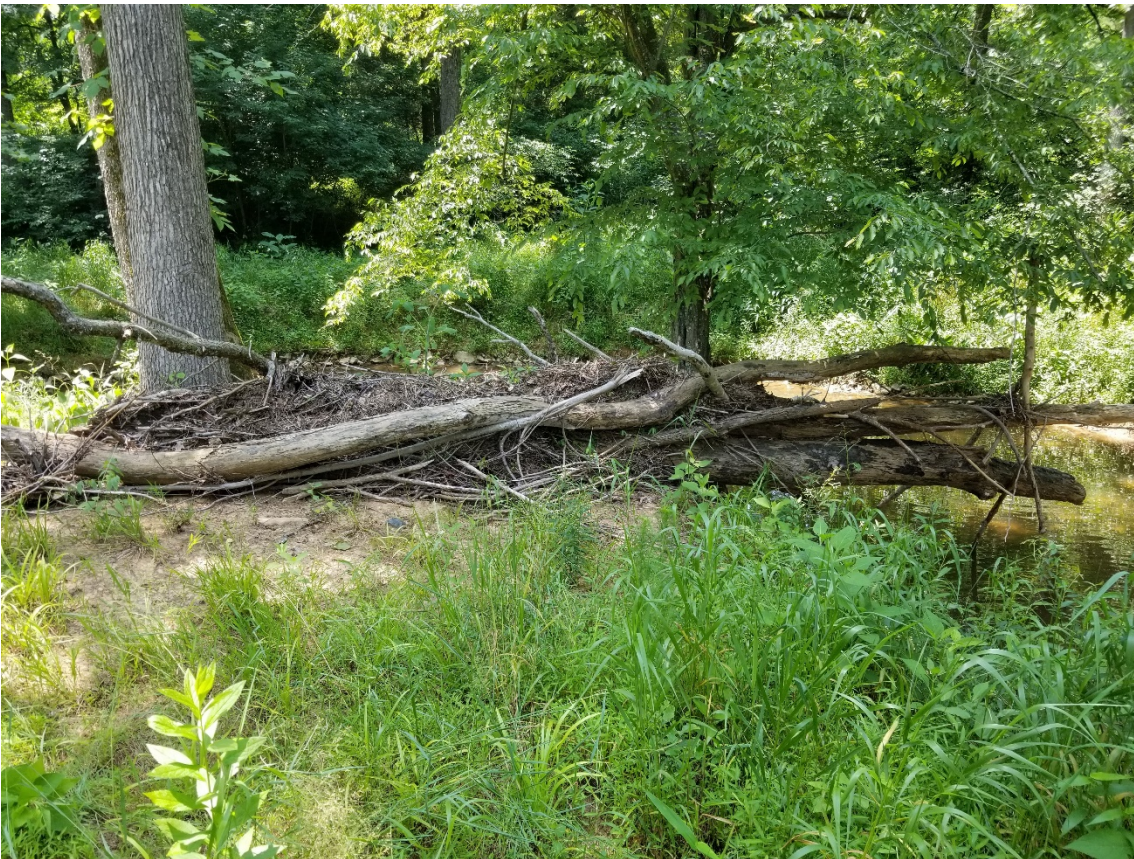
6/4/2019. Large and small woody debris from bankfull events floated onto the floodplain.

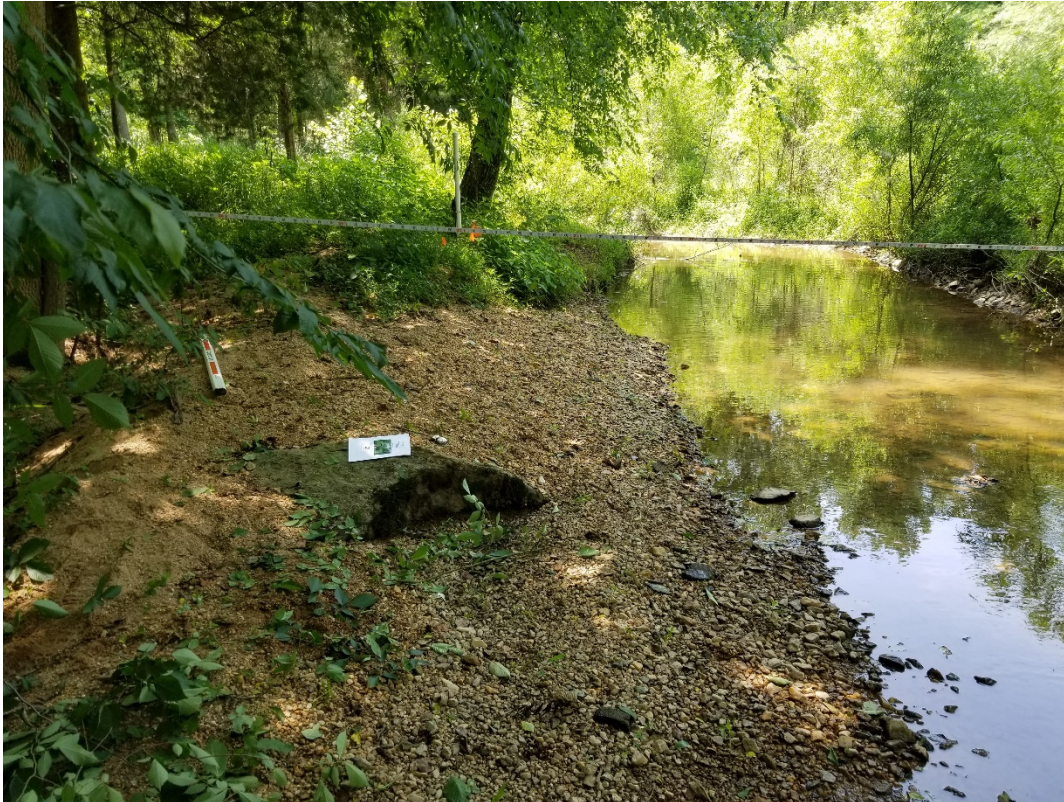
Overbank sediment deposition, XS2 6/4/2019
