Monitoring Report Year 4

Bowman
(Mt. Pleasant Creek Restoration Project)
DMS Project Number 44
401: DWR 07-2252v2
404: SAW-2008-01382

Randolph County, North Carolina

Monitoring Data Collected: July-October 2020

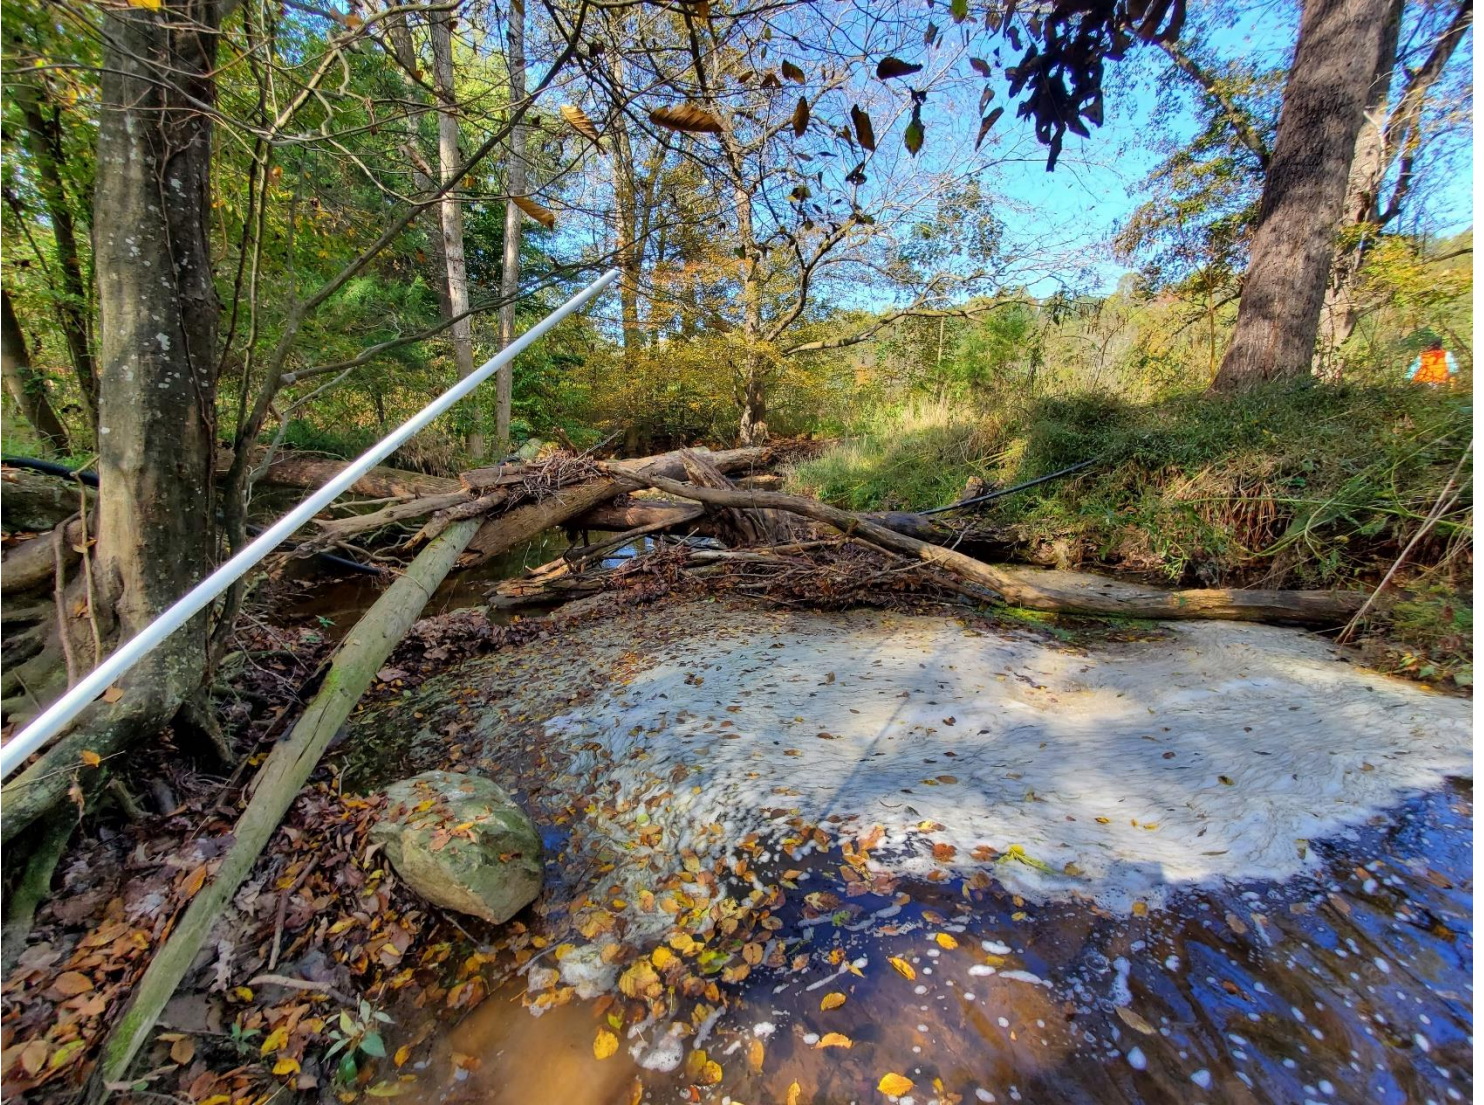
10/22/2020. Bankfull debris deposited in stream.

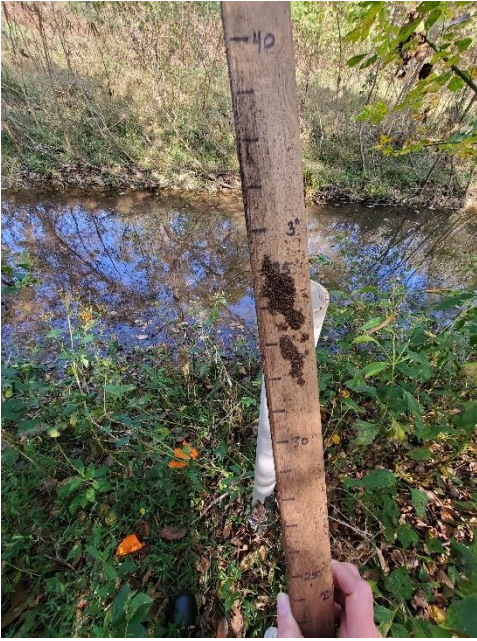
10/22/2020. Cork indicating stream flow reached 11" above bankfull flow (bankfull is at 24").

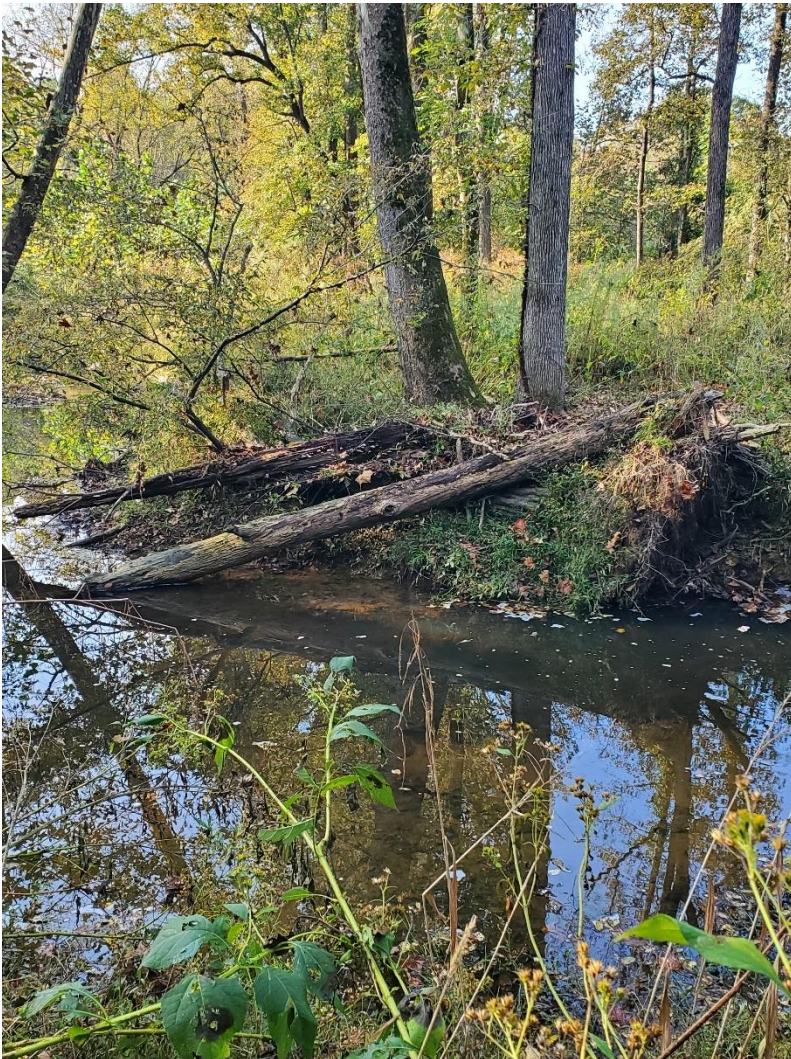
There were numerous bankfull events during 2020 and rainfall extremes documented in the rainfall tables. Bankfull events were documented once in the monitoring year through the manual crest gauge, but visual evidence of significant and repeated bankfull events were apparent. There were several very large trees lifted into the floodplain, evidence of significant rack and debris, and establishment of some benching. Stream banks area stable, but riffles showed evidence of bankfull deposition, especially XS 4. This is likely due to the significant events occurring in such a large drainage area, and some downstream debris that is slowing flow. Willow whip live stakes are vigorous and have established a strong bank foothold.

10/22/2020. Large and small woody debris from bankfull events floated onto the floodplain.

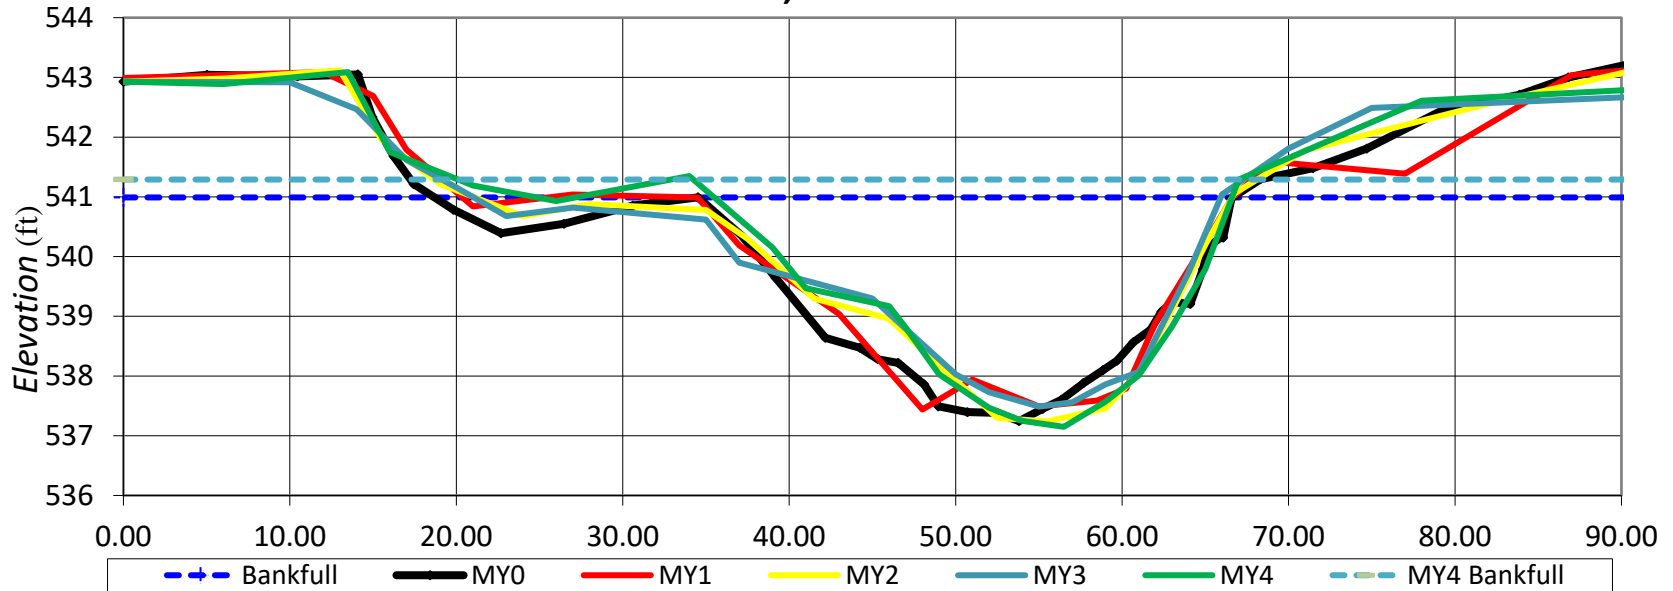
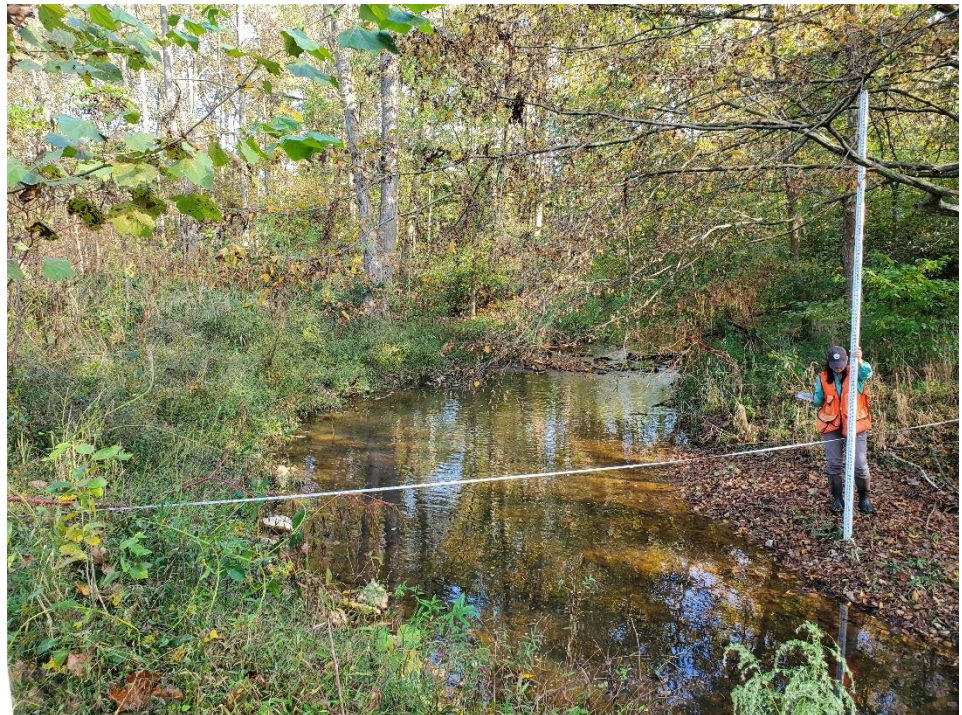
Bowman Site, Cape Fear River Basin X2, Pool

SUMMARY DATA	
Bankfull Elevation:	541.4
Bankfull Cross-Sectional Area:	85.8
Bankfull Width:	33.0
Flood Prone Area Elevation:	-
Flood Prone Width:	-
Max Depth at Bankfull:	4.2
Mean Depth at Bankfull:	2.5
W / D Ratio:	-
Entrenchment Ratio:	-
Bank Height Ratio:	-

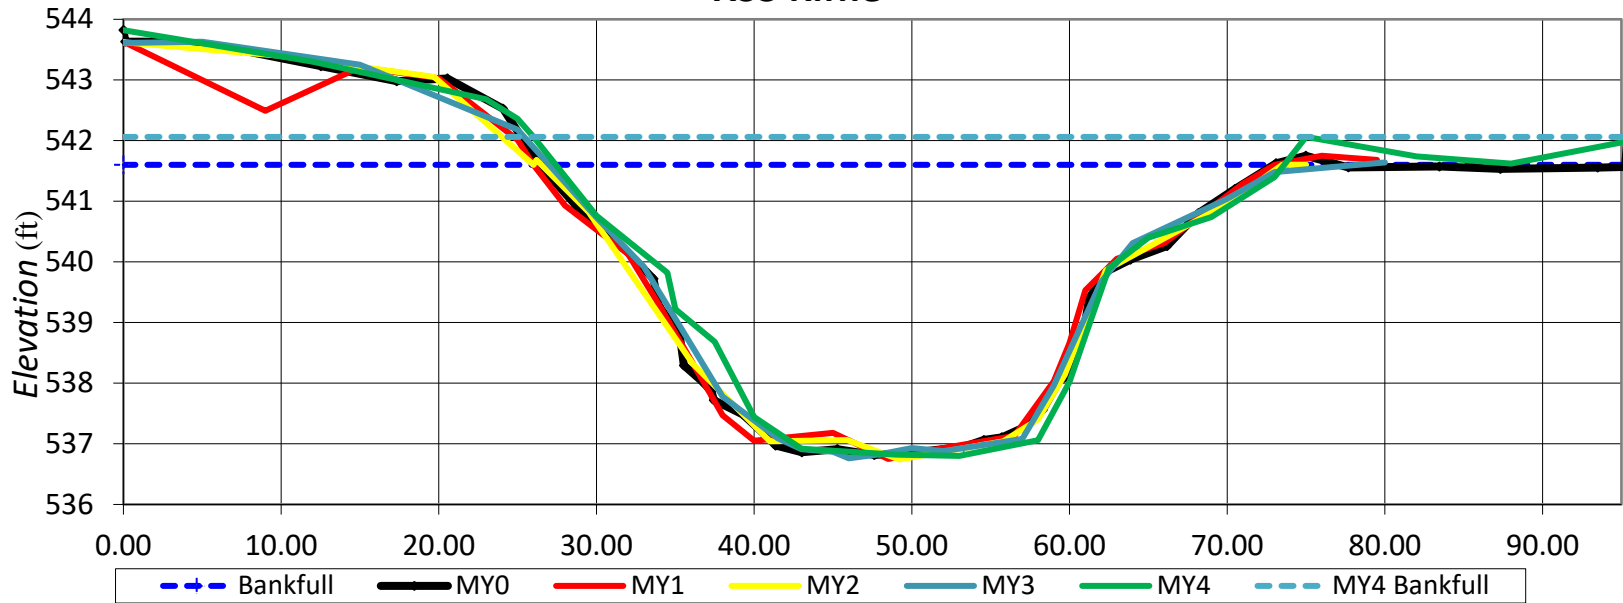
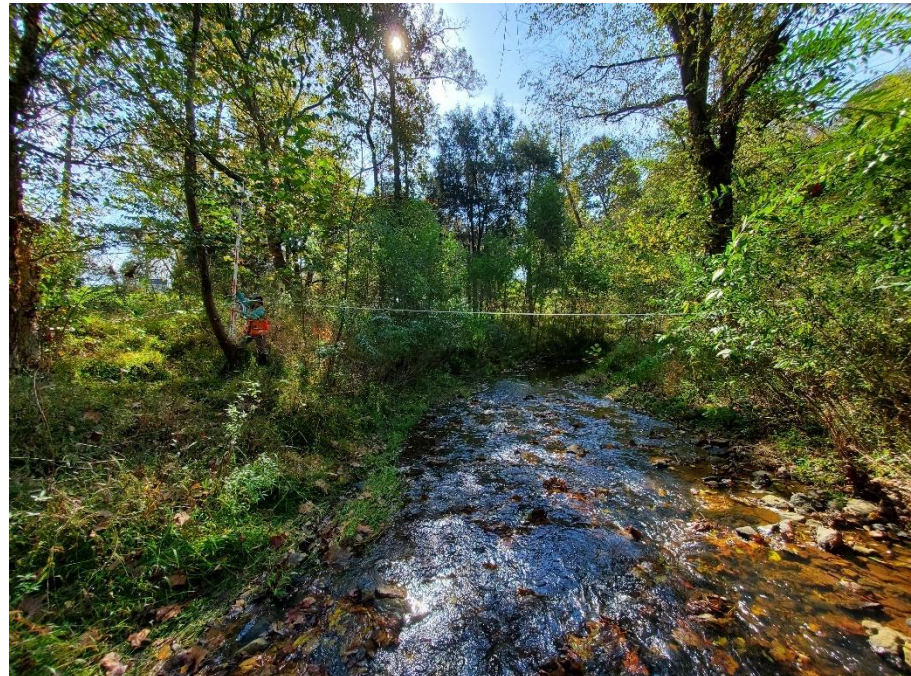
Bowman Site, Cape Fear River Basin XS3 Riffle

River Basin:	Cape Fear
Watershed:	Sandy Creek
XS ID	XS3, Riffle
Drainage Area (sq mi):	5.24
Date:	10/22/2020, MY4
Field Crew:	Crocker, Allen, Famularo
SUMMARY DATA	
Bankfull Elevation:	542.1
Bankfull Cross-Sectional Area:	159.5
Bankfull Width:	49.0
Flood Prone Area Elevation:	-
Flood Prone Width:	>100
Max Depth at Bankfull:	5.3
Mean Depth at Bankfull:	3.3
W / D Ratio:	15.1
Entrenchment Ratio:	2.0
Bank Height Ratio:	0.9

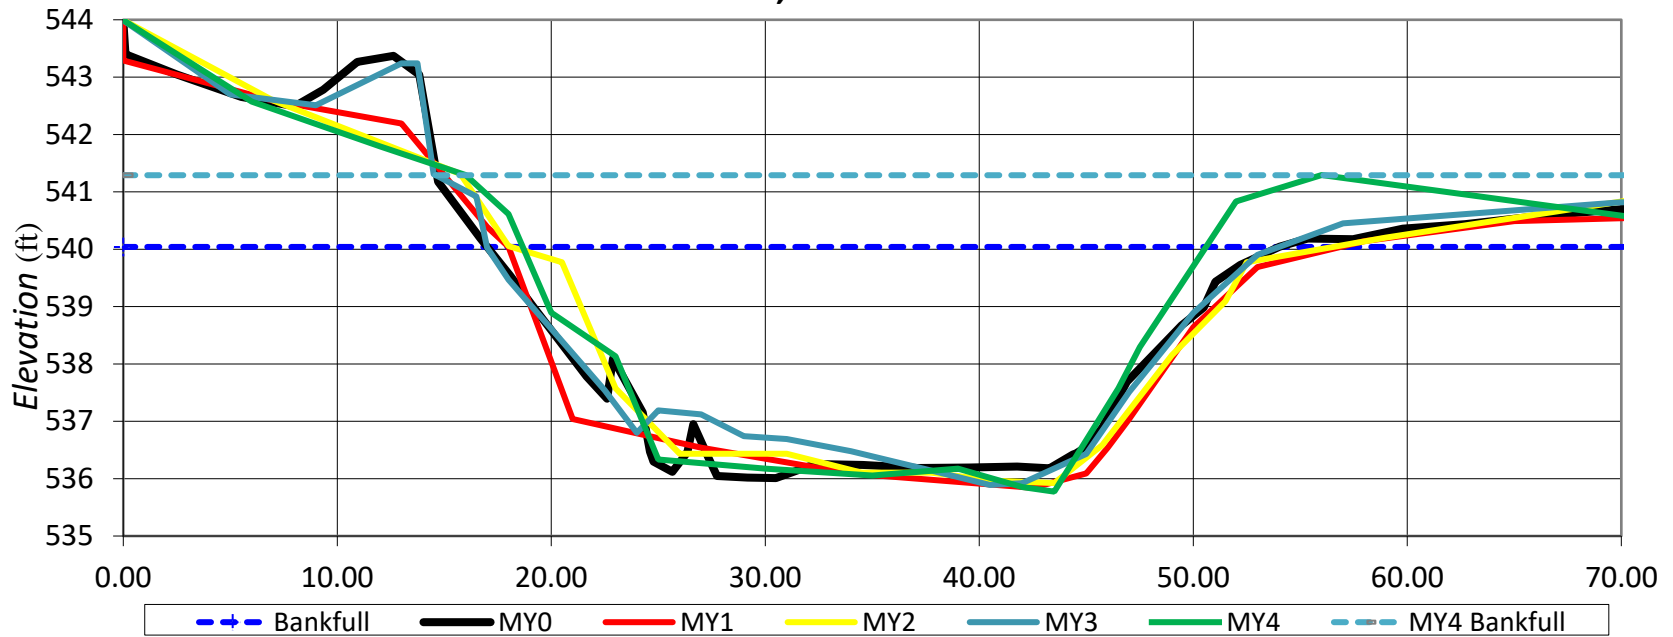
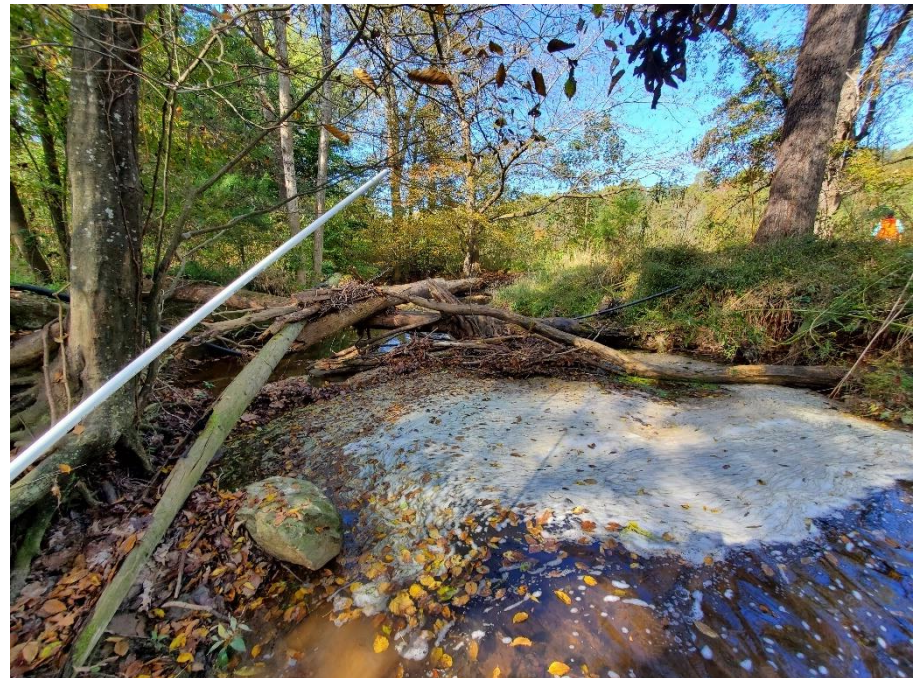
Bowman Site, Cape Fear River Basin X4, Riffle

SUMMARY DATA	
Bankfull Elevation:	541.3
Bankfull Cross-Sectional Area:	147.7
Bankfull Width:	40.0
Flood Prone Area Elevation:	--
Flood Prone Width:	>100
Max Depth at Bankfull:	5.5
Mean Depth at Bankfull:	3.7
W / D Ratio:	10.8
Entrenchment Ratio:	3.1
Bank Height Ratio:	0.8
