# Monitoring Year 5 & Closeout Report

**Bowman**  
**(Mt. Pleasant Creek Restoration Project)**  
**DMS Project Number 44**  
**401: DWR 07-2252v2**  
**404: SAW-2008-01382**

**Randolph County, North Carolina**

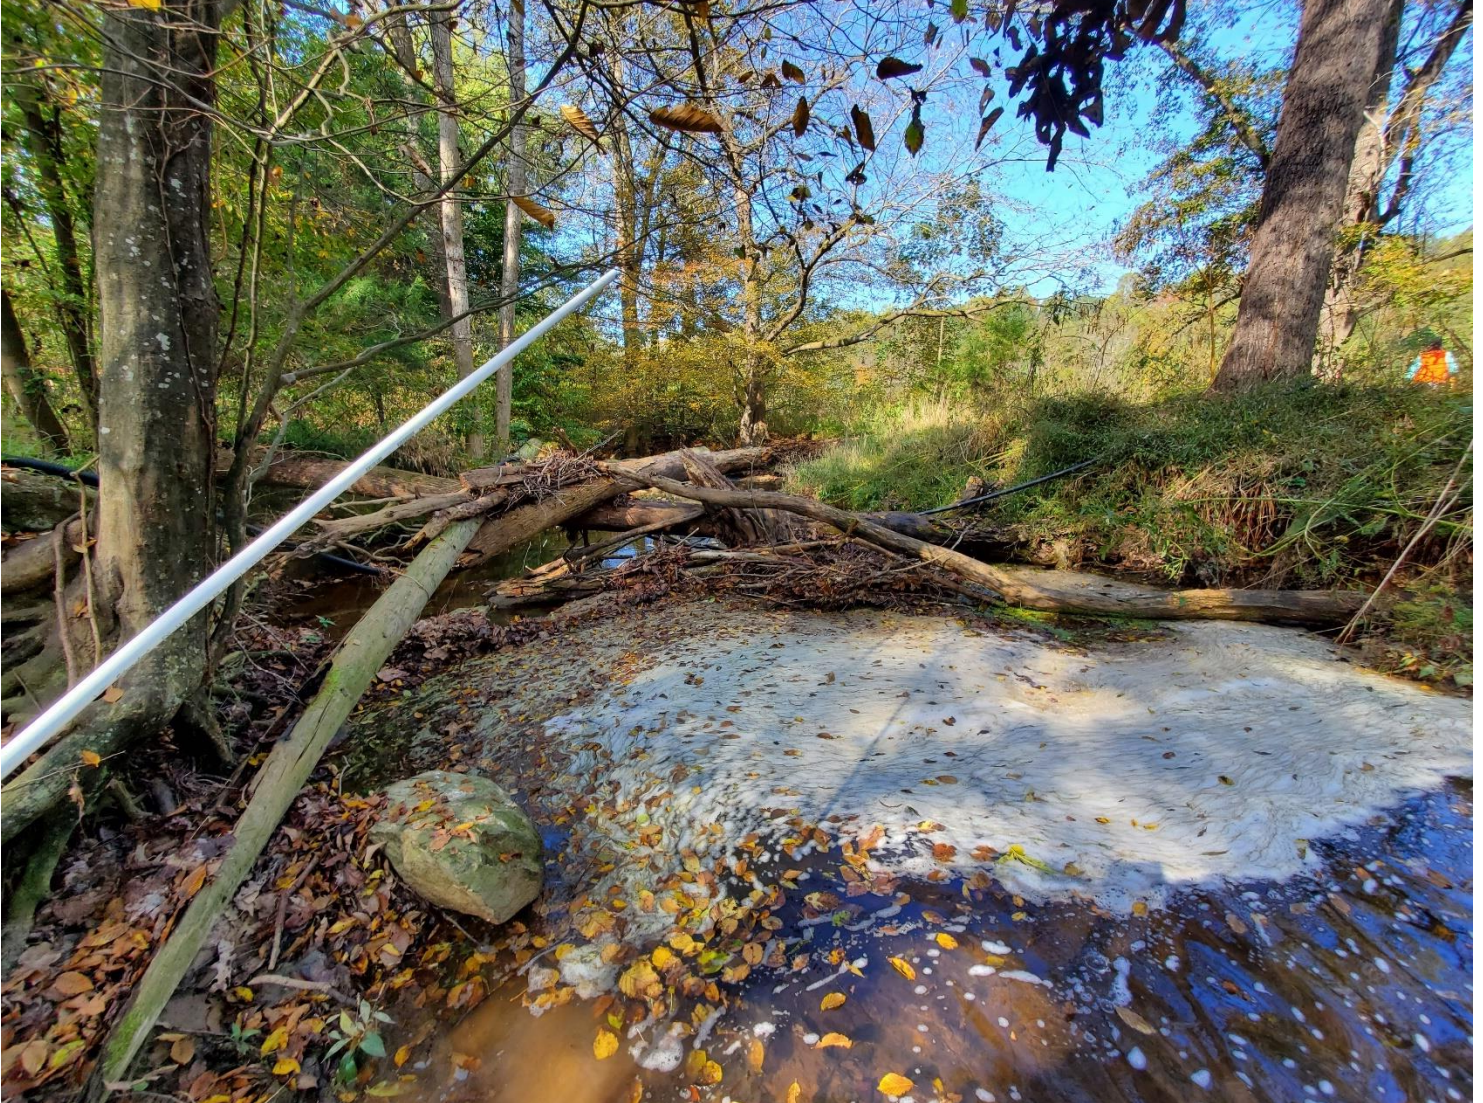
10/22/2020. Bankfull debris deposited in stream.

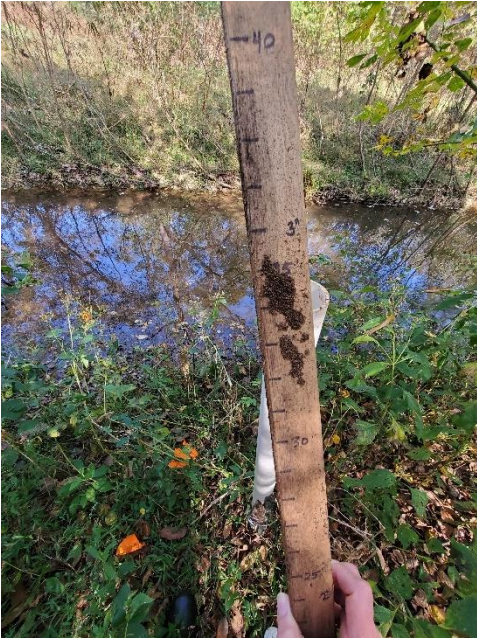
10/22/2020. Cork indicating stream flow reached 11" above bankfull flow (bankfull is at 24").

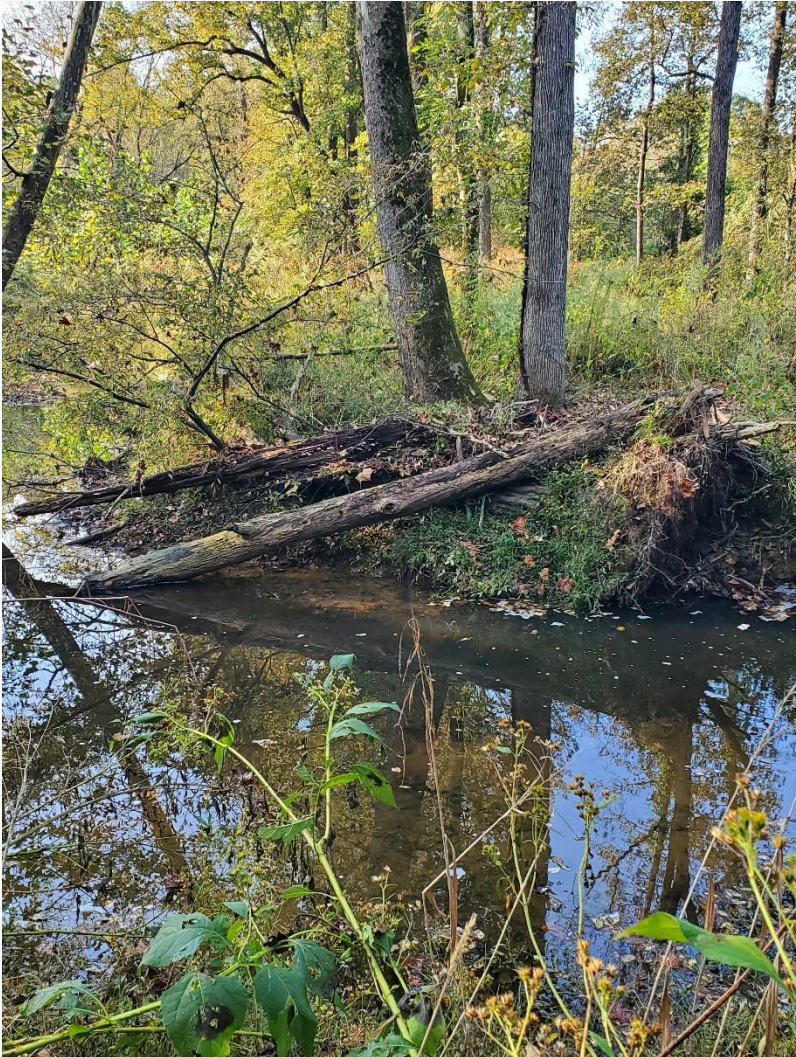
10/22/2020. Large and small woody debris from bankfull events floated onto the floodplain.

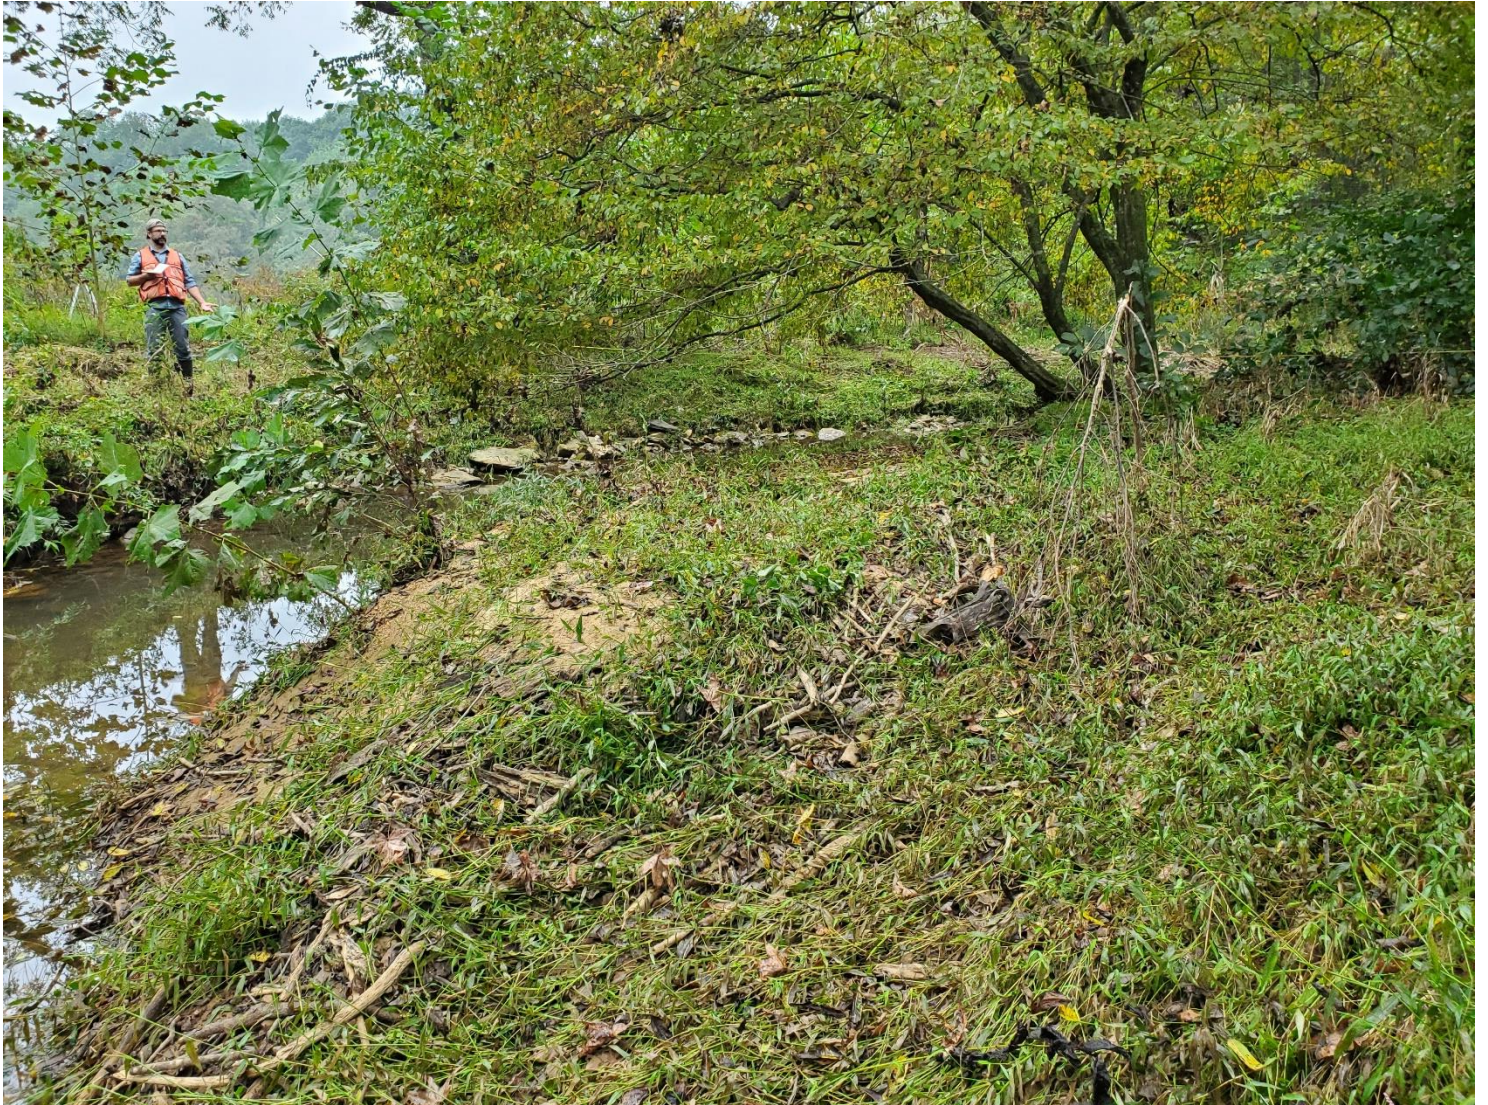
9/30/2021. Deposition of fines and bar development at top of project.

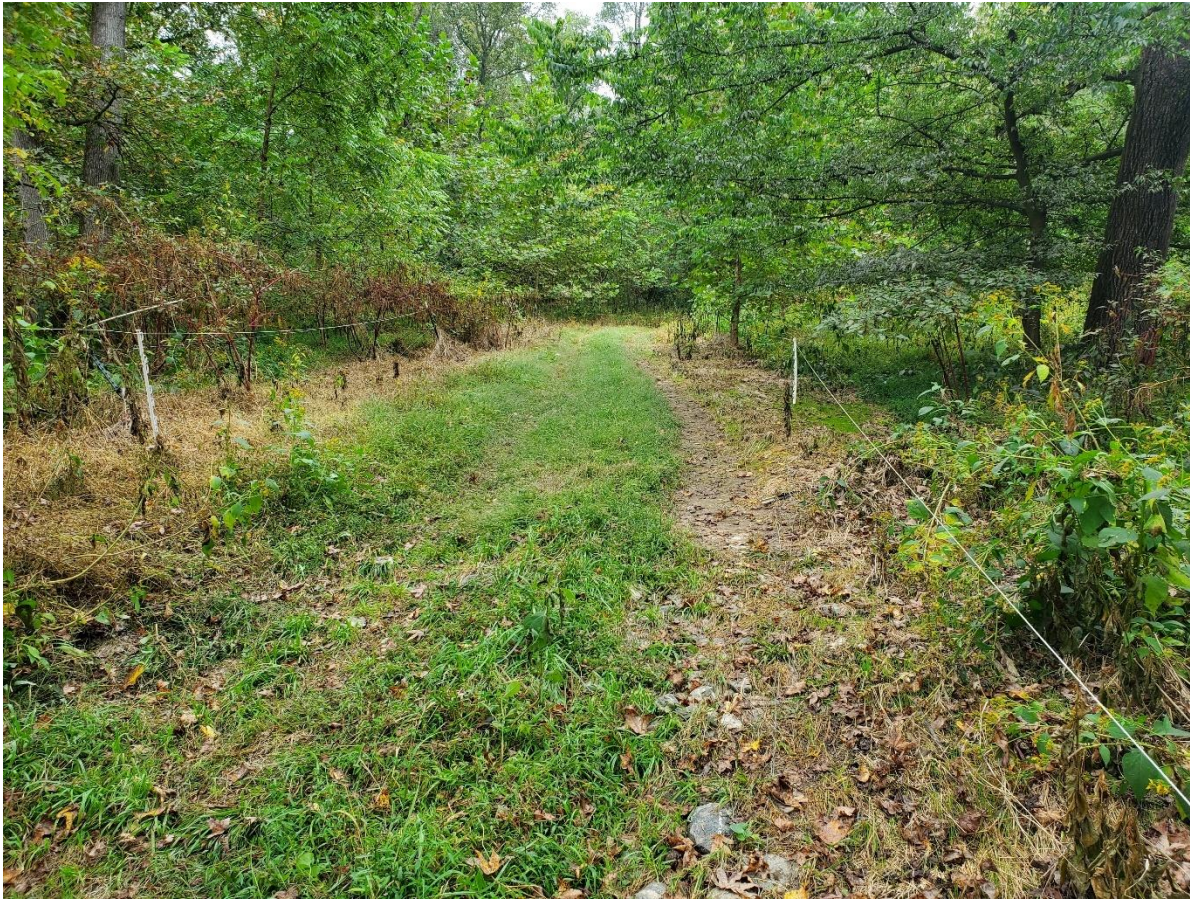
9/30/2021. Temporary fence installed along crossing.

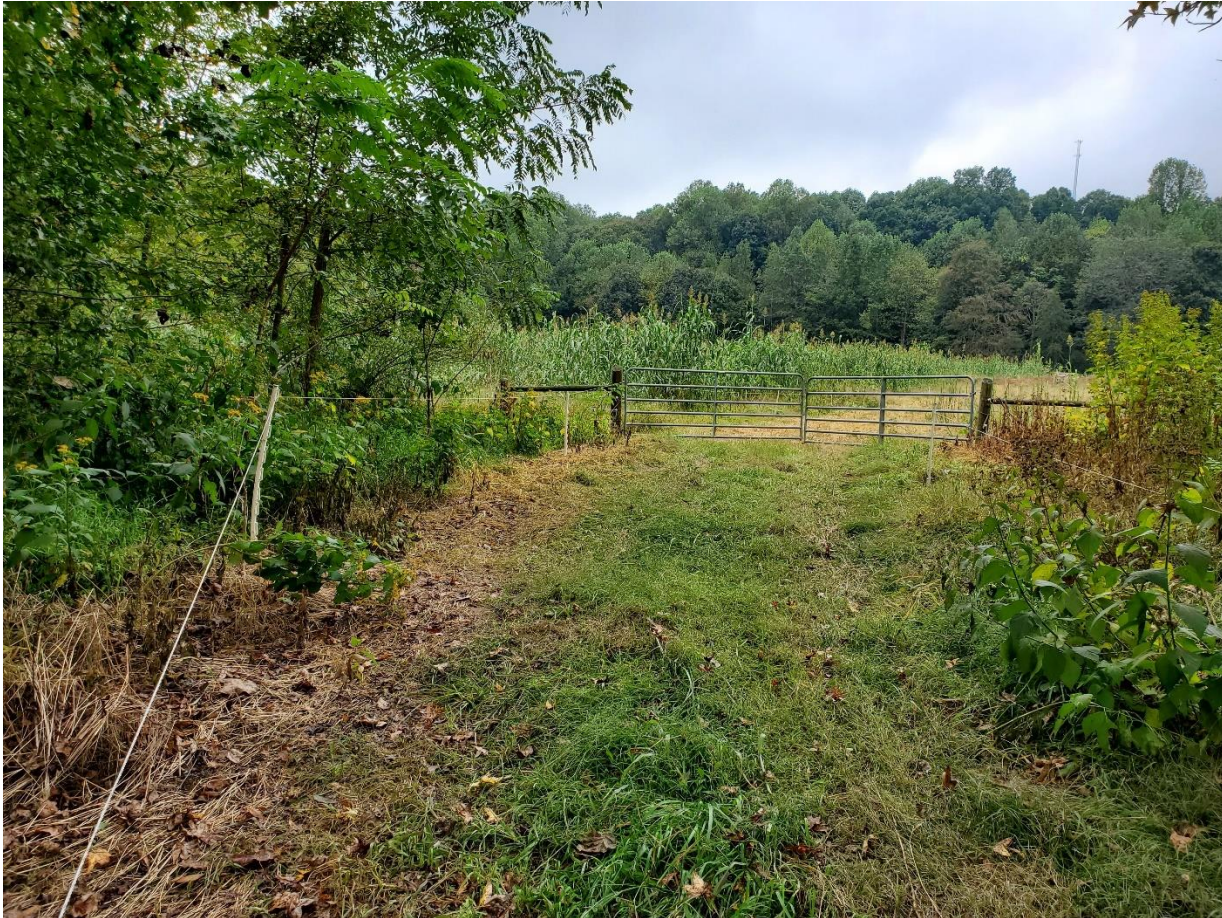
9/30/2021. Crossing gates stay closed.

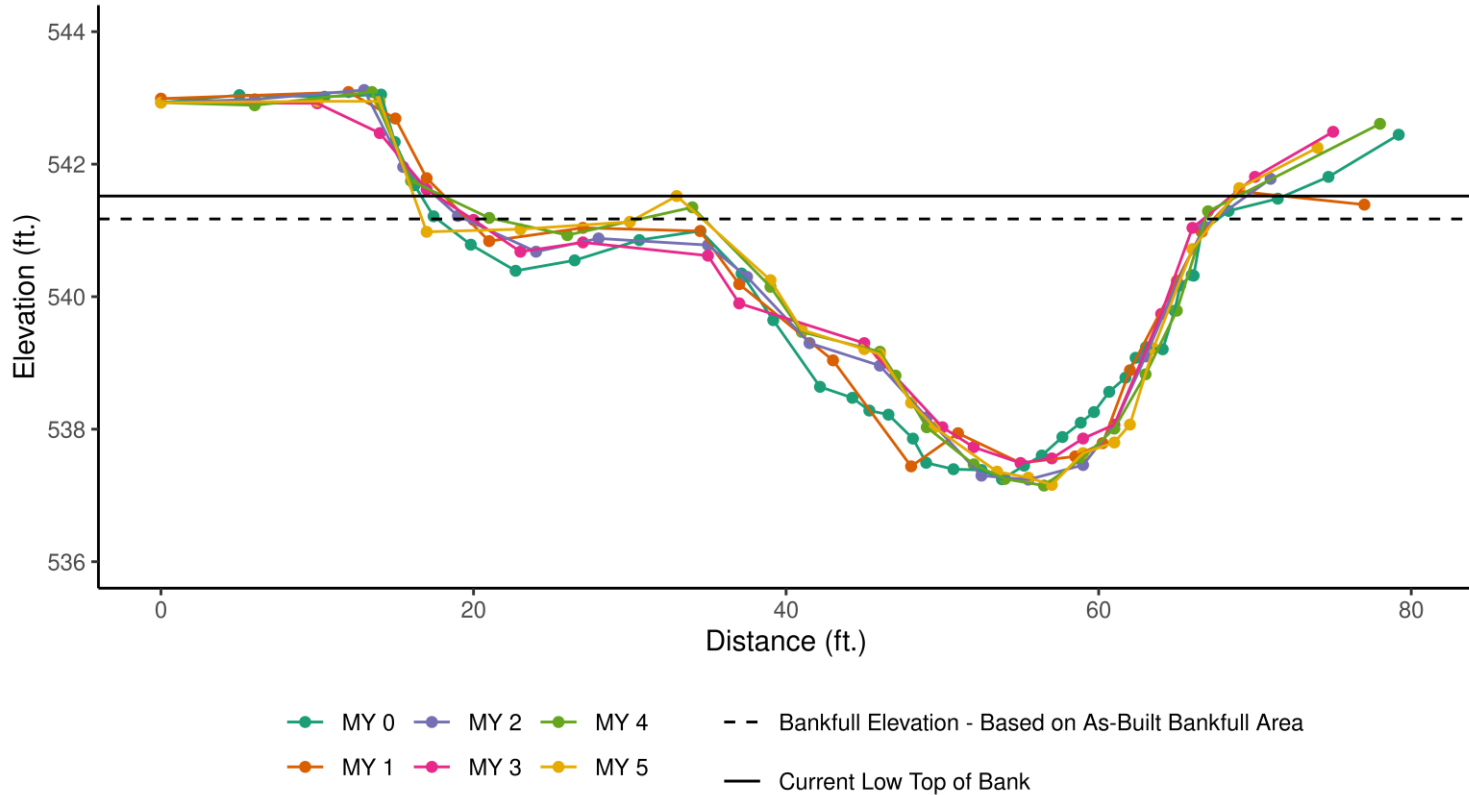
Cross Section 2 (Pool) MY5

MY0	MY1	MY2	MY3	MY4	MY5
Bankfull Elevation - Based on As-Built Bankfull Area	540.99	541.06	541.12	541.25	541.14	541.17
Bank Height Ratio - Based on As-Built Bankfull Area	1.00	0.98	0.91	0.83	1.05	1.09
Thalweg Elevation	537.24	537.44	537.24	537.49	537.15	537.16
LTOB Elevation	540.99	540.99	540.78	540.62	541.35	541.52
LTOB Max Depth	3.75	3.55	3.54	3.13	4.20	4.36
LTOB Cross Sectional Area	75.52	73.40	64.79	56.23	82.27	87.40

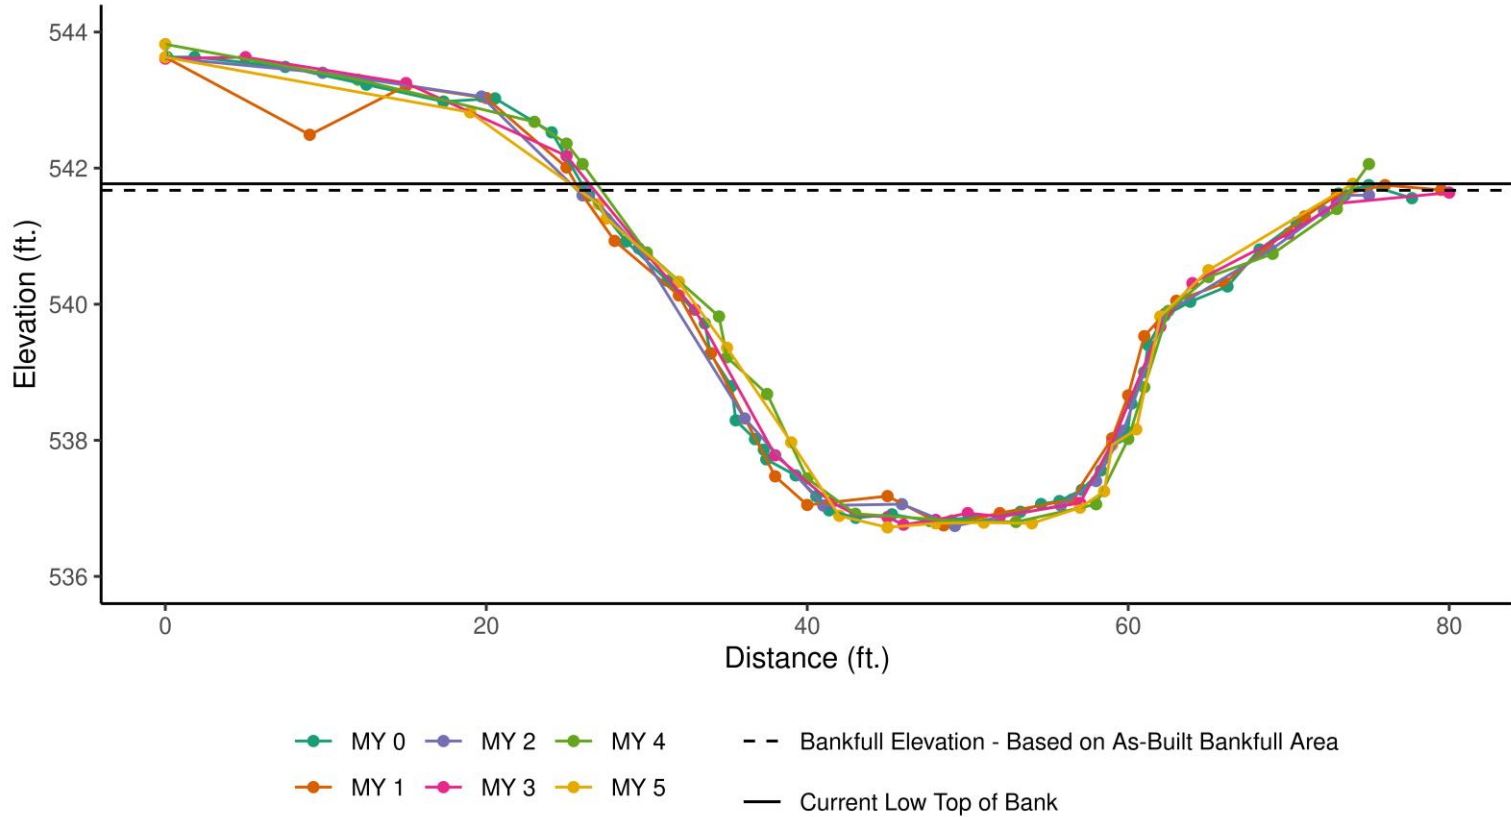
### Cross Section 3 (Riffle) MY5

MY0	MY1	MY2	MY3	MY4	MY5
Bankfull Elevation - Based on As-Built Bankfull Area	541.60	541.62	541.59	541.66	541.66	541.67
Bank Height Ratio - Based on As-Built Bankfull Area	1.00	1.00	1.00	0.96	1.08	1.02
Thalweg Elevation	536.82	536.75	536.74	536.76	536.80	536.72
LTOB Elevation	541.60	541.60	541.60	541.48	542.06	541.77
LTOB Max Depth	4.78	4.85	4.86	4.72	5.26	5.05
LTOB Cross Sectional Area	135.29	134.19	135.77	126.91	154.17	139.91

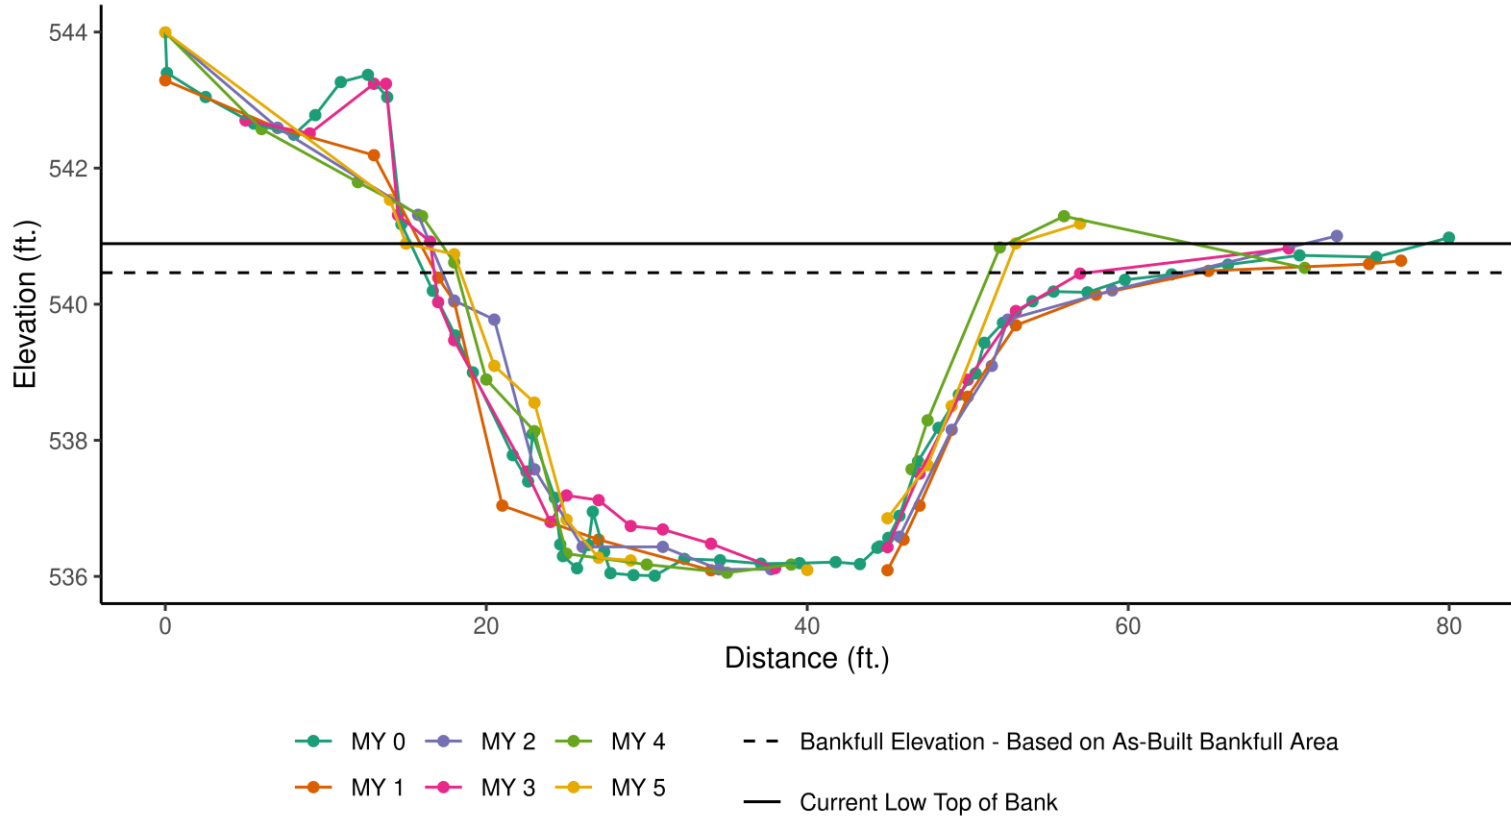
### Cross Section 4 (Riffle) MY5

MY0	MY1	MY2	MY3	MY4	MY5
Bankfull Elevation - Based on As-Built Bankfull Area	540.20	539.98	540.22	540.29	540.37	540.46
Bank Height Ratio - Based on As-Built Bankfull Area	1.00	1.04	1.00	1.04	1.20	1.10
Thalweg Elevation	536.01	535.84	535.92	535.89	535.77	536.09
LTOB Elevation	540.20	540.14	540.20	540.45	541.29	540.89
LTOB Max Depth	4.19	4.30	4.28	4.56	5.52	4.80
LTOB Cross Sectional Area	109.47	115.74	108.56	115.90	142.03	124.35
