**MONITORING YEAR 3, 4, AND 5 REPORT**  
**BOWLIN-PEAK CREEK MITIGATION SITE**

Ashe County, North Carolina

EEP Project Number: 92606  
Contract Number: D06082; Task Order: 06NW01-1

Period Covered: July 2009 - June 2012

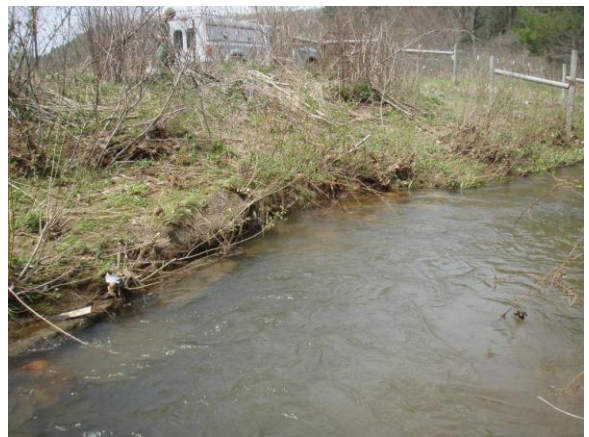
SPA MY4-5, eroding left bank, 19 Apr 11.

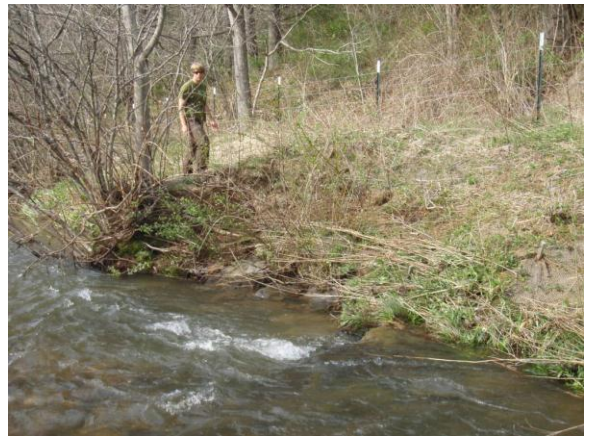
SPA MY4-6, eroding right bank, 19 Apr 11.

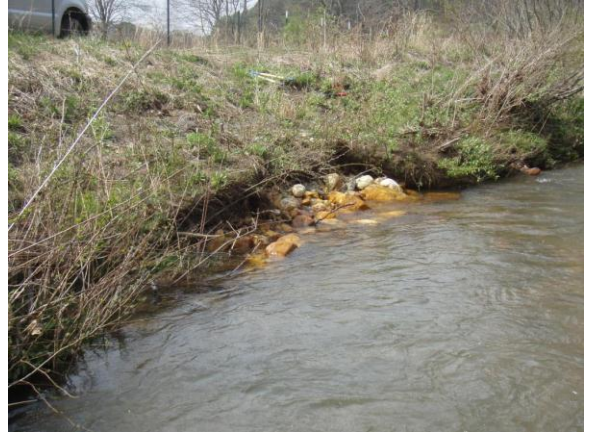
SPA MY4-7, eroding left bank, 19 Apr 11.

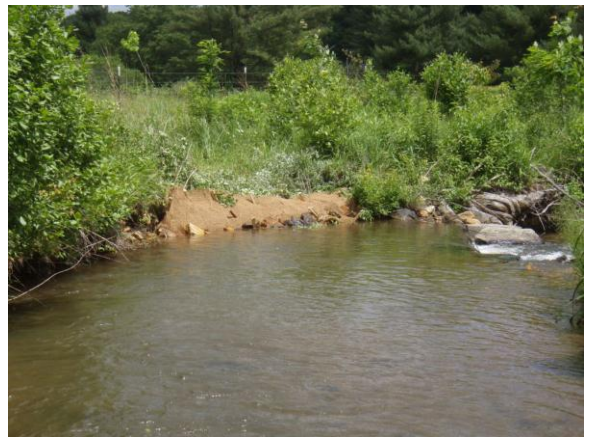
SPA MY5-2, eroding left bank, 9 Apr 12.

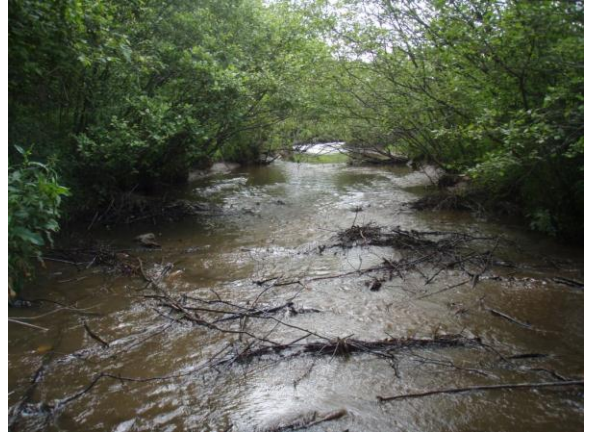
On 9 April 2012, a beaver dam was identified at station 18+11. The dam caused sediment to fill in the pool behind the dam and backed water up to station 16+75. The dam was removed on 29 May 2012 and the fine sediment appeared to be flushing out of the pool.

SPA MY5-6, beaver dam, 10 Apr 12.

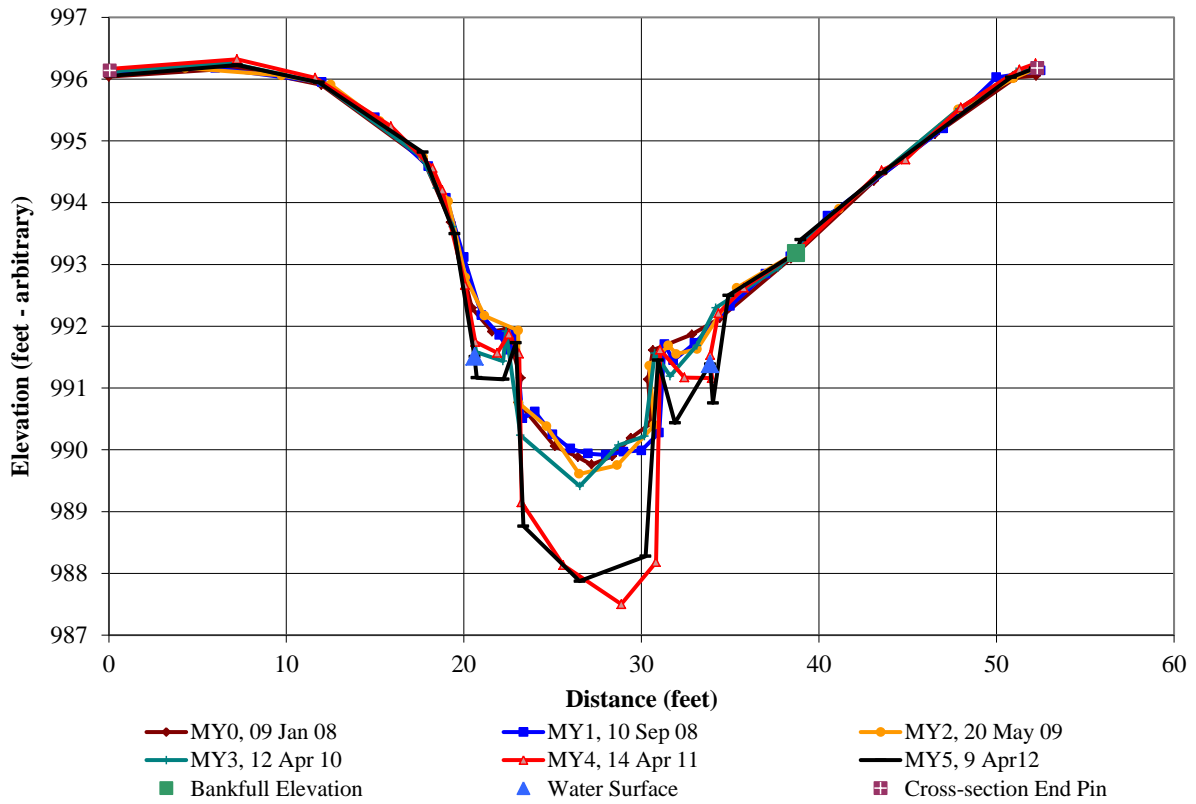
**Cross-section 2, Pool**  
**Bowlin-Peak Creek/Project Number:92606**

- Cross-section 2 transects a pool and the downstream portion of a log cross-vane. The cross-section dimension was relatively stable between MY0 and MY3. The stream channel thalweg elevation decreased approximately 1.9 ft in MY4 and decreased approximately 2.3 ft from the as-built condition. Additionally, the right bank migrated approximately 0.5 ft to the right. Although not shown on the cross-section overlay, the stream was piping under the right arm of the log cross vane. This change in channel dimension in MY4 was the result of several bankfull storm events falling over a 1.8 ft tall beaver dam 25 ft upstream of the log cross vane. This increased the water's stream power and its ability to move larger sediment. The thalweg elevation increased approximately 0.4 ft in MY5 and the right bank eroded an additional 0.6 ft.

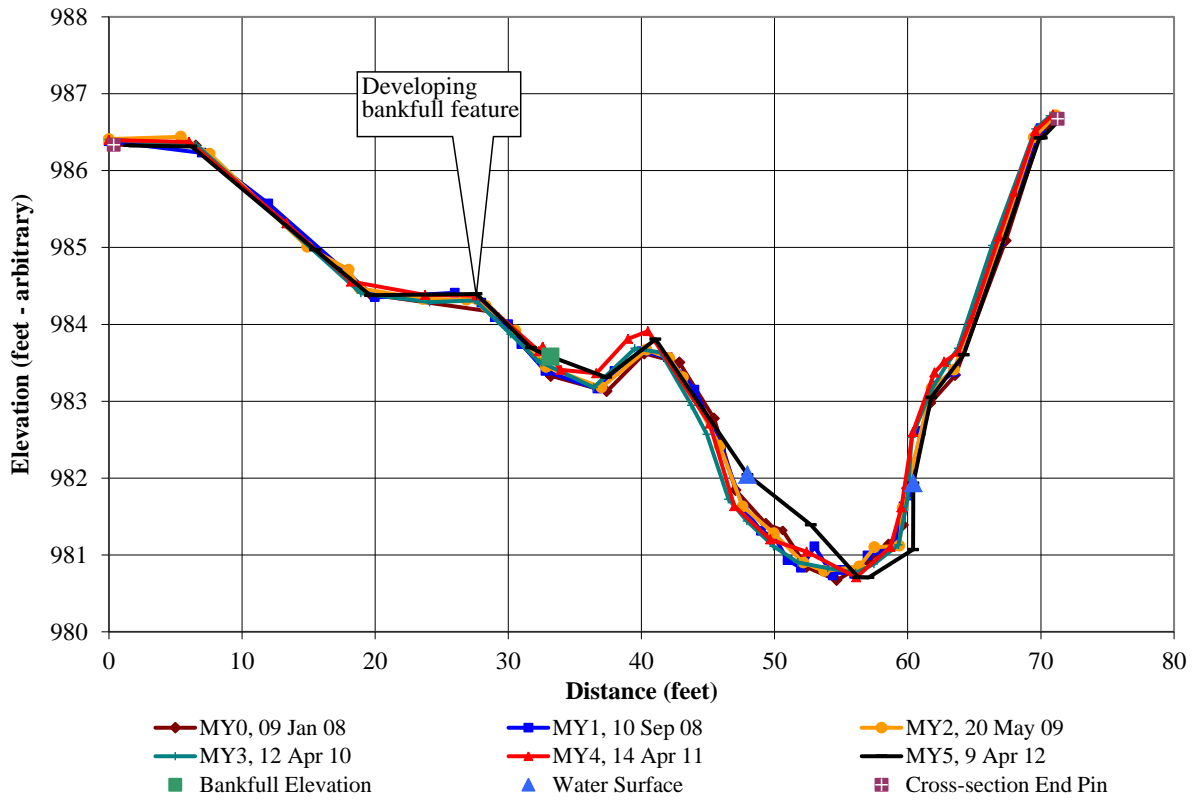
**Cross-section 6, Riffle**  
**Bowlin-Peak Creek/Project Number:92606**

- Cross-section 6 transects a riffle. The stream channel and banks have remained stable the since the as-built survey with only minor channel adjustments. In MY5, the cross-section transected the head of a pool caused by a downstream beaver dam. The stream channel thalweg moved slightly to the right as a point bar formed on the left bank. The beaver dam was removed after the MY5 survey and water appeared to flush out the finer sediment in the point bar.
