MY0 FINAL MONITORING REPORT

BRAHMA SITE

Alamance County, North Carolina
Cape Fear River Basin
Cataloging Unit 03030002

DMS Project No. 100092
Full Delivery Contract No. 7743
DMS RFP No. 16-007571
USACE Action ID No. SAW-2019-00126
DWR Project No. 20190158

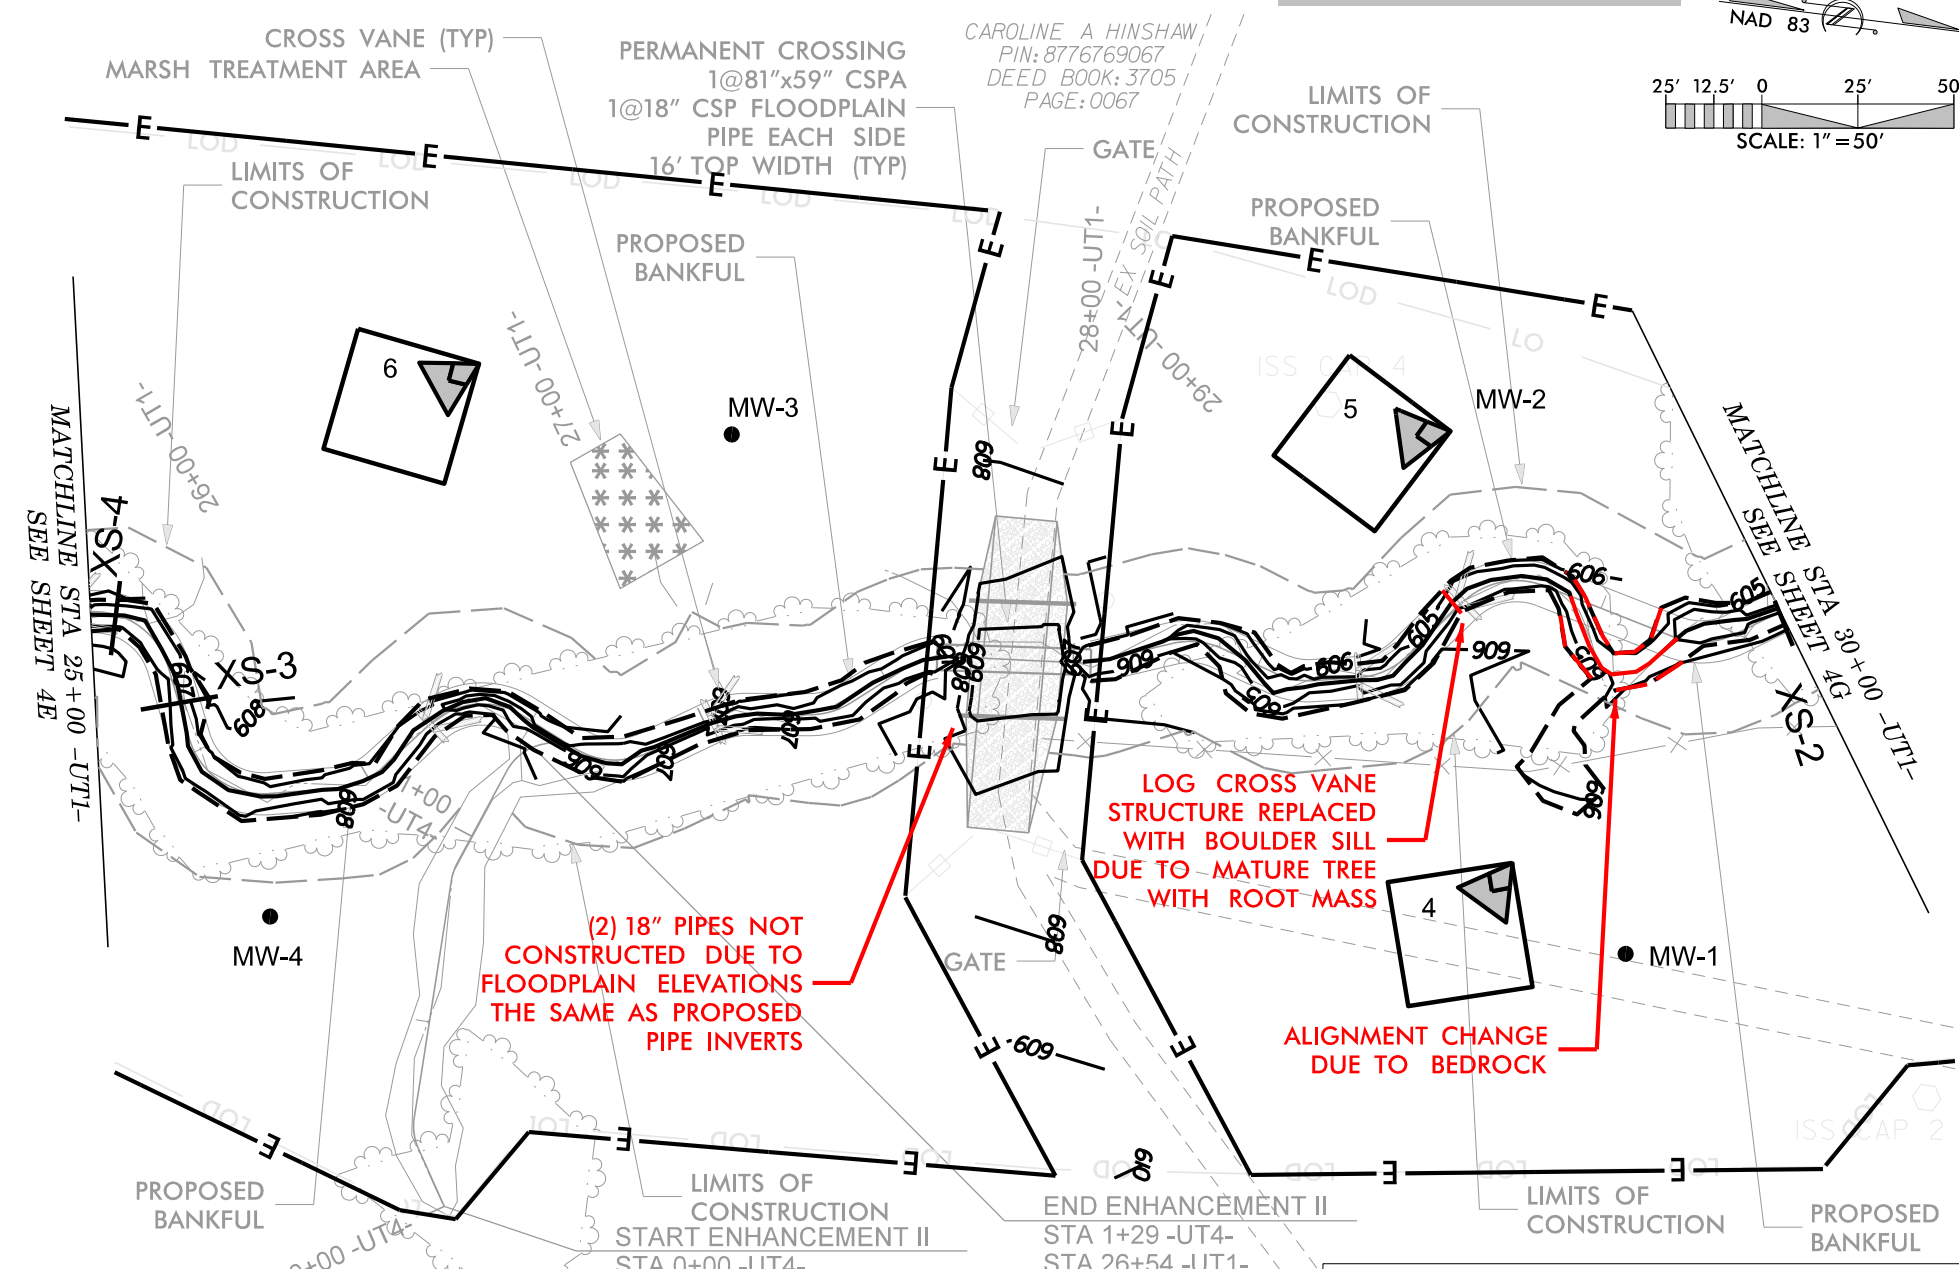
(2) 18" PIPES NOT CONSTRUCTED DUE TO FLOODPLAIN ELEVATIONS THE SAME AS PROPOSED PIPE INVERTS
