MY2 MONITORING REPORT

BRAHMA SITE

Alamance County, North Carolina

DMS Project No. 100092

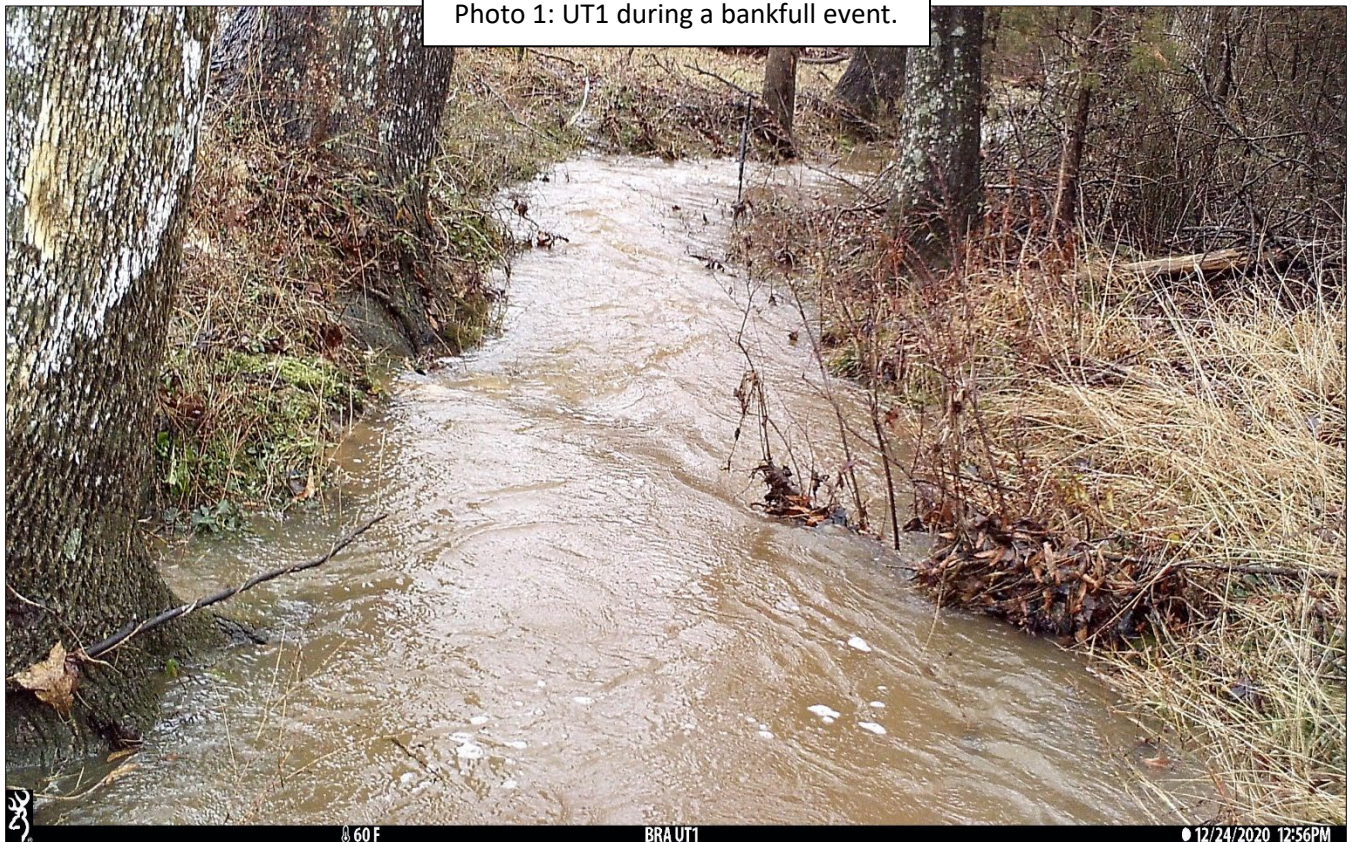
Photo 1: UT1 during a bankfull event.

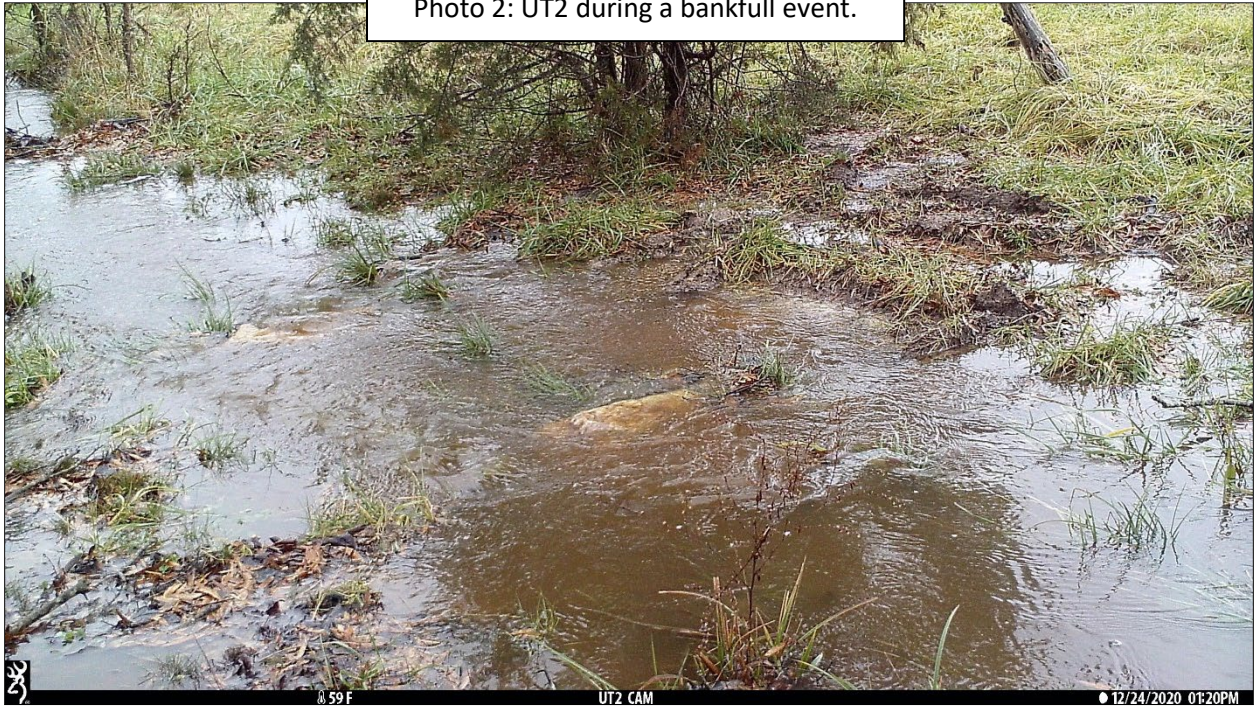
Photo 2: UT2 during a bankfull event.

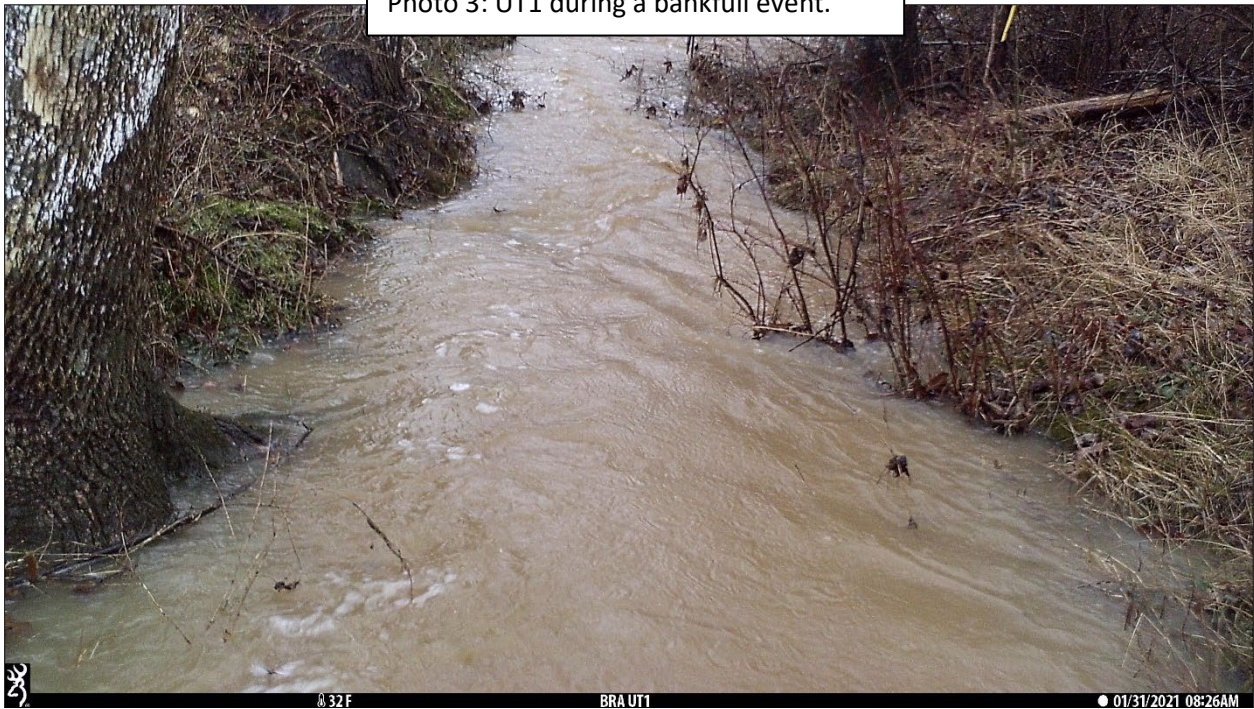
Photo 3: UT1 during a bankfull event.

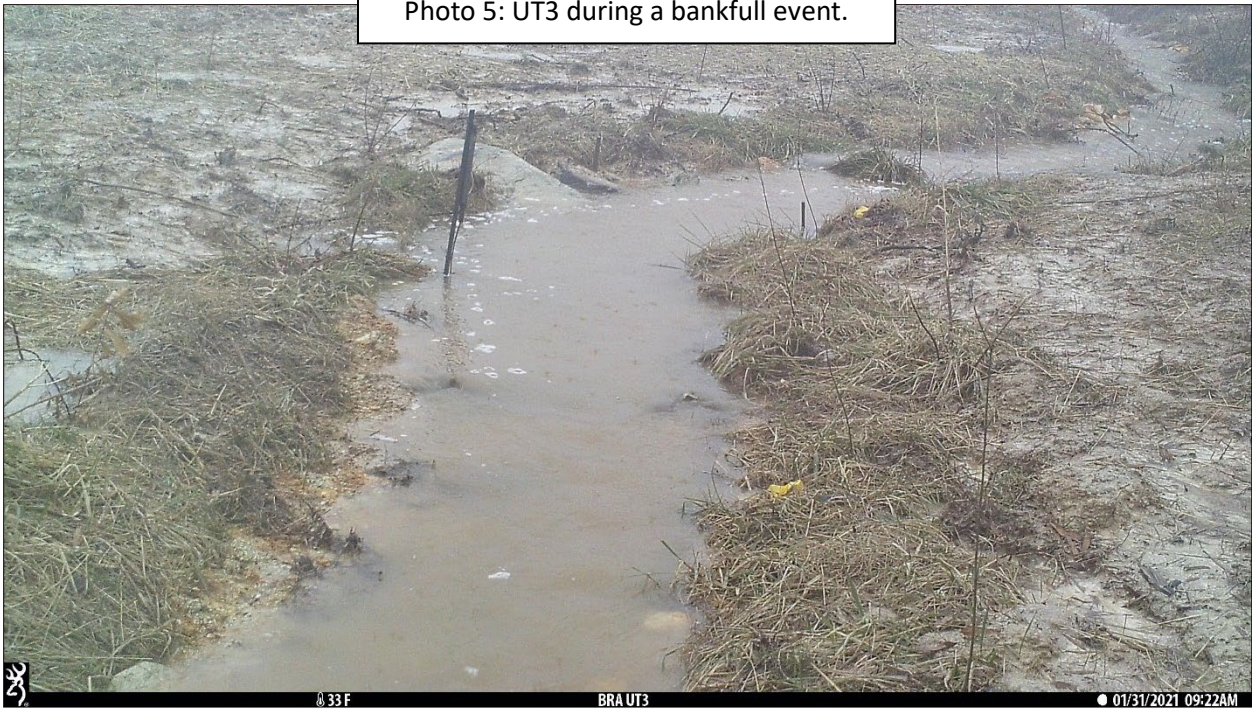
Photo 5: UT3 during a bankfull event.

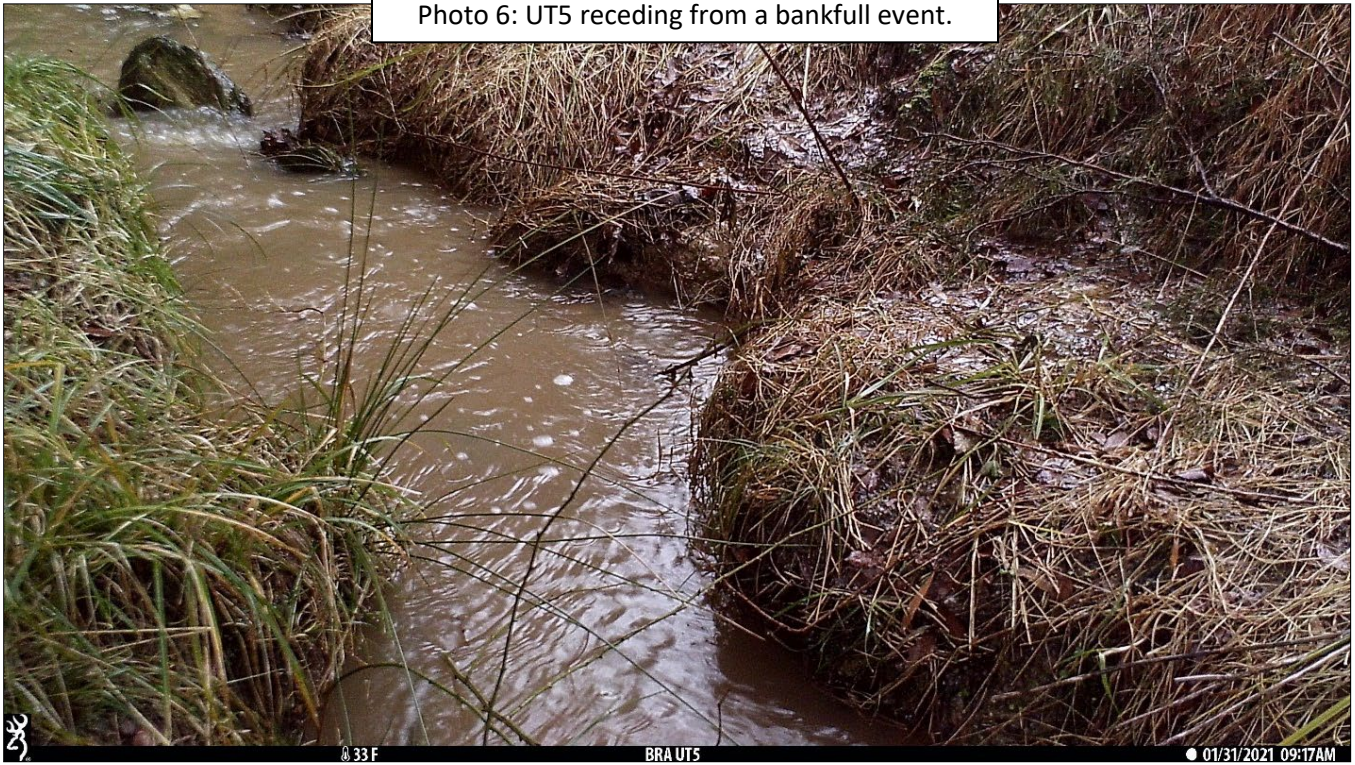
Photo 6: UT5 receding from a bankfull event.

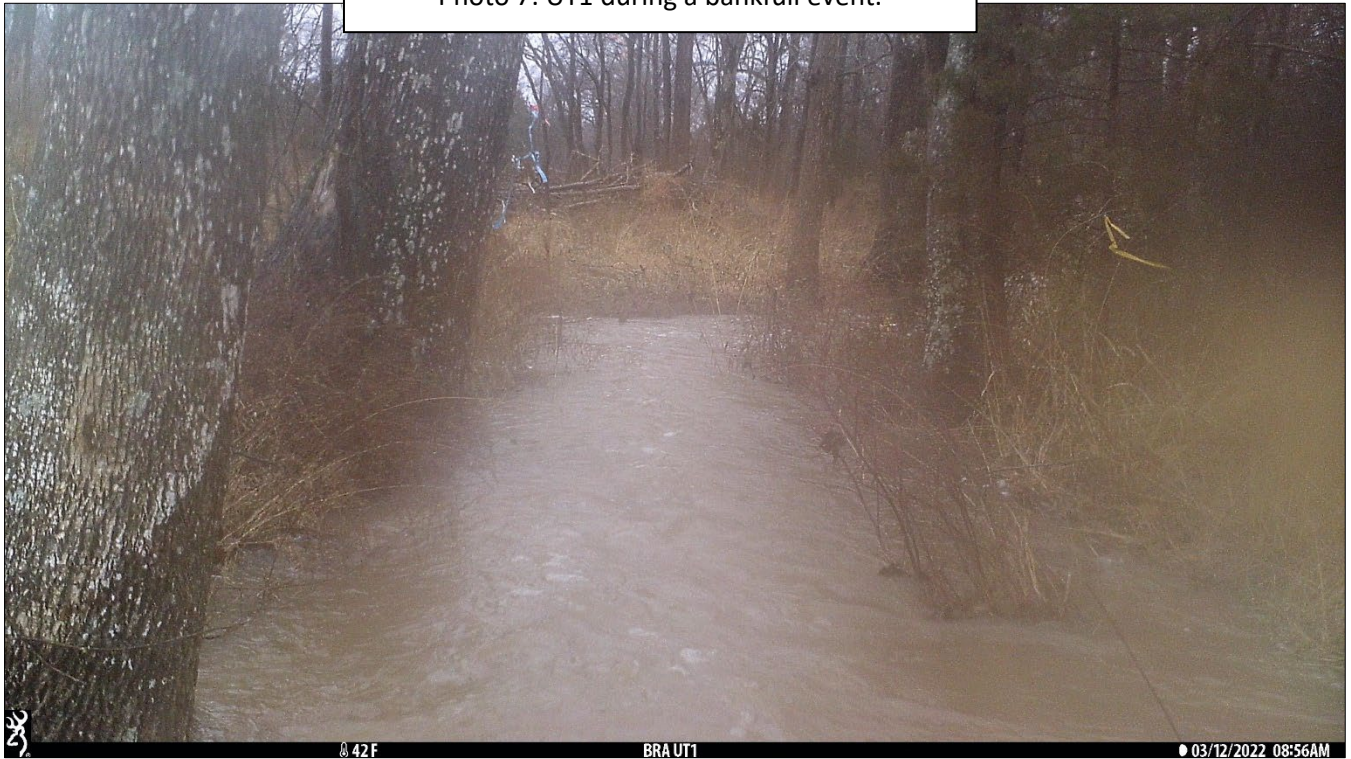
Photo 7: UT1 during a bankfull event.

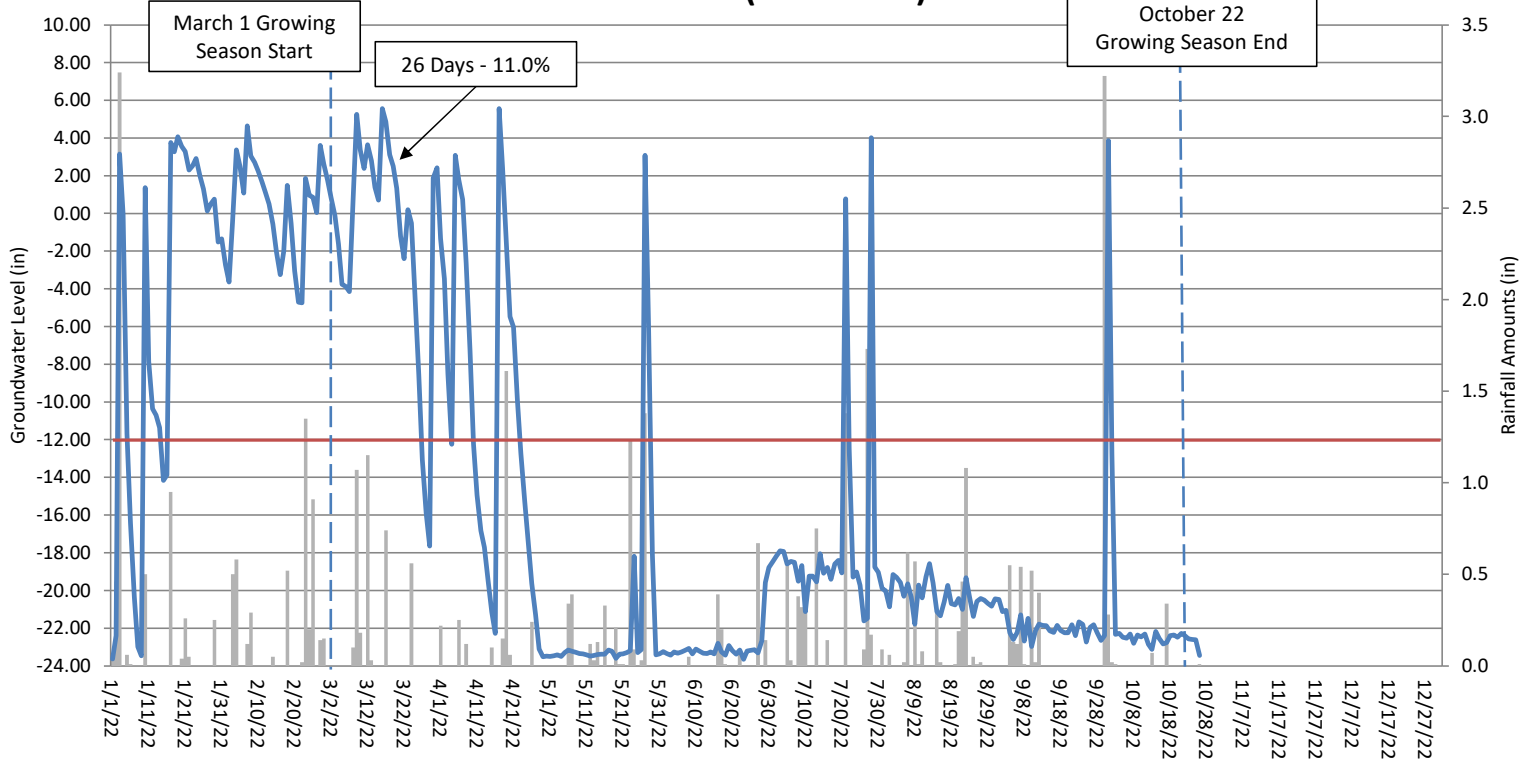
Brahma Groundwater Gauge 12 Year 2 (2022 Data)

- Eleven of twelve groundwater gauges met success criteria for the year 2 (2022) monitoring period. Gauges 12 missed the 12% hydroperiod success criteria by two days giving it a hydroperiod of 11.0% (Appendix D).

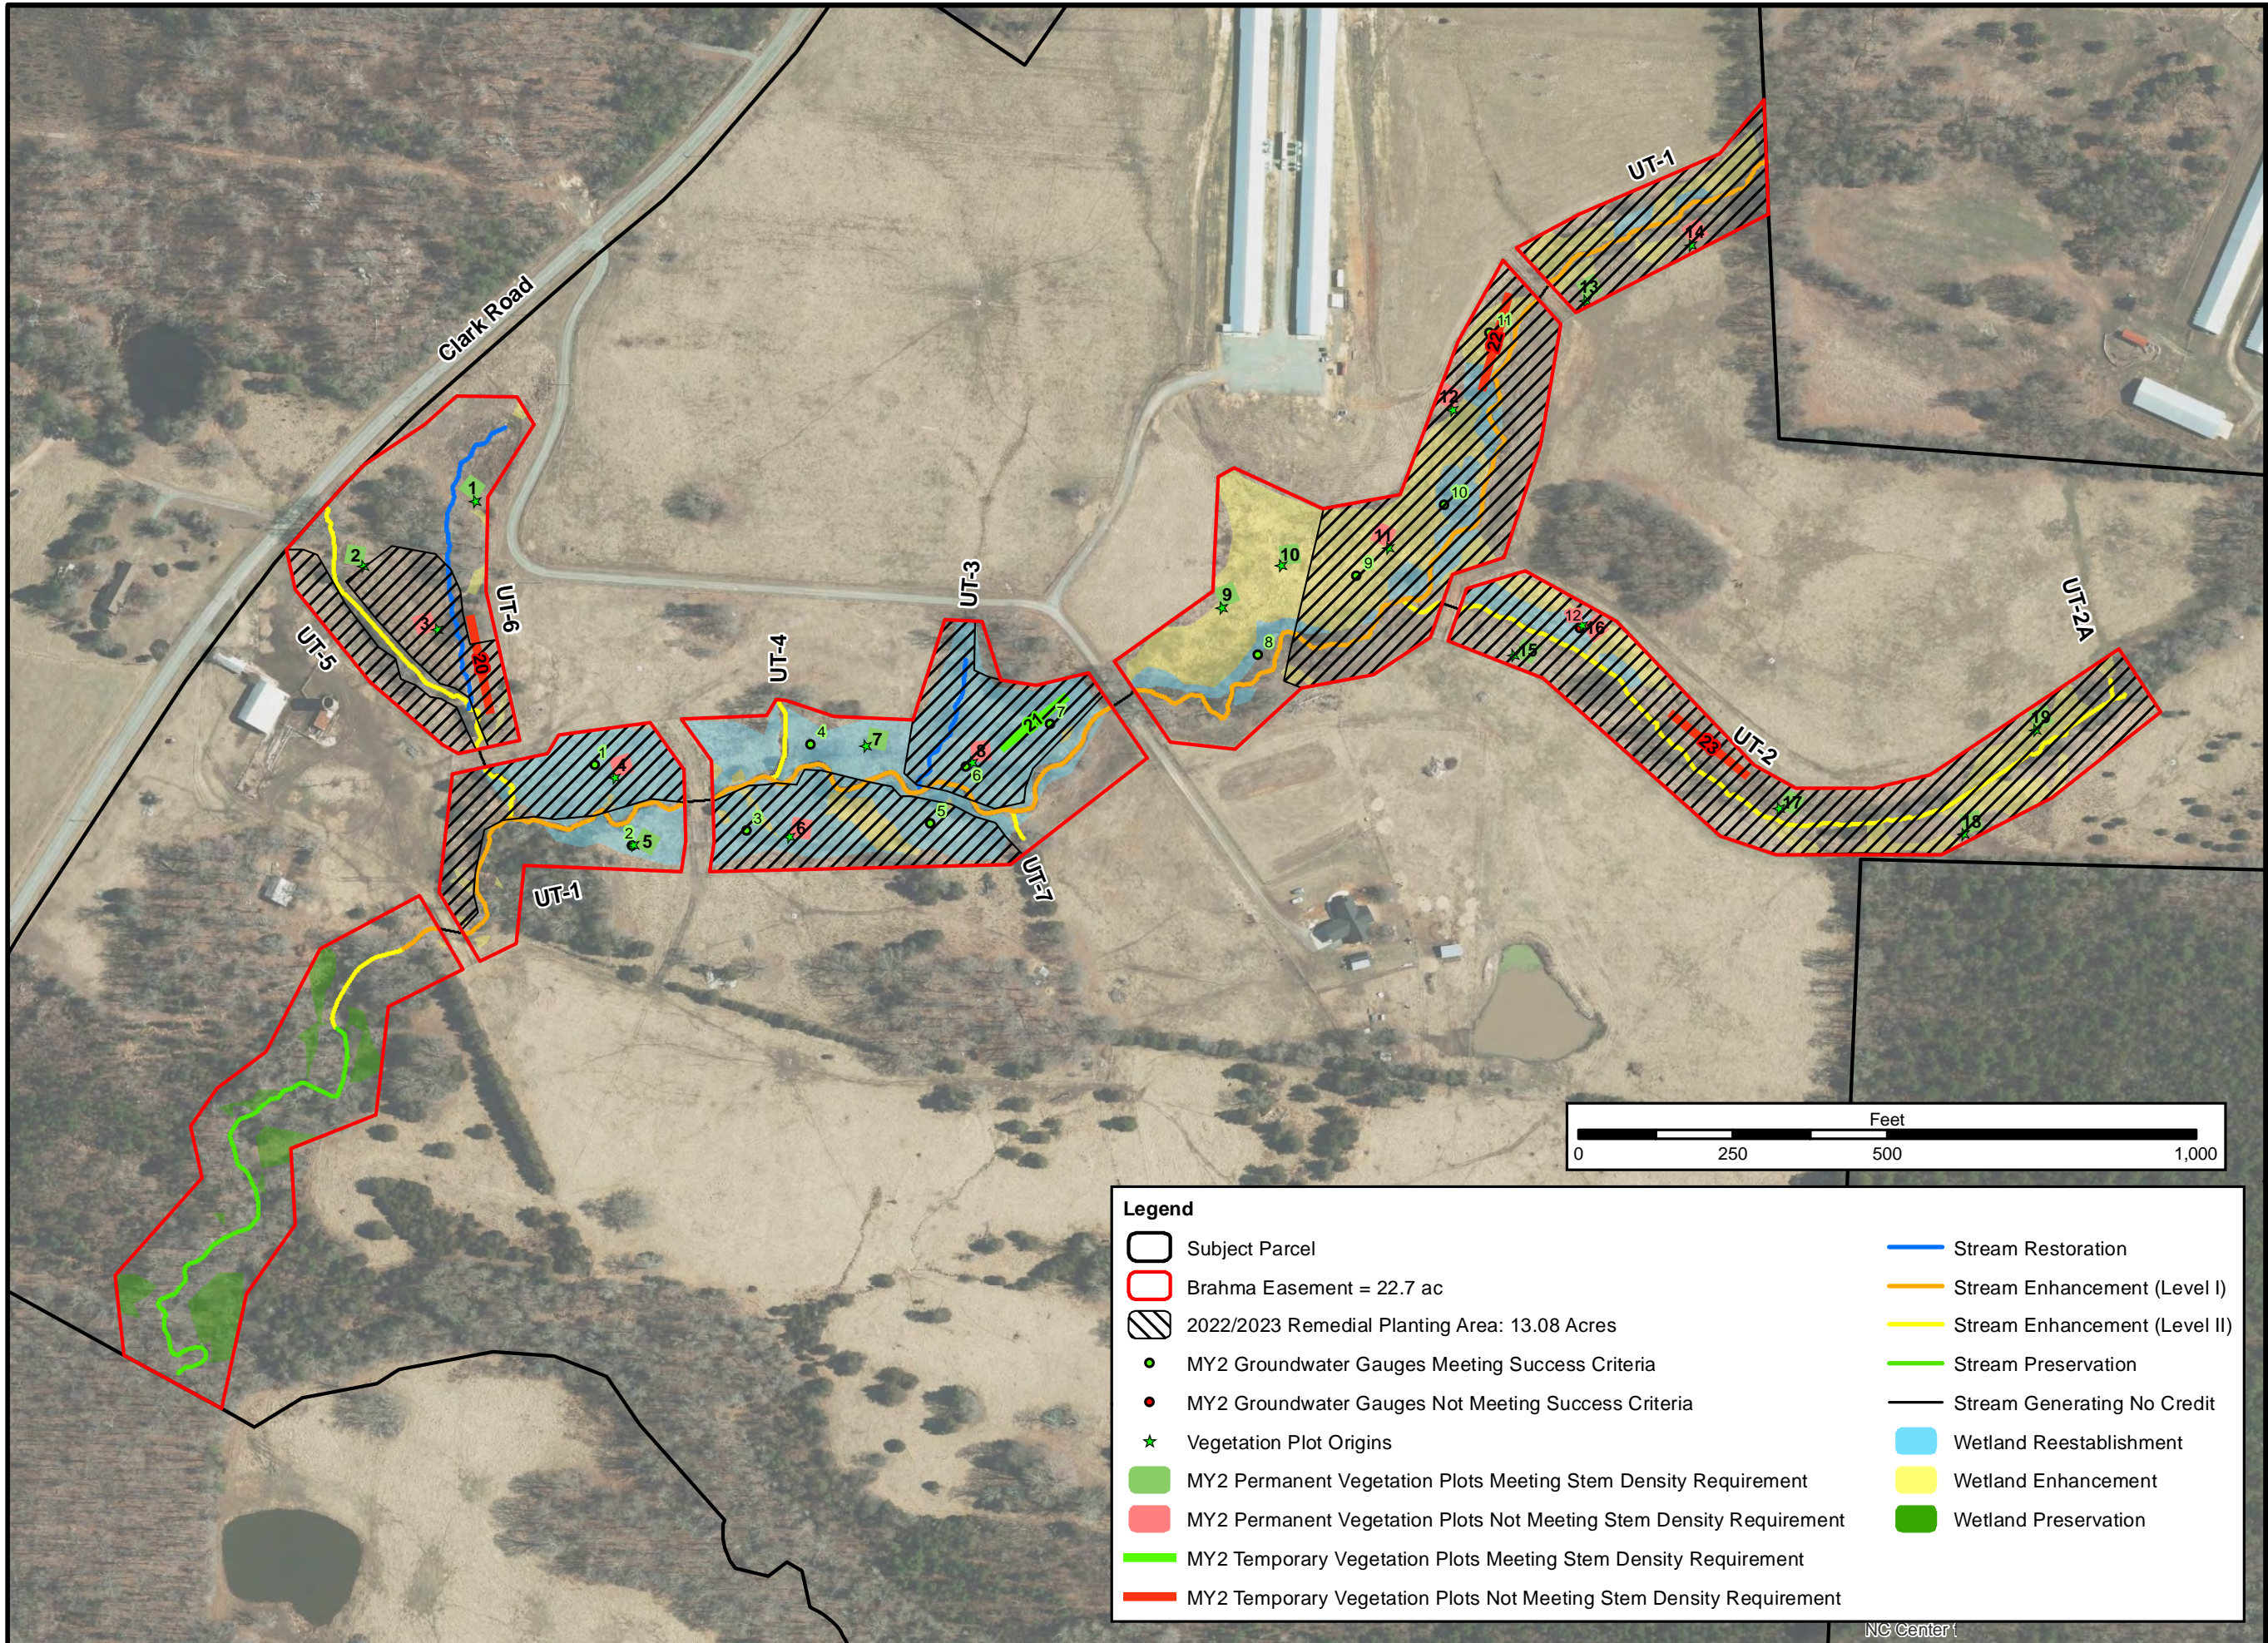
During the 2022 growing season, Restoration Systems (RS) observed areas of low planted-stem densities at the Brahma Mitigation Site (Site). These observations were confirmed by quantitative vegetation surveying; results of the vegetation survey, both permanent plots and random transects, are included in the MY2 (2022) Monitoring Report. The survey showed a site-wide average of 340 planted stems/acre, excluding live stakes, slightly above the MY 3 vegetation success criteria of 320 stems per acre. However, 11 of the 23 surveyed plots/transects failed to achieve the 320 stems per acre criteria. The 11 failing plots/transects averaged 209 stems/acre, below the MY7 vegetation success criteria for planted stems.
