# **MY3 FINAL MONITORING REPORT**

## **BRAHMA SITE**

Alamance County, North Carolina  
Cape Fear River Basin  
Cataloging Unit 03030002

DMS Project No. 100092  
Full Delivery Contract No. 7743  
DMS RFP No. 16-007571  
USACE Action ID No. SAW-2019-00126  
DWR Project No. 20190158

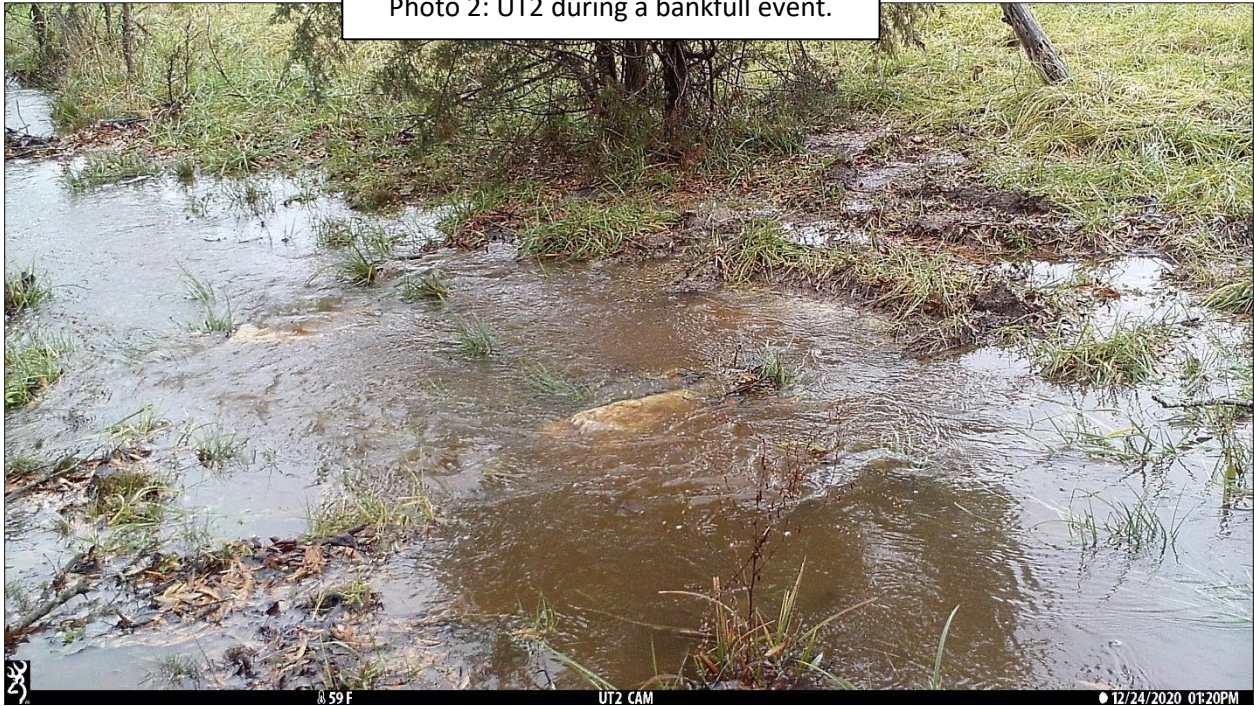
Photo 2: UT2 during a bankfull event.

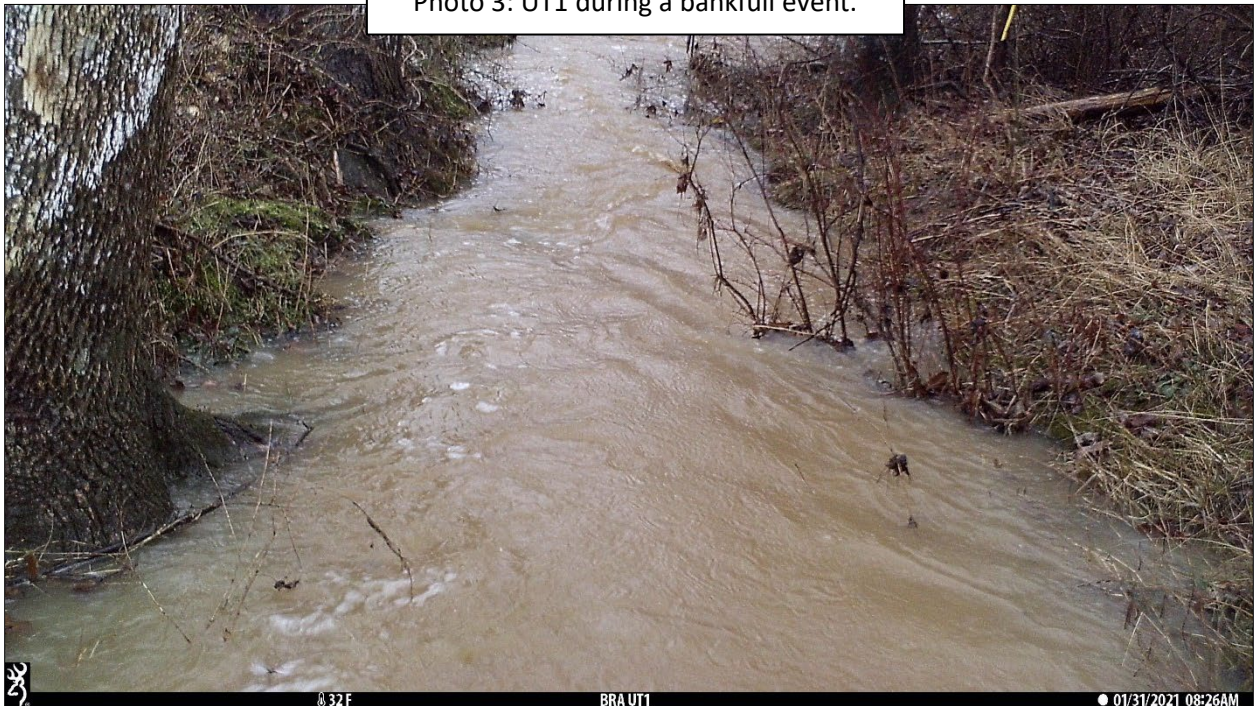
Photo 3: UT1 during a bankfull event.

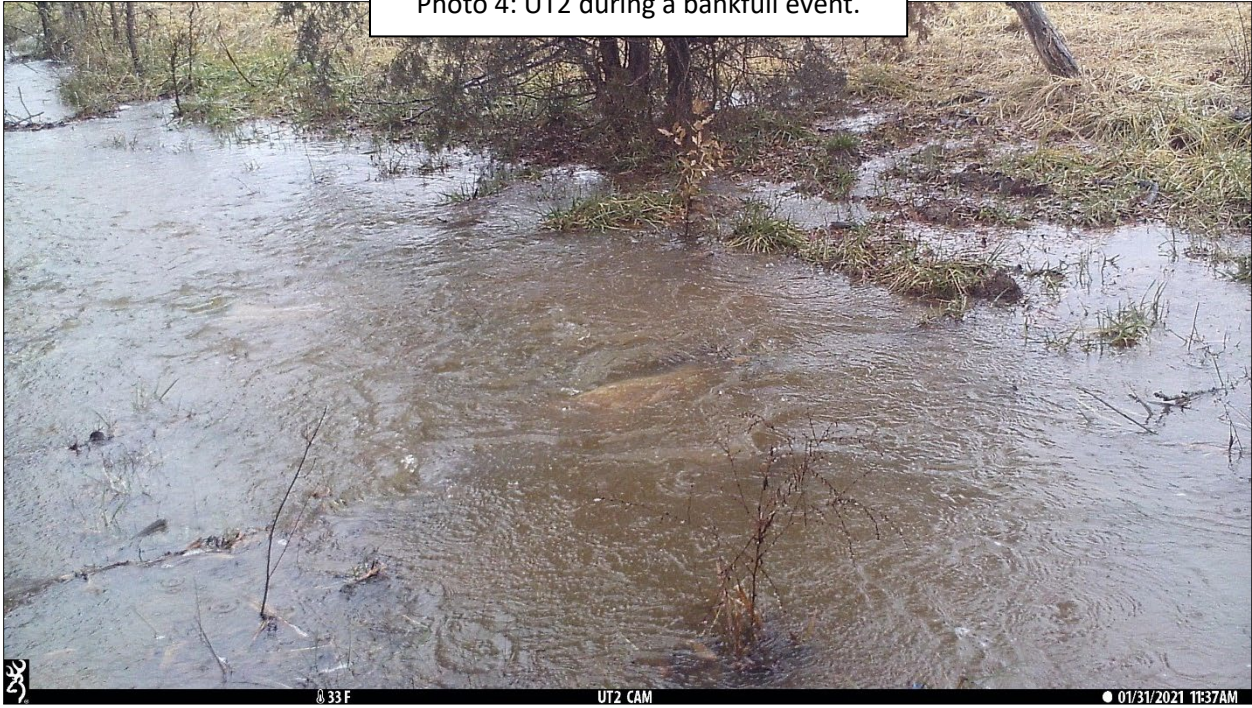
Photo 4: UT2 during a bankfull event.

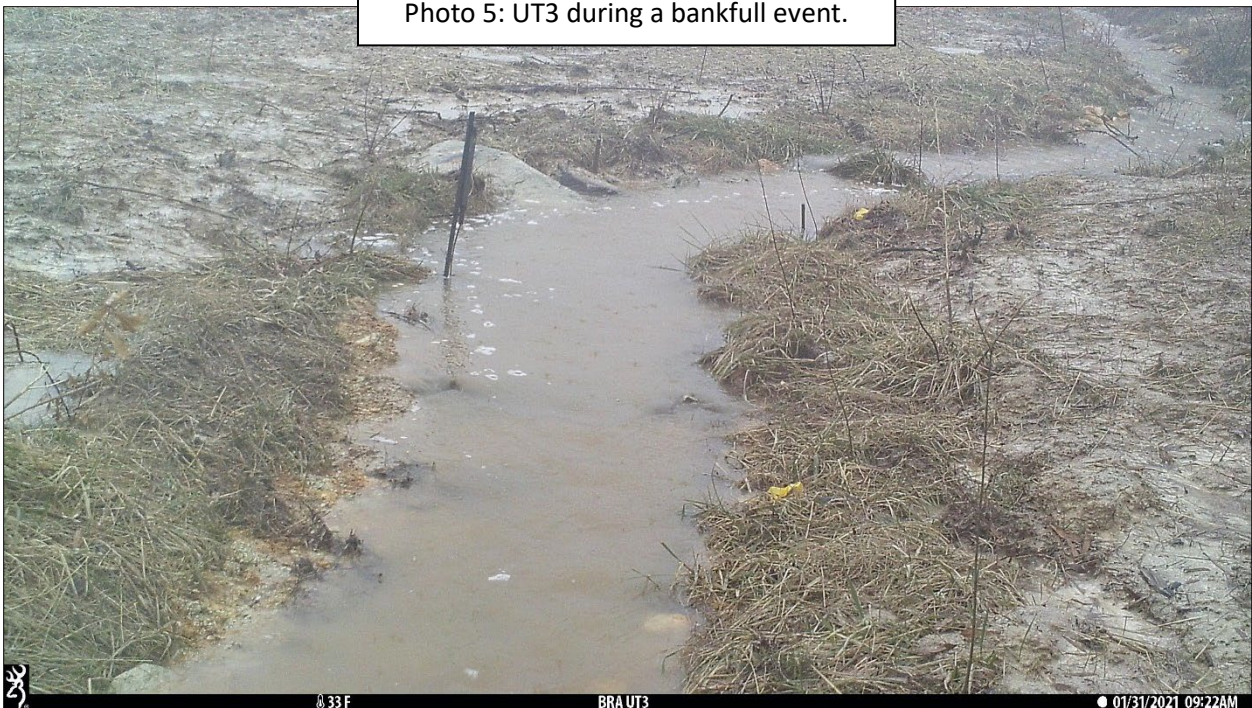
Photo 5: UT3 during a bankfull event.

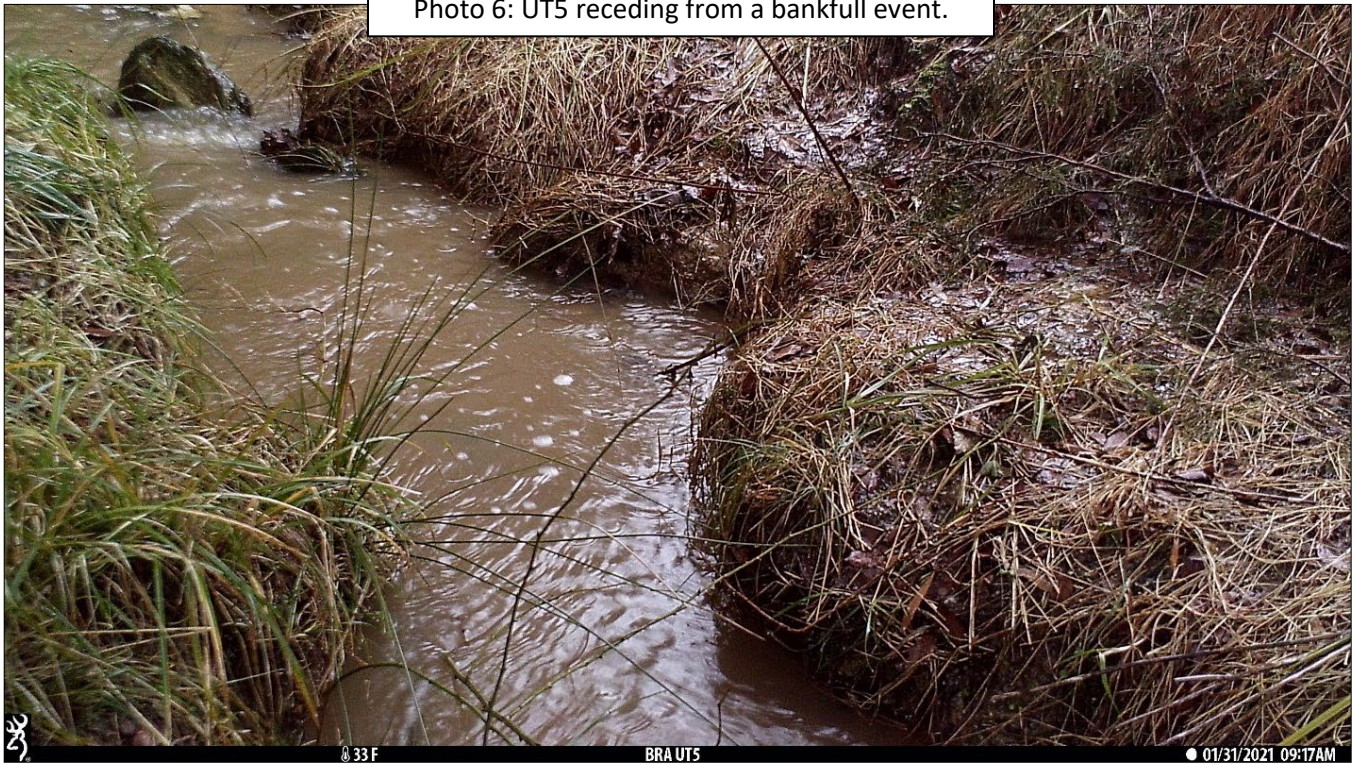
Photo 6: UT5 receding from a bankfull event.

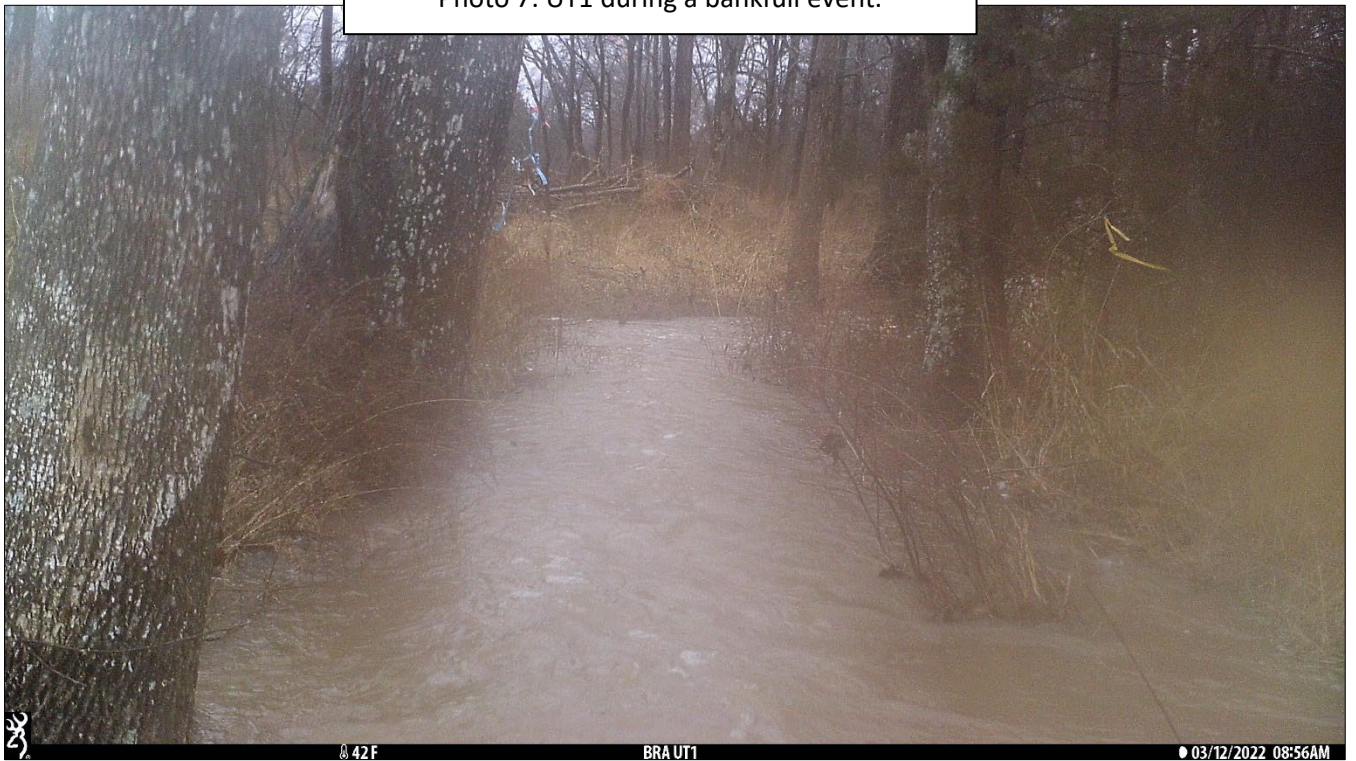
Photo 7: UT1 during a bankfull event.

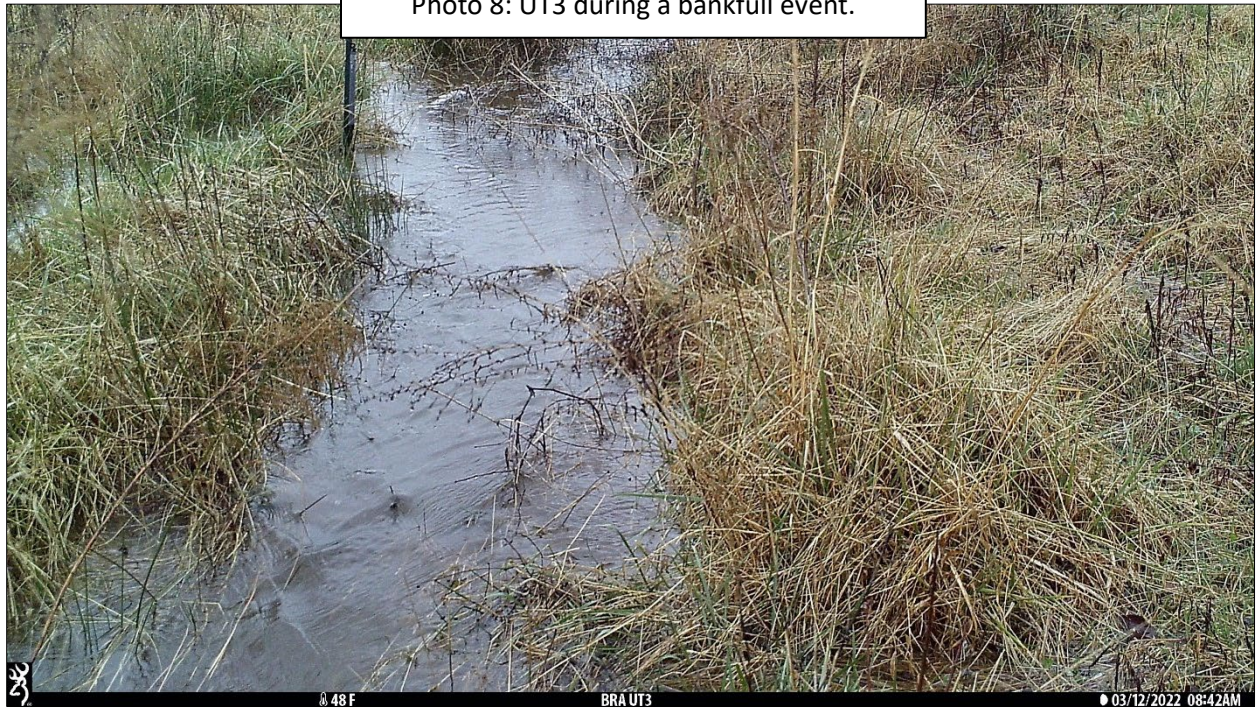
Photo 8: UT3 during a bankfull event.

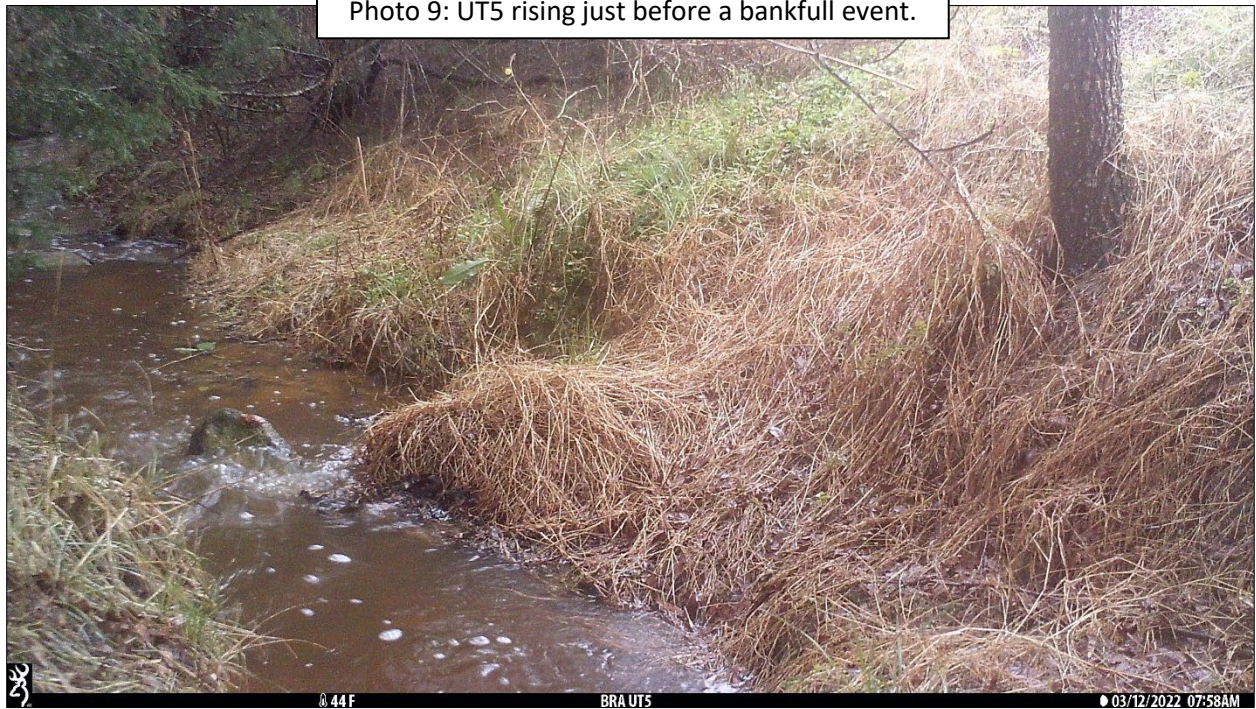
Photo 9: UT5 rising just before a bankfull event.

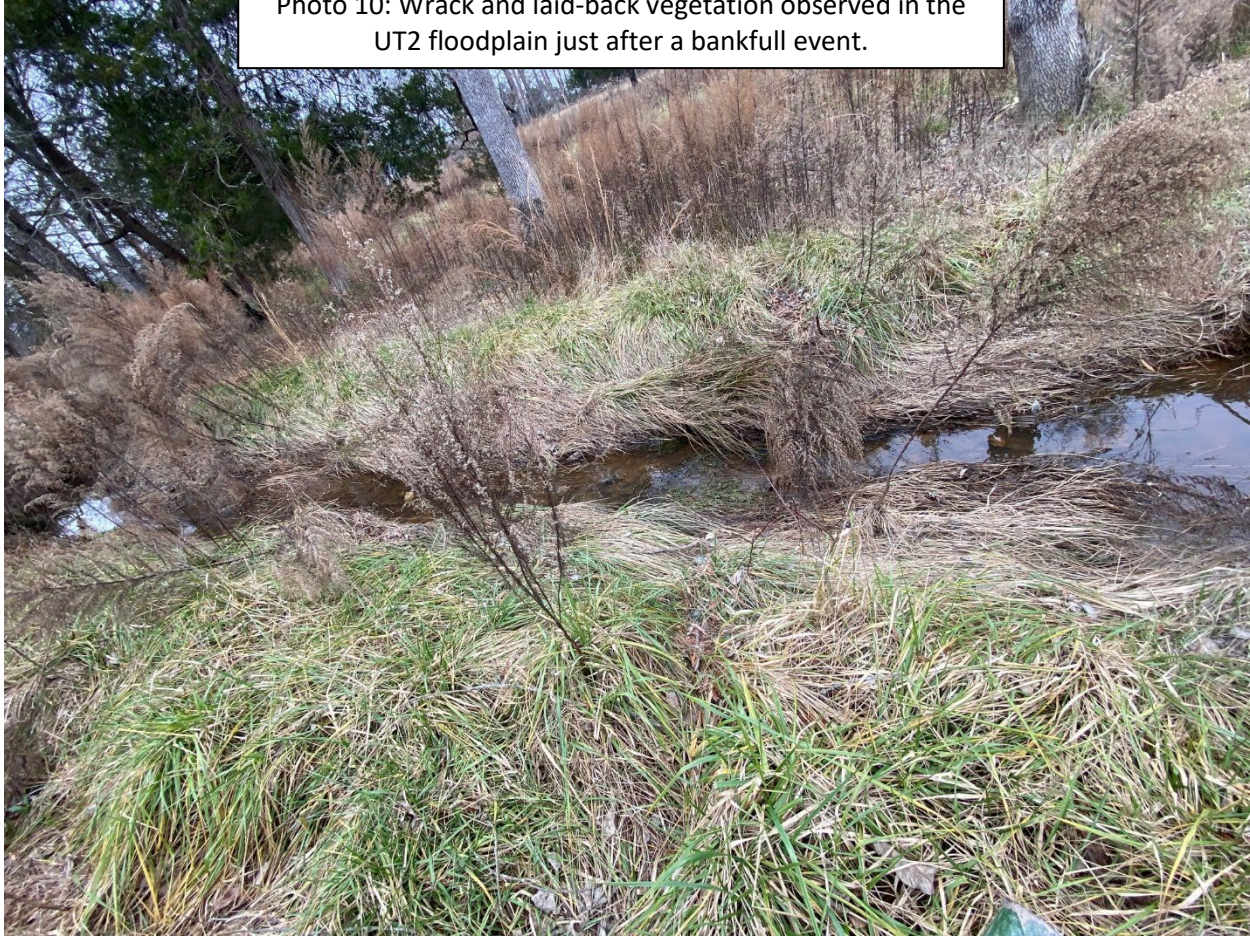
Photo 10: Wrack and laid-back vegetation observed in the UT2 floodplain just after a bankfull event.

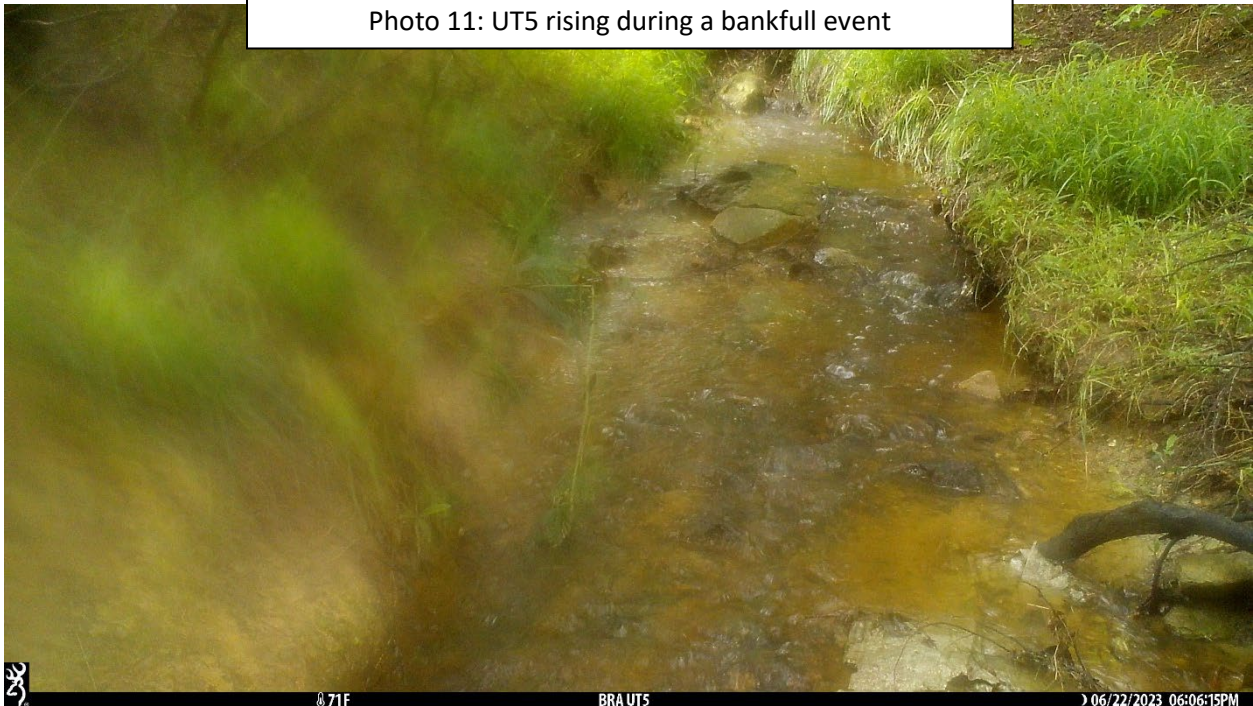
Photo 11: UT5 rising during a bankfull event

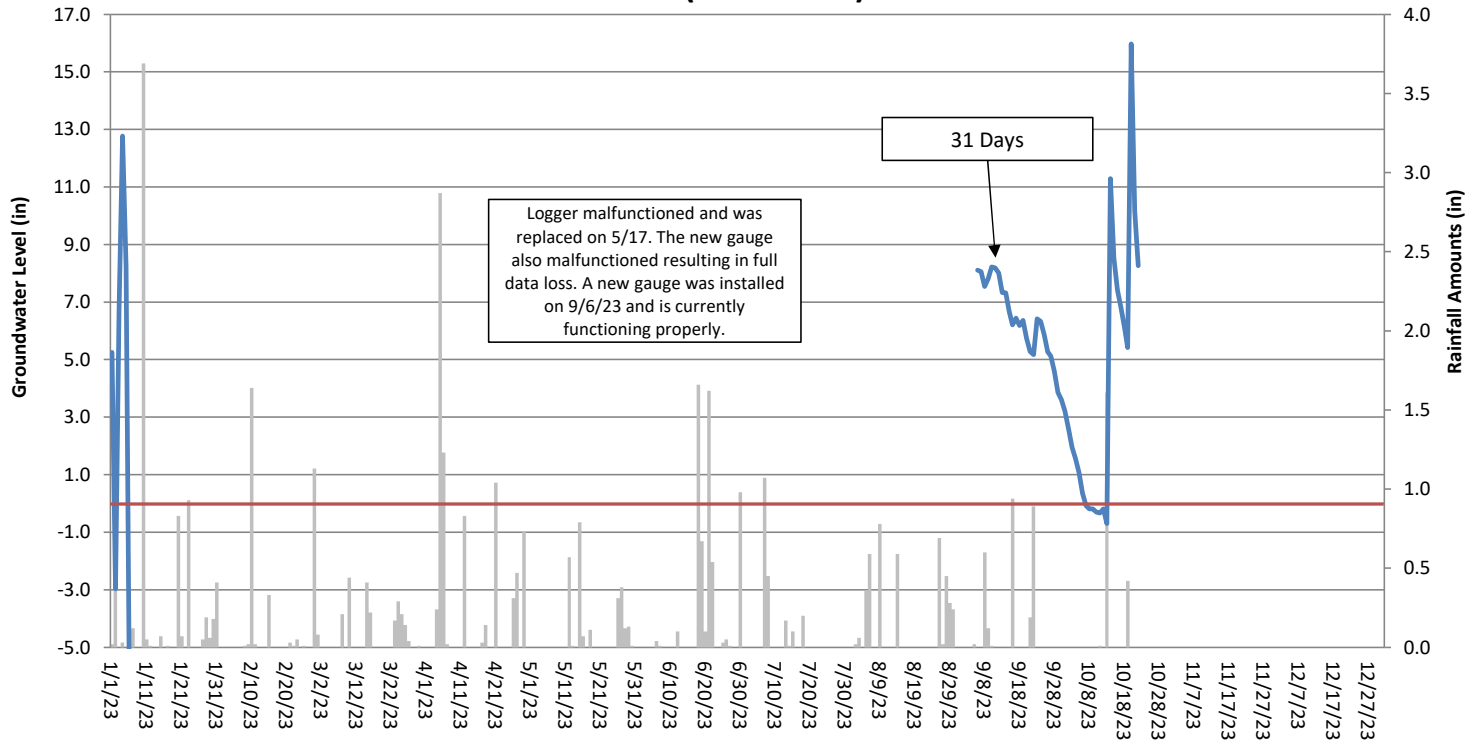
# Brahma Crest Gauge UT-1 Year 3 (2023 Data)

All streams are functioning as designed, and no stream areas of concern were observed during year 3 (2023) monitoring. Stream morphology data is available in Appendix C. Stream flow/crest data for UT1 was lost due to a gauge malfunction, however success criteria for surface flow was still met, and visual observations along with photo evidence shows year-round flow through the channel. The gauge was replaced on September 6, 2023 and is currently functioning properly.

Total Cumulative  
Flow - 43 Days
