Briles Stream Restoration Monitoring Report Year 3 of 5 (2011) FINAL

Randolph County, North Carolina

Project ID No. 047

Submitted November 2011

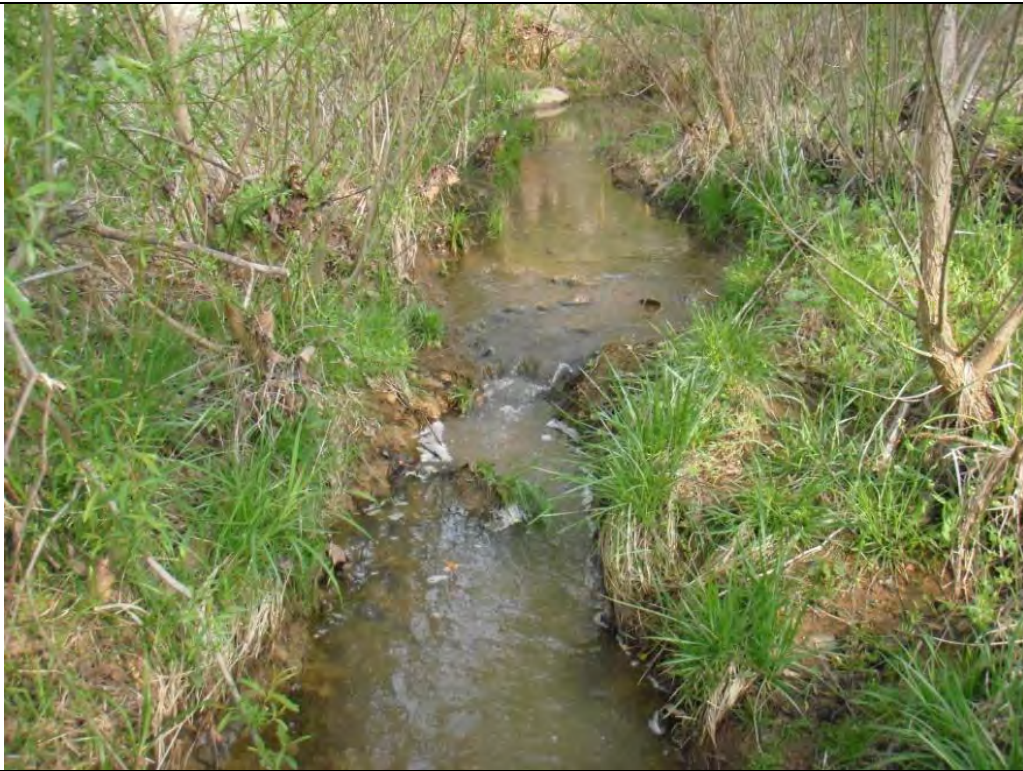
A visual assessment and geomorphic survey were completed for the site, and indicated that the project reaches were performing within established success criteria ranges as shown below. Two small head cuts were observed near stations 10+75 and 15+25. These head cuts have been monitored for the previous two monitoring years, and do not seem to be active or progressing. This can be seen in the longitudinal profile in the appendix. Minor erosion was observed along the banks and bankfull benches from station 18+50 to 19+50, and appeared to be caused by the lack of vegetation growth in these locations. No significant bank erosion was recorded, and the geomorphic measurements are within the range of the design parameters. Bankfull indicators were noted and recorded along the project reach (Appendix E, Photos SP3 and SP4). There is no crest gauge installed on site.

SP1: Head cut at STA 10+75
Taken: April 2011

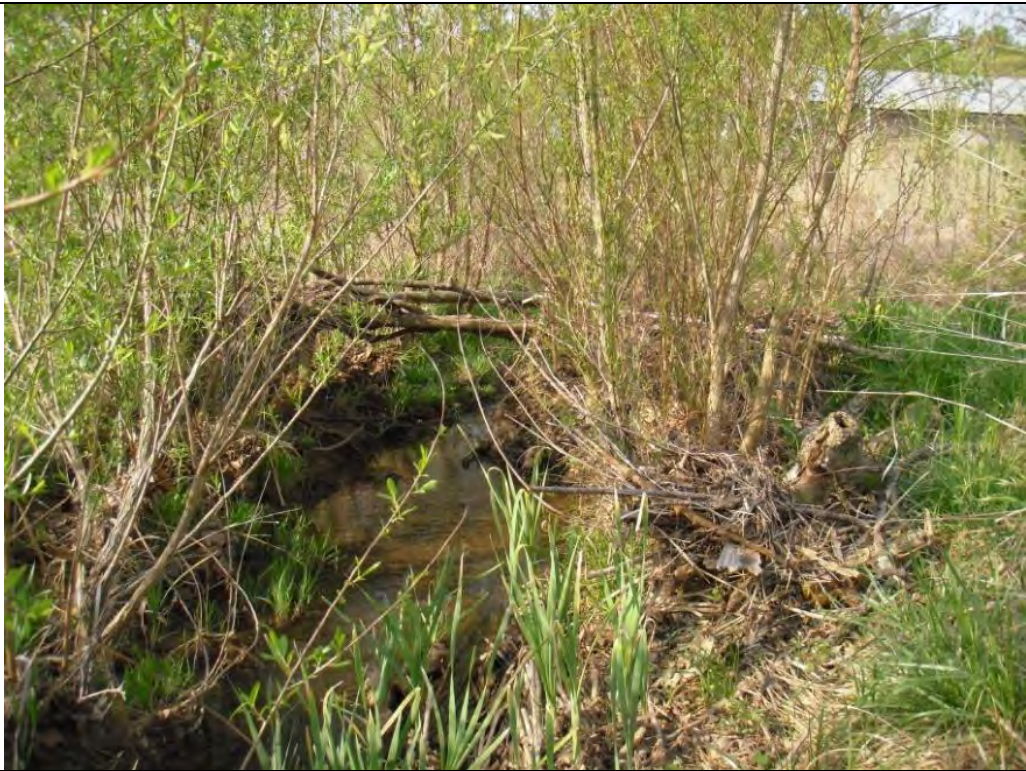
SP3: Bankfull indicator on Reach UTJC1
Taken: April 2011

Date of Data Collection	Date of Occurrence	Method	Photo # (if available)
7/6/2010	N/A	Rack lines observed along channel bank	
4/19/2011	N/A	Rack lines observed along channel bank	SP3/SP4

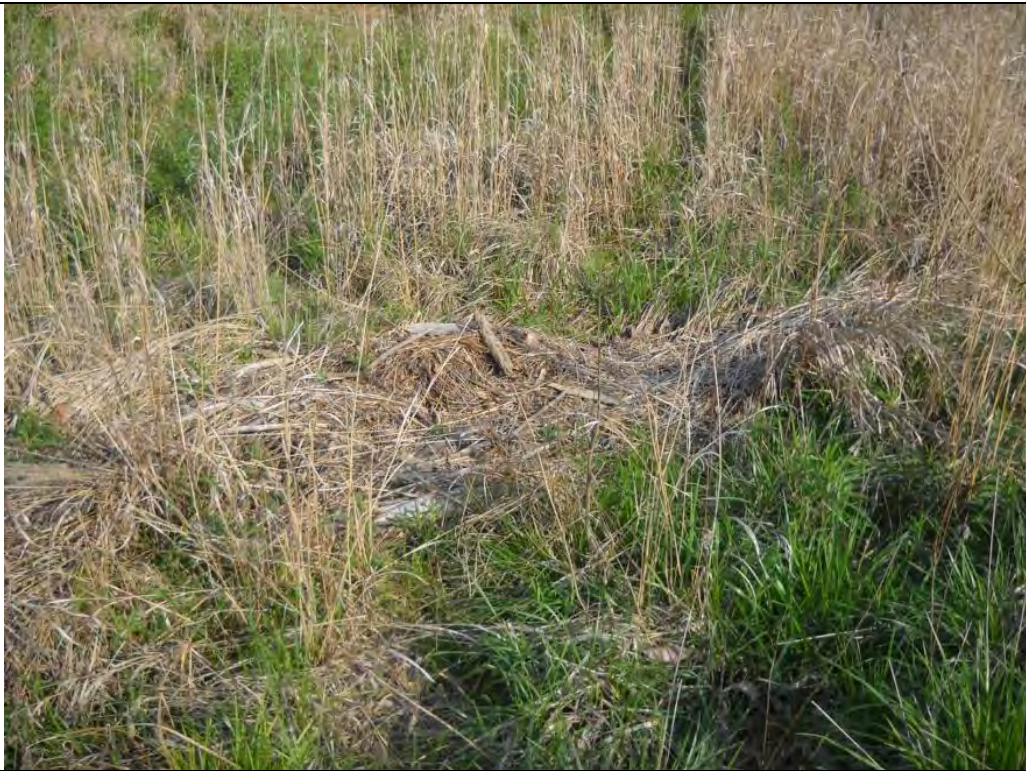
SP4: Bankfull indicator on Reach UTJC1
Taken: April 2011
