FINAL
ANNUAL MONITORING REPORT
YEAR 5 (2013)
BRILES STREAM RESTORTION SITE
RANDOLPH COUNTY, NORTH CAROLINA
(EEP Project No. 047, Contract No. 004809)
Construction Completed November 2007

January 2014

Prepared by:
Axiom Environmental, Inc.
218 Snow Avenue
Raleigh, North Carolina 27603

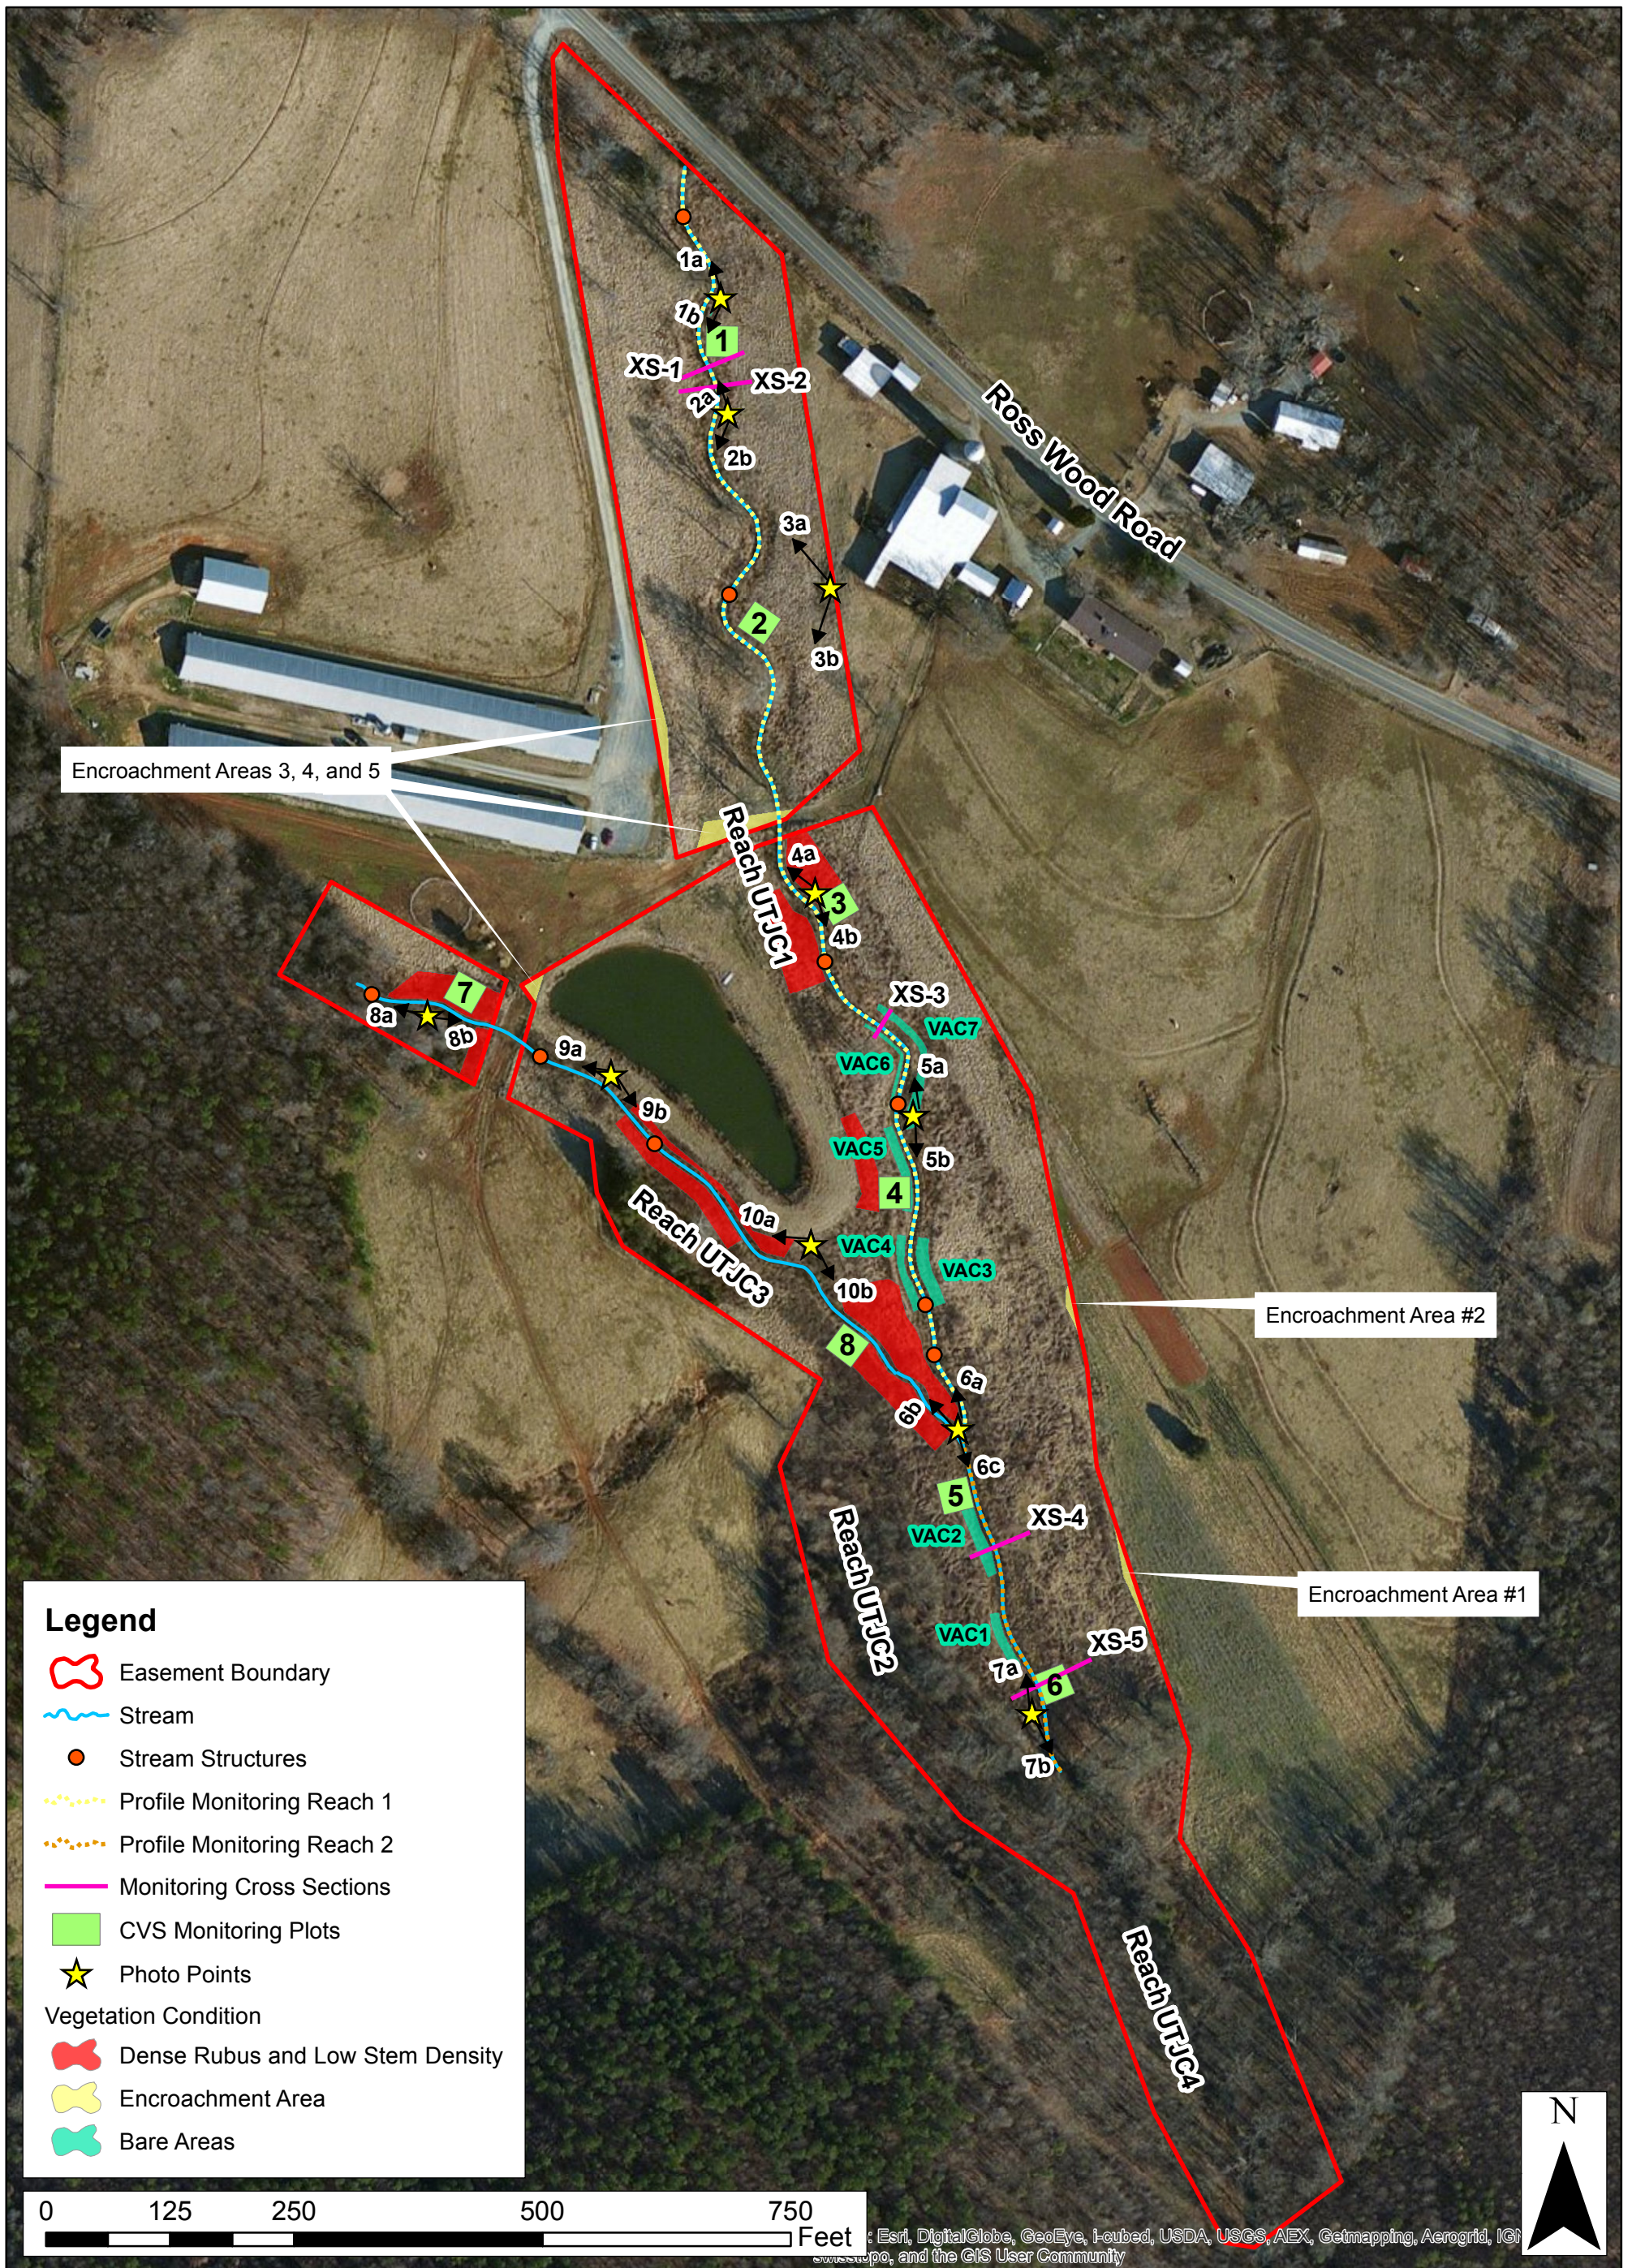
FIGURE
2

Map Identifier	Feature/Issue
VAC1	Bare bench and low stem density on the right bank of UTJC2
VAC2	Low stem density on the right bank of UTJC2
VAC3	Low stem density on the left bank of UTJC1
VAC4	Low stem density on the right bank of UTJC1; several <i>Pinus taeda</i> individuals have established here, but planted stem density is low
VAC5	Bare bench and low stem density on the right bank of UTJC1
VAC6	Low stem density on the right bank of UTJC1
VAC7	Bare bench and low stem density on the left bank of UTJC1; woody vegetation was replanted, but area remains bare.

Five small easement encroachment areas were identified at the Site. These are identified on Figure 2 (Appendix B).

Map Identifier	Issue
Encroachment Areas 1, 2	Agricultural fields extend into the easement; no fencing is present and boundary markers are not visible
Encroachment Areas 3, 4, 5	Constructed fence extends into the easement

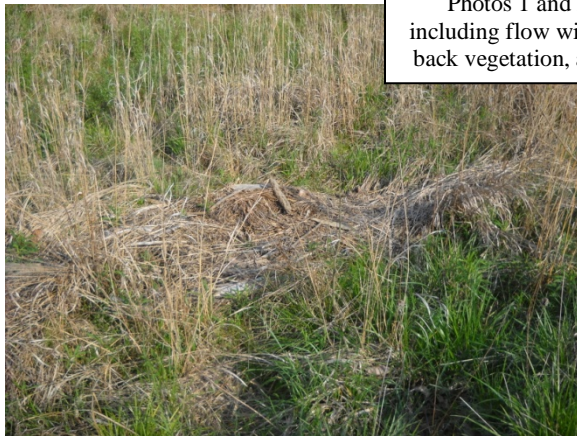
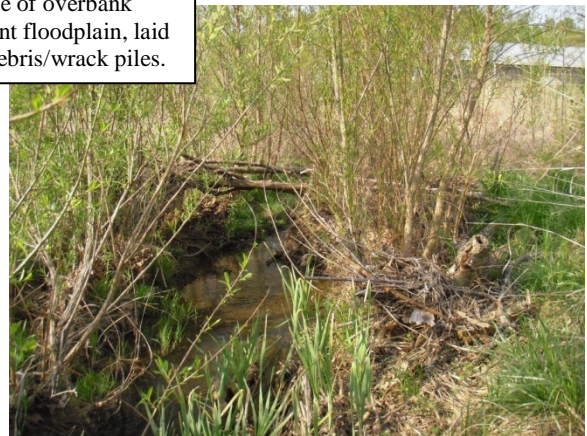
Photos 1 and 2: Evidence of overbank including flow within adjacent floodplain, laid back vegetation, and large debris/wrack piles.

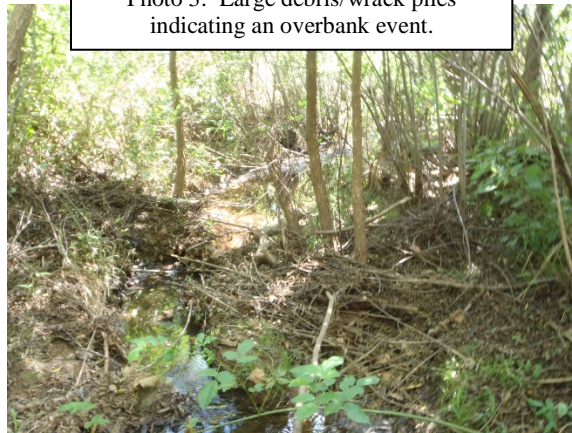
Photo 3: Large debris/wrack piles indicating an overbank event.
