# **BROCK STREAM RESTORATION SITE Monitoring Year 1 (2009)**

**Jones County, North Carolina  
EEP Project No. 92333**

**Final Monitoring Report**

**January 2011**

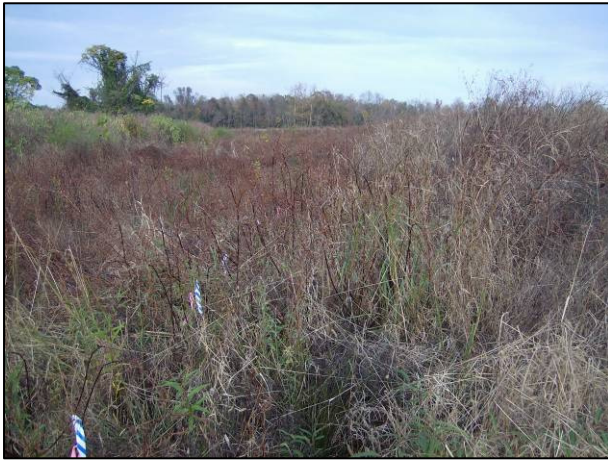
**Photostation 2.**  
Facing northeast across Vegetation Plot #1.  
Taken November 17, 2009

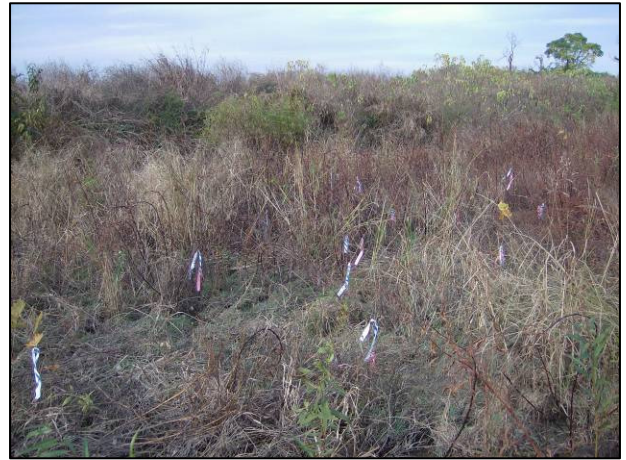
**Photostation 3.**  
Facing north across Vegetation Plot #1.  
Taken November 17, 2009

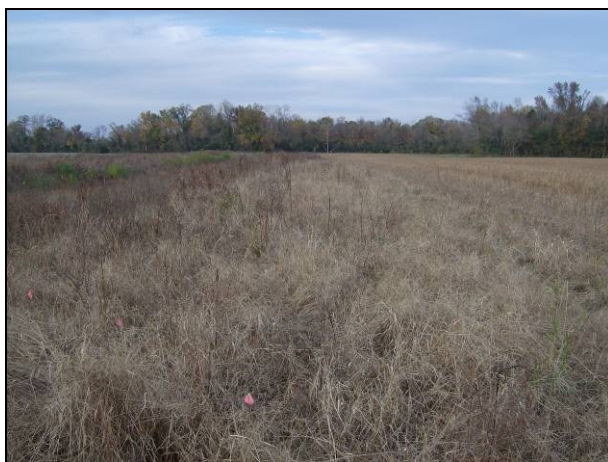
Monitoring counts for each plot were conducted as part of Year 1 monitoring activities. In summary, first year mortality rates exceeded 50% in Vegetation Plots #2 and #4. These rates however, were low in Vegetation Plots #1 and #3 as compared with the baseline planting counts. Average stem counts based on all of the plots dropped to approximately 465 stems per acre. Vegetation Plots #1, #2 and #4 exhibited 1,133, 283 and 445 stems per acre, respectively. Vegetation Plot #3 exhibited 161 planted, hardwood stems per acre. Potential reasons for mortality were mainly unknown; however, it is very likely that drought played a major role. A complete breakdown of this information is provided in Appendix A along with photographs of each vegetation plot taken during the assessment.

**Photostation 5.**  
Facing north across Vegetation Plot #2.  
Taken November 17, 2009

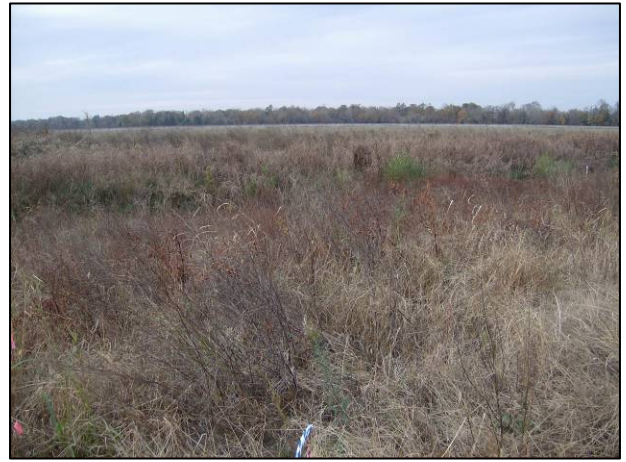
**Photostation 6.**  
Facing northwest across Vegetation Plot #2.  
Taken November 17, 2009

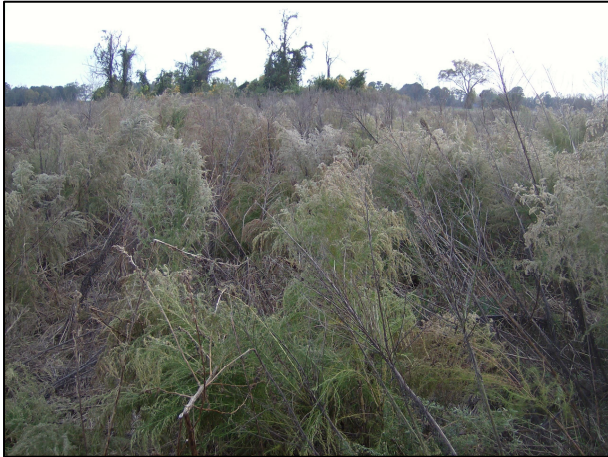
**Photostation 8.**  
Facing southwest across Vegetation Plot #3.  
Taken November 17, 2009

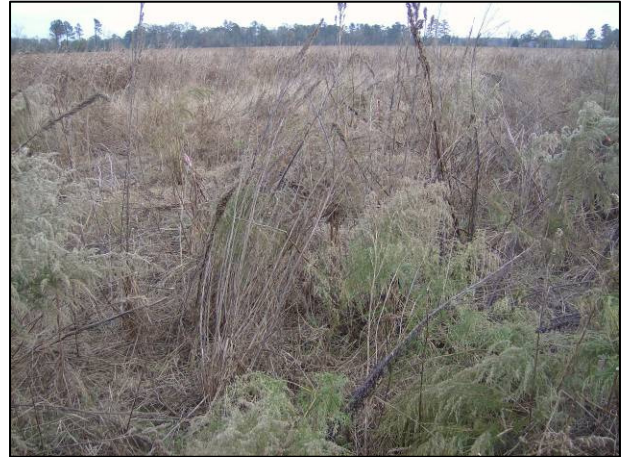
**Photostation 9.**  
Facing southeast across Vegetation Plot #3.  
Taken November 17, 2009

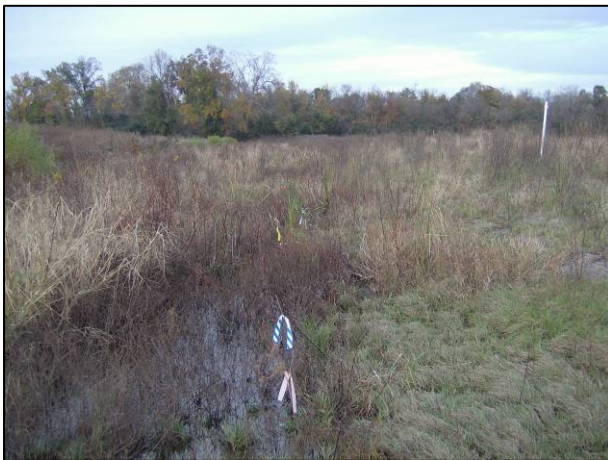
**Photostation 11.**  
Facing northeast across Vegetation Plot #4.  
Taken November 17, 2009

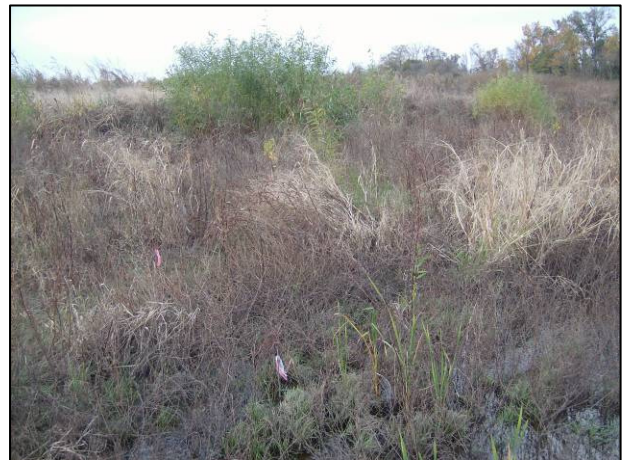
**Photostation 12.**  
Facing north across Vegetation Plot #4.  
Taken November 17, 2009

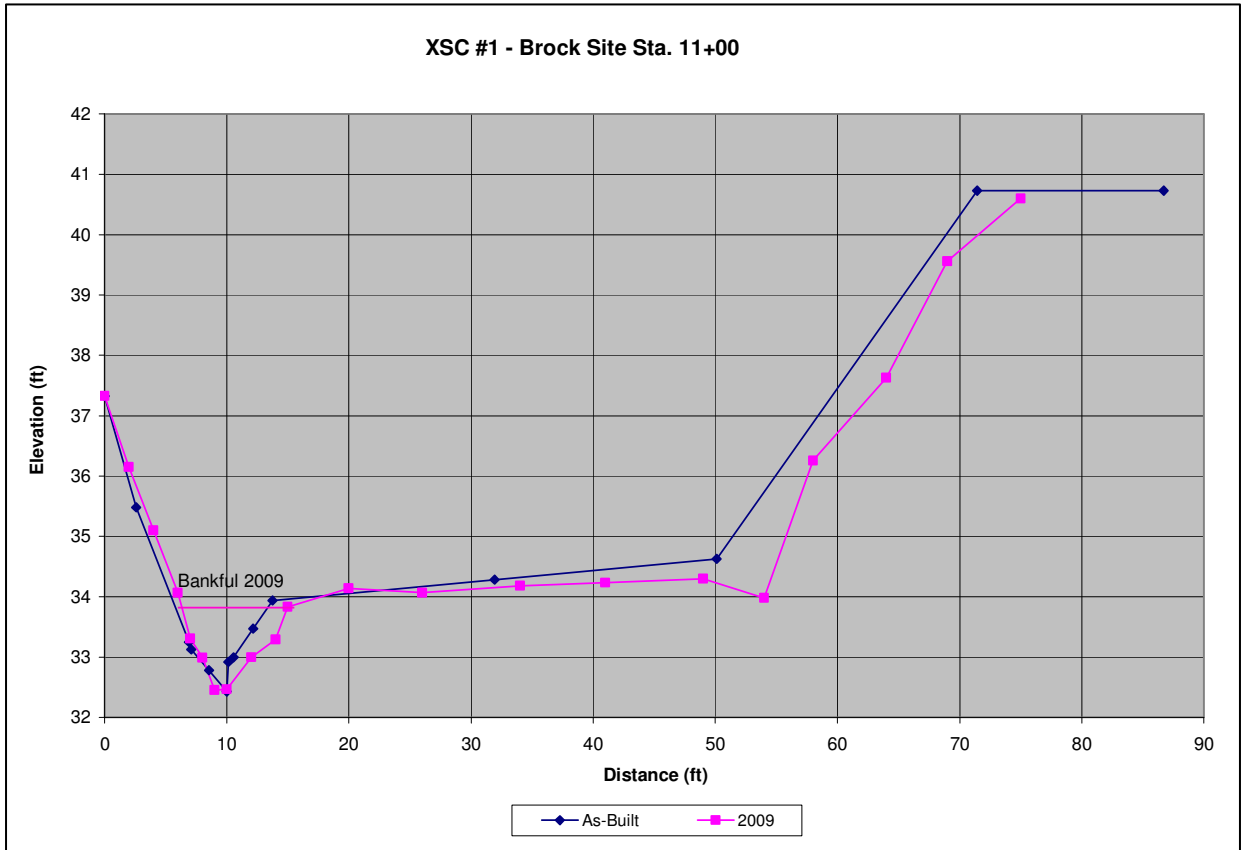
**Cross Section #1 Comparison  
Station 11+00**

*Note: The as-built survey data was based on compilation of topographic contours and not an actual cross section survey. As a result, variability exists between the actual cross section survey (conducted as part of monitoring efforts) and as-built data.*

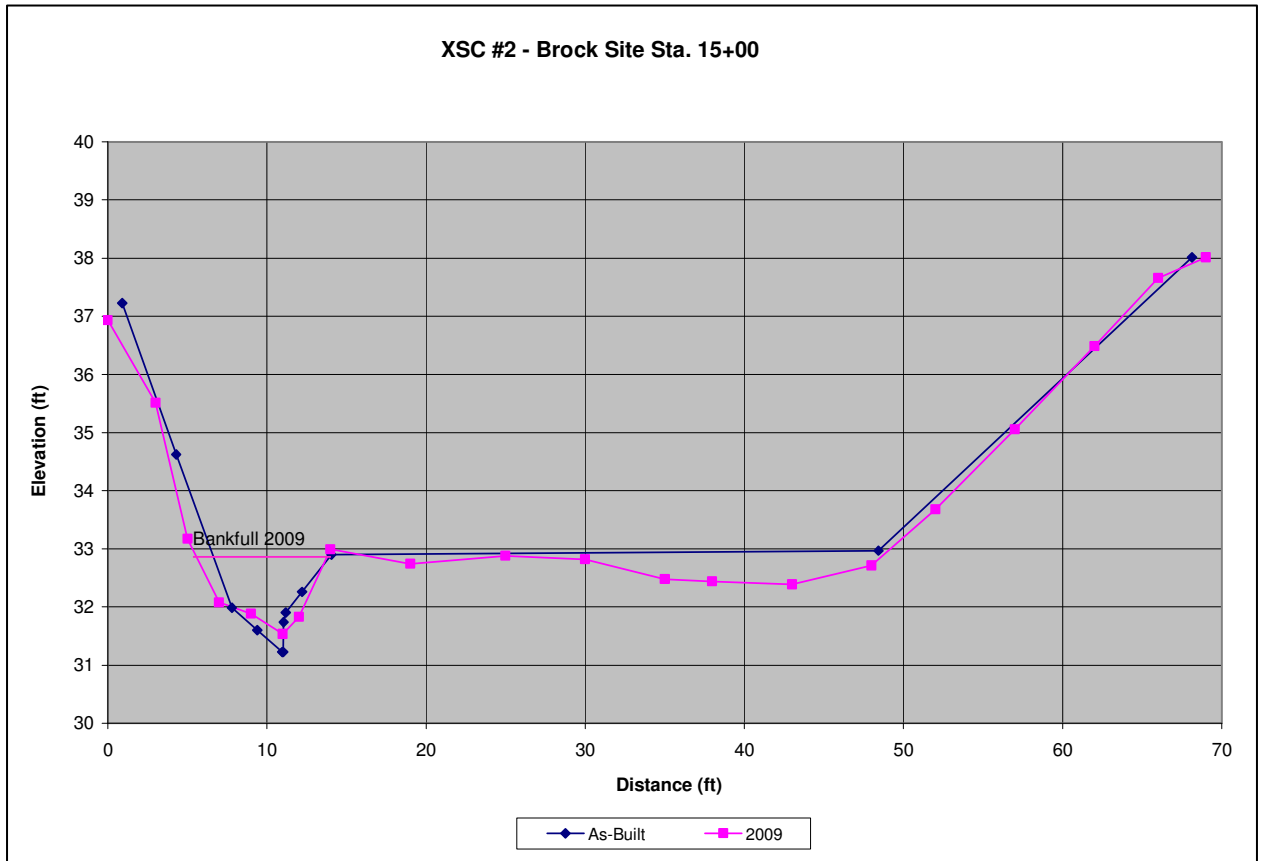
**Cross Section #2 Comparison  
Station 15+00**

*Note: The as-built survey data was based on compilation of topographic contours and not an actual cross section survey. As a result, variability exists between the actual cross section survey (conducted as part of monitoring efforts) and as-built data.*

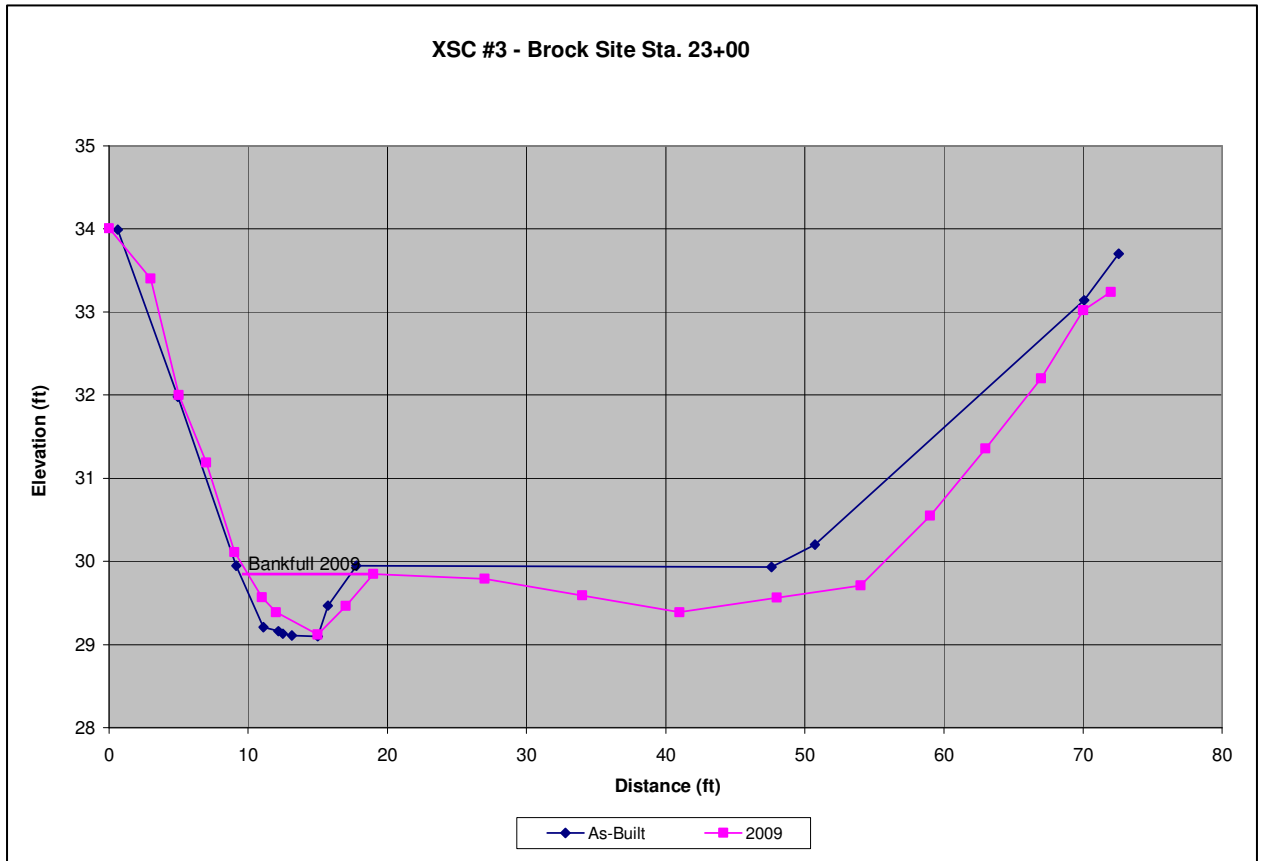
**Cross Section #3 Comparison  
Station 23+00**

*Note: The as-built survey data was based on compilation of topographic contours and not an actual cross section survey. As a result, variability exists between the actual cross section survey (conducted as part of monitoring efforts) and as-built data.*
