# **BROCK STREAM RESTORATION SITE Monitoring Year 2 (2010)**

**Jones County, North Carolina  
EEP Project No. 92333**

**Final Monitoring Report**

**March 2011**

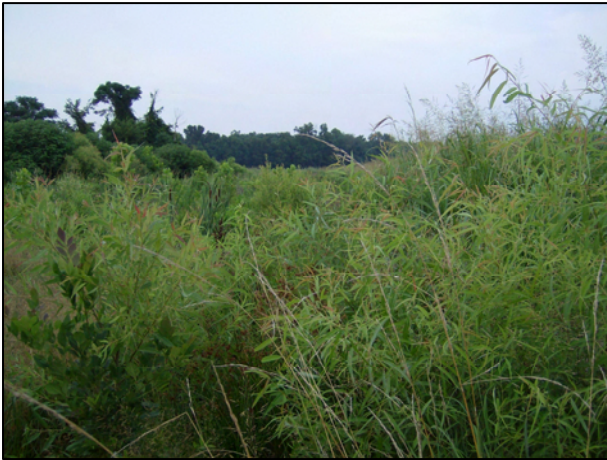
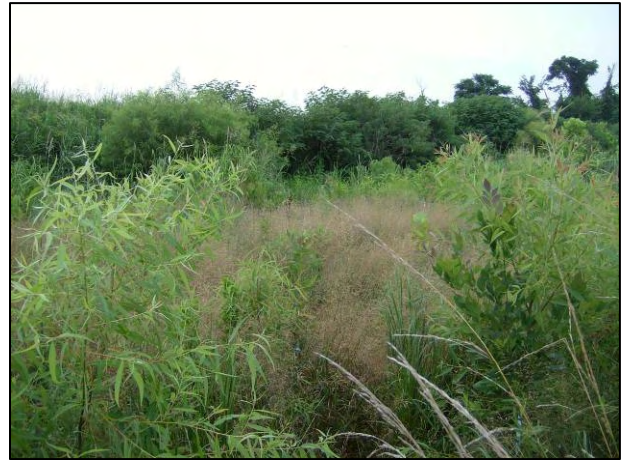
### Vegetation Plot #1

**Photostation 2.**  
Facing northeast across Vegetation Plot #1.  
Taken July 2010

**Photostation 3.**  
Facing north across Vegetation Plot #1.  
Taken July 2010

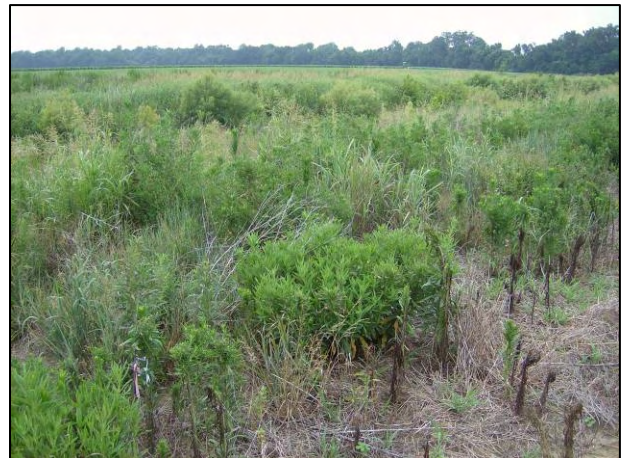
### Vegetation Plot #2

**Photostation 6.**  
Facing northwest across Vegetation Plot #2.  
Taken July 2010

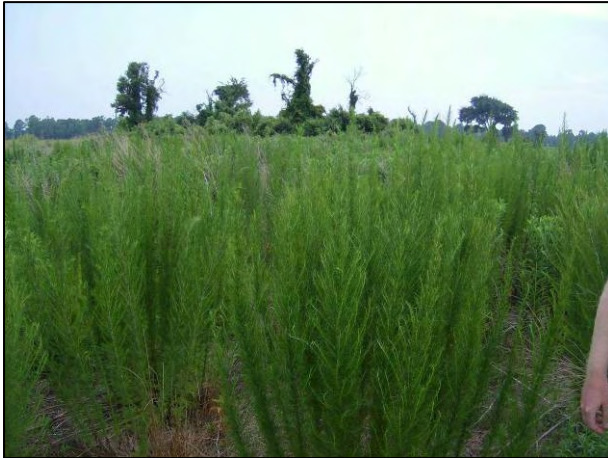
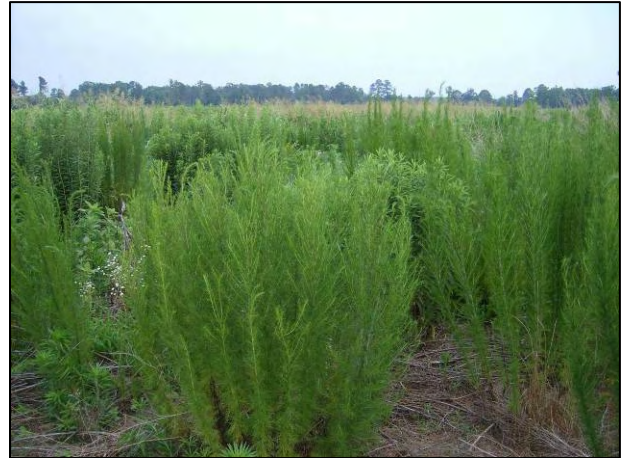
### Vegetation Plot #3

**Photostation 8.**  
Facing southwest across Vegetation Plot #3.  
Taken July 2010

**Photostation 9.**  
Facing southeast across Vegetation Plot #3.  
Taken July 2010

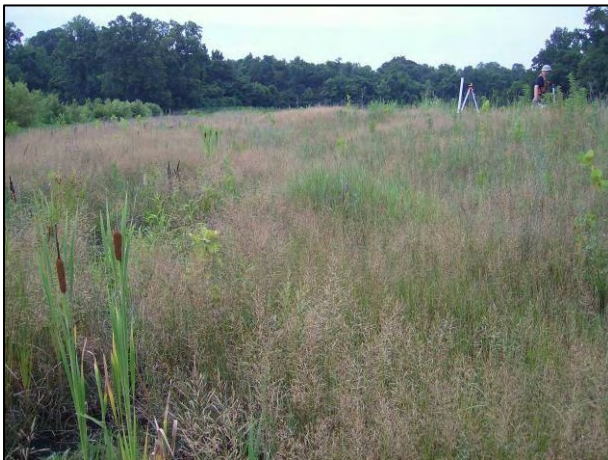
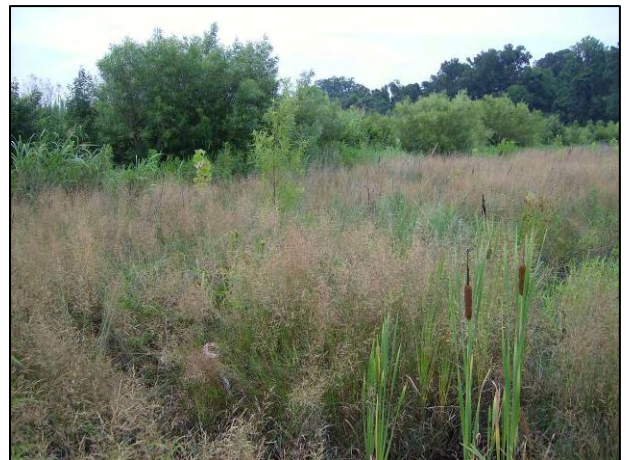
### Vegetation Plot #4

**Photostation 11.**  
Facing northeast across Vegetation Plot #4.  
Taken July 2010

**Photostation 12.**  
Facing north across Vegetation Plot #4.  
Taken July 2010

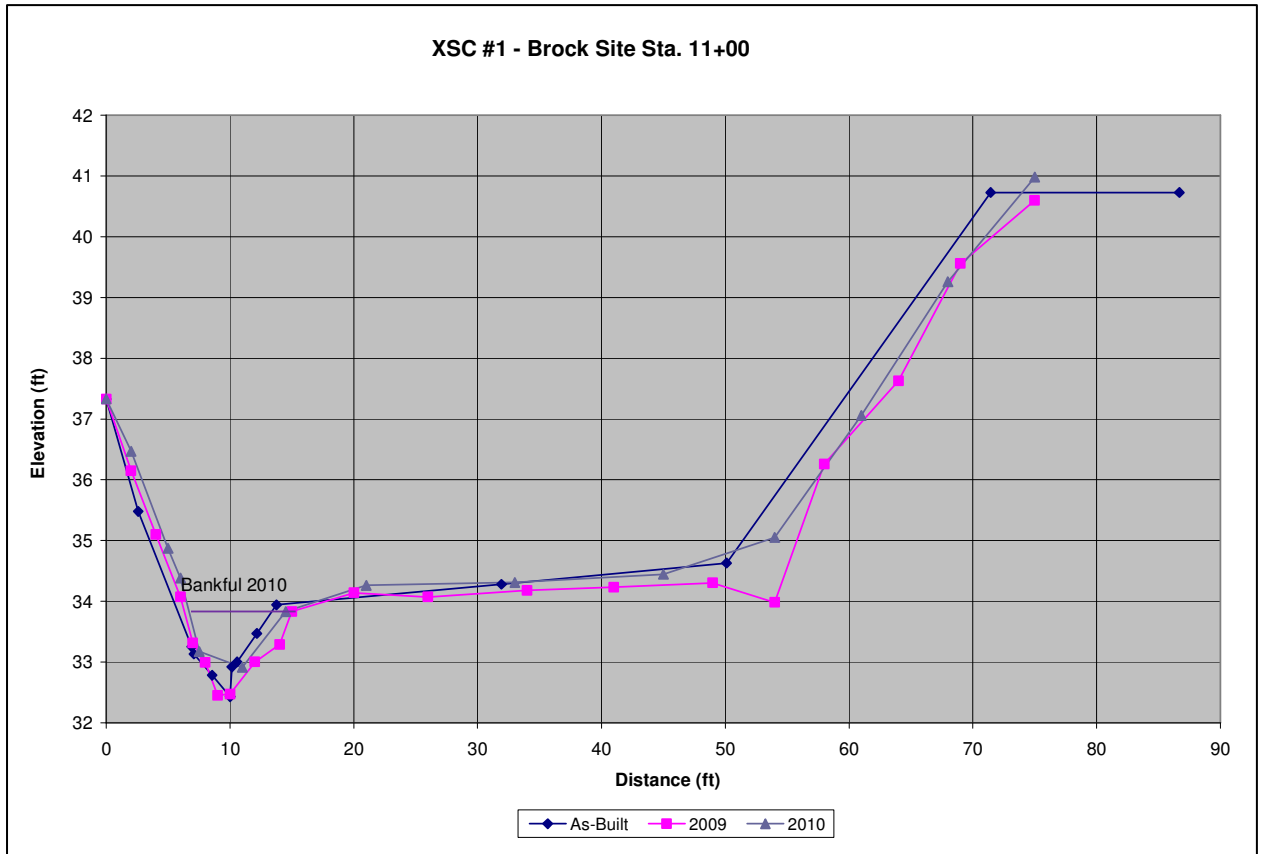
**Cross Section #1 Comparison  
Station 11+00**

*Note: The as-built survey data was based on compilation of topographic contours and not an actual cross section survey. As a result, variability exists between the actual cross section survey (conducted as part of monitoring efforts) and as-built data.*

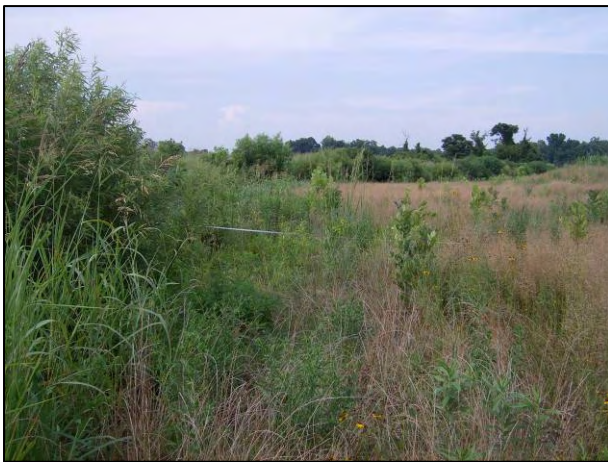
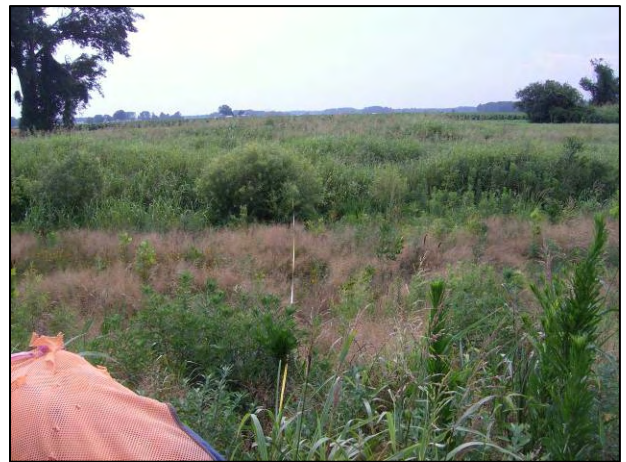
**Year 2 (2010) Cross Section Photographs**

Facing north along the west side of Cross Section #1.  
Taken July 2010

Facing west across Cross Section #1.  
Taken July 2010

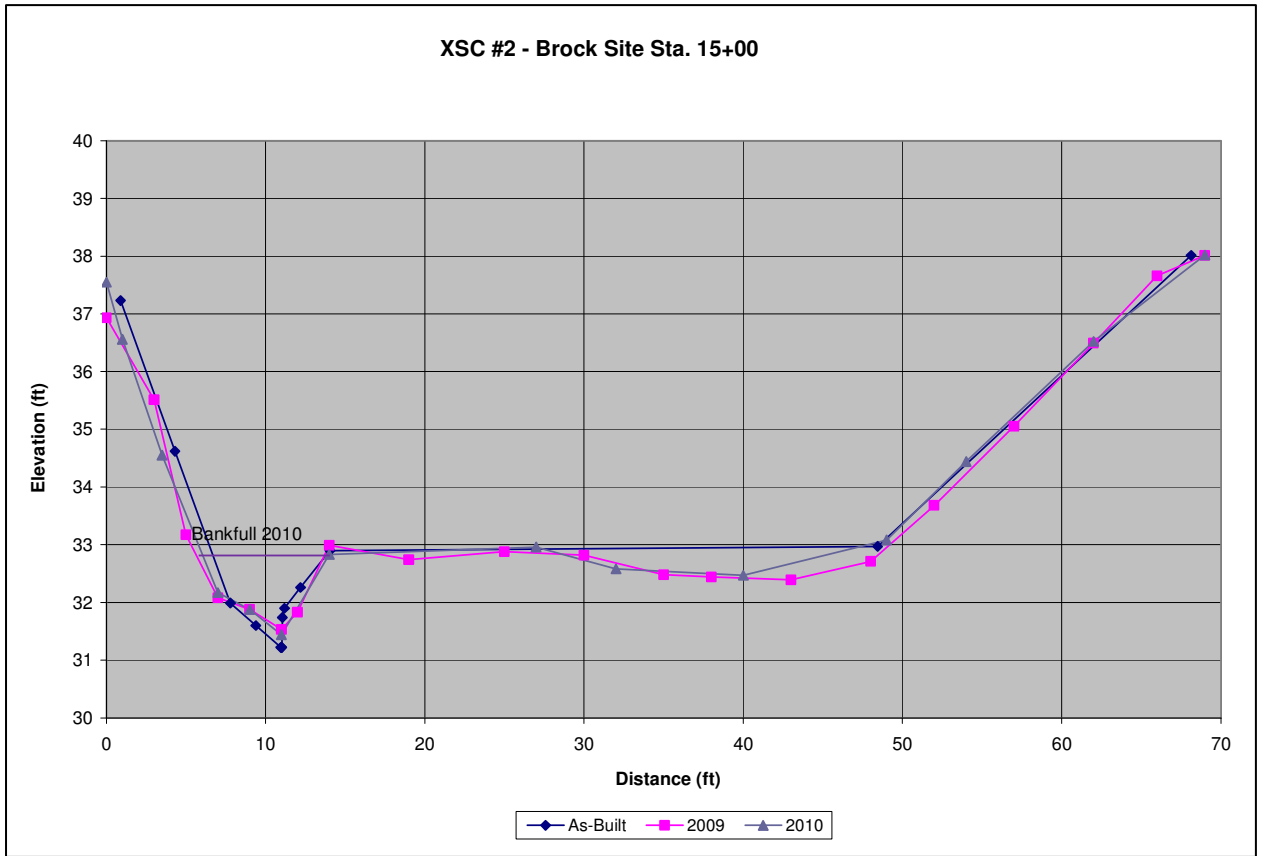
**Cross Section #2 Comparison  
Station 15+00**

*Note: The as-built survey data was based on compilation of topographic contours and not an actual cross section survey. As a result, variability exists between the actual cross section survey (conducted as part of monitoring efforts) and as-built data.*

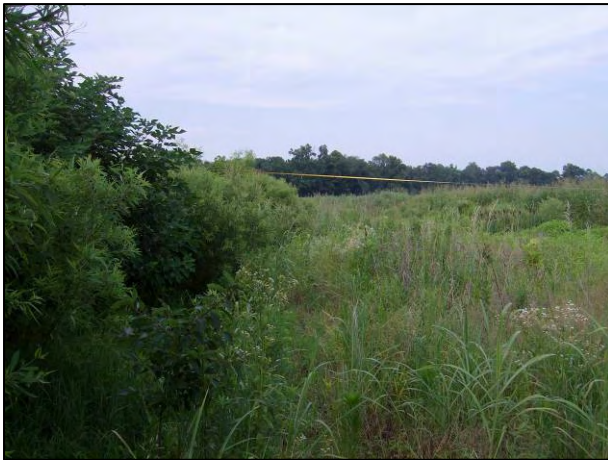
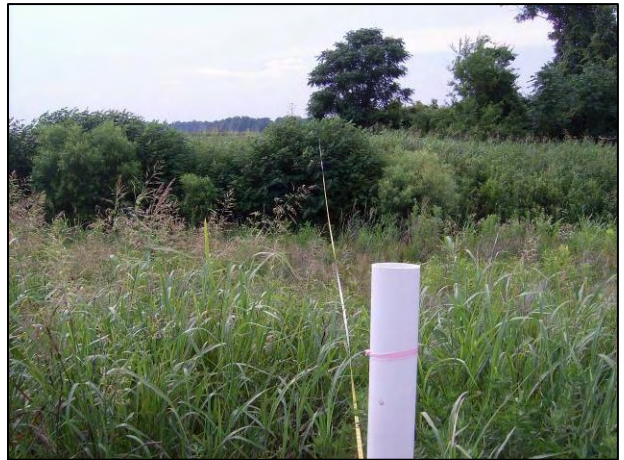
**Year 2 (2010) Cross Section Photographs**

Facing northeast along the west side of Cross Section #2.  
Taken July 2010

Facing northwest along the west side of Cross Section #2.  
Taken July 2010

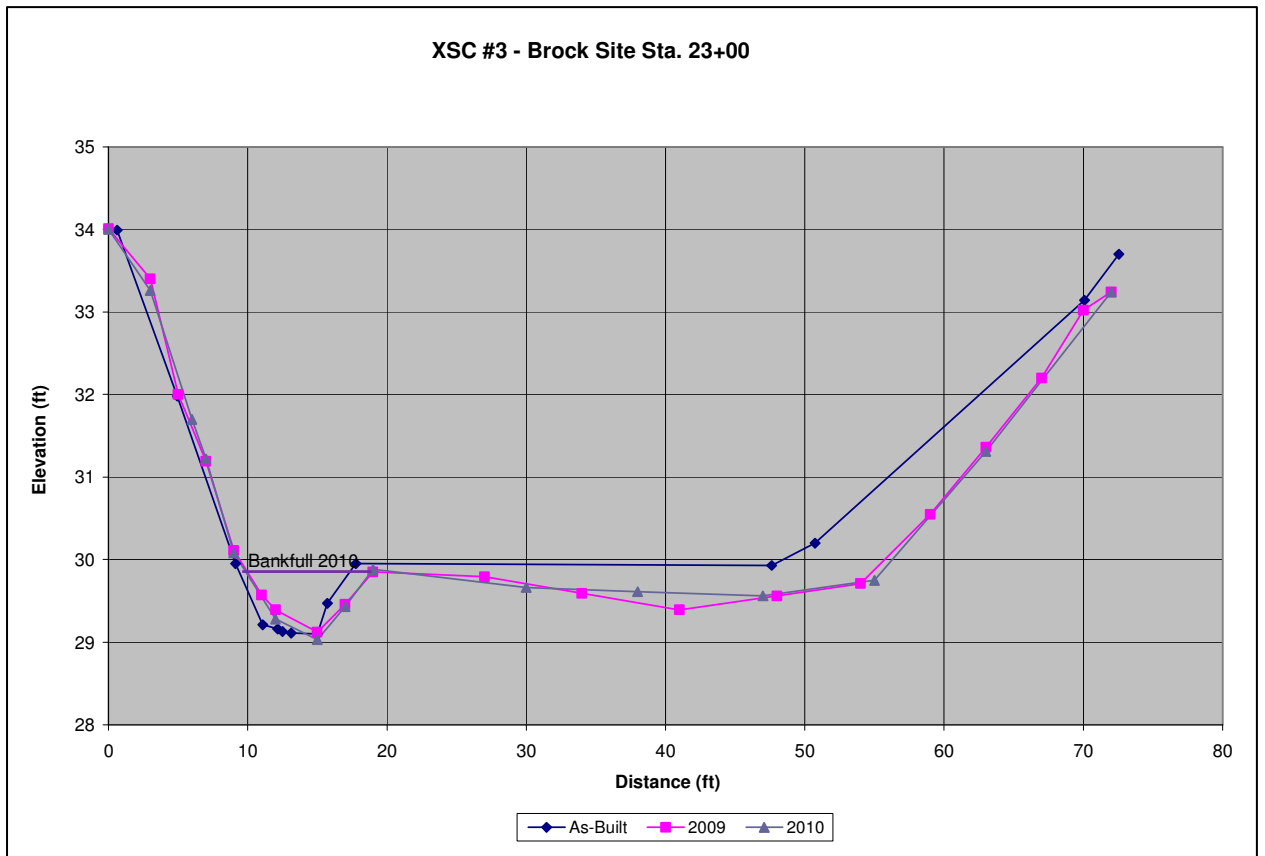
**Cross Section #3 Comparison  
Station 23+00**

*Note: The as-built survey data was based on compilation of topographic contours and not an actual cross section survey. As a result, variability exists between the actual cross section survey (conducted as part of monitoring efforts) and as-built data.*

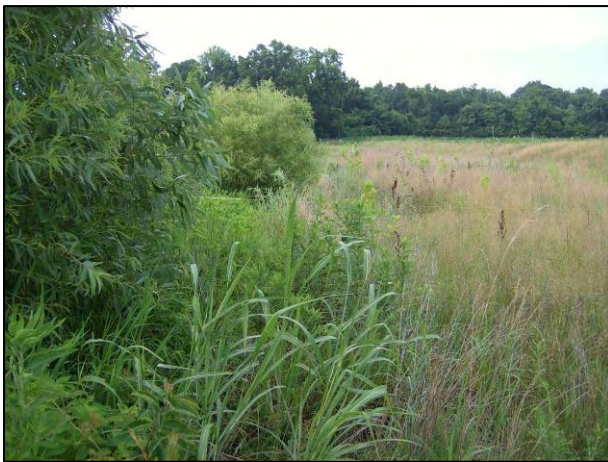
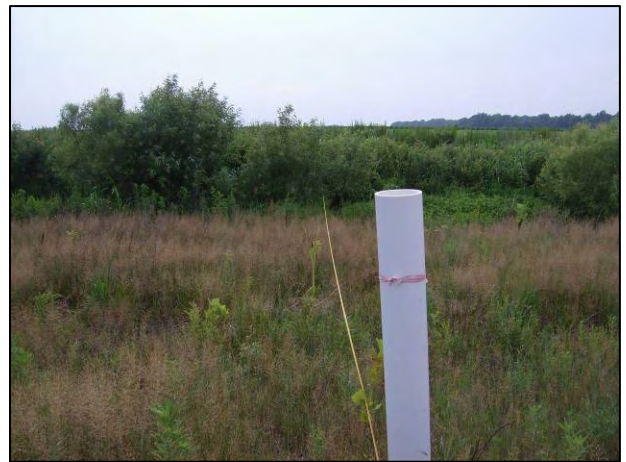
**Year 2 (2010) Cross Section Photographs**

Facing northeast along the west side of Cross Section #3.  
Taken July 2010.

Facing northwest along the west side of Cross Section #3.  
Taken July 2010.
