# **BROCK STREAM RESTORATION SITE Monitoring Year 3 (2011)**

**Jones County, North Carolina  
EEP Project No. 92333**

**Final Monitoring Report**

**September 2011**

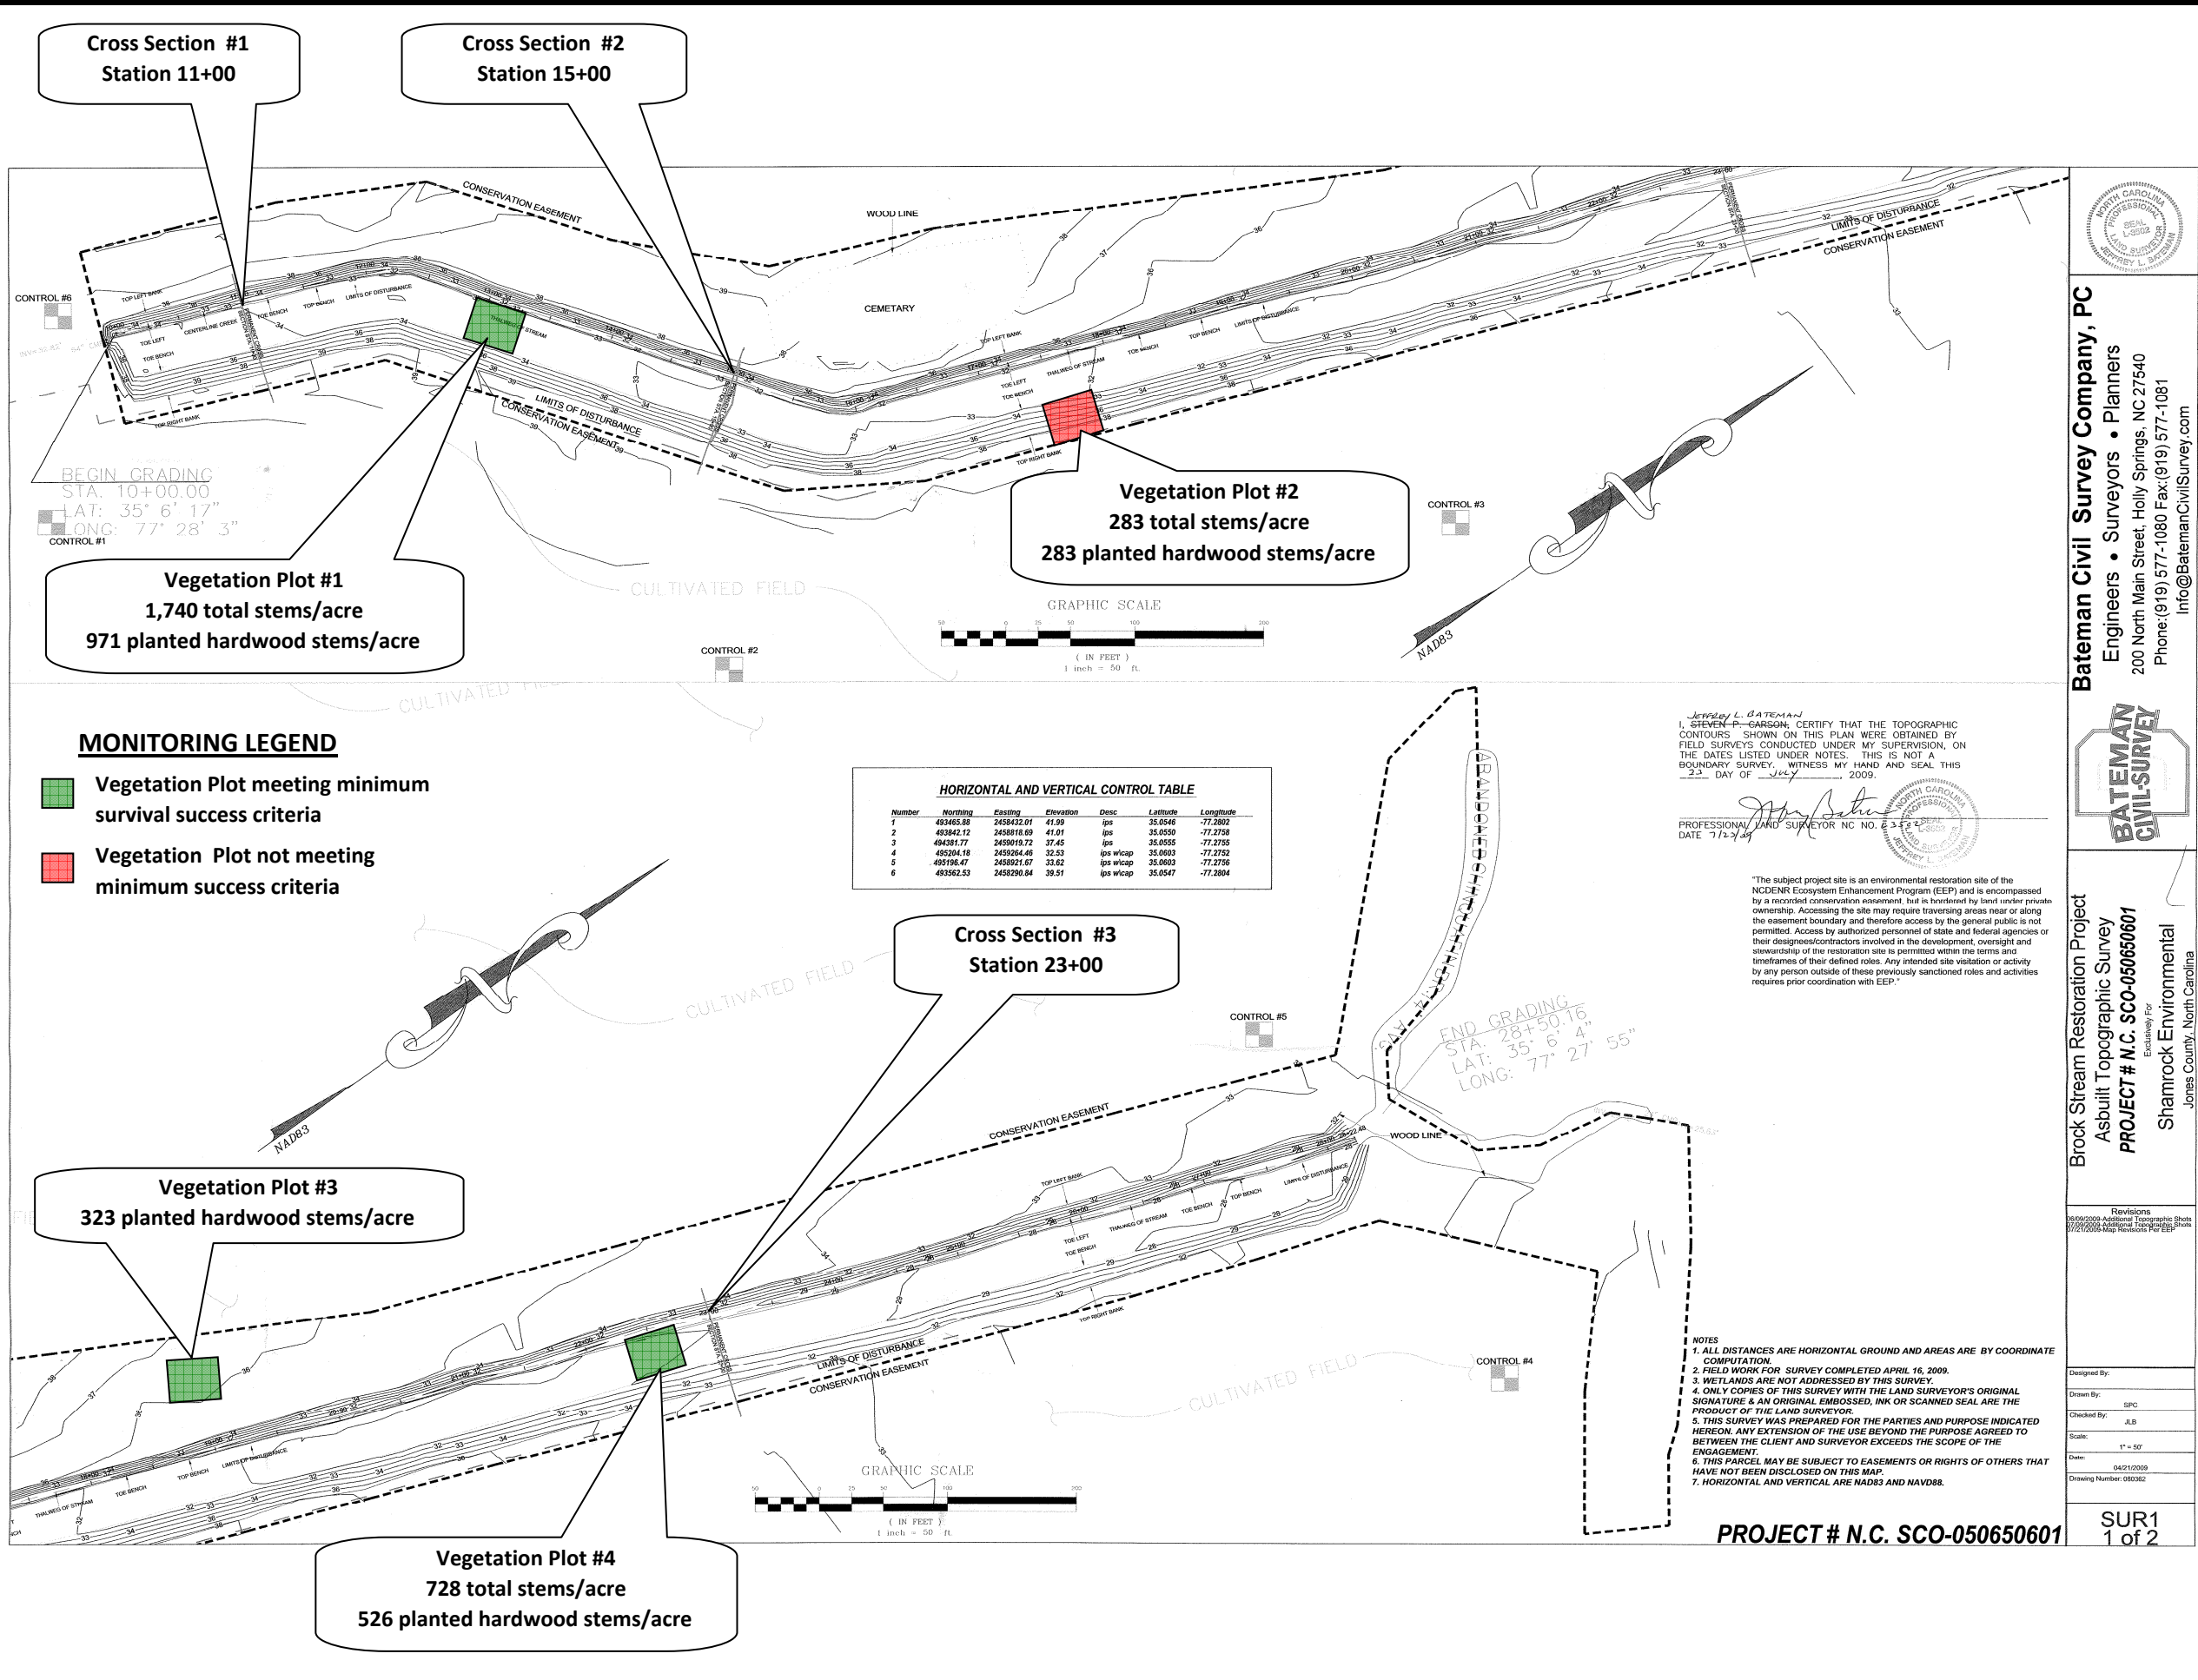
Figure 4

Vegetative problem areas are defined as those areas either lacking vegetation or containing exotic vegetation and are generally categorized within the following categories: Bare Bank, Bare Bench, Bare Floodplain or Invasive Population. Based on the monitoring site assessment, vegetation problem areas currently exist within the Project Site from a stem count basis. Visual assessments however, did not reveal any previous areas void of vegetation. The majority of the bare floodplain areas that were observed during 2009 filled in with vegetation prior to the Year 2 assessment and have remained consistent through Year 3. Vegetation problem areas are summarized in Appendix A - Table 7 and are depicted on Figure 4.

As previously mentioned, a supplemental planting was conducted during February 2010 as part of the contractor's vegetation warranty. This planting increased total stem counts throughout the project area but failed to increase the counts above the Year 3 minimum success criteria in one of the four vegetation plots. The extent of the supplemental planting is also shown on Figure 4.

EEP will oversee a supplemental planting during the 2011-2012 dormant season in the areas exhibiting low stem densities. This planting will consist of native species, consistent with those noted in the original planting plan, averaging 2.0 to 2.5 feet in height. Species identification tags will be placed on each stem.

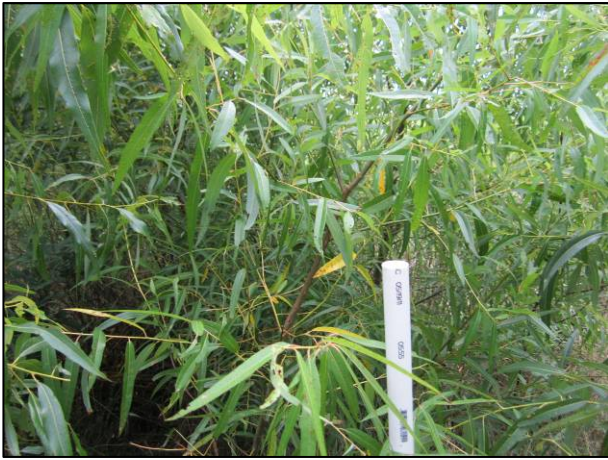
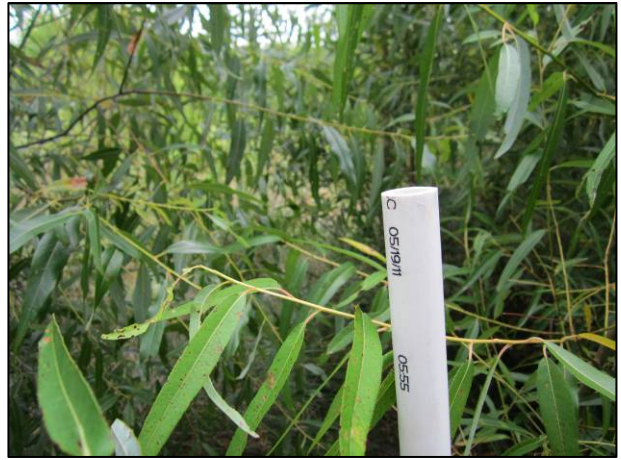
### Vegetation Plot #1

**Photostation 2.**  
Facing northeast across Vegetation Plot #1.  
Taken July 2011

**Photostation 3.**  
Facing north across Vegetation Plot #1.  
Taken July 2011

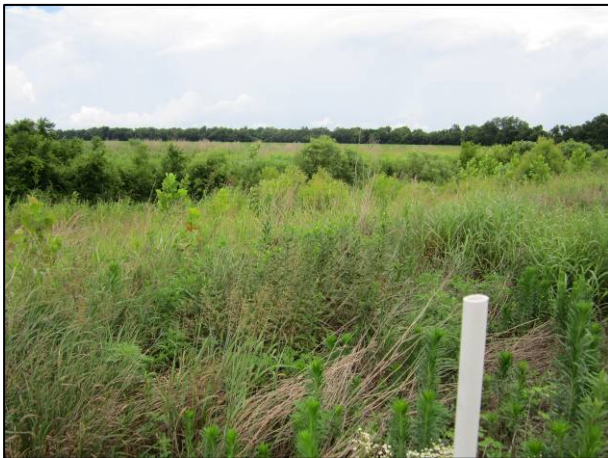
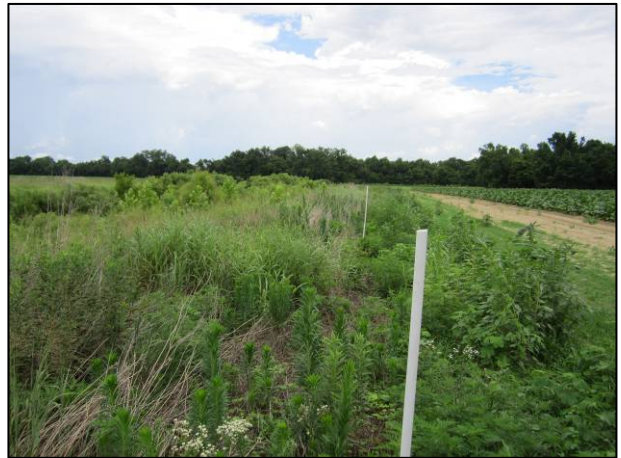
### Vegetation Plot #2

Vegetation Plots #1, #3 and #4 met the success criteria required for buffer mitigation or Nutrient Offset Nitrogen credit and Vegetation Plots #1 and #4 met the success criteria for stream mitigation credit. Vegetation Plot #2 failed to meet the same criteria for both mitigation types. A complete breakdown of this information is provided in Appendix A along with photographs of each vegetation plot taken during the assessment.

**Photostation 5.**  
Facing north across Vegetation Plot #2.  
Taken July 2011

**Photostation 6.**  
Facing northwest across Vegetation Plot #2.  
Taken July 2011

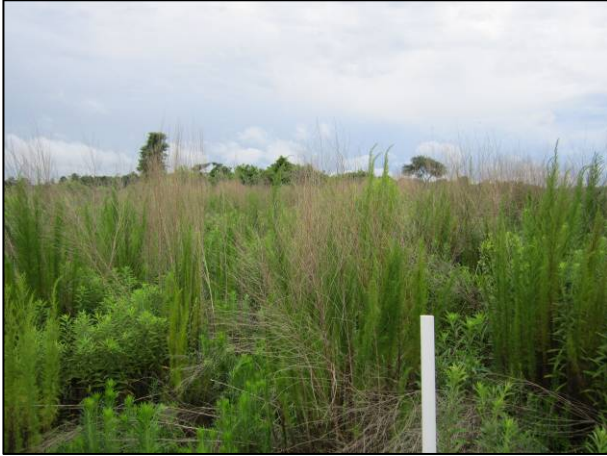
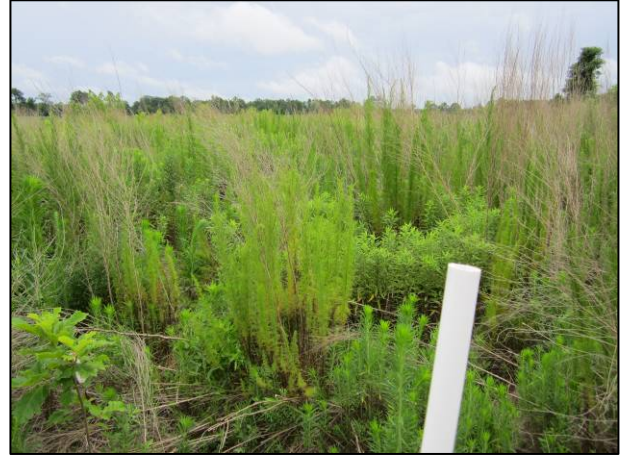
### Vegetation Plot #3

**Photostation 8.**  
Facing southwest across Vegetation Plot #3.  
Taken July 2011

**Photostation 9.**  
Facing southeast across Vegetation Plot #3.  
Taken July 2011

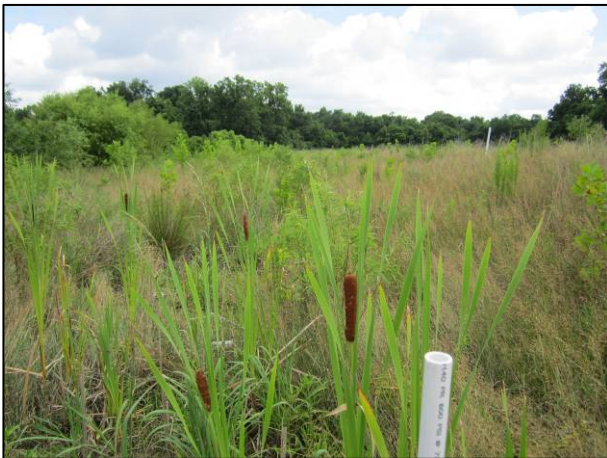
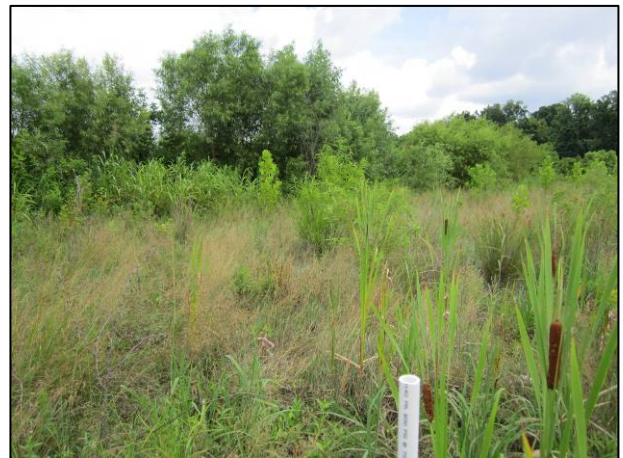
### Vegetation Plot #4

**Photostation 11.**  
Facing northeast across Vegetation Plot #4.  
Taken July 2011

**Photostation 12.**  
Facing north across Vegetation Plot #4.  
Taken July 2011

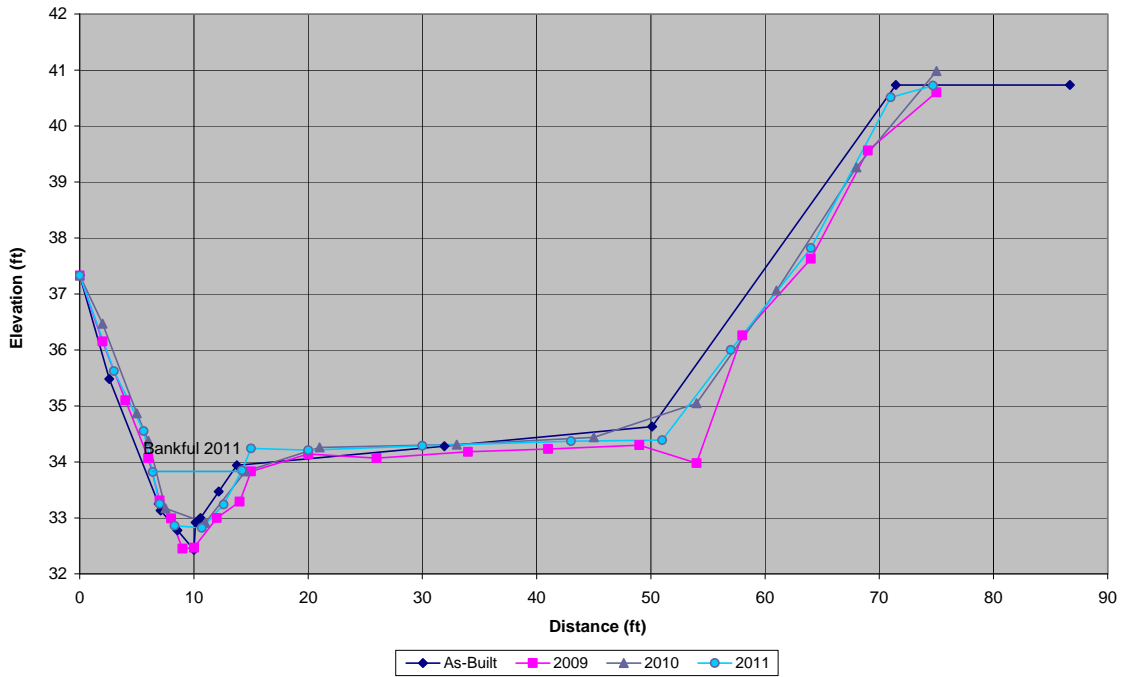
**XSC #1 - Brock Site Sta. 11+00**

*Note: The as-built survey data was based on compilation of topographic contours and not an actual cross section survey. As a result, variability exists between the actual cross section survey (conducted as part of monitoring efforts) and as-built data.*

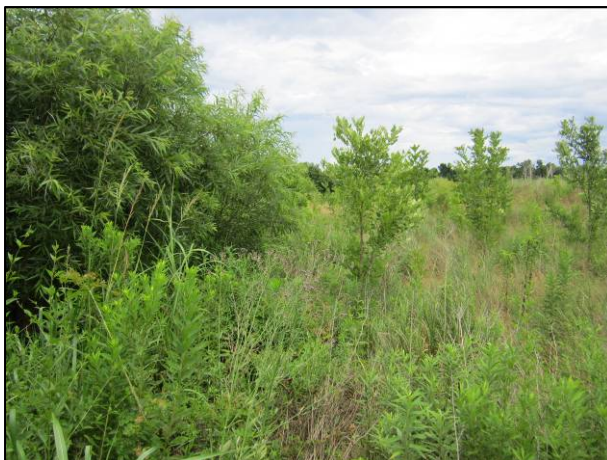
Facing north along the west side of Cross Section #1.  
Taken July 2011

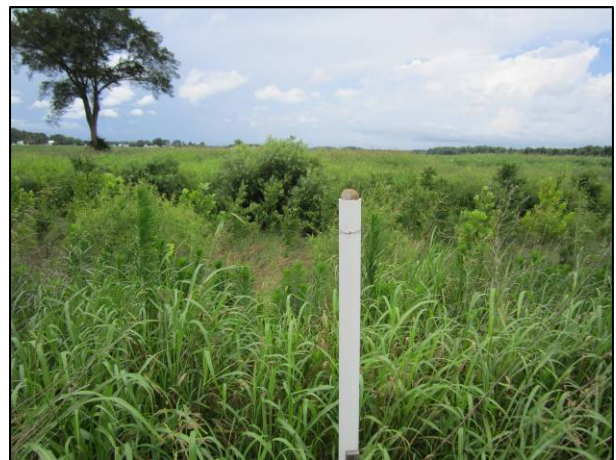
Facing west across Cross Section #1.  
Taken July 2011

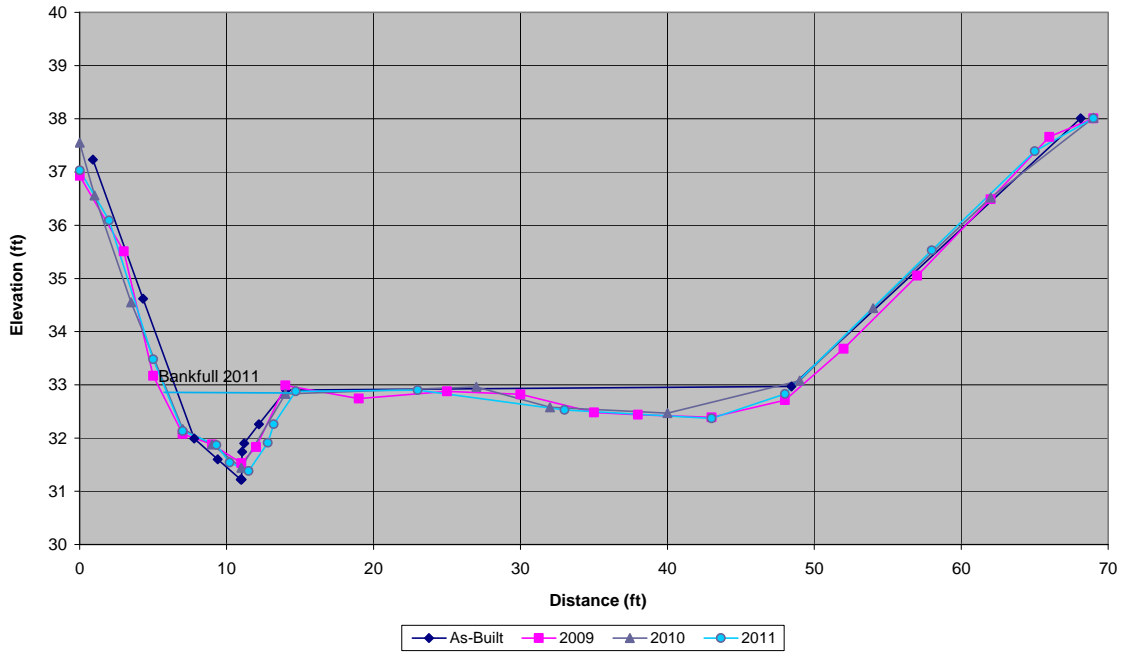
**XSC #2 - Brock Site Sta. 15+00**

*Note: The as-built survey data was based on compilation of topographic contours and not an actual cross section survey. As a result, variability exists between the actual cross section survey (conducted as part of monitoring efforts) and as-built data.*

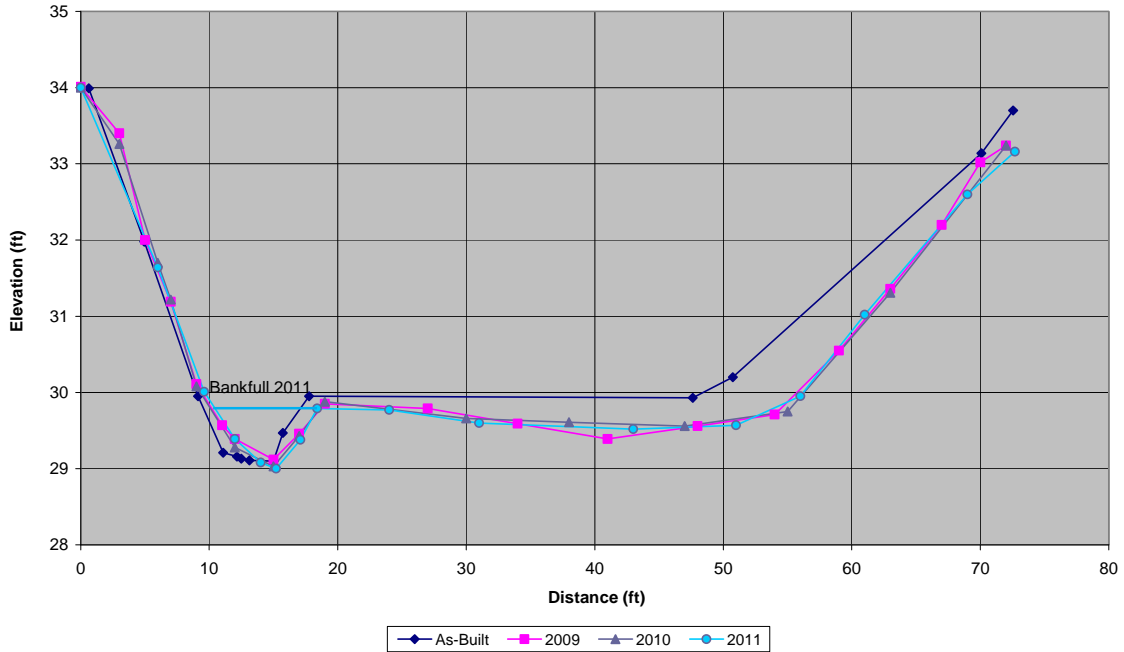
**XSC #3 - Brock Site Sta. 23+00**

*Note: The as-built survey data was based on compilation of topographic contours and not an actual cross section survey. As a result, variability exists between the actual cross section survey (conducted as part of monitoring efforts) and as-built data.*
