BROCK STREAM RESTORATION SITE Monitoring Year 4 (2012)

**Jones County, North Carolina
EEP Project No. 92333**

Final Monitoring Report

December 2012

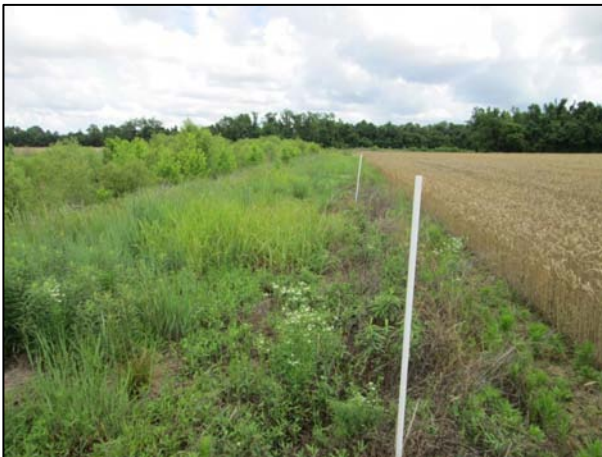
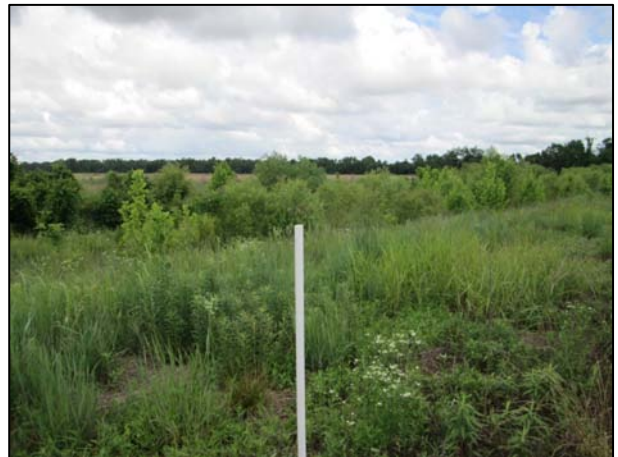
Vegetation Plots #1 and #4 met the success criteria required for buffer mitigation or Nutrient Offset Nitrogen credit, as well as the success criteria for stream mitigation credit. Vegetation Plots #2 and #3 failed to meet the criteria for buffer mitigation or Nutrient Offset Nitrogen credit. Vegetation Plot #2 also failed to meet the criteria for stream mitigation credit. A complete breakdown of this information is provided in Appendix A along with photographs of each vegetation plot taken during the assessment.

EEP will oversee a supplemental planting during the 2012-2013 dormancy season in the areas exhibiting low stem densities. This planting will consist of native species, consistent with those noted in the original planting plan, averaging 3.0 to 3.5 feet in height.
