BROCK STREAM RESTORATION SITE Monitoring Year 5 (2013)

**Jones County, North Carolina
EEP Project No. 92333**

Final Monitoring Report

December 2013

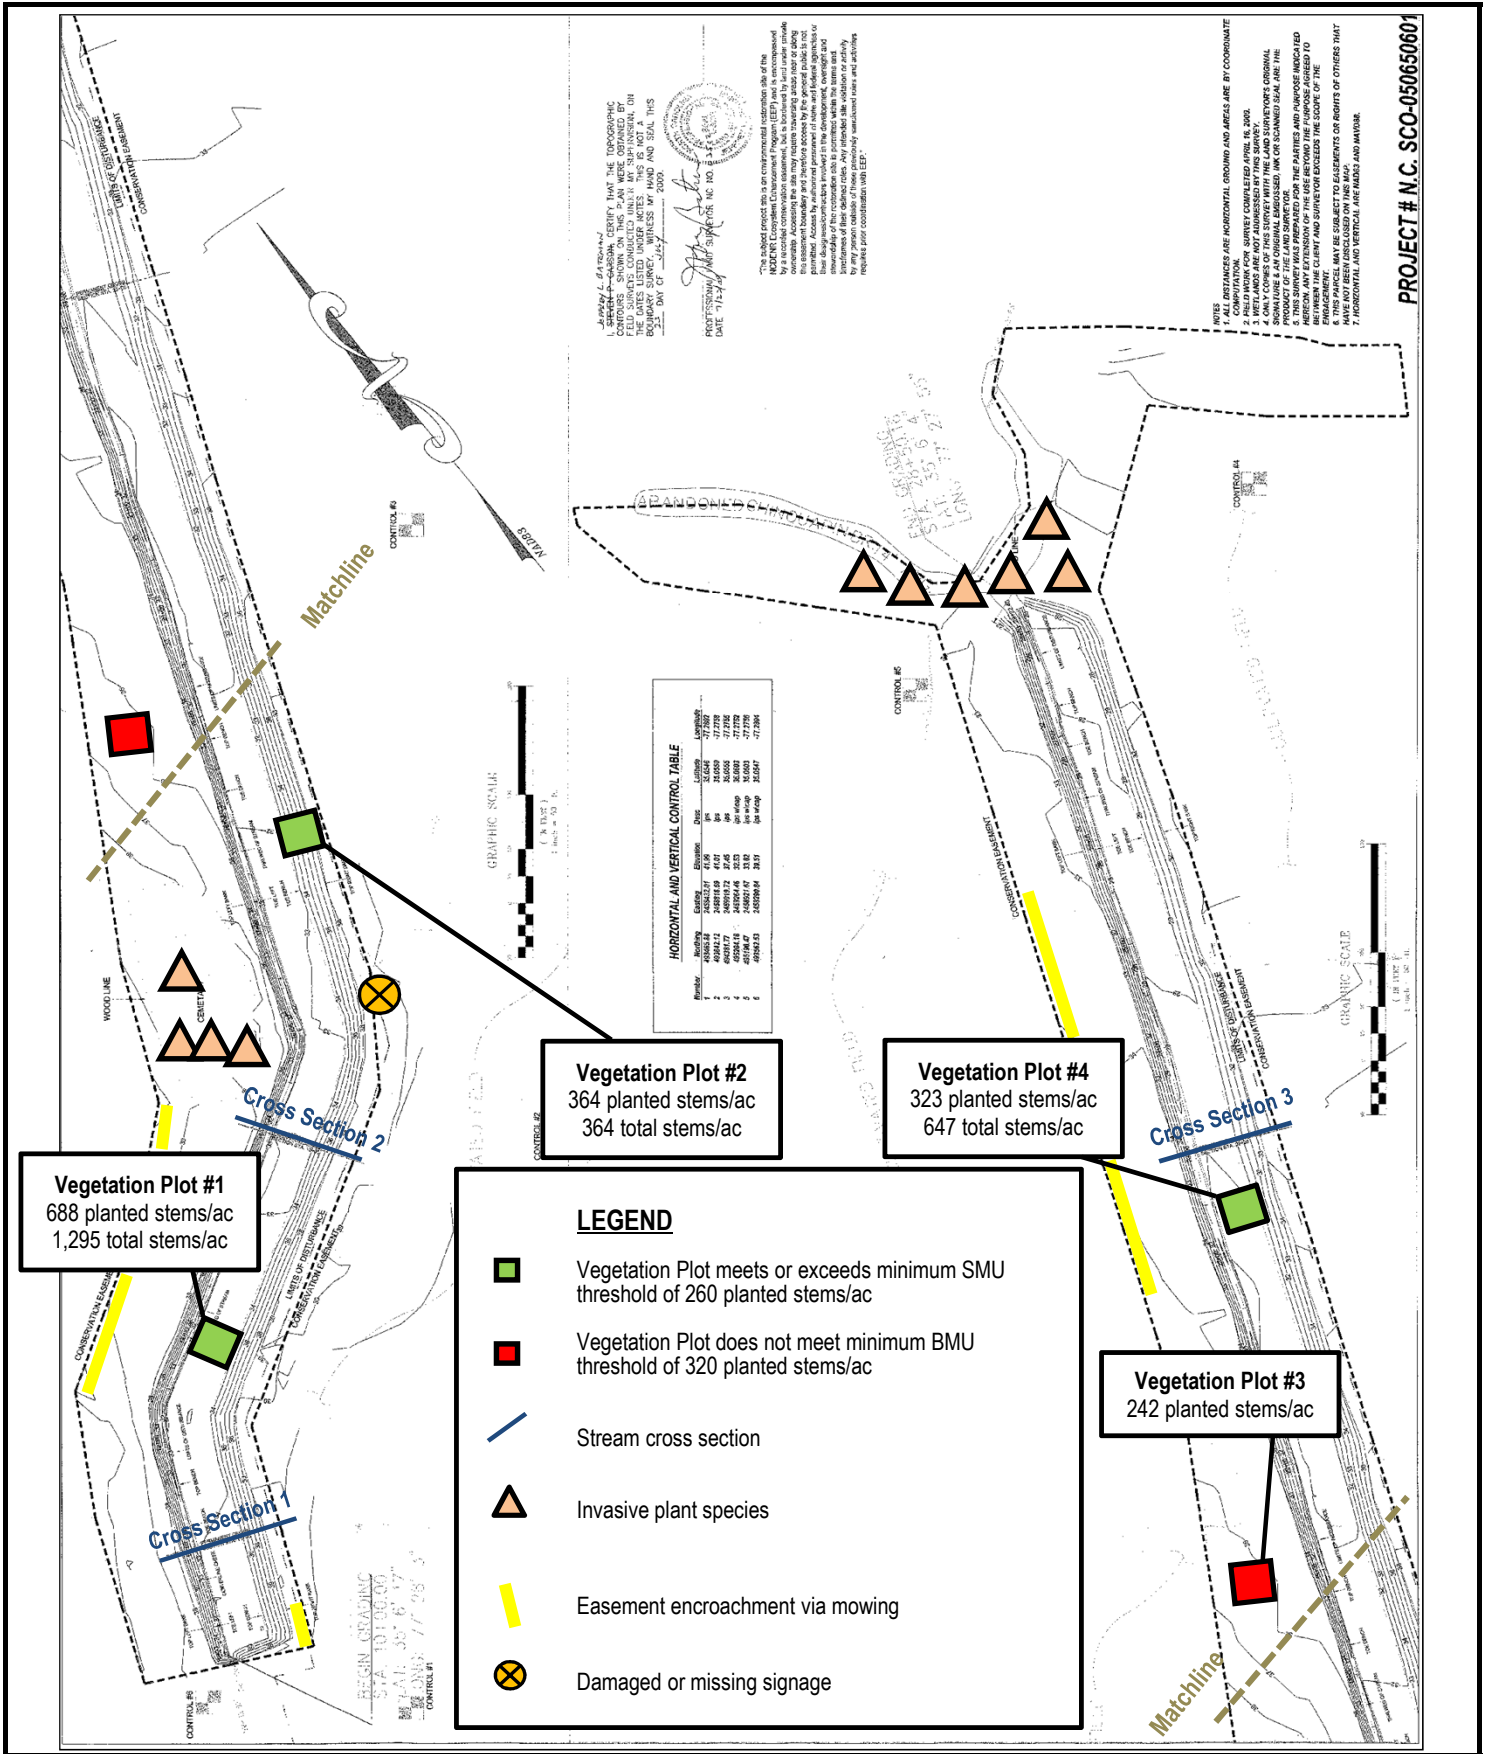
FIGURE 4

During the early summers of 2012 and 2013, both vegetation and boundary signage was partially destroyed along the eastern portion of the easement adjacent to the agricultural field. This destruction was caused by the mowing of an approximately 15-foot corridor immediately inside the easement area adjacent to the reach. Many of the trees throughout this area were severely impacted. Easement encroachment was also noted along the western side of the Project Site. Recent visits to the Project Site have not revealed any additional mowing or maintenance activities. Vegetation problem areas are summarized in Appendix A - Table 7 and are depicted on Figure 4.

Invasive plant species were observed along the western side of the Project Site in the vicinity of the historical cemetery, as well as near the downstream end within the riparian corridor associated with Big Chinquapin Branch. Chinaberry tree (*Melia azedarach*), Chinese privet (*Ligustrum sinense*) and multiflora rose (*Rosa multiflora*) were observed within the cemetery while mainly Chinese privet was noted near the downstream end of the Project Site. A contract is currently in place with HARP for four consecutive invasive treatments within these areas.

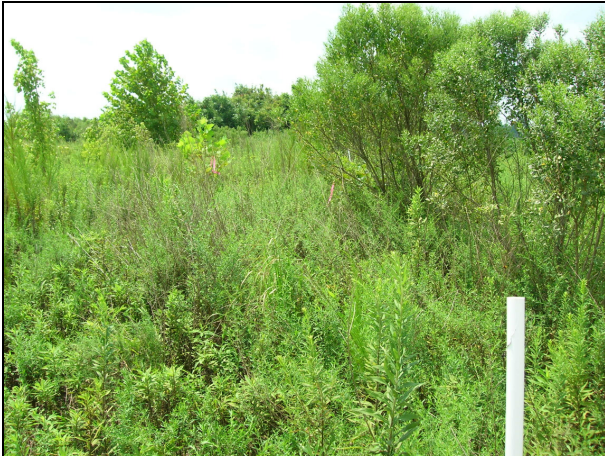
Photostation 8.
Facing southwest across Vegetation Plot #3.
Taken August 2013.

Vegetation Plots #1, #2 and #4 met the success criteria required for buffer mitigation or Nutrient Offset Nitrogen credit, as well as the success criteria for stream mitigation credit. Vegetation Plot #3 failed to meet the criteria for buffer mitigation or Nutrient Offset Nitrogen credit. A complete breakdown of this information is provided in Appendix A along with photographs of each vegetation plot taken during the assessment.

As mentioned in previous reports, a supplemental planting was conducted during February 2010 as part of the contractor's vegetation warranty. A second supplemental planting occurred on March 18, 2013 to augment trees in areas exhibiting low planted stem densities. Little to no increase in planted stem counts was discovered however, during MY 5 vegetation assessments. Vegetation Plot #2 was the only plot exhibiting an increase in planted stems. As per the MY 5 assessment, Vegetation Plot #3 remains below the required mitigation threshold.

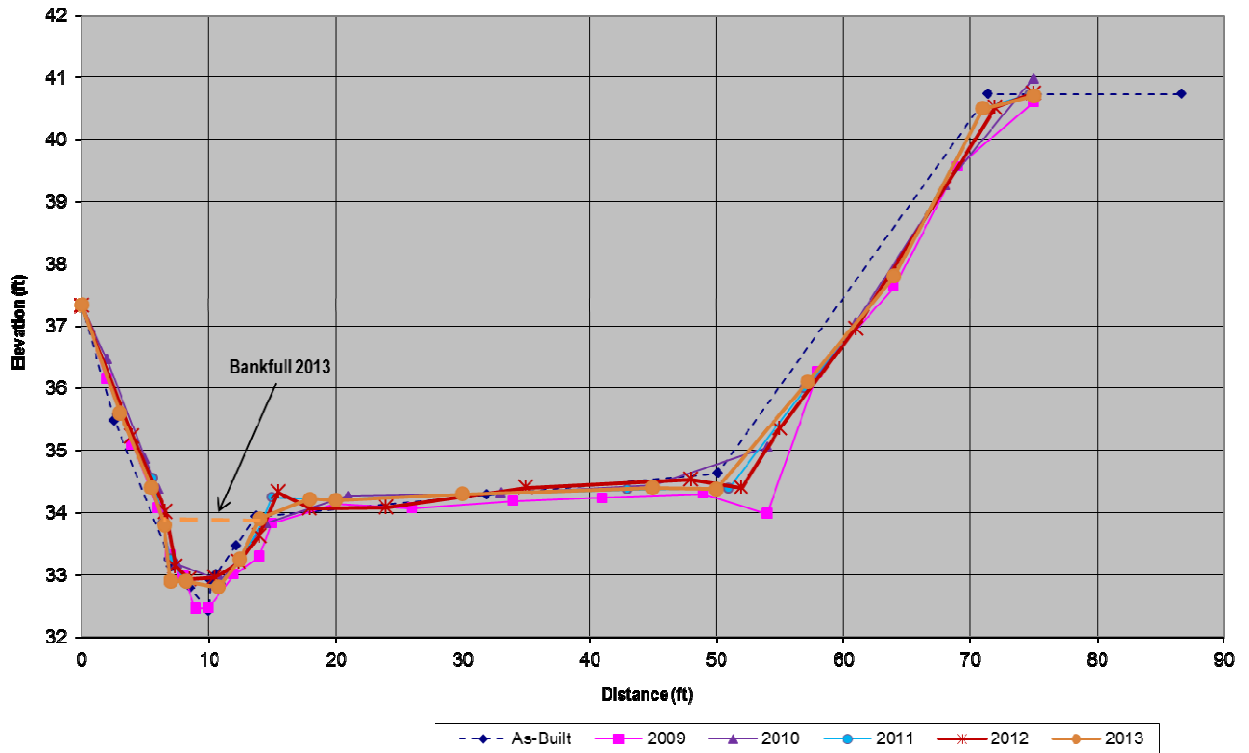
XSC #1 - Brock Site Sta. 11+00

No significant changes to the dimension were observed during MY 5 monitoring activities. A visual assessment of the channel was conducted throughout its length and no problem areas were noted. Although elevation changes were observed based on the data collected, the visual assessments did not locate any obvious areas of instability and/or erosion.
