# Buffalo Creek Watershed Phase II Year 1 Monitoring Report Greensboro, North Carolina

North Carolina Department of Environment and Natural Resources  
Ecosystem Enhancement Program

January 2006

# Buffalo Creeks Phase II Benbow and Brown Bark Parks Year 1 Monitoring Report Greensboro, North Carolina

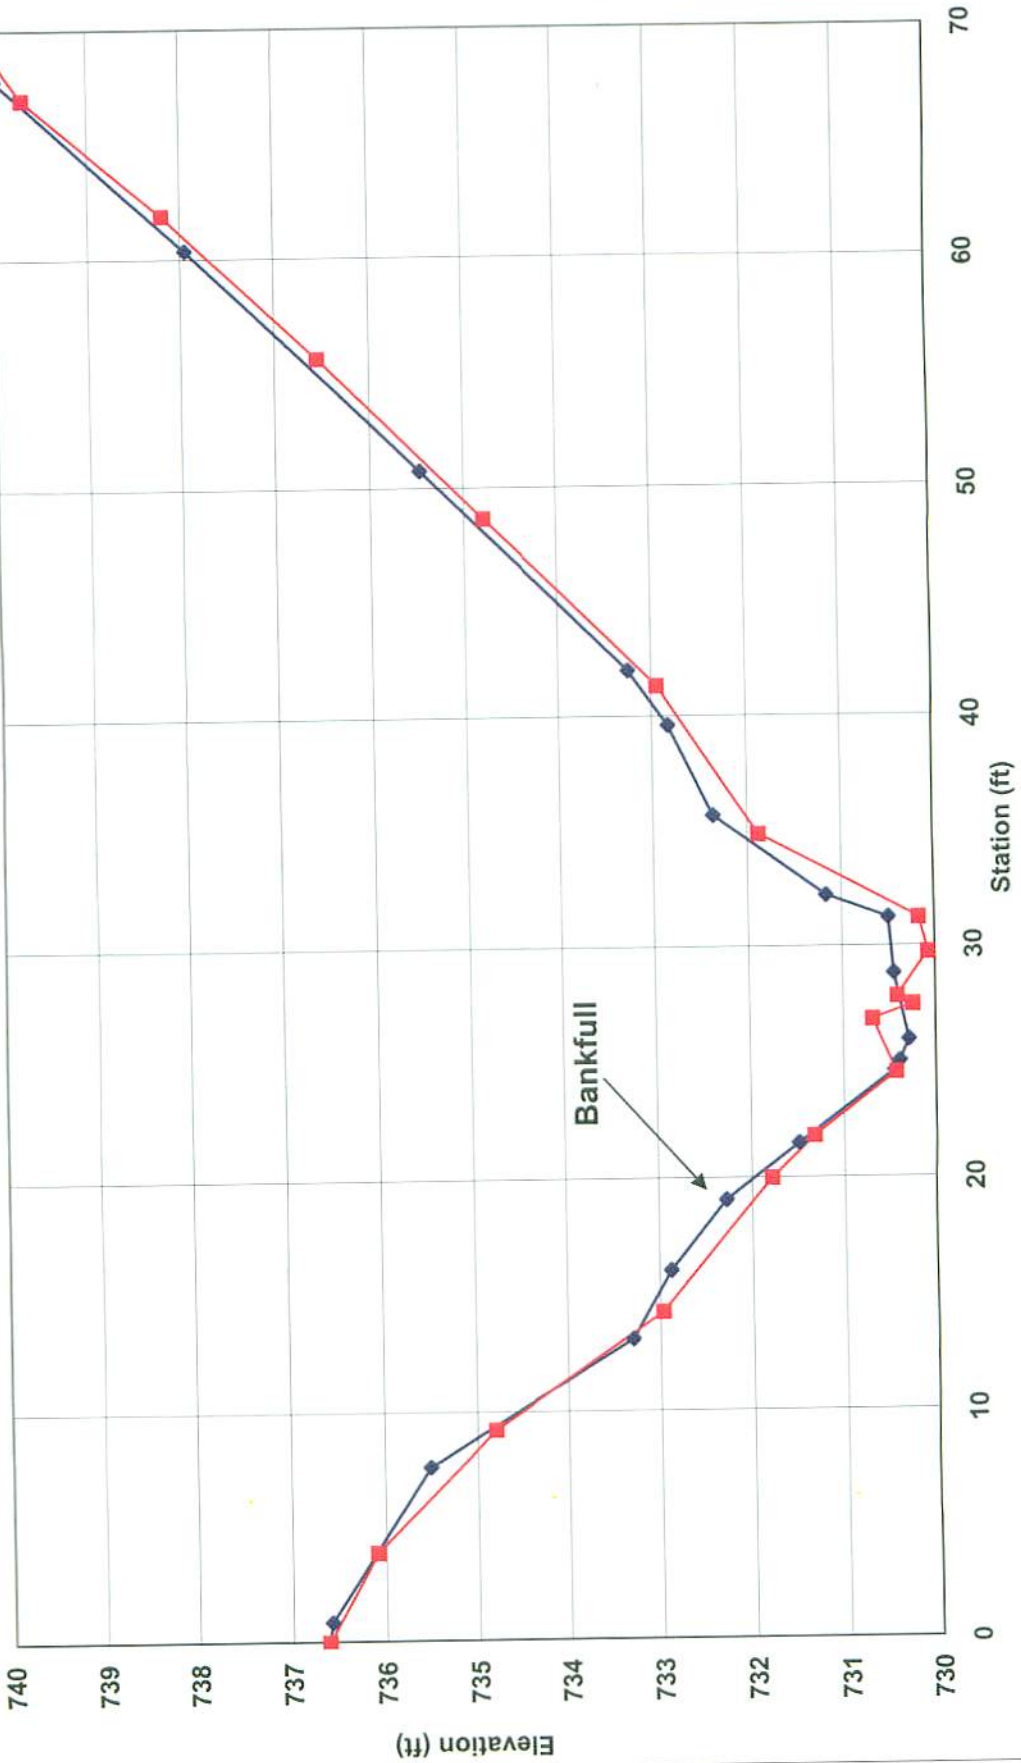
# Benbow Cross Section 1 - Riffle

The natural channel design for Reach 1 of Benbow Park was based on a combined Rosgen Priority 2 and 3 restoration approach. The incised Rosgen type “E5” channel was changed to a “B5c” and has remained so. There are three cross sections in this reach. Cross Sections 1 and 3 are stable riffles with very minor variations in dimension. The thalweg in the pool at Cross Section 2 has shifted to the left along with bank erosion that merits continued observation for possible repair.

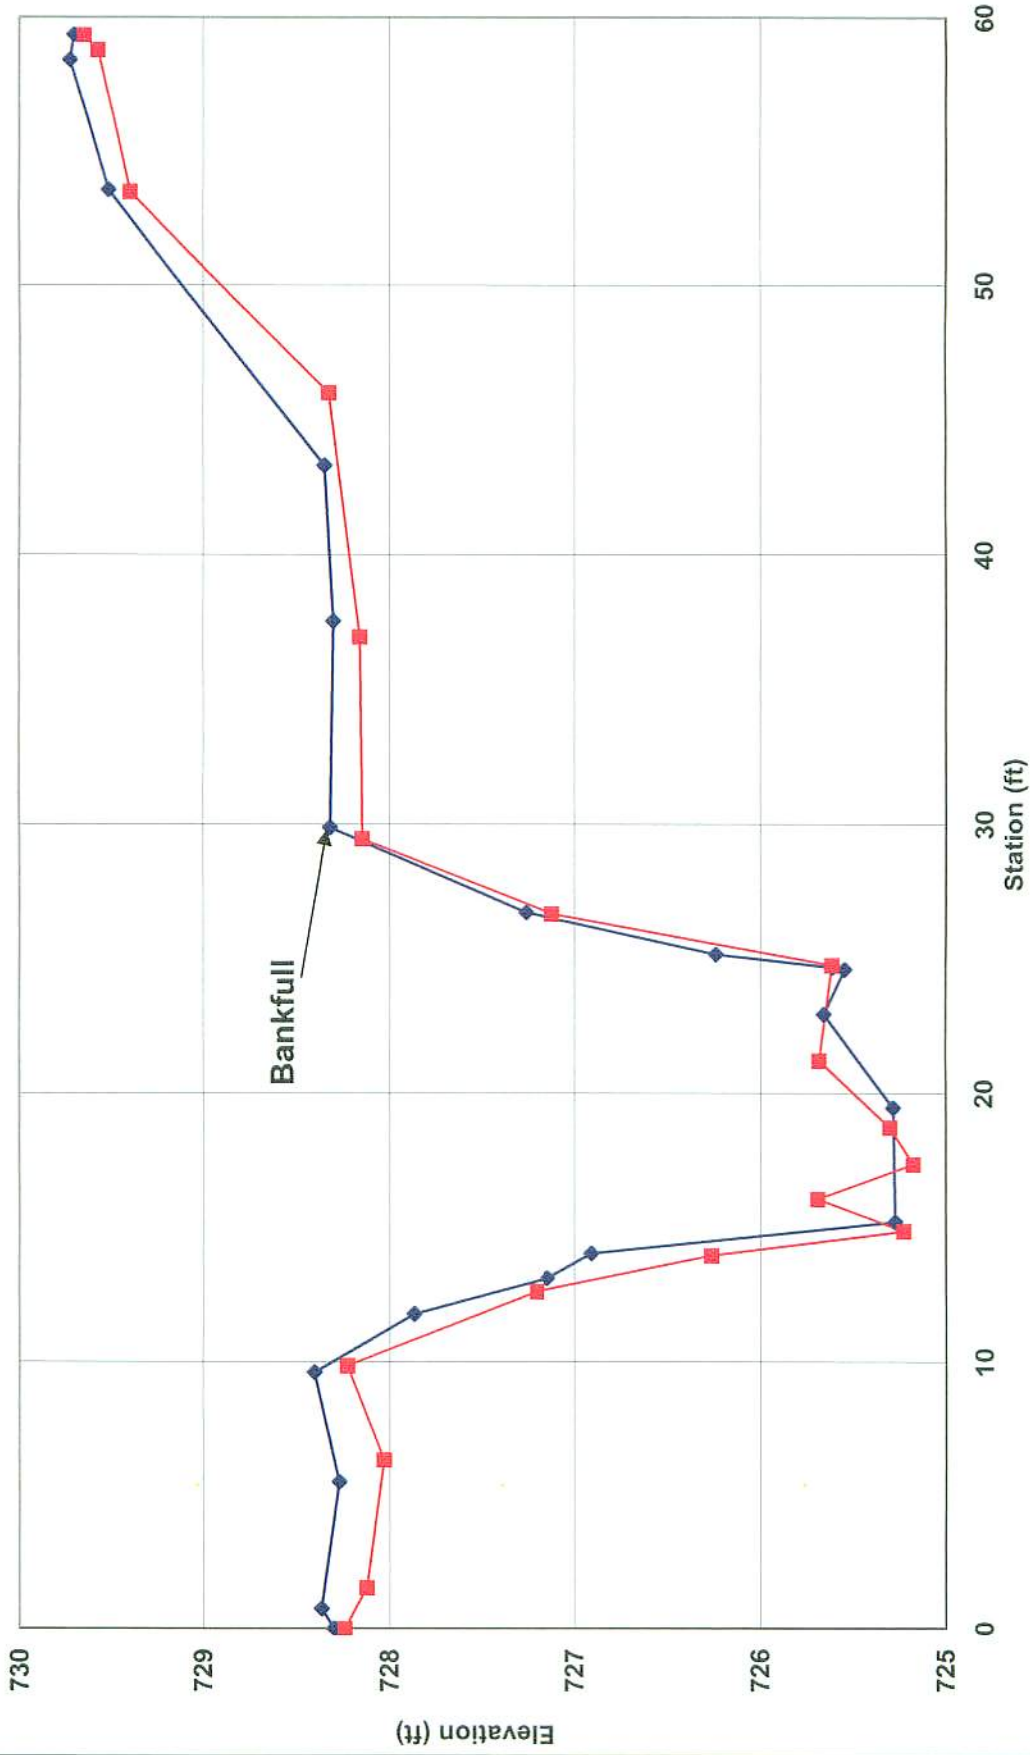
# Benbow Cross Section 4 - Riffle

The natural channel design for Reach 2 was based on a Rosgen Priority 1 approach. The existing straight channel was replaced with a new meandering channel at a higher elevation, which gives it access to its existing floodplain. There are three cross sections in this reach. Cross Sections 4 and 6 are stable riffles with minor variations in dimension. Cross Section 5 is a root wad pool that has increased in depth.

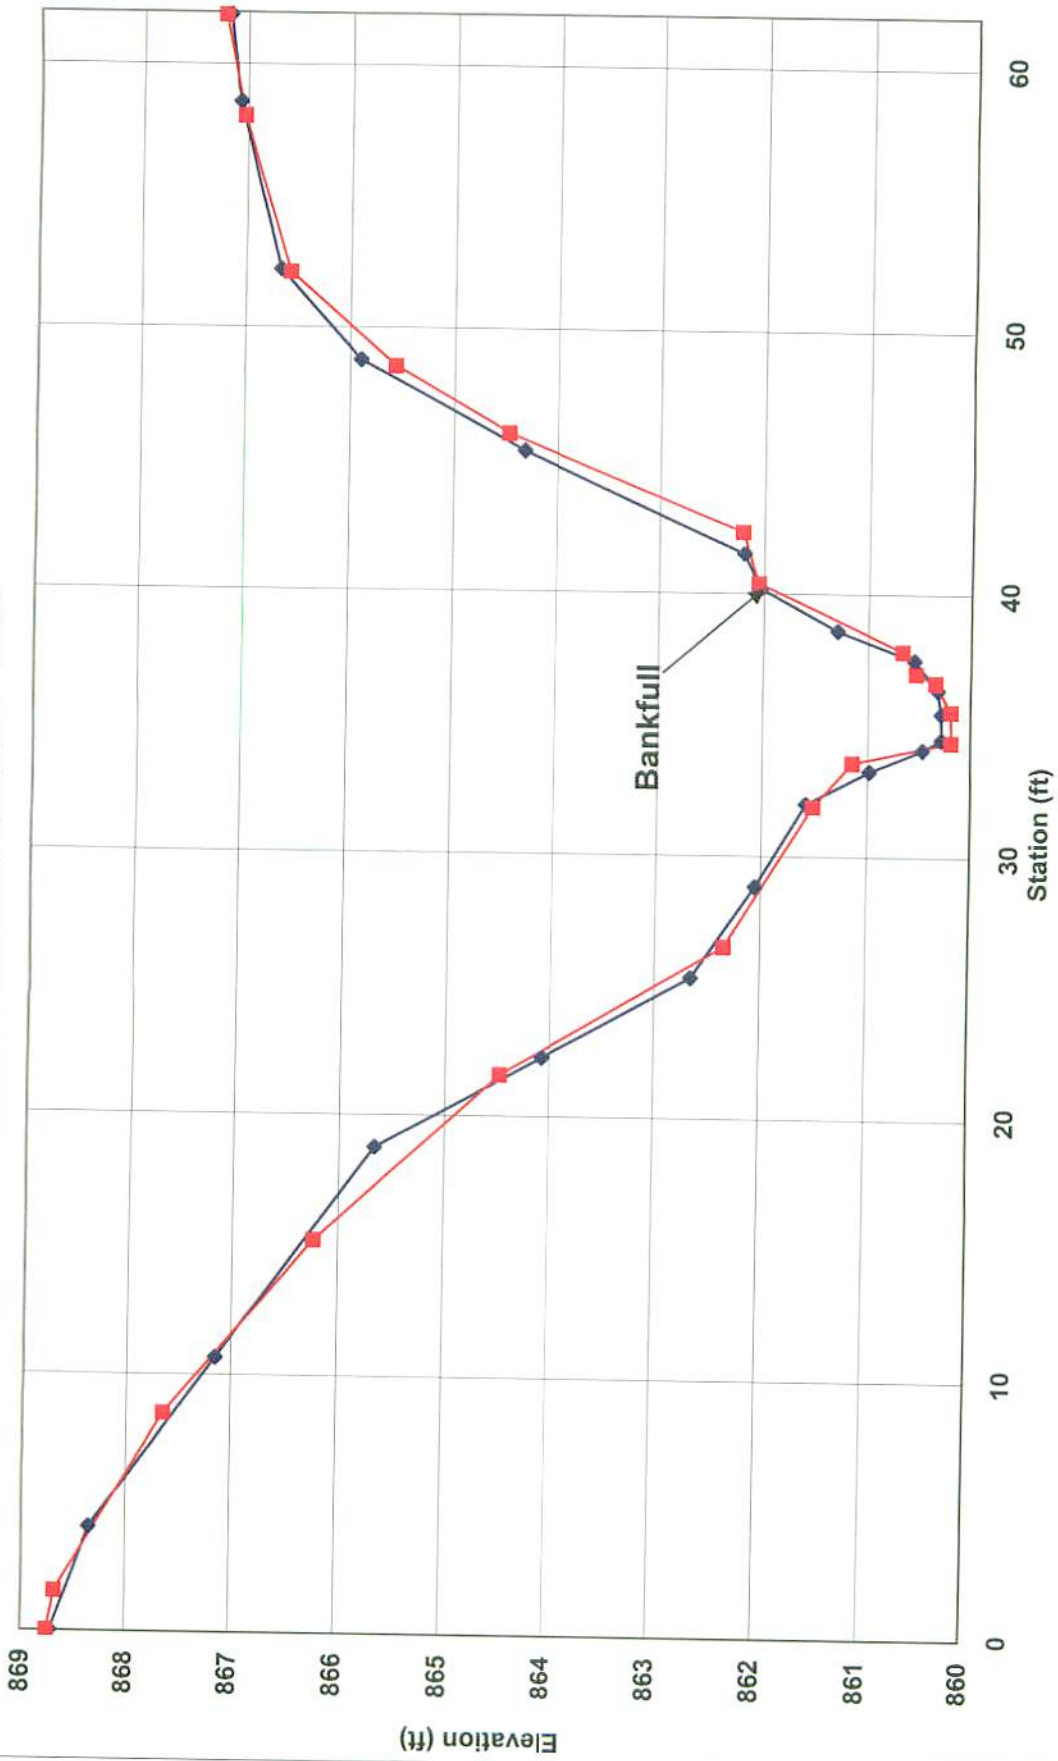
# Brown Bark Cross Section 1 - Rifle

The natural channel design for the Brown Bark Park Reach was based on a combined Rosgen Priority 2 and 3 restoration approach. The existing Rosgen type “C5/E5” was changed to a “B5/C5” as part of the restoration work. There are six cross sections in this reach. Cross Sections 1, 3, 5, and 6 are stable riffles with minor changes in dimension. Cross Section 2 is a pool with root wads that has had an increase in depth of one foot where the root wads are. Cross section 4 is also a pool, without root wads, that has had minor changes to its dimension since construction.

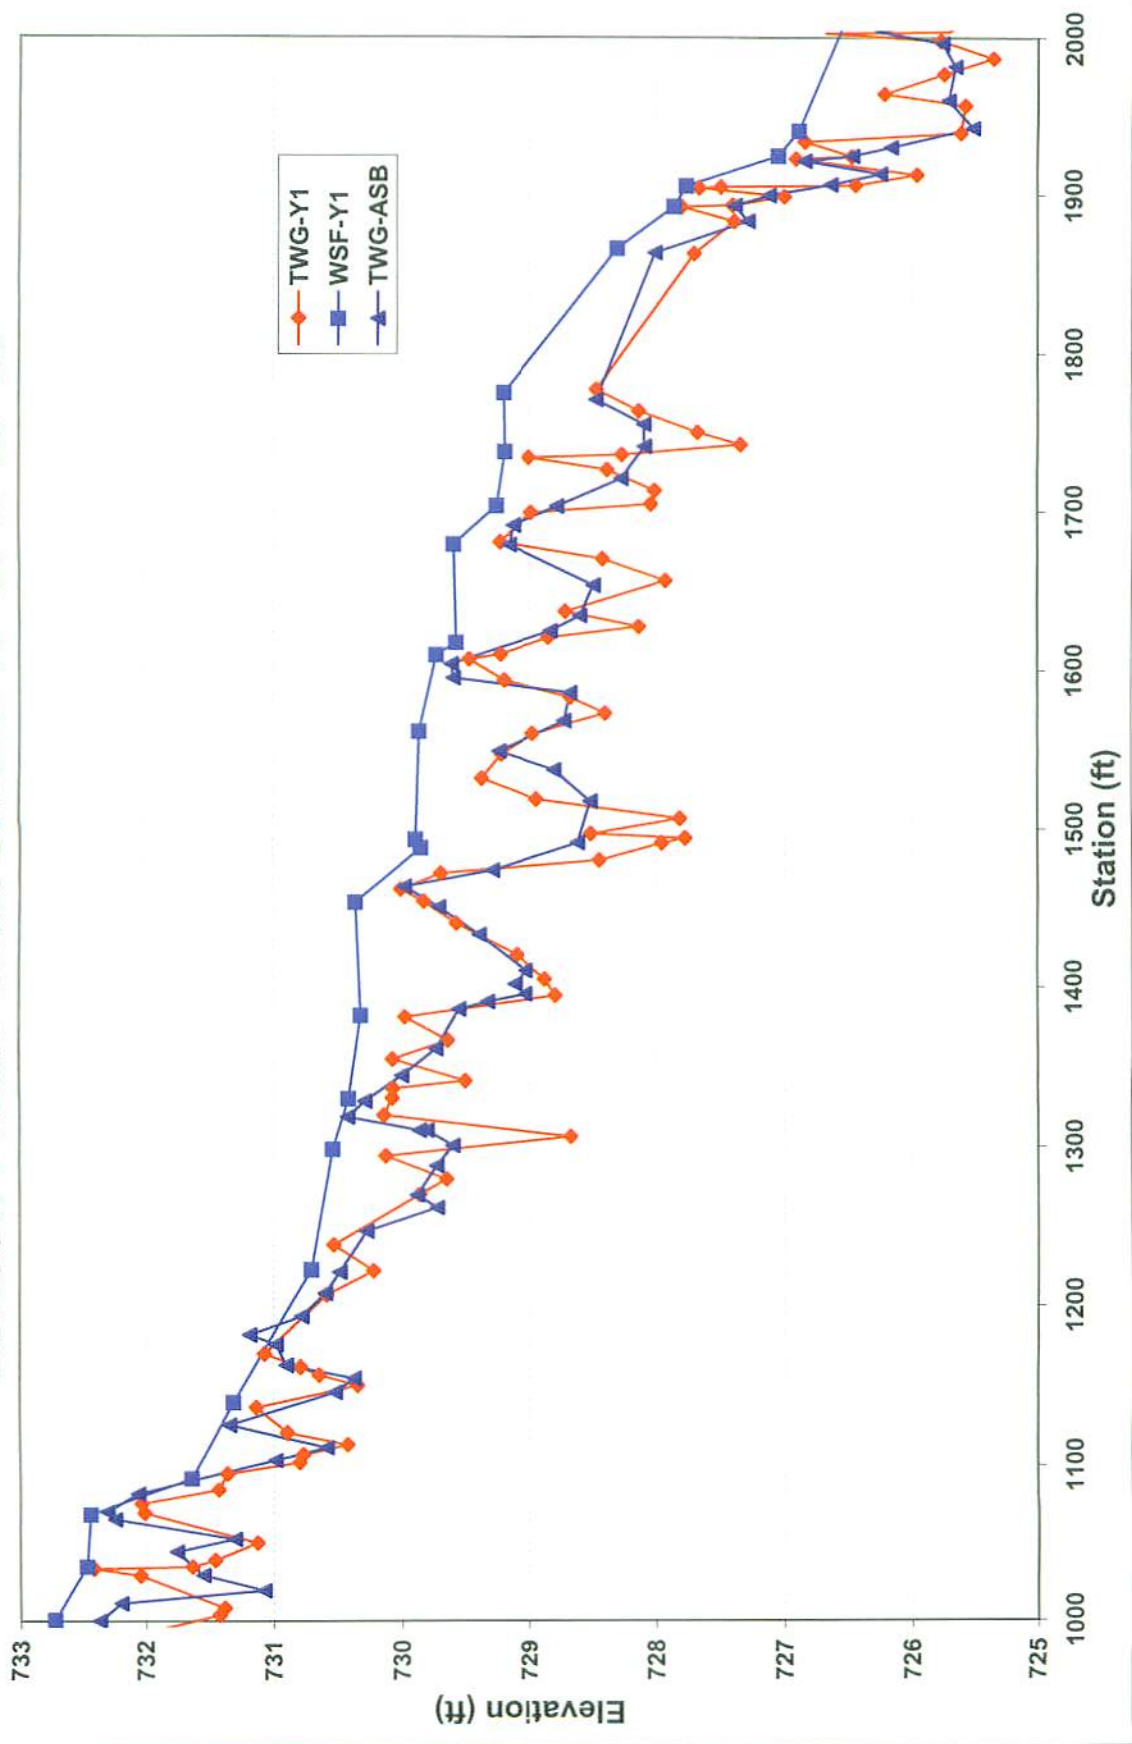
# Benbow Profile Chart Station 10+00 to 20+00

Buck Engineering completed longitudinal profiles using a total station. This included 4500 feet of channel in Benbow and Brown bark reaches. Measurements included the thalweg and water surface. The survey shows there is no change in sinuosity or pattern. The bedform diversity has improved and the riffle/pool sequence has remained fairly constant. The new thalweg shows some deeper pools and some with minor deposition.
