**Brown Bark Park
Stream Restoration Monitoring Report
EEP Project # 52
Monitoring Year – 03
2007**

February 2008

In 2004, the North Carolina Ecosystem Enhancement Program (EEP) conducted stream restoration at Brown Bark Park within the Buffalo Creek Watershed in Greensboro, North Carolina. The 0.3-mi² watershed is located within the USGS 14-digit HUC 03030002020040 and the NCDWQ Sub-basin 03-06-02 of the Cape Fear River Basin. The project restored approximately 2,834 linear feet of channel. The design was developed to address vertical instability and the lack of bed variability. The restoration plan called for correcting these problems by stabilizing stream banks, installing in-stream structures, adjusting the stream planform, and replanting the riparian areas with native vegetation. Project construction occurred in 2004. This report describes the results from the third year of monitoring that took place in 2007.

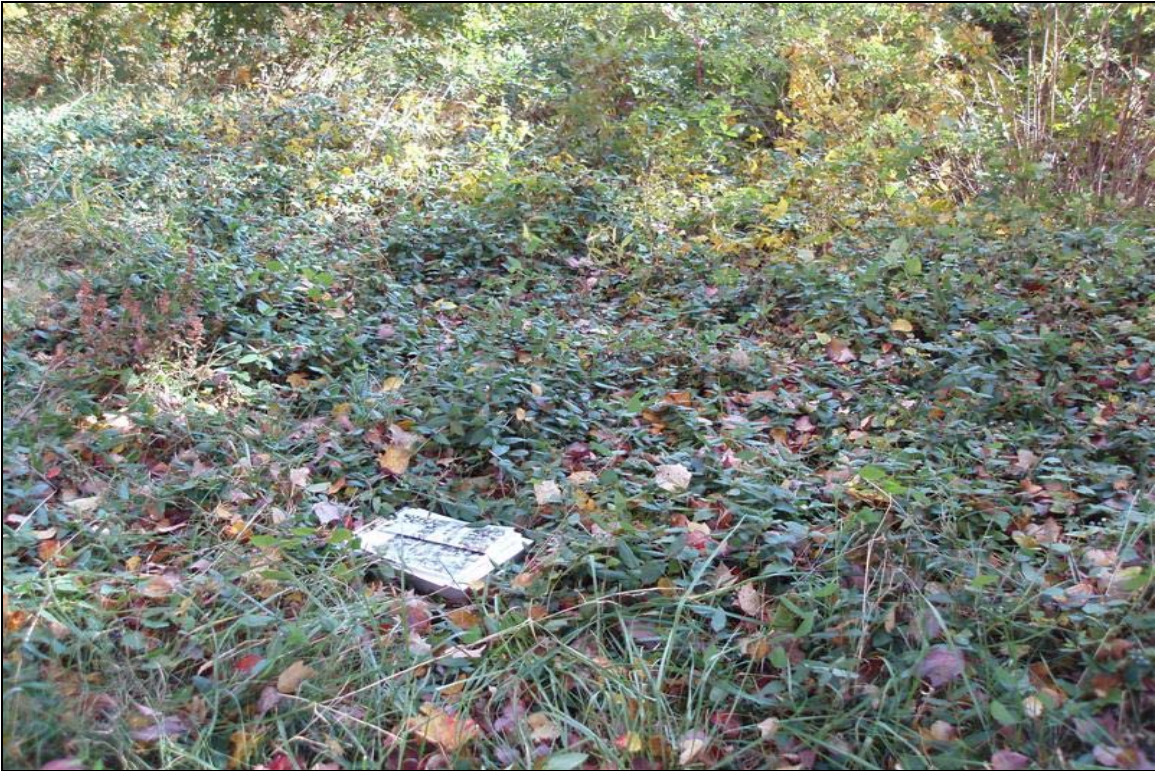
There are some invasive species in the riparian buffer. These species include mimosa (*Albizia julibrissin*), white mulberry (*Morus alba*), Japanese honeysuckle (*Lonicera japonica*), Bradford pear (*Pyrus calleryana*), multiflora rose (*Rosa multiflora*), and porcelainberry (*Ampelopsis brevipedunculata*). Most of the invasive species are scattered throughout the buffer and do not densely populate any one area more than others. Given the suburban park environment, there are many sources of invasive vegetation in close proximity to the project. Currently the invasive species do not warrant control efforts, but they should continue to be monitored.

VP1 – Japanese honeysuckle (*Lonicera japonica*) and porcelainberry (*Ampelopsis brevipedunculata*). Photo taken near Station 10+00. 11/19/07 - MY 03

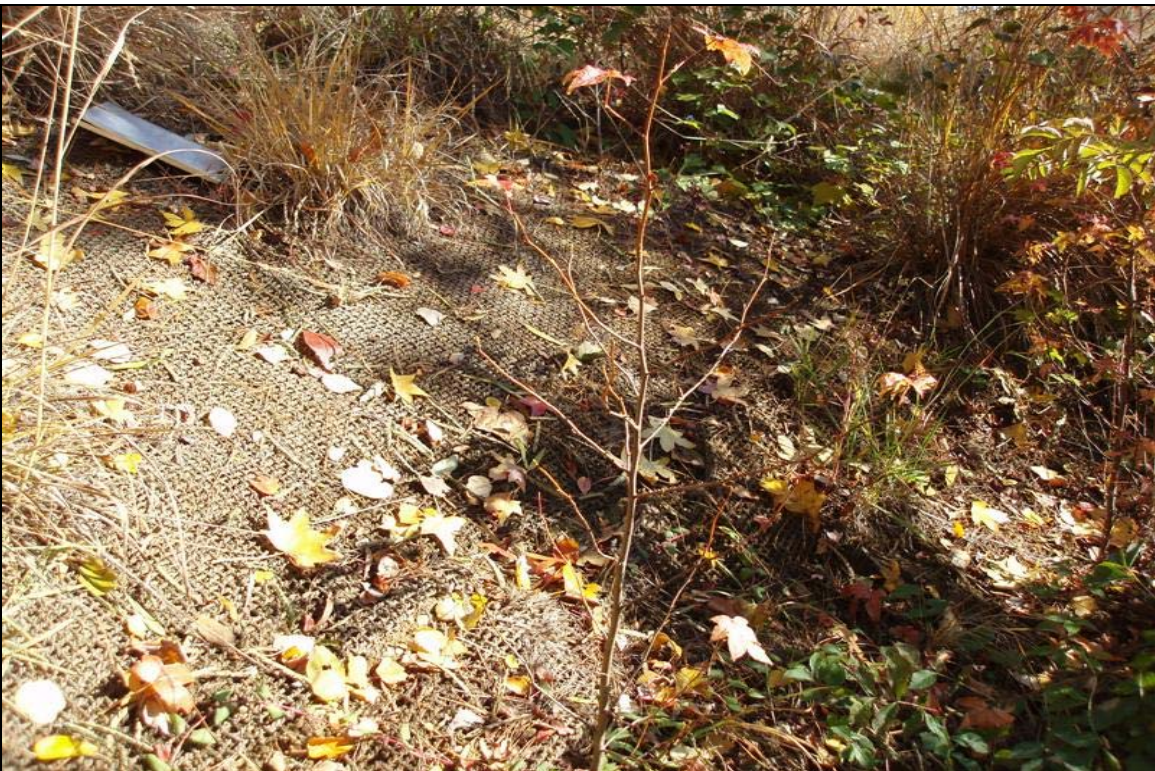
VP2 – Banks with unvegetated coir matting. Photo taken near Station 10+75. 11/19/07 - MY 03

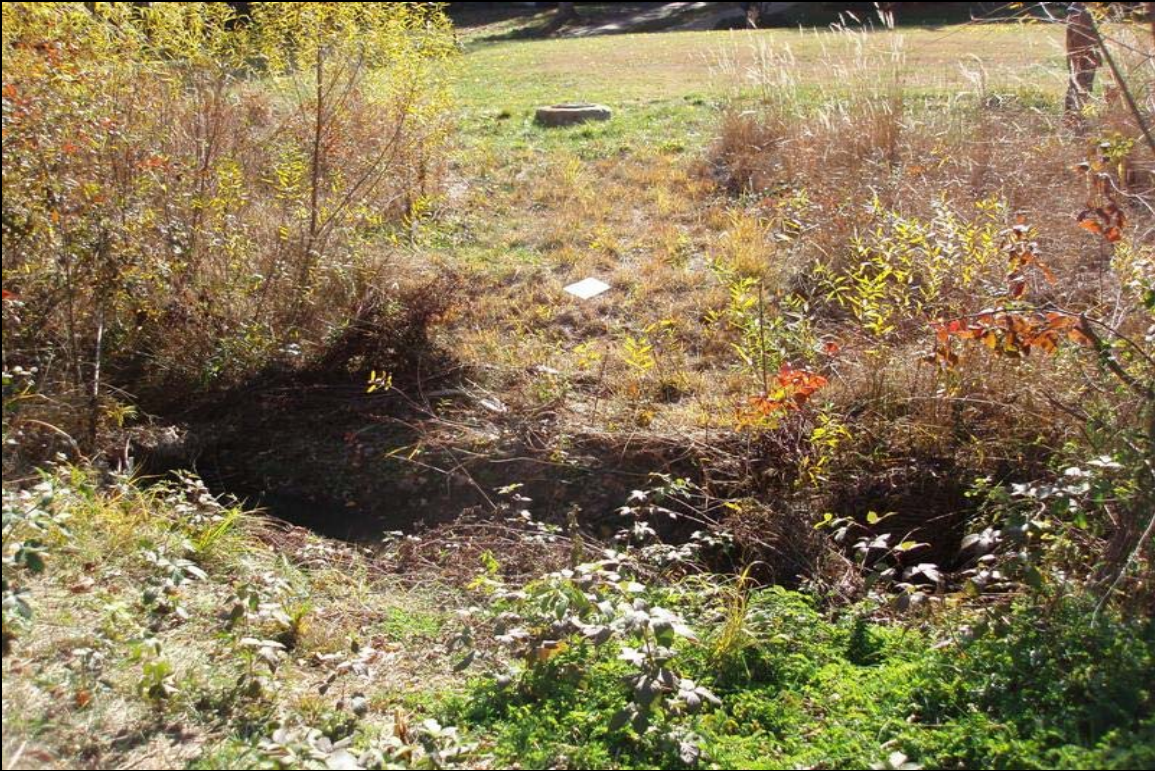
VP3 – The riparian buffer has been mowed along with the sewer line easement. Photo taken near Station 23+60. 11/19/07 - MY 03

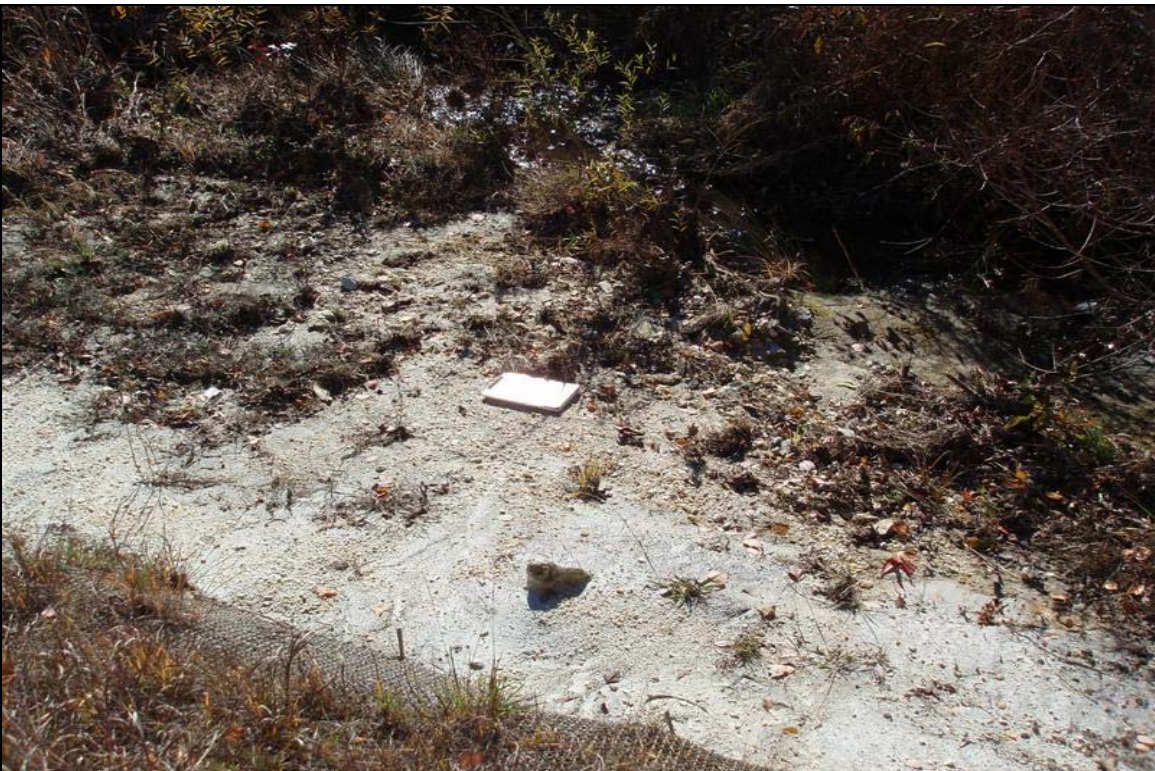
VP4 – Bare floodplain/bank with exposed subsoil. Photo taken near Station 27+10. 11/19/06 - MY 03

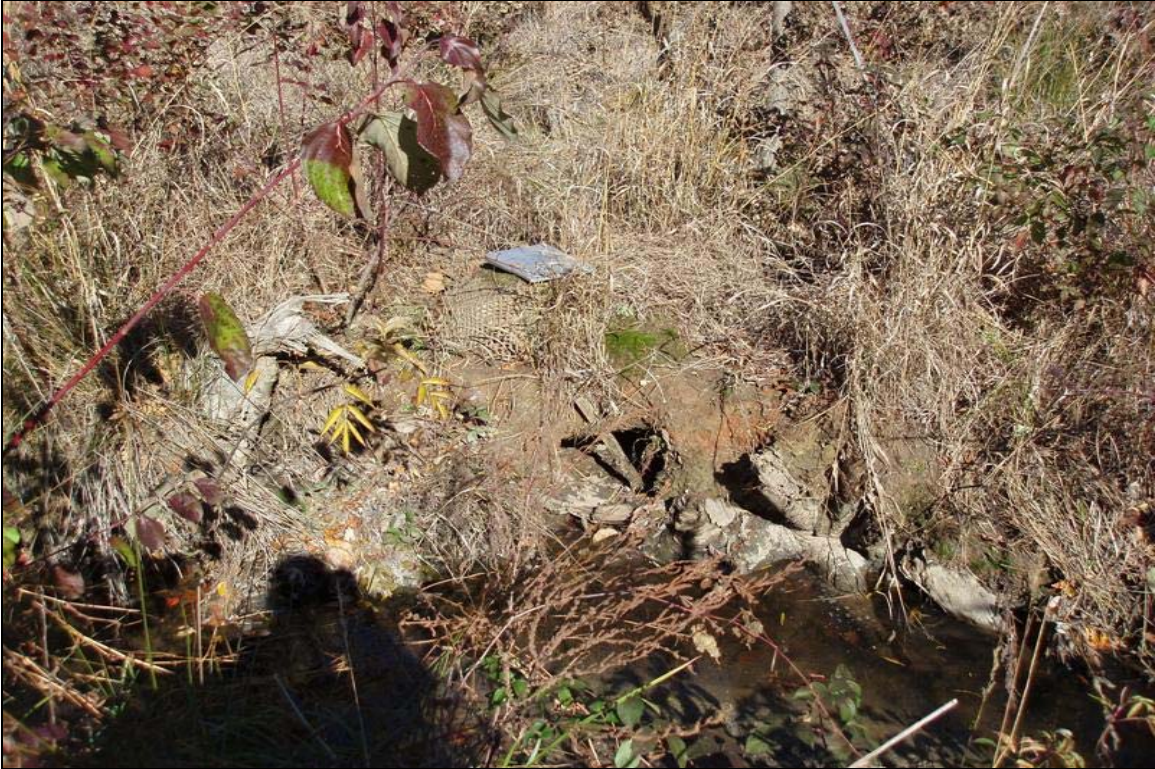
SP1 – Scour behind rootwads under the streambank. Photo taken near Station 18+00. 11/19/07 - MY 03

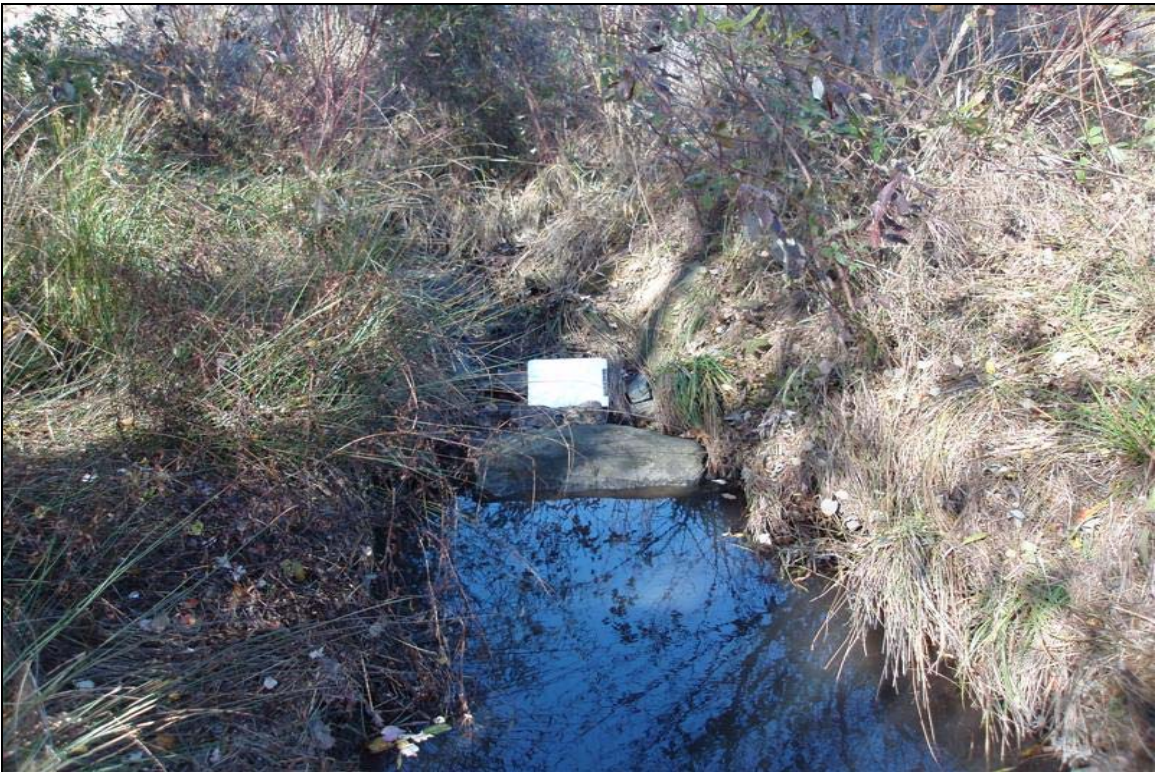
SP2 – Base flow going around a header stone in cross vane. Photo taken near Station 19+20. 11/19/07 - MY 03

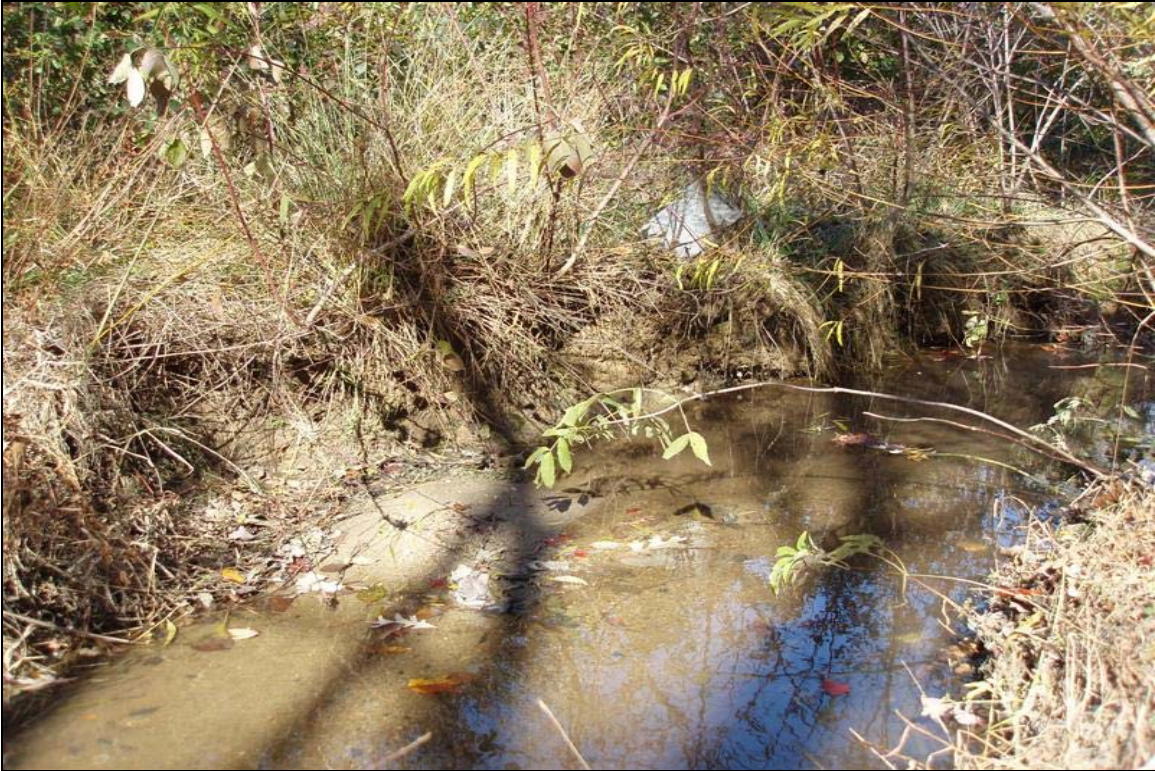
SP3 – Bank erosion. Photo taken near Station 31+50. 11/19/07 - MY 03
