**Brown Bark Park  
Stream Restoration Monitoring Report  
EEP Project # 52  
Monitoring Year – 04  
2008**

**March 2009**

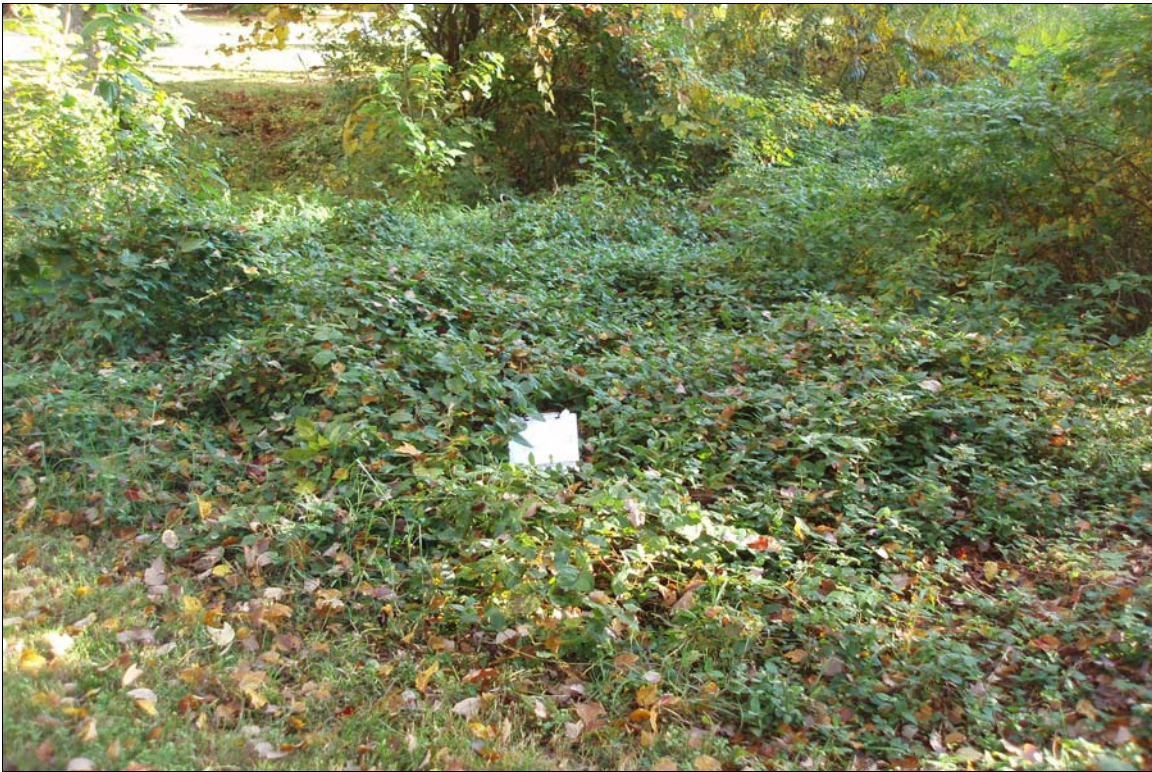
VP1 – Japanese honeysuckle (*Lonicera japonica*) and porcelainberry (*Ampelopsis brevipedunculata*). Photo taken near Station 10+00. 11/7/08 - MY 04

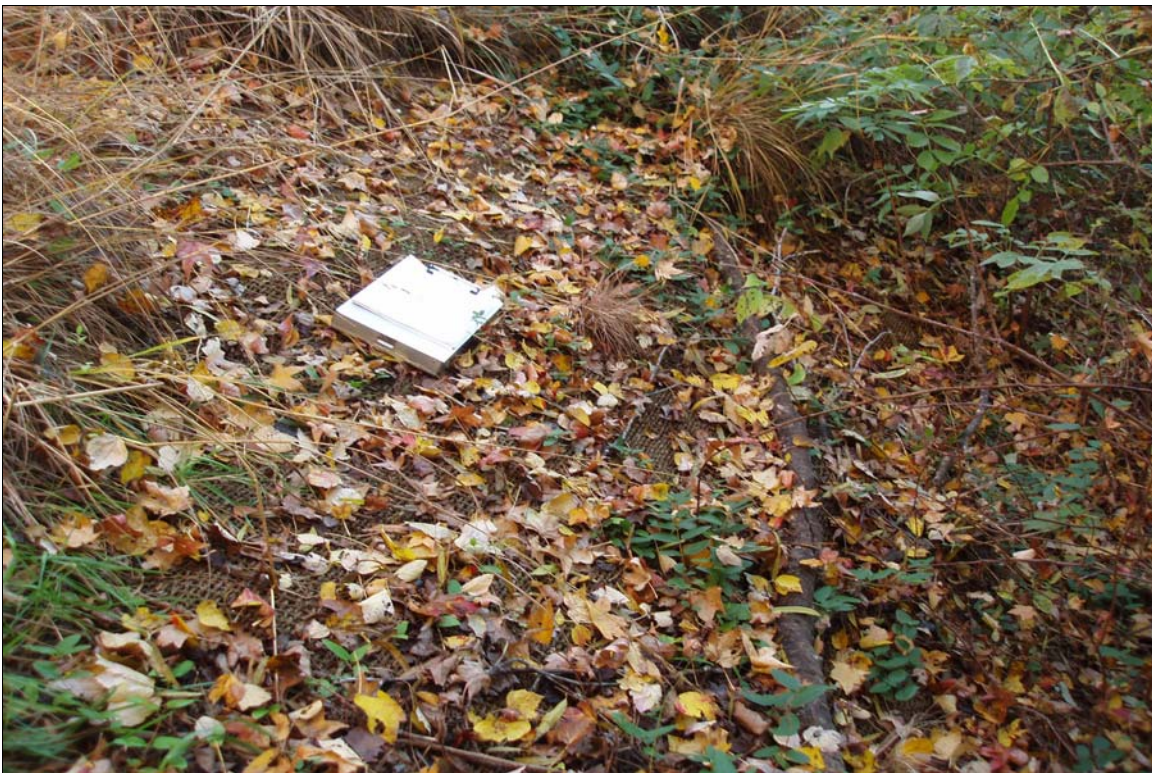
VP2 – Banks with unvegetated coir matting. Photo taken near Station 10+75. 11/7/08 - MY 04

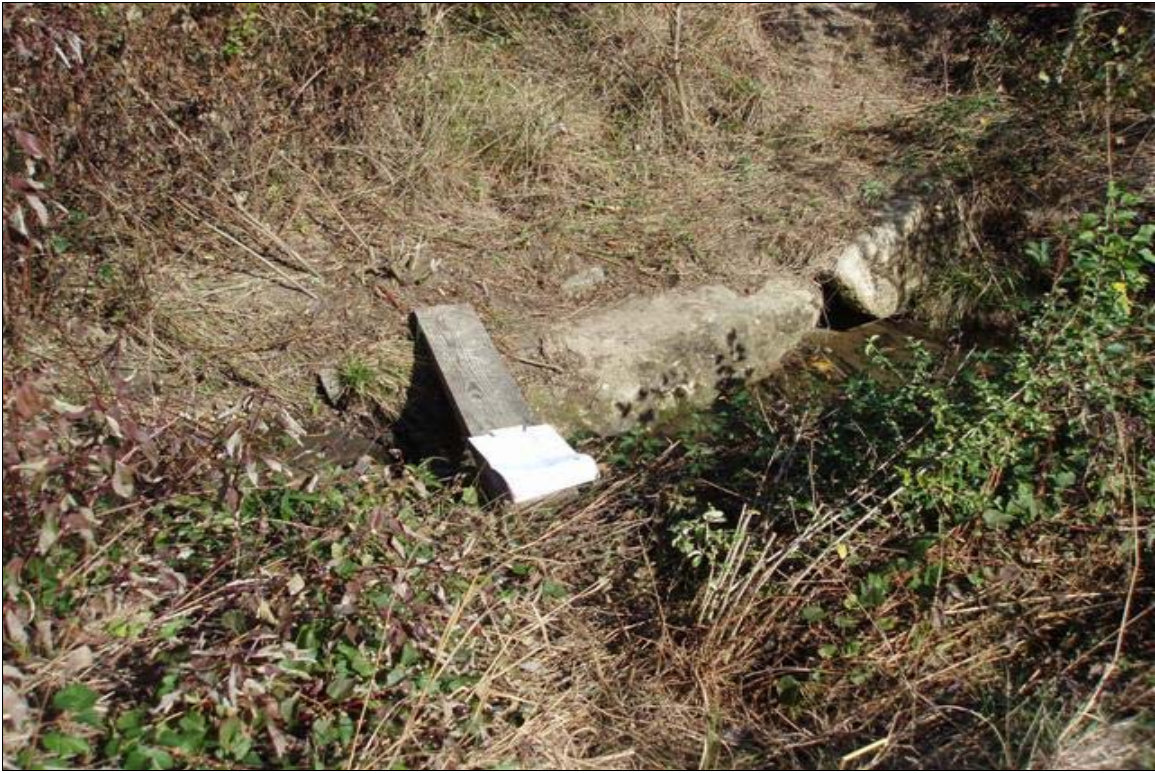
VP3 – The riparian buffer has been cut to create a path. Photo taken near Station 14+20. 10/29/08 - MY 04

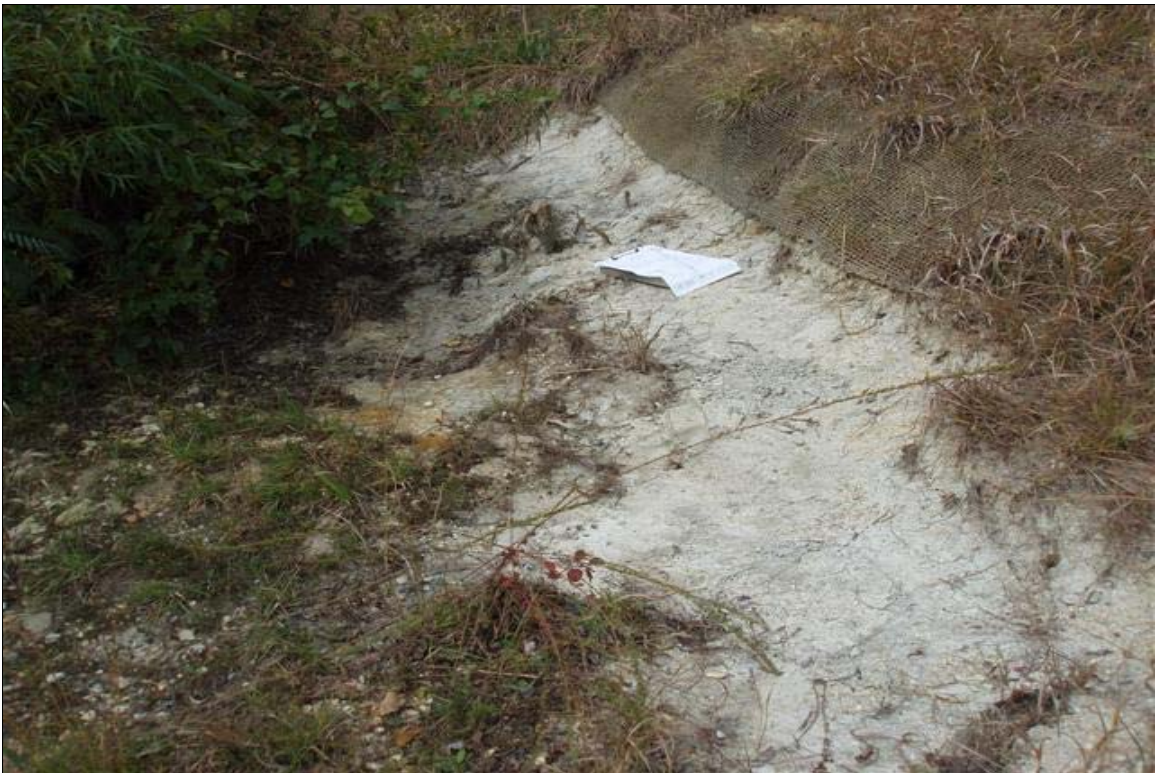
VP4 – Bare floodplain/bank with exposed subsoil. Photo taken near Station 27+10. 10/29/08 - MY 04

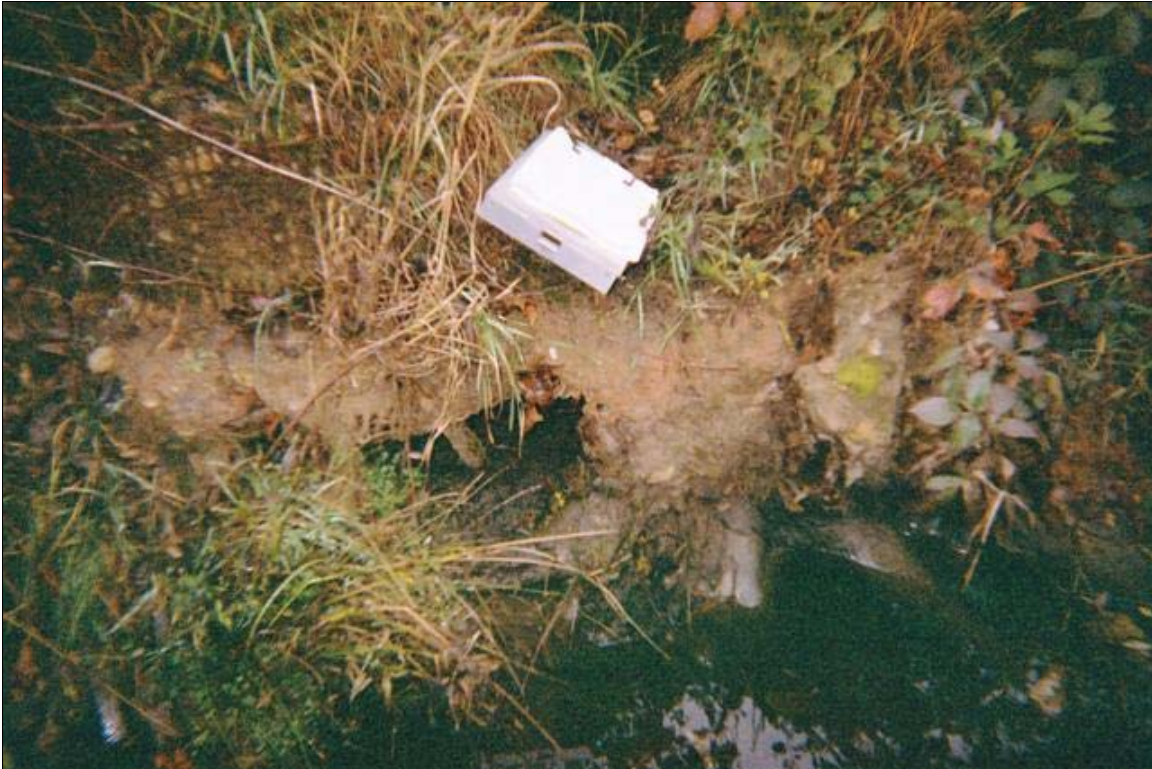
SP1 – Scour behind rootwads under the streambank. Photo taken near Station 18+00. 11/5/08 - MY 04

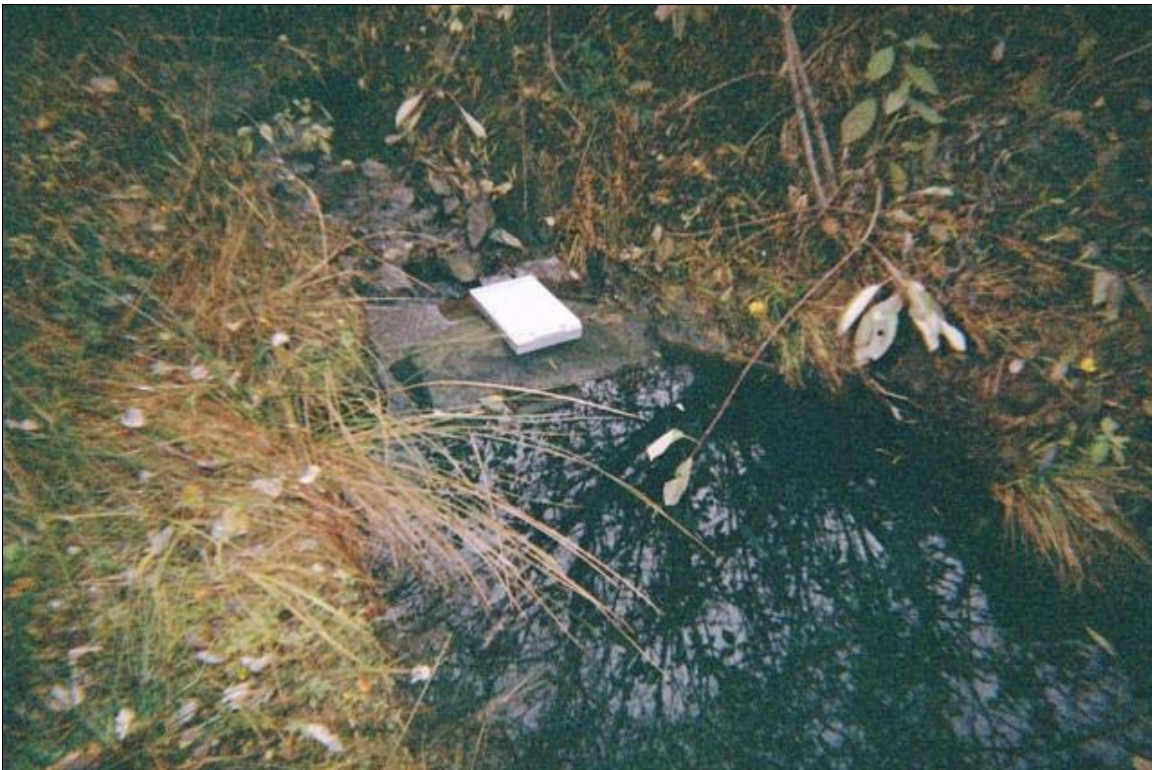
SP2 – Base flow going around a header stone in cross vane. Photo taken near Station 19+20. 11/5/08 - MY 04

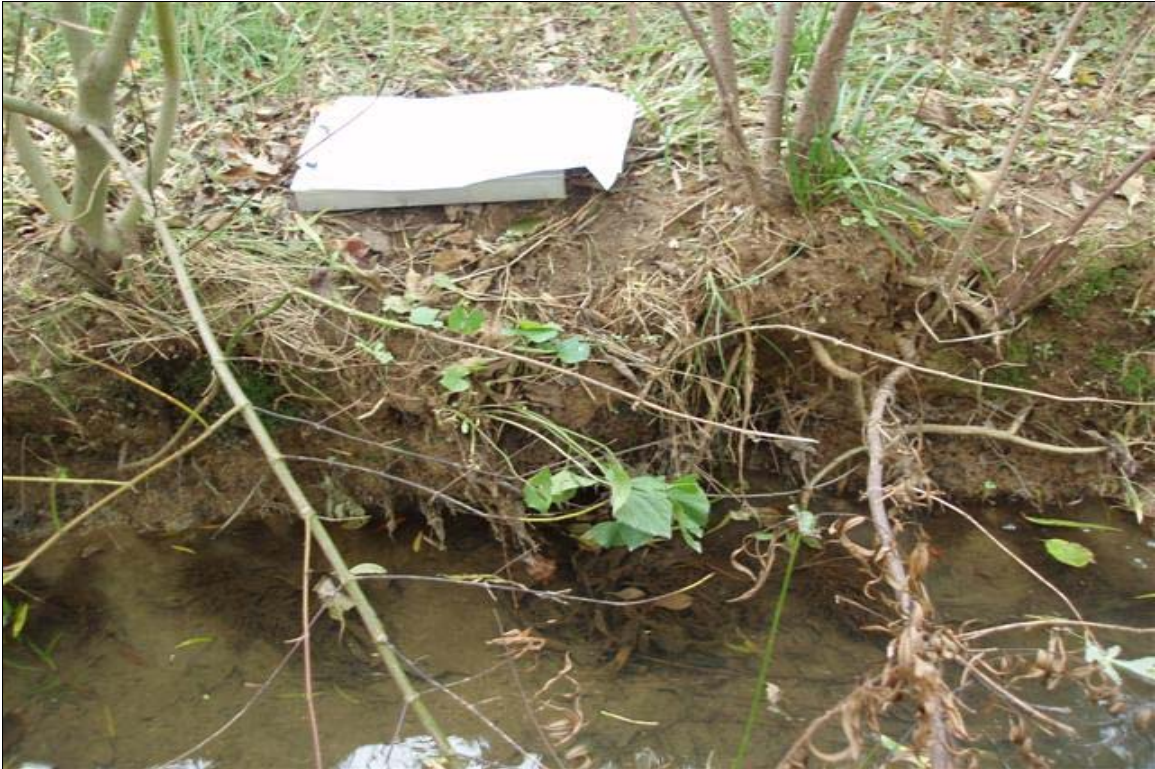
SP3 – Bank erosion. Photo taken near Station 31+50. 10/29/08 - MY 04

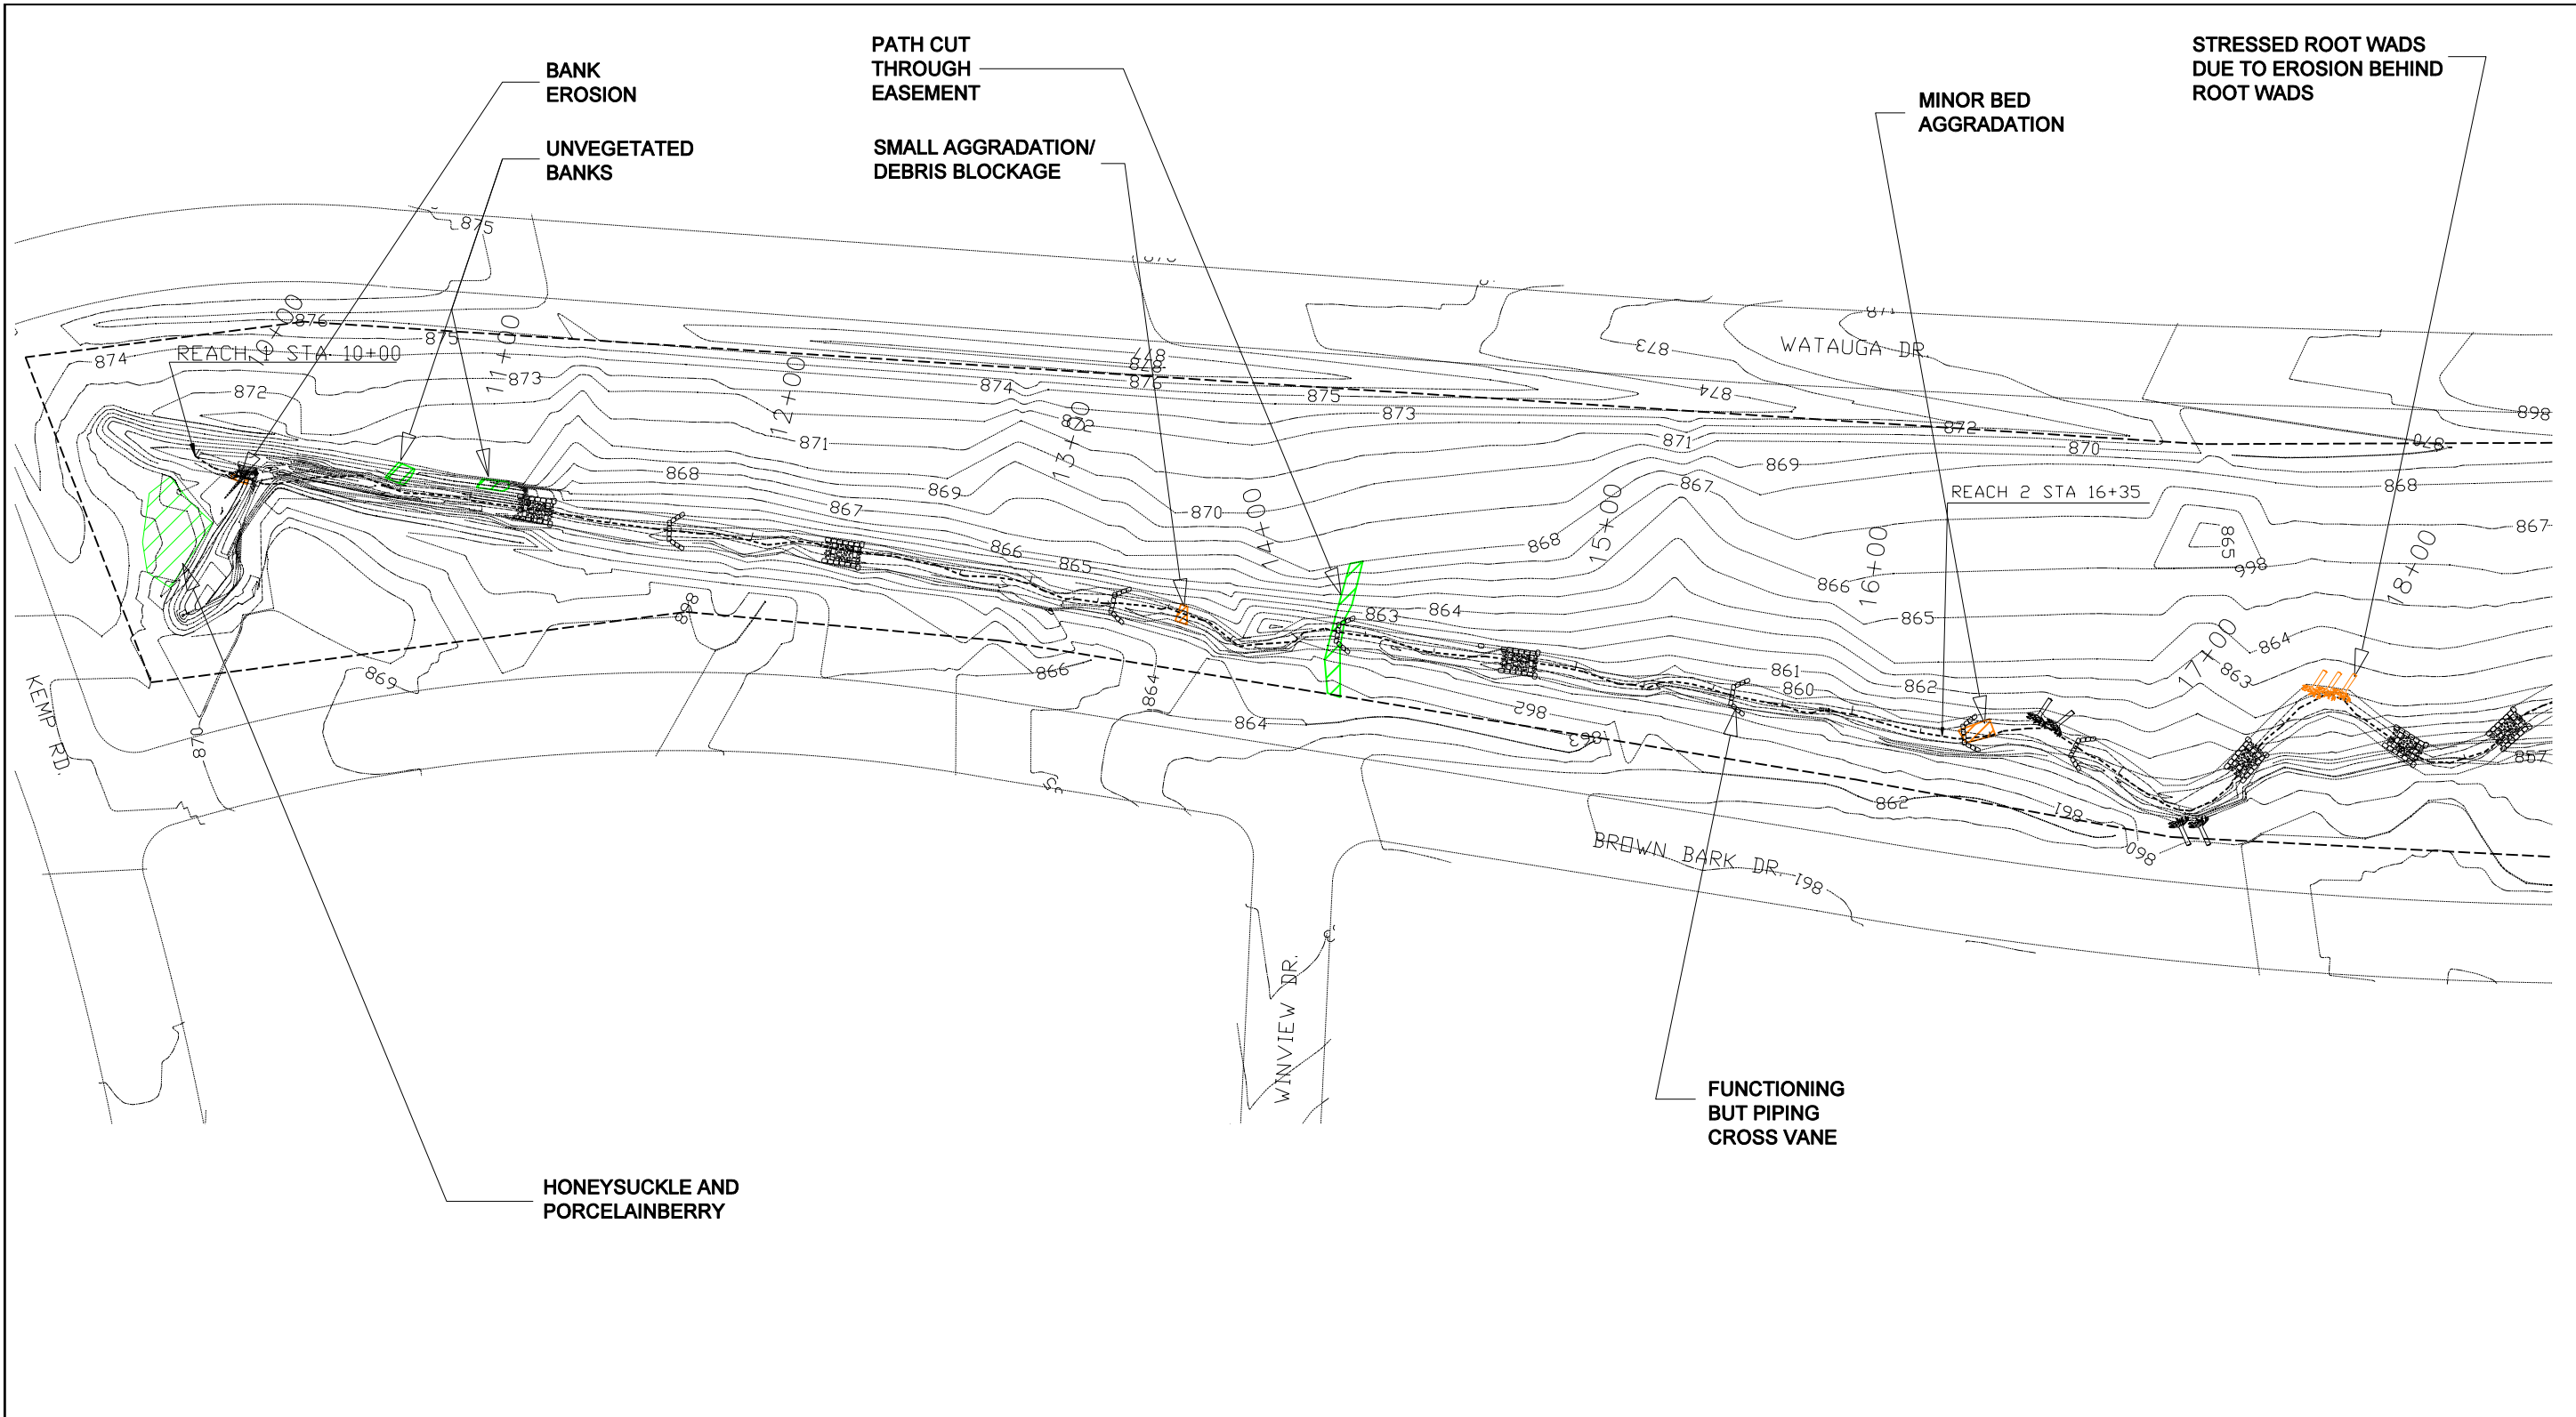
DATE: NOVEMBER 2008  
SCALE: SEE SHEET  
**CURRENT CONDITIONS PLAN VIEW**  
SHEET 1 OF 3

HONEYSUCKLE AND PORCELAINBERRY

PATH CUT THROUGH EASEMENT  
SMALL AGGRADATION/DEBRIS BLOCKAGE

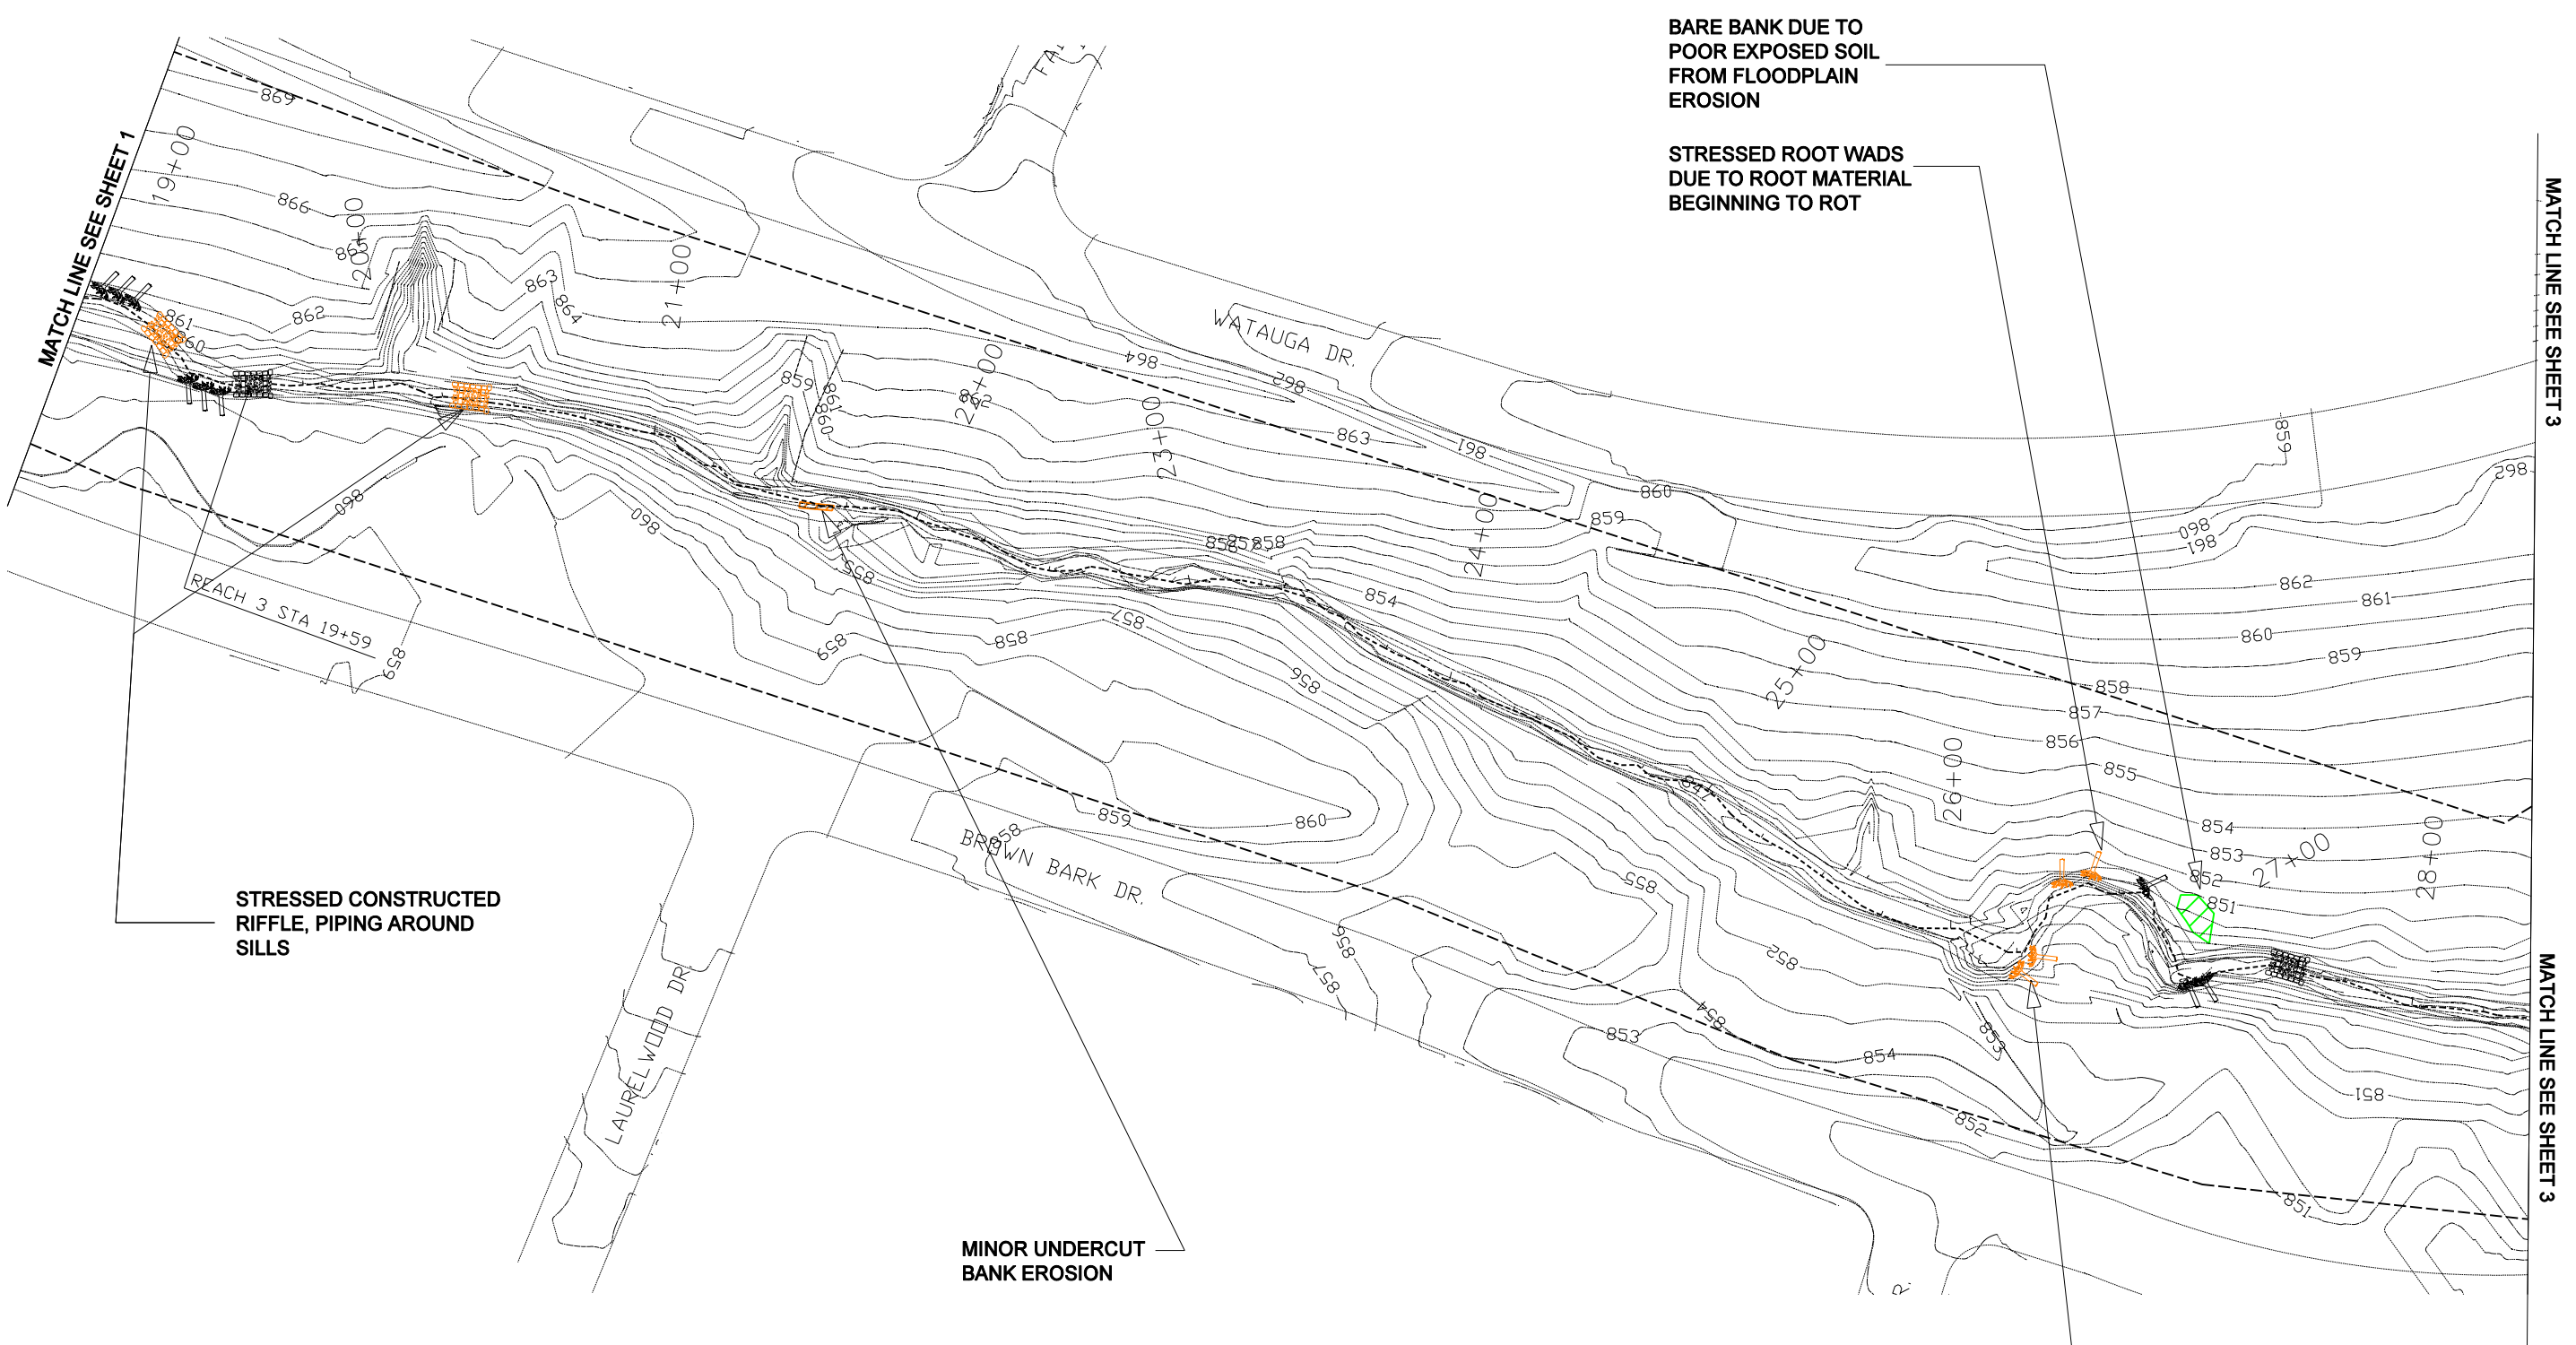
**BROWN BARK PARK**  
GUILFORD COUNTY, NORTH CAROLINA  
EEP PROJECT NUMBER 52 - MY04  
STATION 18+85 TO STATION 28+40

STRESSED ROOT WADS DUE TO ROOT MATERIAL BEGINNING TO ROT

STRESSED ROOT WADS DUE TO MINOR EROSION BEHIND ROOT WADS, THE ROOT MATERIAL BEGINNING TO ROT, AND DISPLACEMENT OF SOME OF THE ROCK BANK PROTECTION

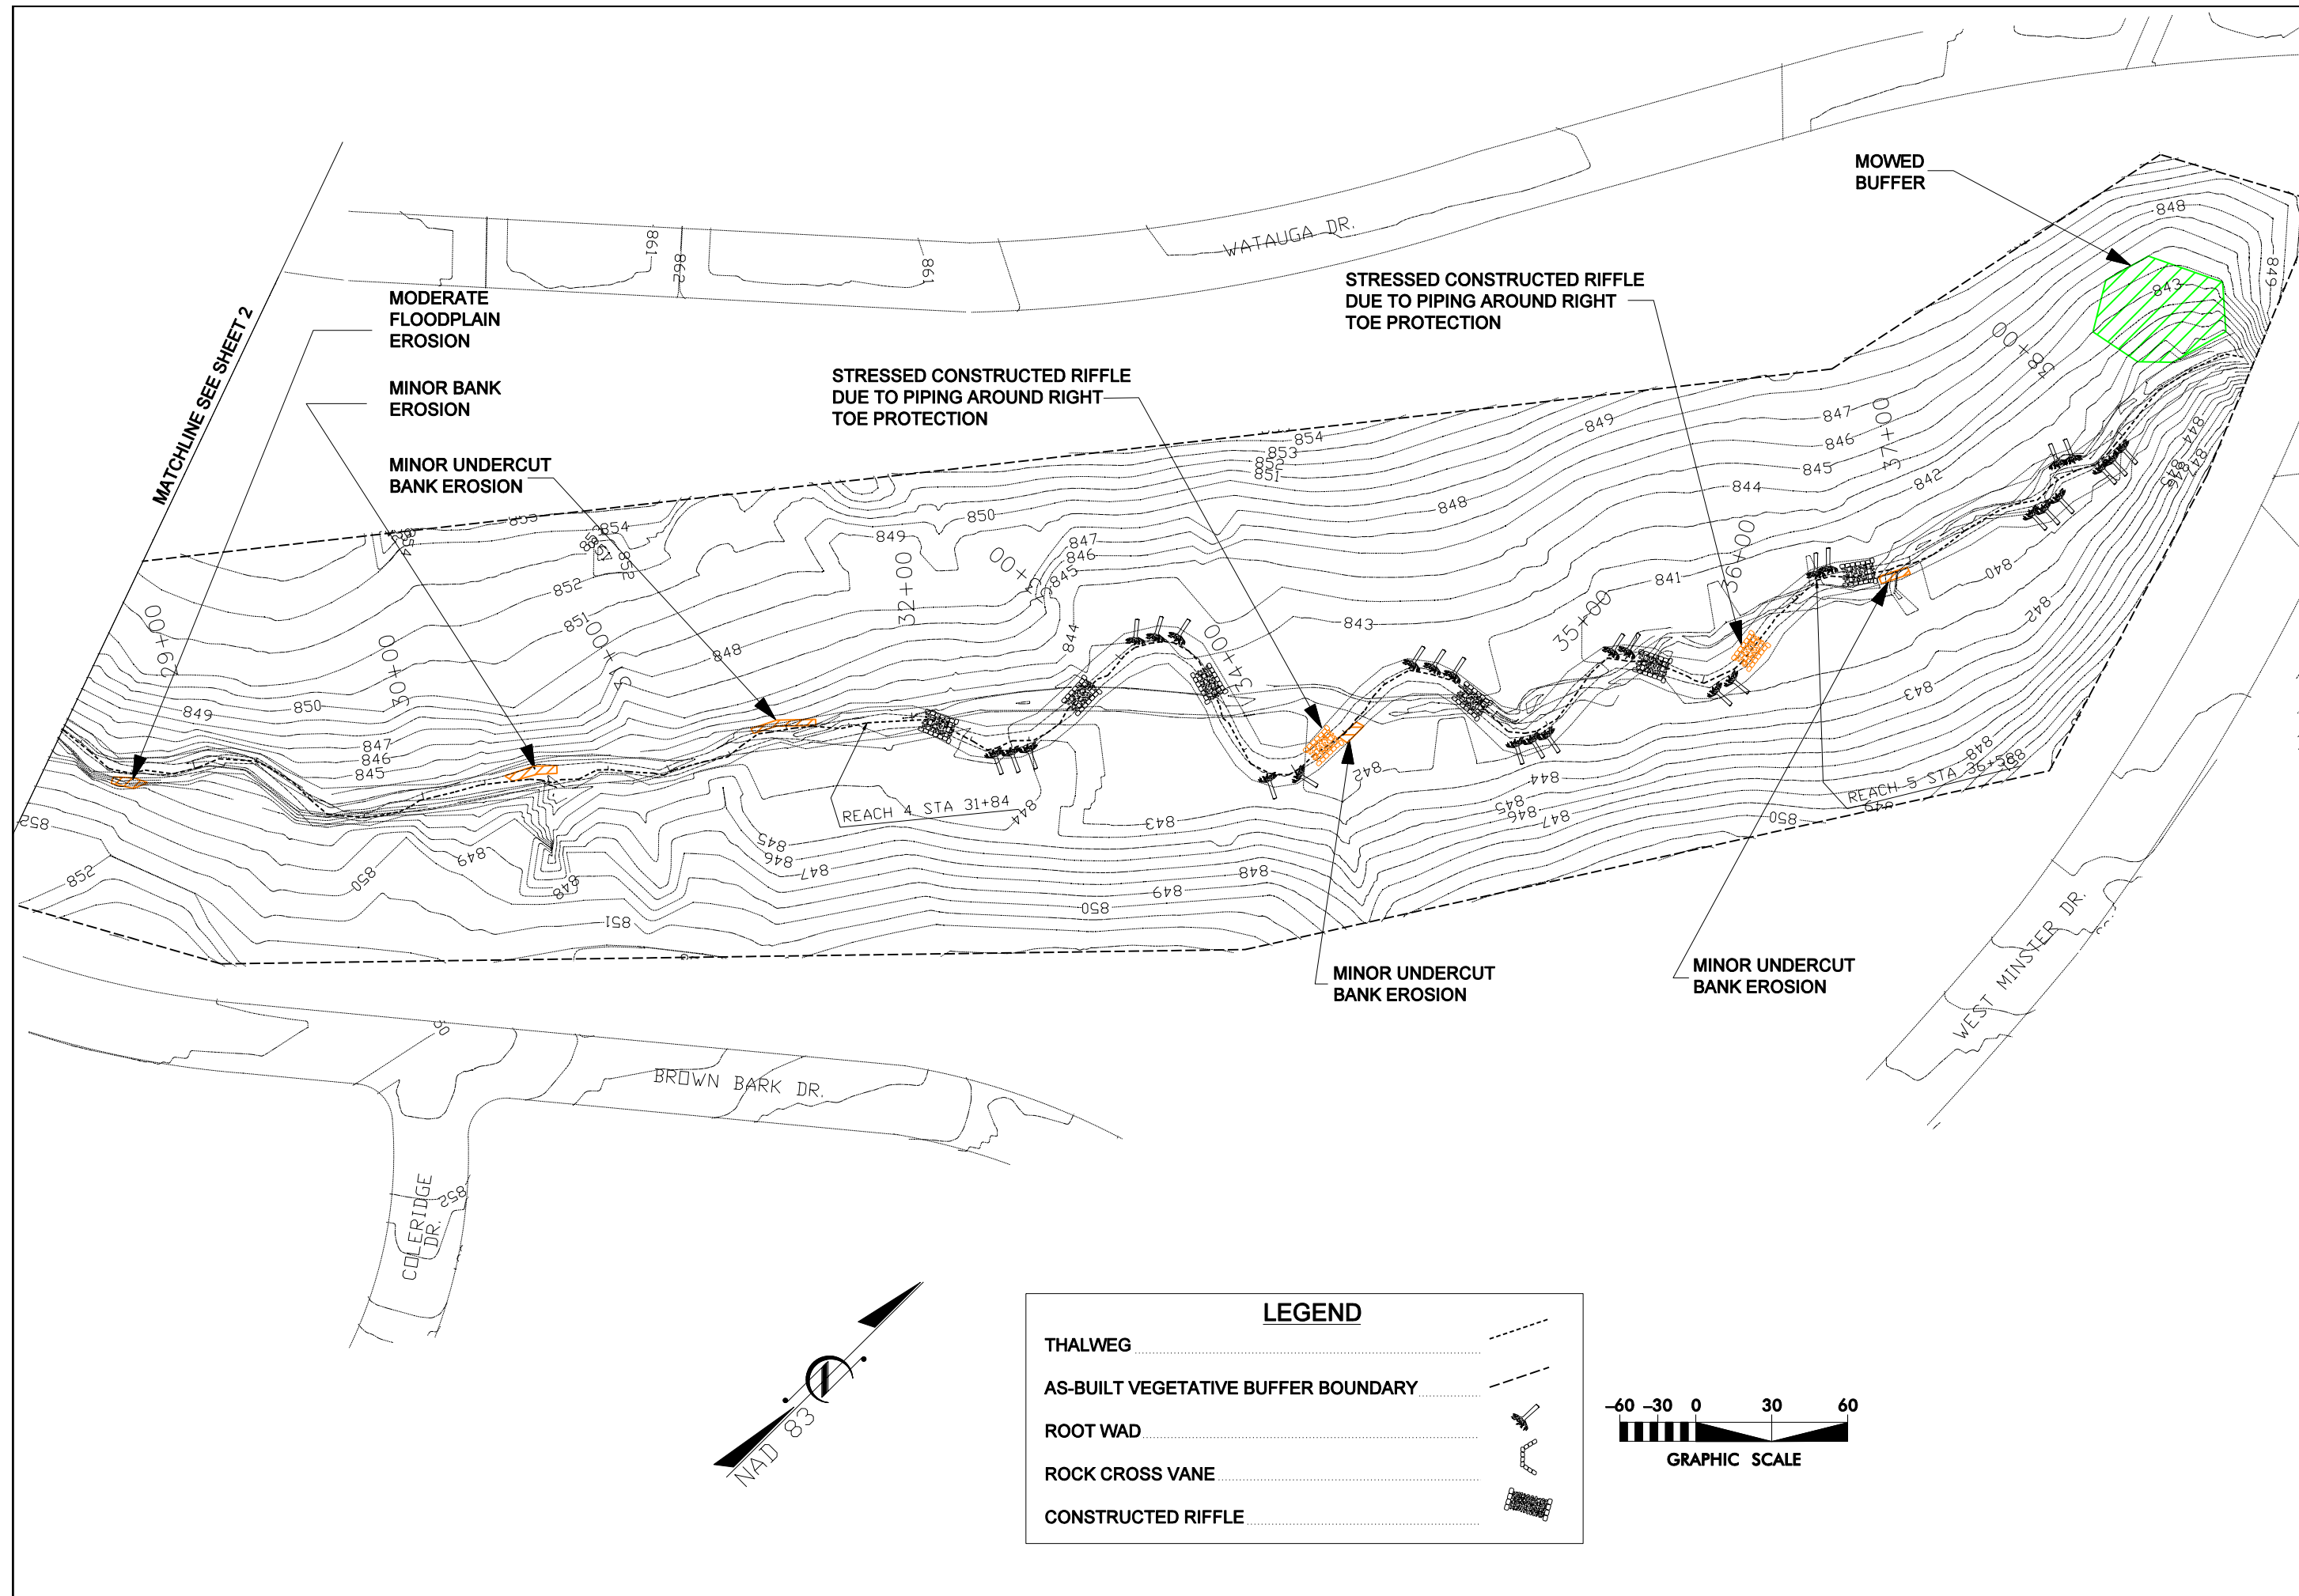
MODERATE FLOODPLAIN EROSION  
MINOR BANK EROSION  
MINOR UNDERCUT BANK EROSION
