BROWN BRANCH STREAM RESTORATION

FIRST YEAR MONITORING REPORT

May 2004

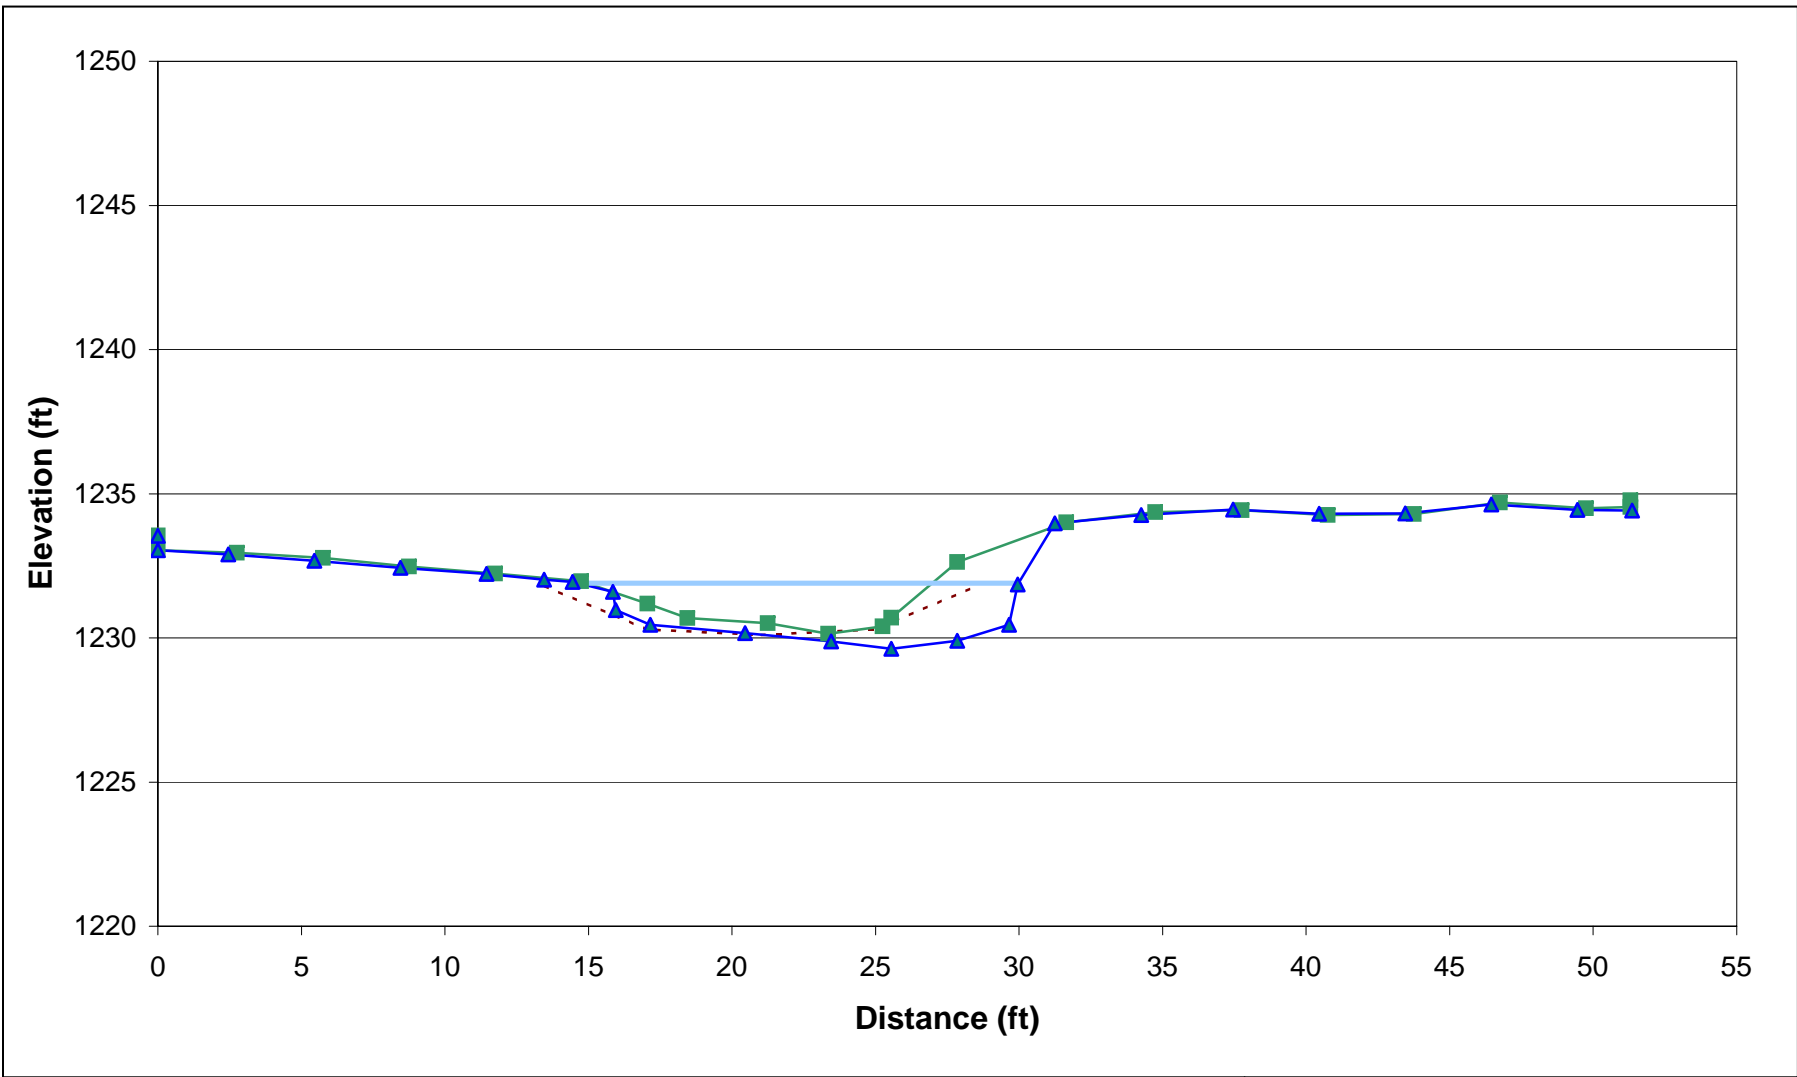
Cross Section #1, Riffle
As-Built Thalweg STA 46+50
First Year Monitoring Conditions
Survey Dates: 1/15/2003, 10/23/2003

In contrast, cross section #1 shows approximately 4 feet of erosion along the right bank and approximately half a foot of bed degradation in the riffle. This site represents one of a handful of erosional hotspots that will require treatment to stabilize the channel locally, and even more importantly, to preserve the integrity of the remainder of the project length. Installation of an upstream rock vane is recommended as treatment at this site, along with regrading, reseeding, and replanting the bank. The same treatment is recommended at cross section #5, also a riffle, which has experienced the same type and magnitude of response.

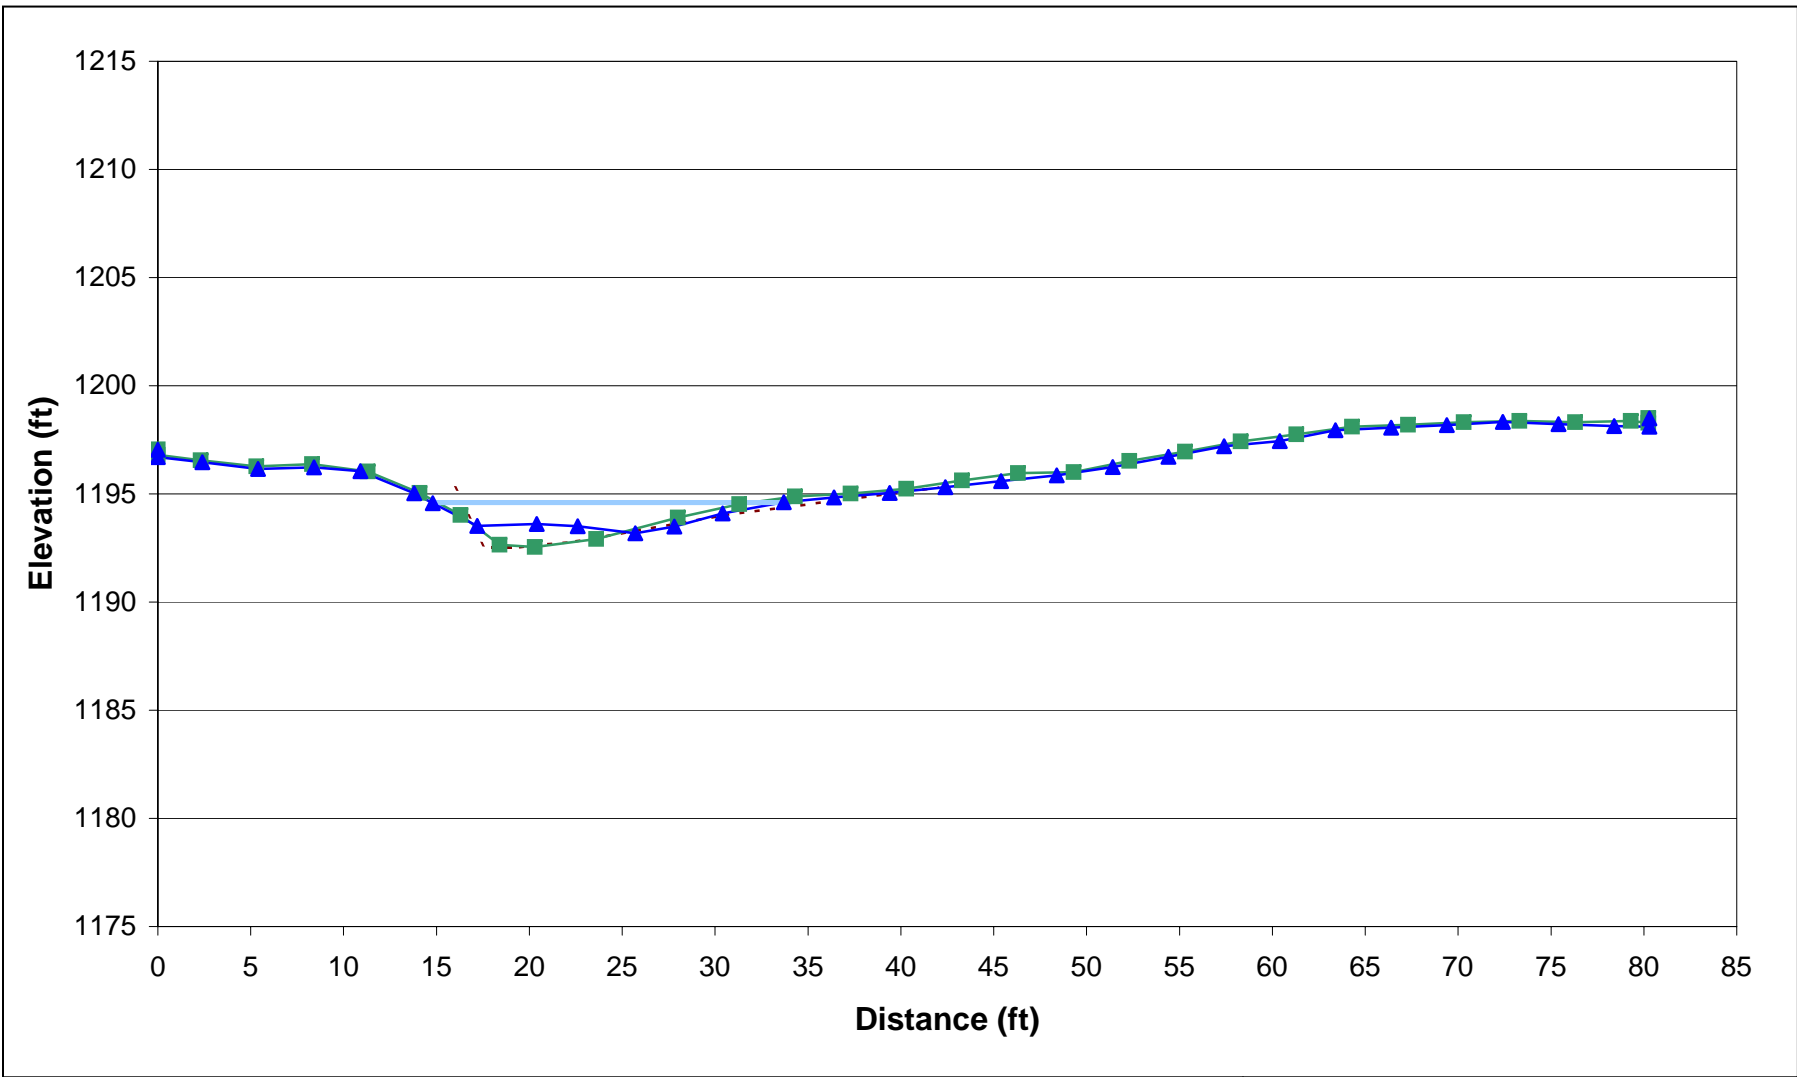
Cross Section #6, Meander
As-Built Thalweg STA 6+45
First Year Monitoring Conditions
Survey Dates: 1/15/2003, 10/23/2003

Cross section #6, situated in a meander bend, has experienced approximately 1 foot of aggradation via the deposition of a small bar in the middle of the bend. While the partial filling of the pool is not ideal, it does not pose a problem to channel stability at this location. Therefore, no treatment is recommended, aside from continued monitoring of the location in future years.

Only at one location along the channel length is a change to the profile recommended. The riffle from as-built station 6+50 – 5+25 has downcut approximately 1.5 feet. This has created a steep, bare toe of slope on the adjacent banks. This riffle should be filled with cobble-sized riffle material to a depth of at least 1 foot to prevent additional bank stability problems.

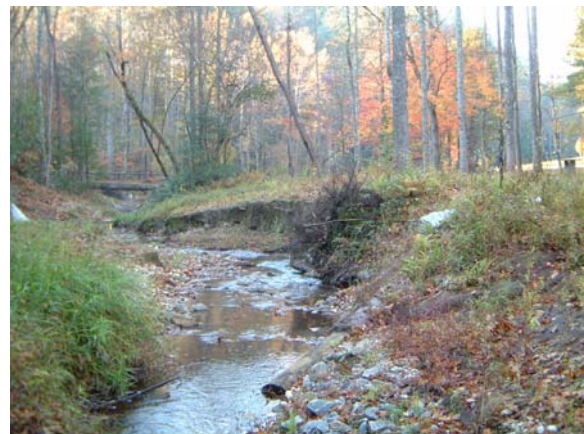
Photograph NM-6. Looking downstream at log vane from as-built Station ~47+25. Severe erosion along right bank.

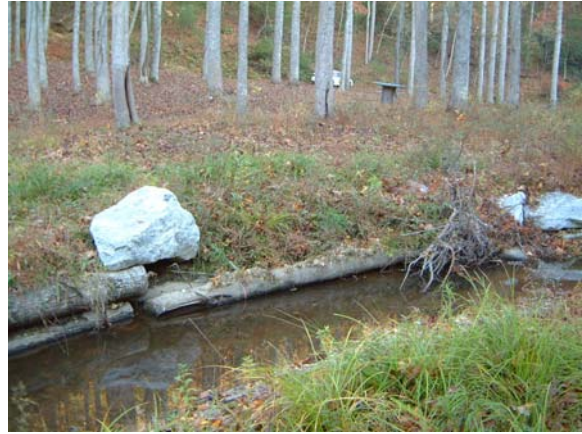
Looking upstream at log wall damage from as-built Station ~49+00.

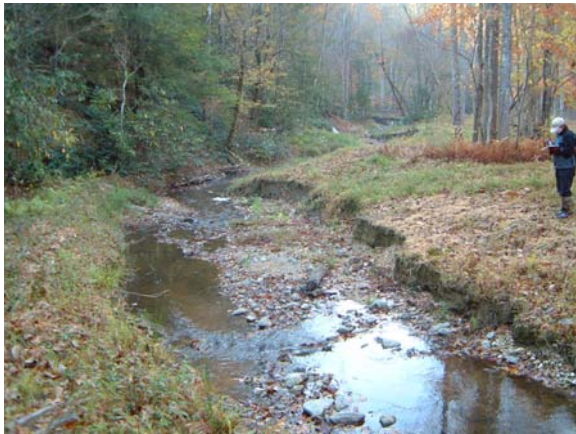
Looking downstream at bank erosion from as-built Station ~49+25.

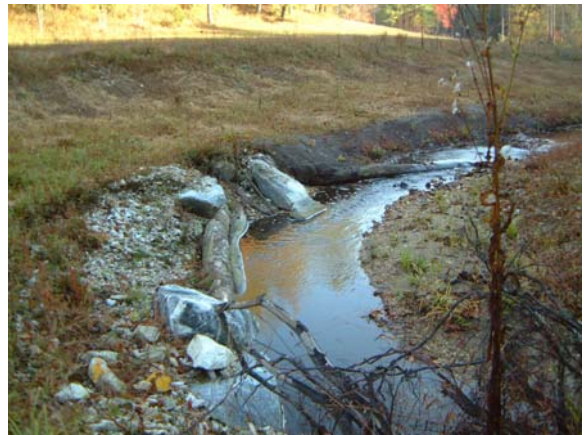
Looking upstream at bank erosion at as-built Station ~36+00.

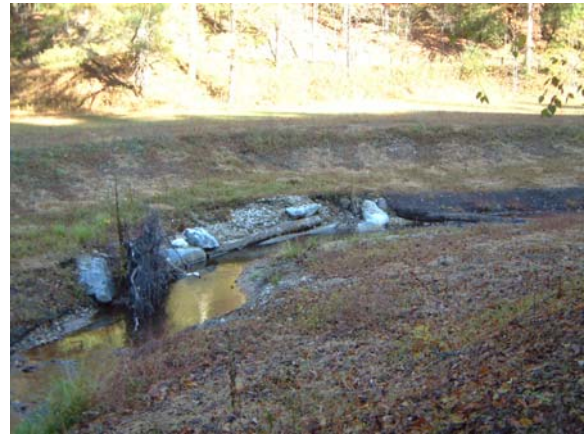
Looking upstream at bank erosion at as-built Station ~36+00.

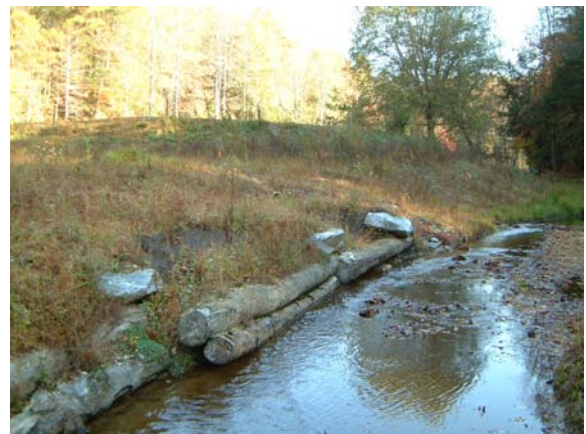
Looking upstream at slumping log wall at as-built Station ~30+50.

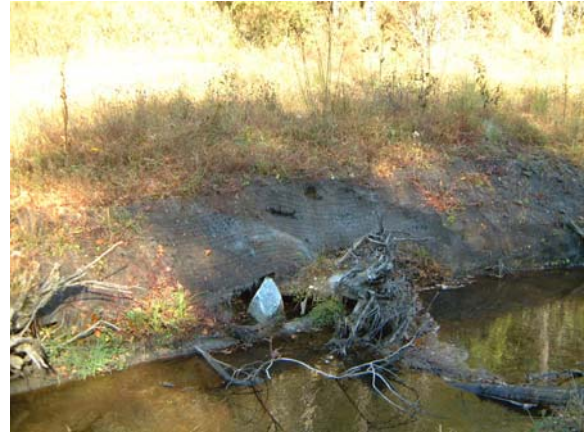
Looking upstream at erosion behind rootwads from as-built Station ~29+90.

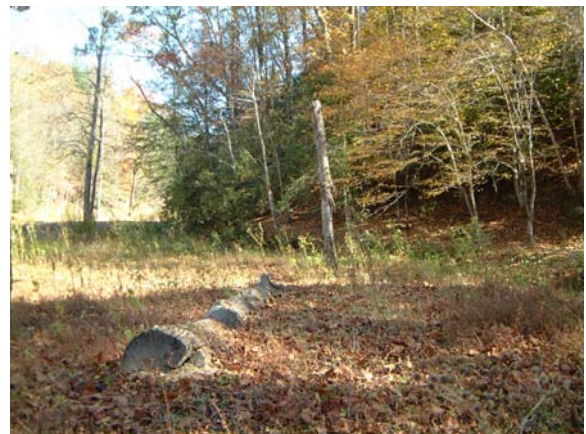
Looking upstream at log and snag at as-built Station ~22+00.

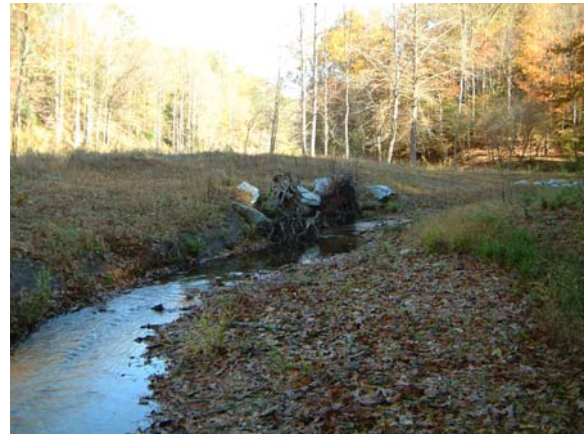
Looking upstream at lateral channel movement and erosion at as-built Station ~19+00.

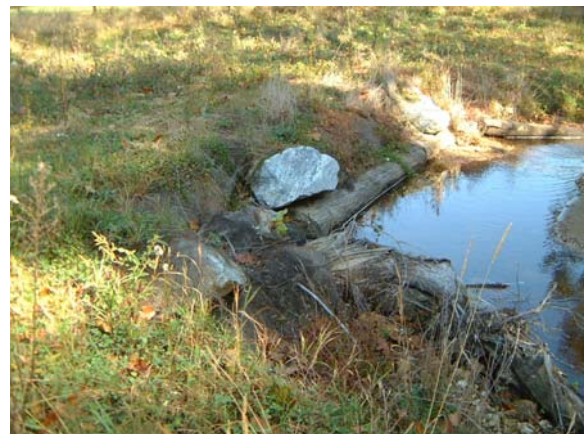
Looking upstream at erosion behind rootwad at as-built Station ~14+00.

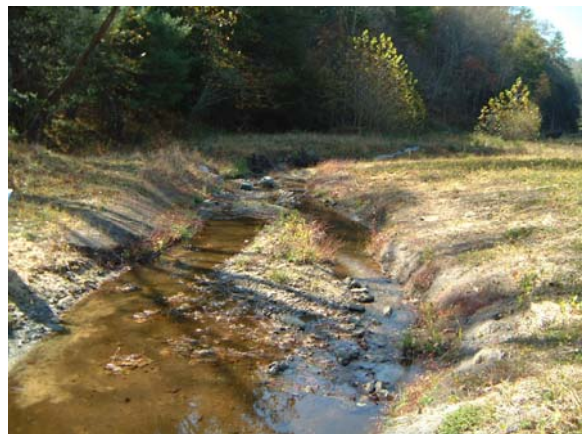
Looking downstream at channel widening at as-built Station ~10+50.
