Brown Branch Stream Restoration (Anita Alta 4-H Camp) 2004 Annual Monitoring Report

February, 2005

2004 Brown Branch Monitoring Abstract

This is the 2nd year of the 5-year monitoring plan for Brown Branch.

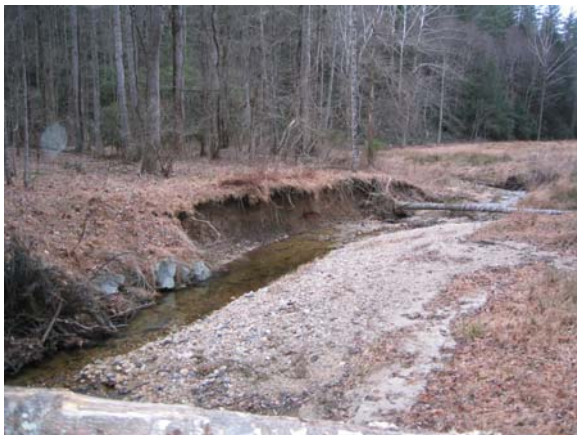
- At station 6+80 to 7+20 there is a 40 ft long area of severe bank erosion on the left bank the bank has an extreme BEHI and is actively eroding. The actively eroding bank height is 6.5 ft with a vertical non-protected bank.

**Issue Photo 1. Bank Erosion Left Bank
STA: 6+75**

- It is recommended to stake in areas where erosion is problematic, particularly on outside meander bends.

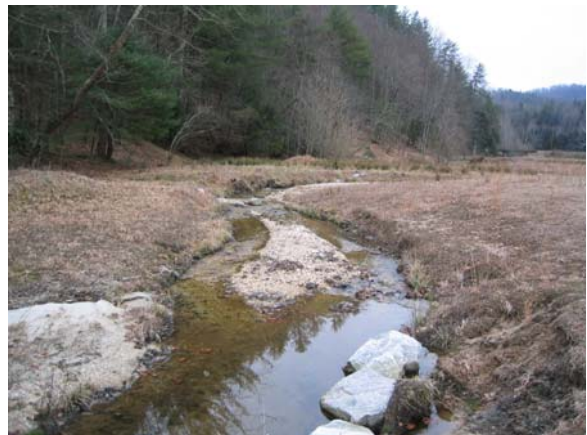
- At station 40+20 to 40+50 there is a 30 ft long mid channel bar.
 - At station 43+10 to 43+60 there is a 50 ft long mid channel bar that. This mid-channel bar is captured by the surveyed cross-section #5 and is photo documented.

**Issue Photo 2. Mid-Channel Bar
STA: 40+20**

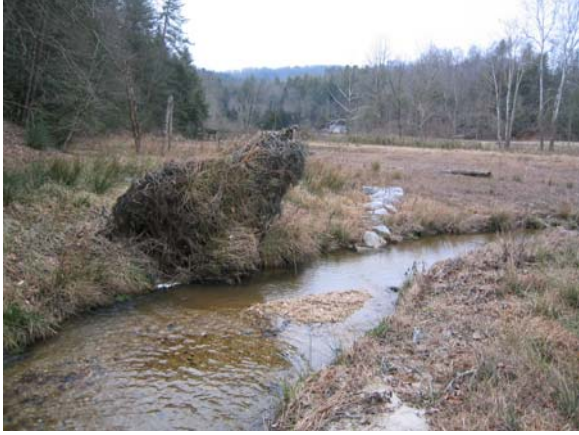
- From station 10+00 to 51+00 the average slope for this reach is 1.0% and pools are filling with sediment and loosing capacity
 - This reach has not significantly aggraded but the riffle are becoming shorter and generating steeper riffle slopes.

**Issue Photo 3 Pool Filling with Sediment
At STA: 44+50**

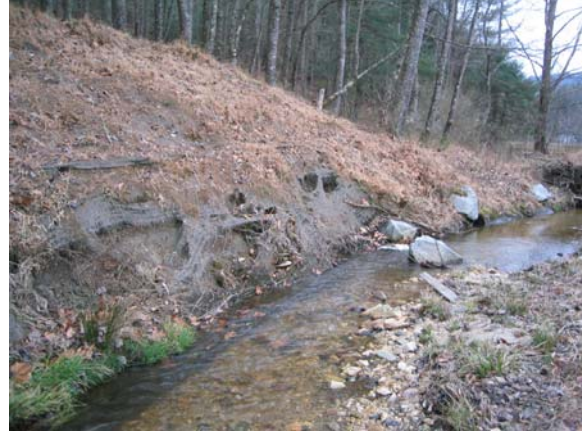
**Issue Photo 4 Bank Erosion at
STA: 38+50**

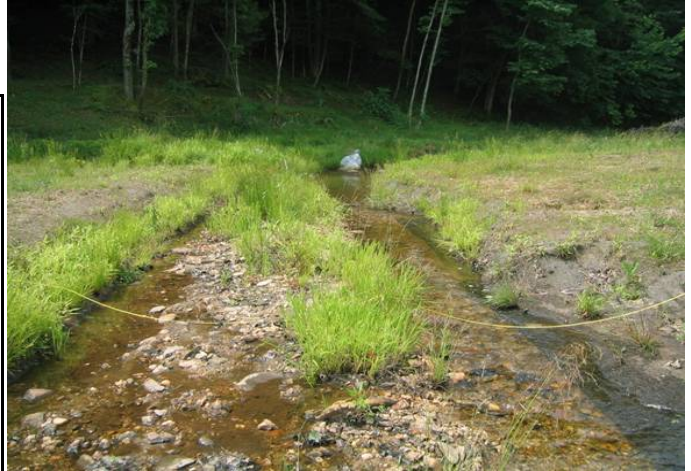
Photo of Cross-Section #5 - Looking Downstream @ STA 43+23

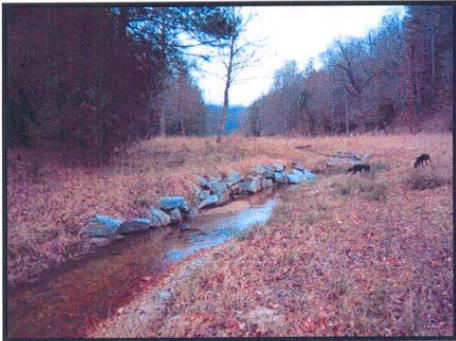
STA 18+50 Looking Downstream @Failing Boulder Bar

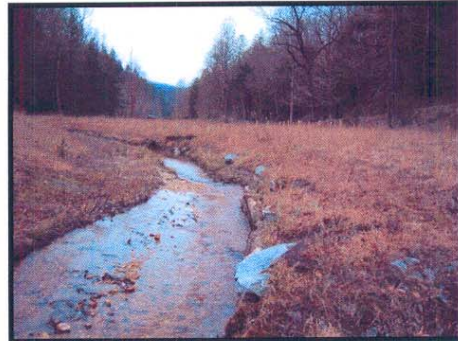
STA 20+50 Looking Downstream @ Wide Meander Bend with Exposed Toe Log

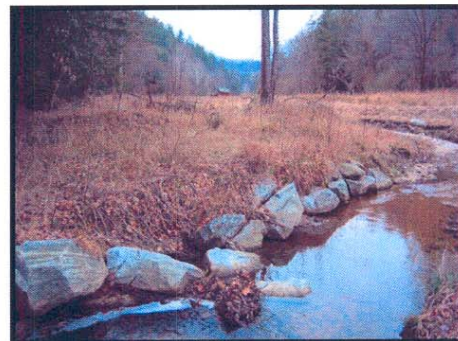
STA 25+90 Looking Downstream @Failing Boulder Wall

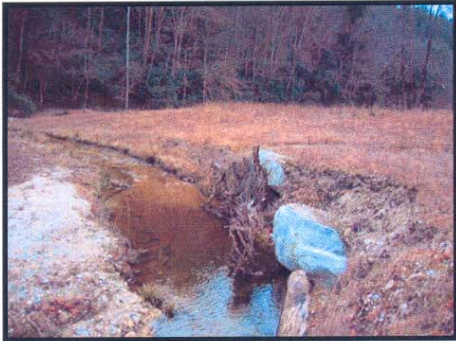
STA 28+50 Looking Downstream @ Bank Erosion Tight Radius of Curvature

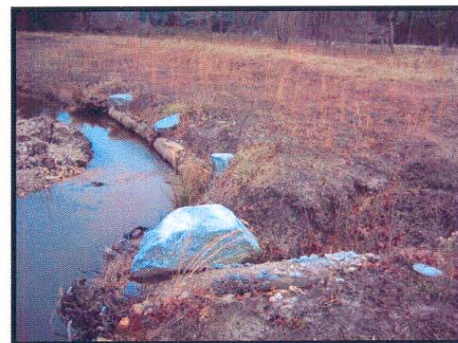
STA 46+20 Looking Downstream @Failing Root Wad
