**Brown Branch Stream Restoration
2005 Monitoring Report
Monitoring Year Three**

Ecosystem Enhancement Program Project Number 53

Prepared by: EcoLogic Associates, P.C.
4321-A S. Elm-Eugene St.
Greensboro, NC 27406

Submitted: October, 2006 (Rev 1)

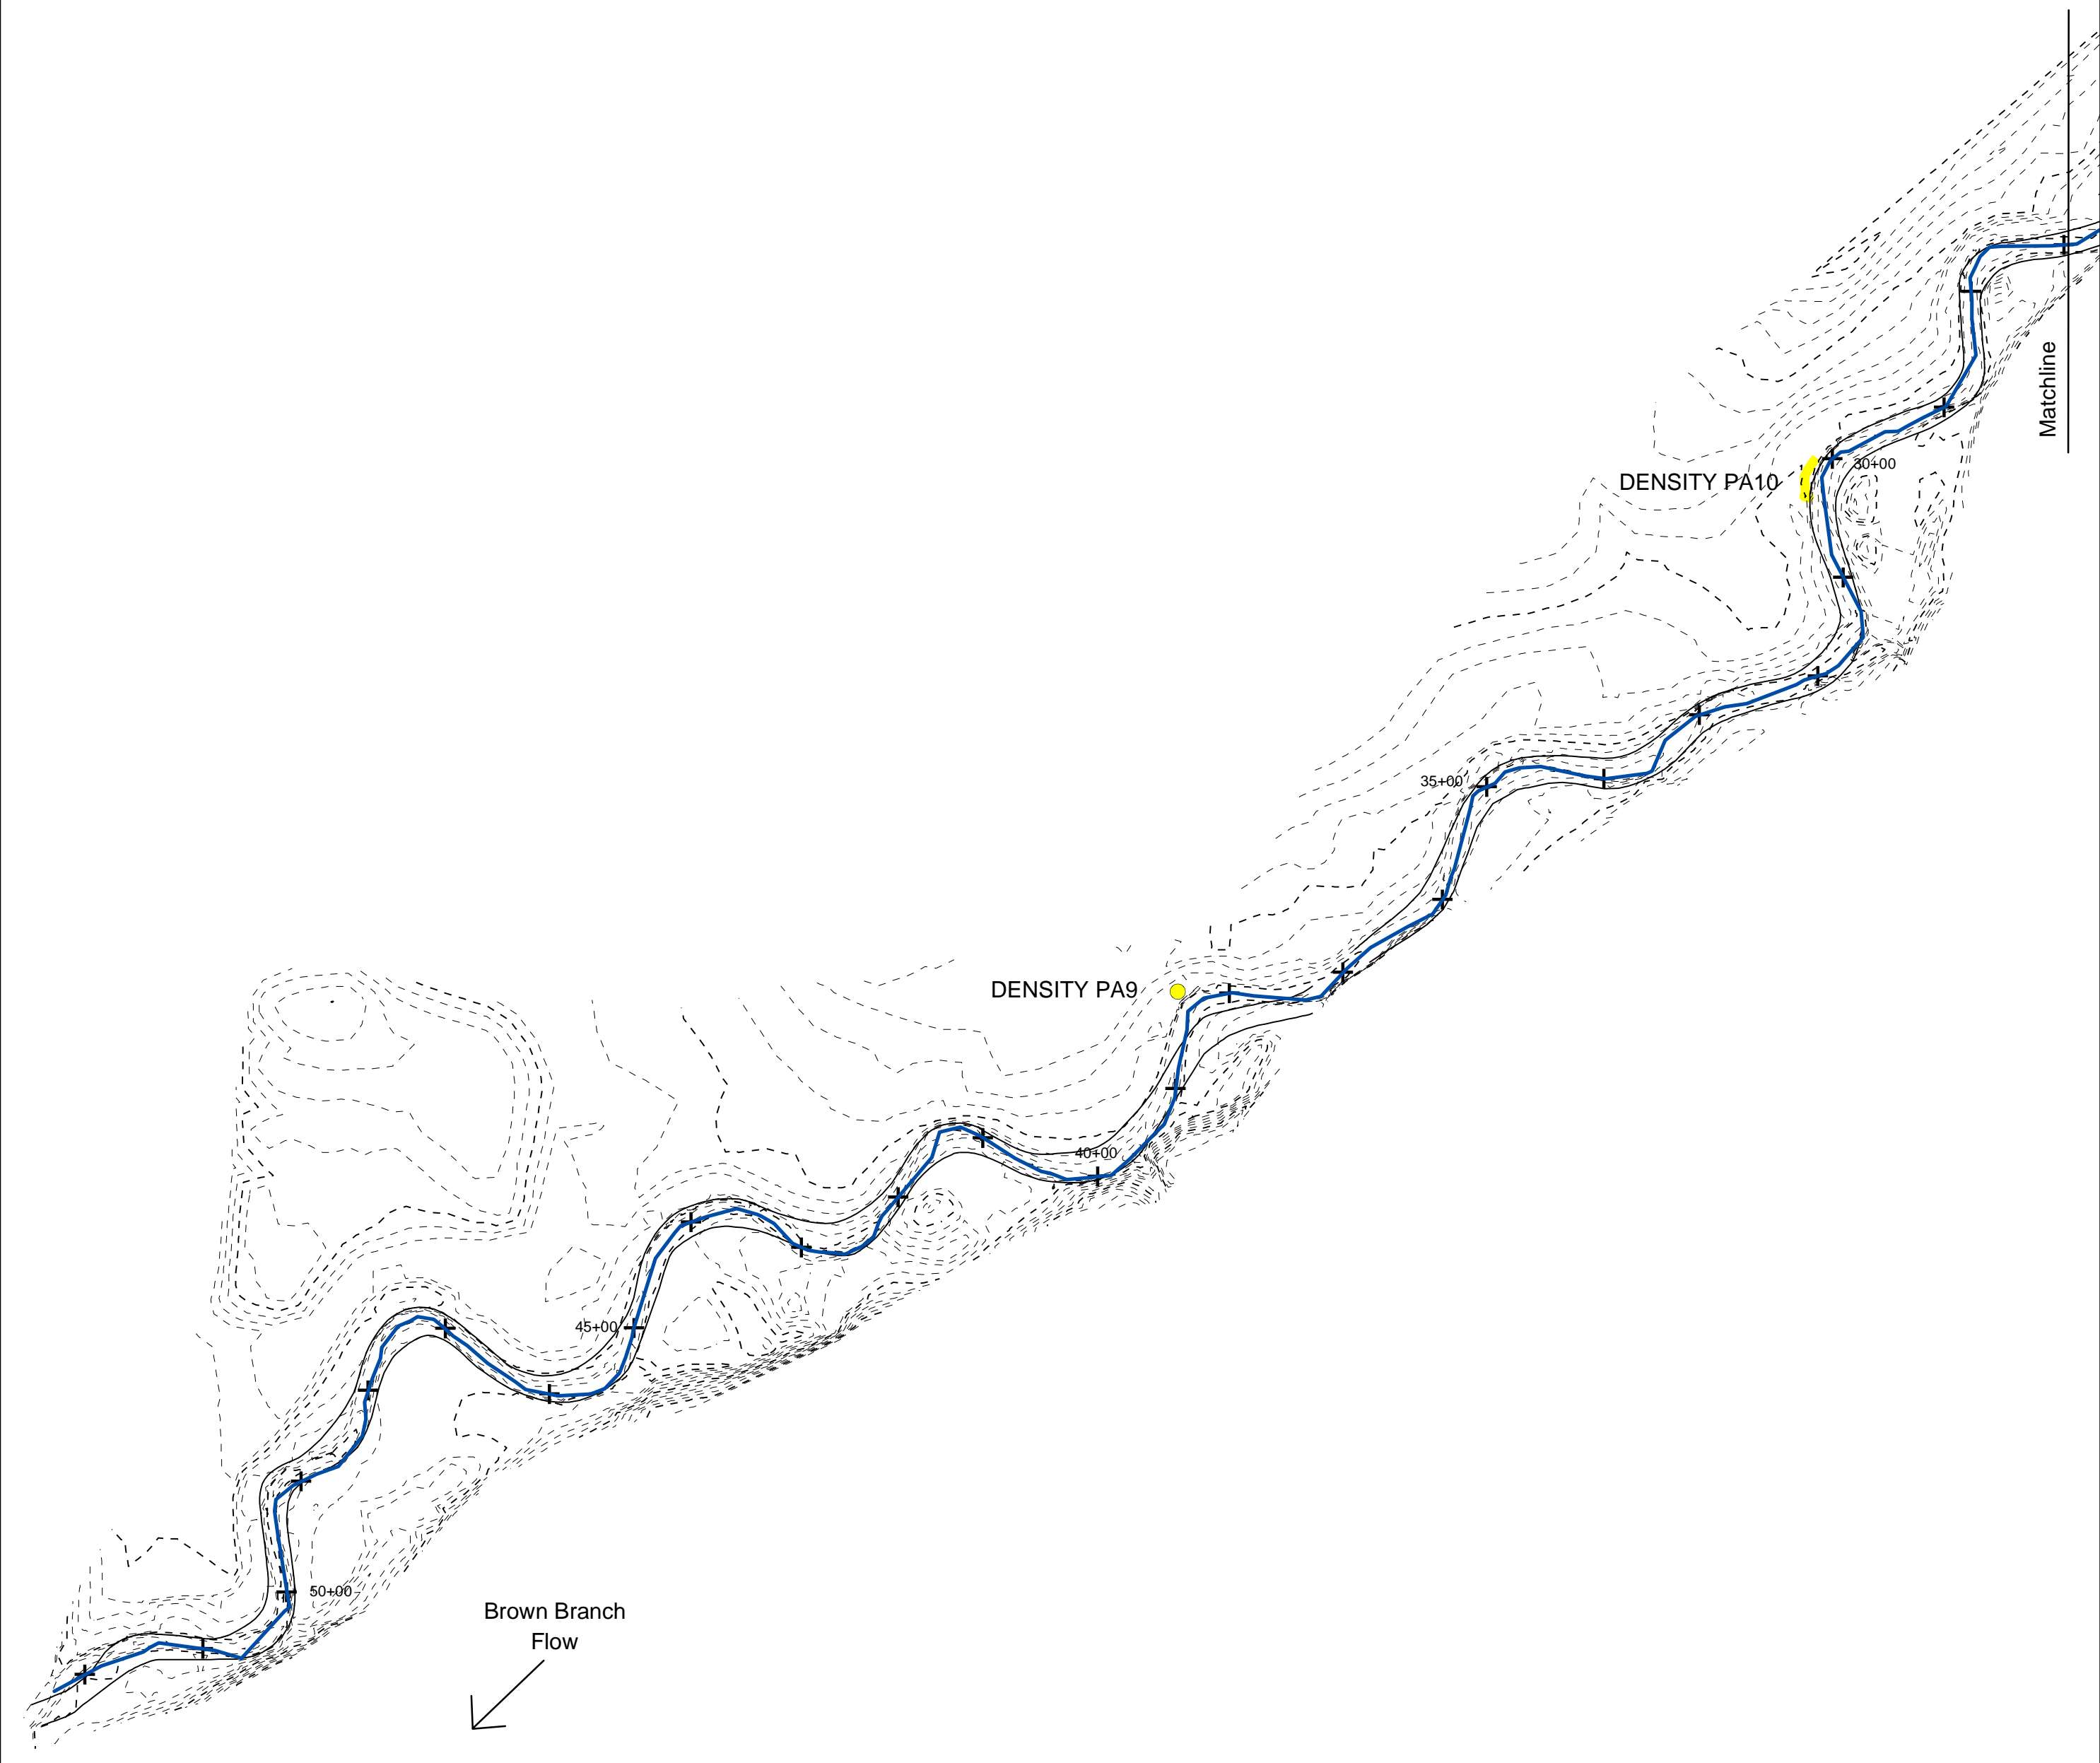
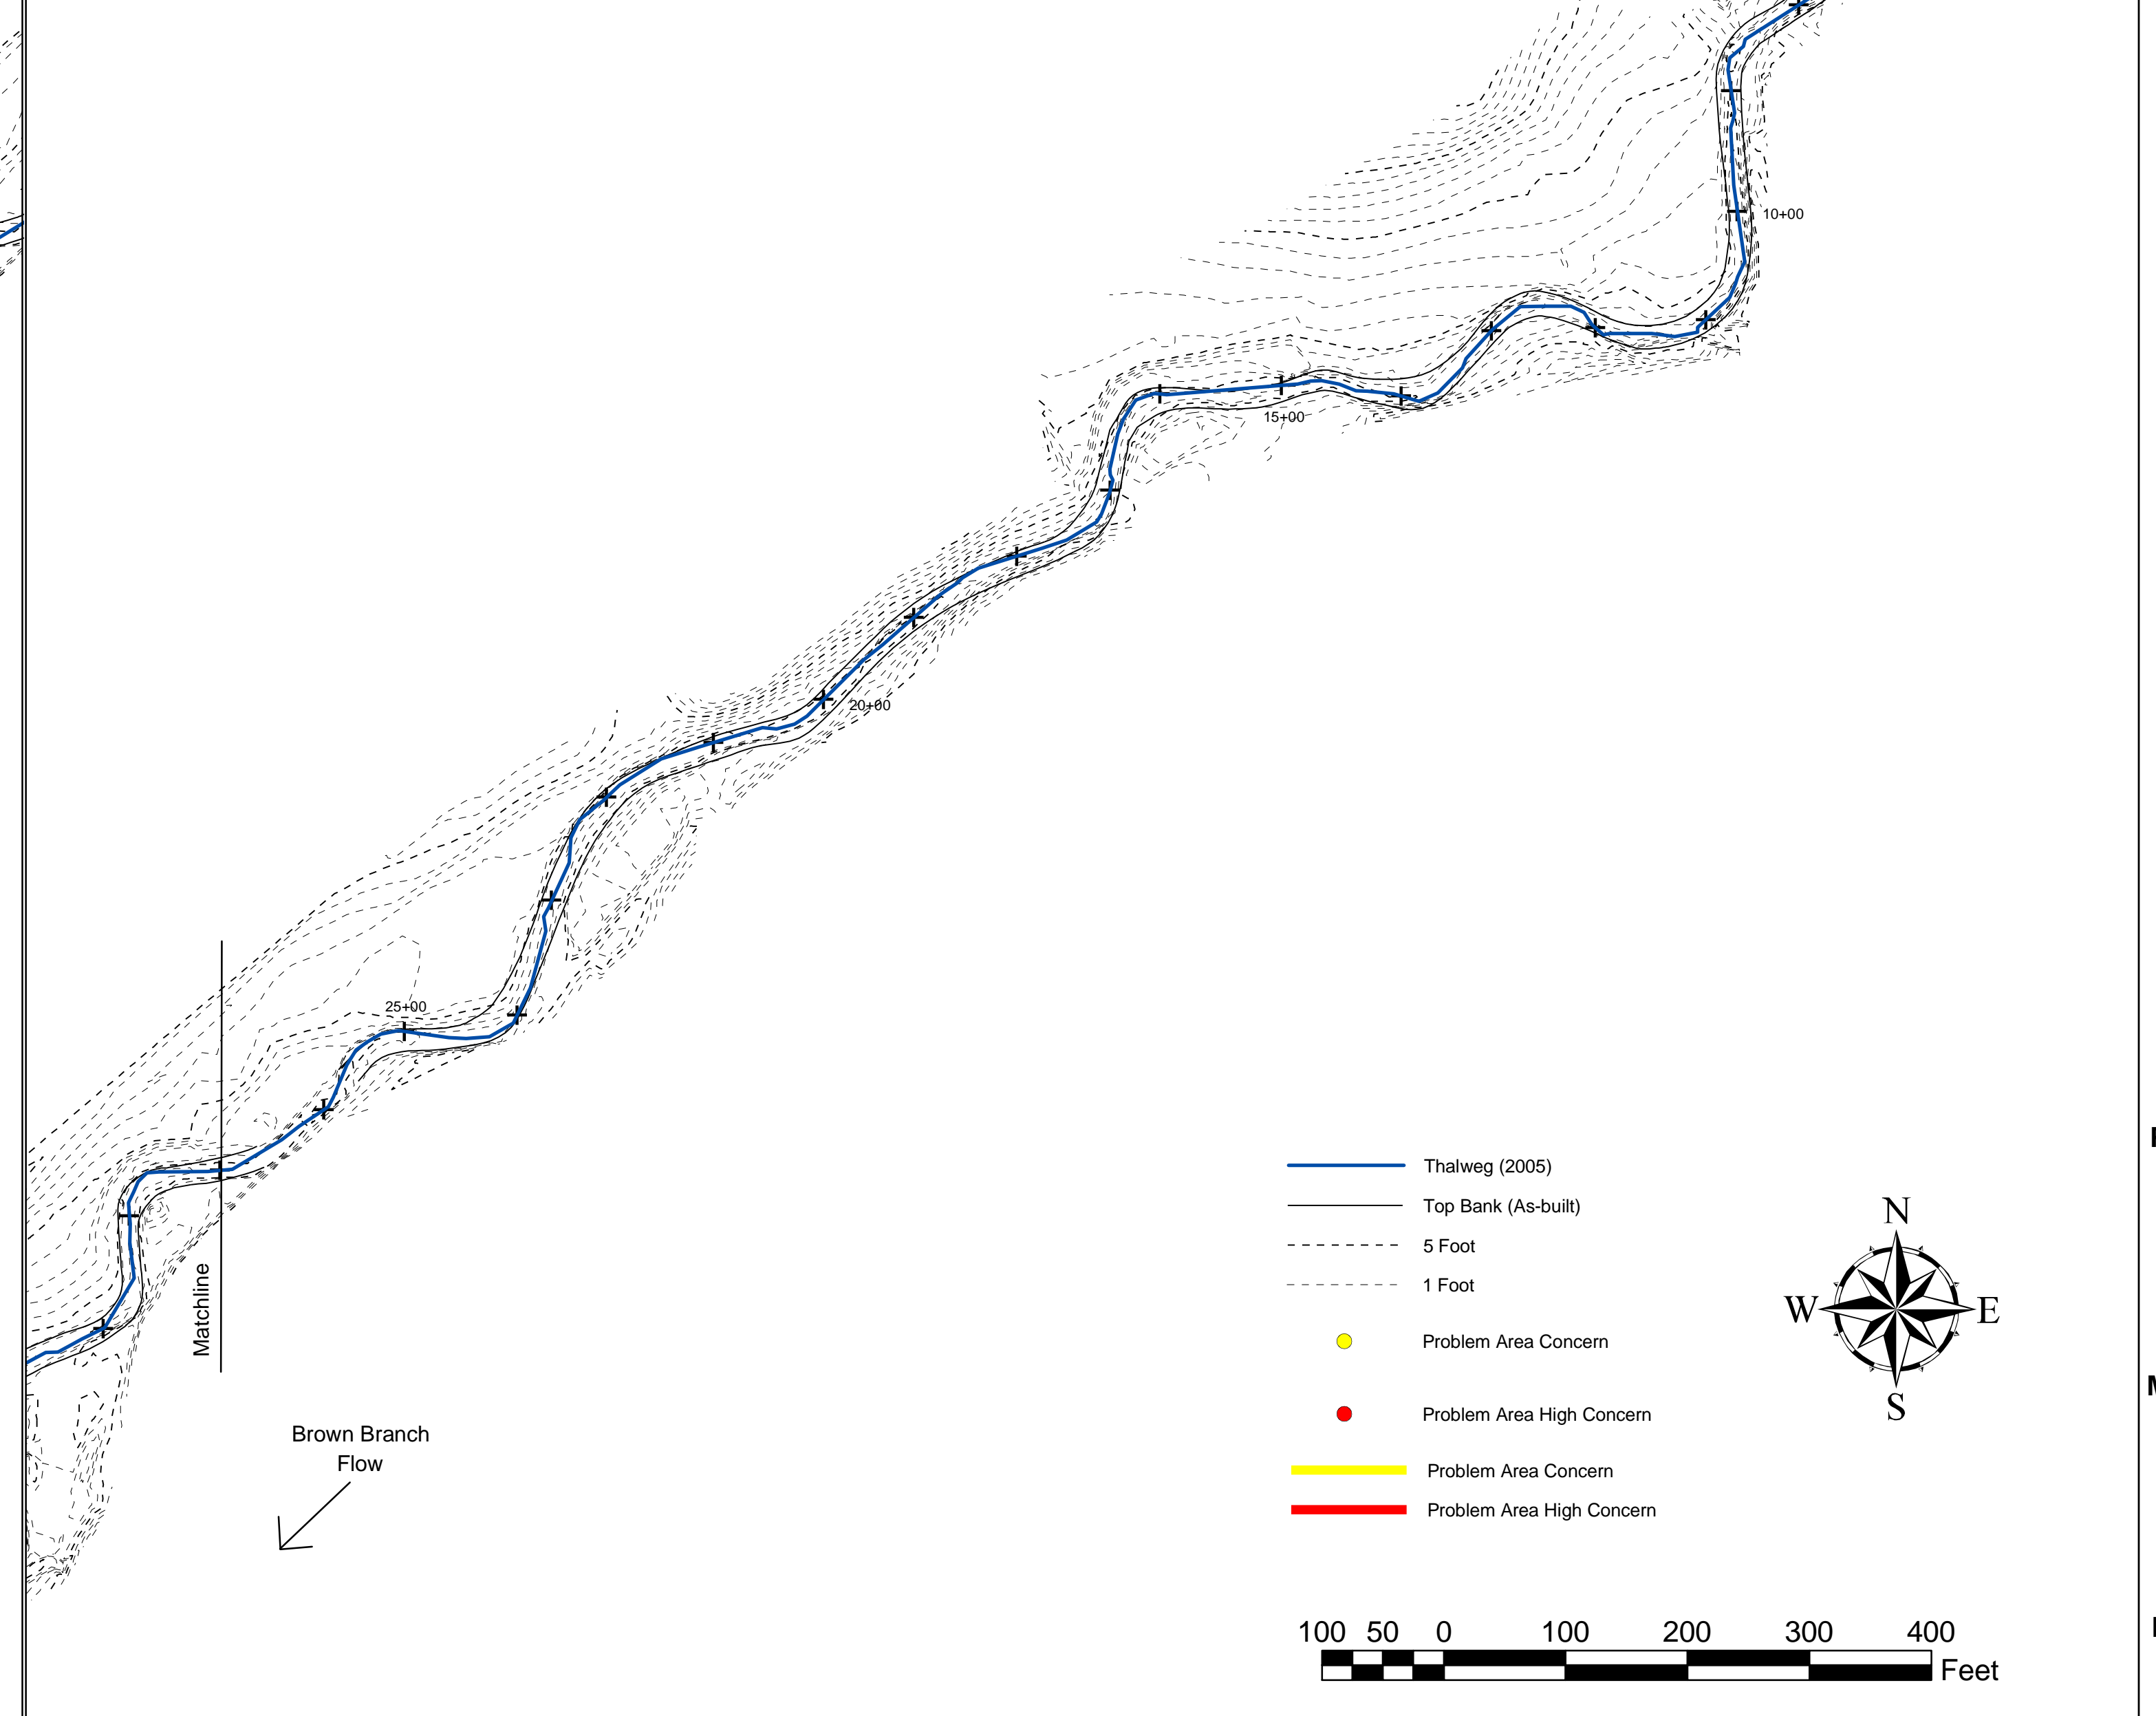
Appendix A. 1

Vegetation Problem Areas				
Project Number: 53				
Segment Reach: Brown Branch				
Feature Issue	Station	Suspected Cause	Photo	Severity
density	13+90	bank erosion	PA9	yellow
density	22+00	scour	PA10	yellow

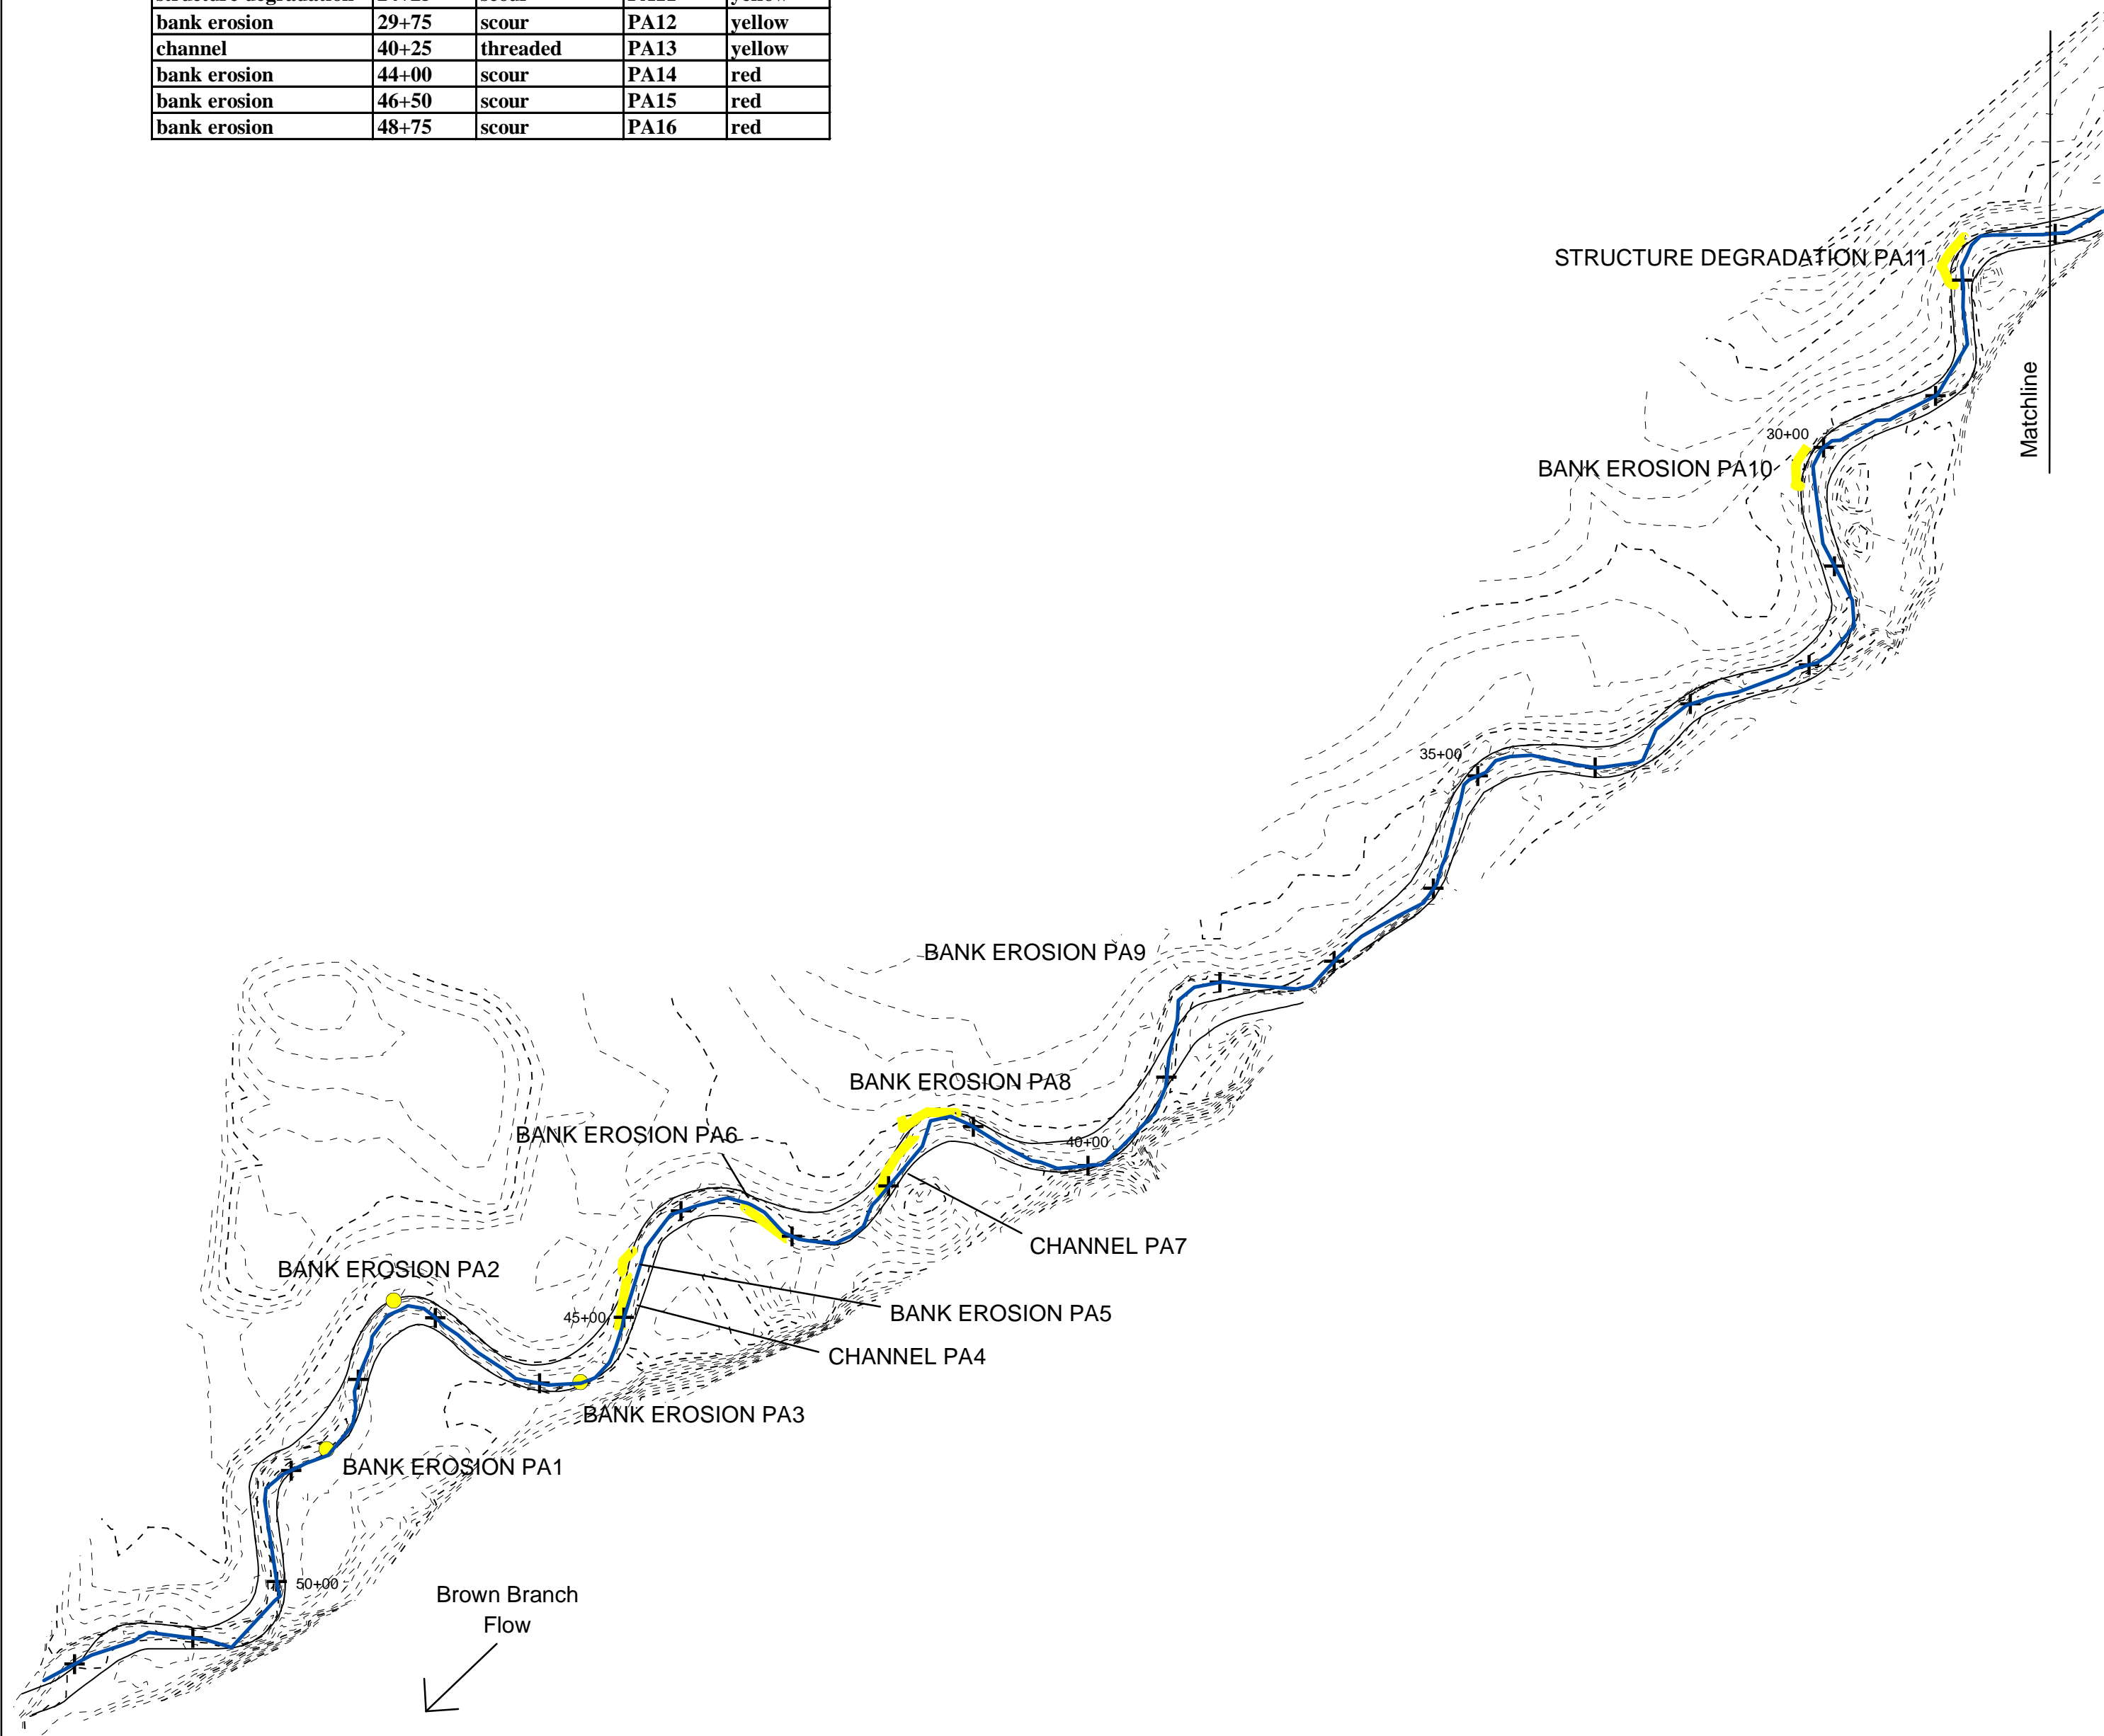
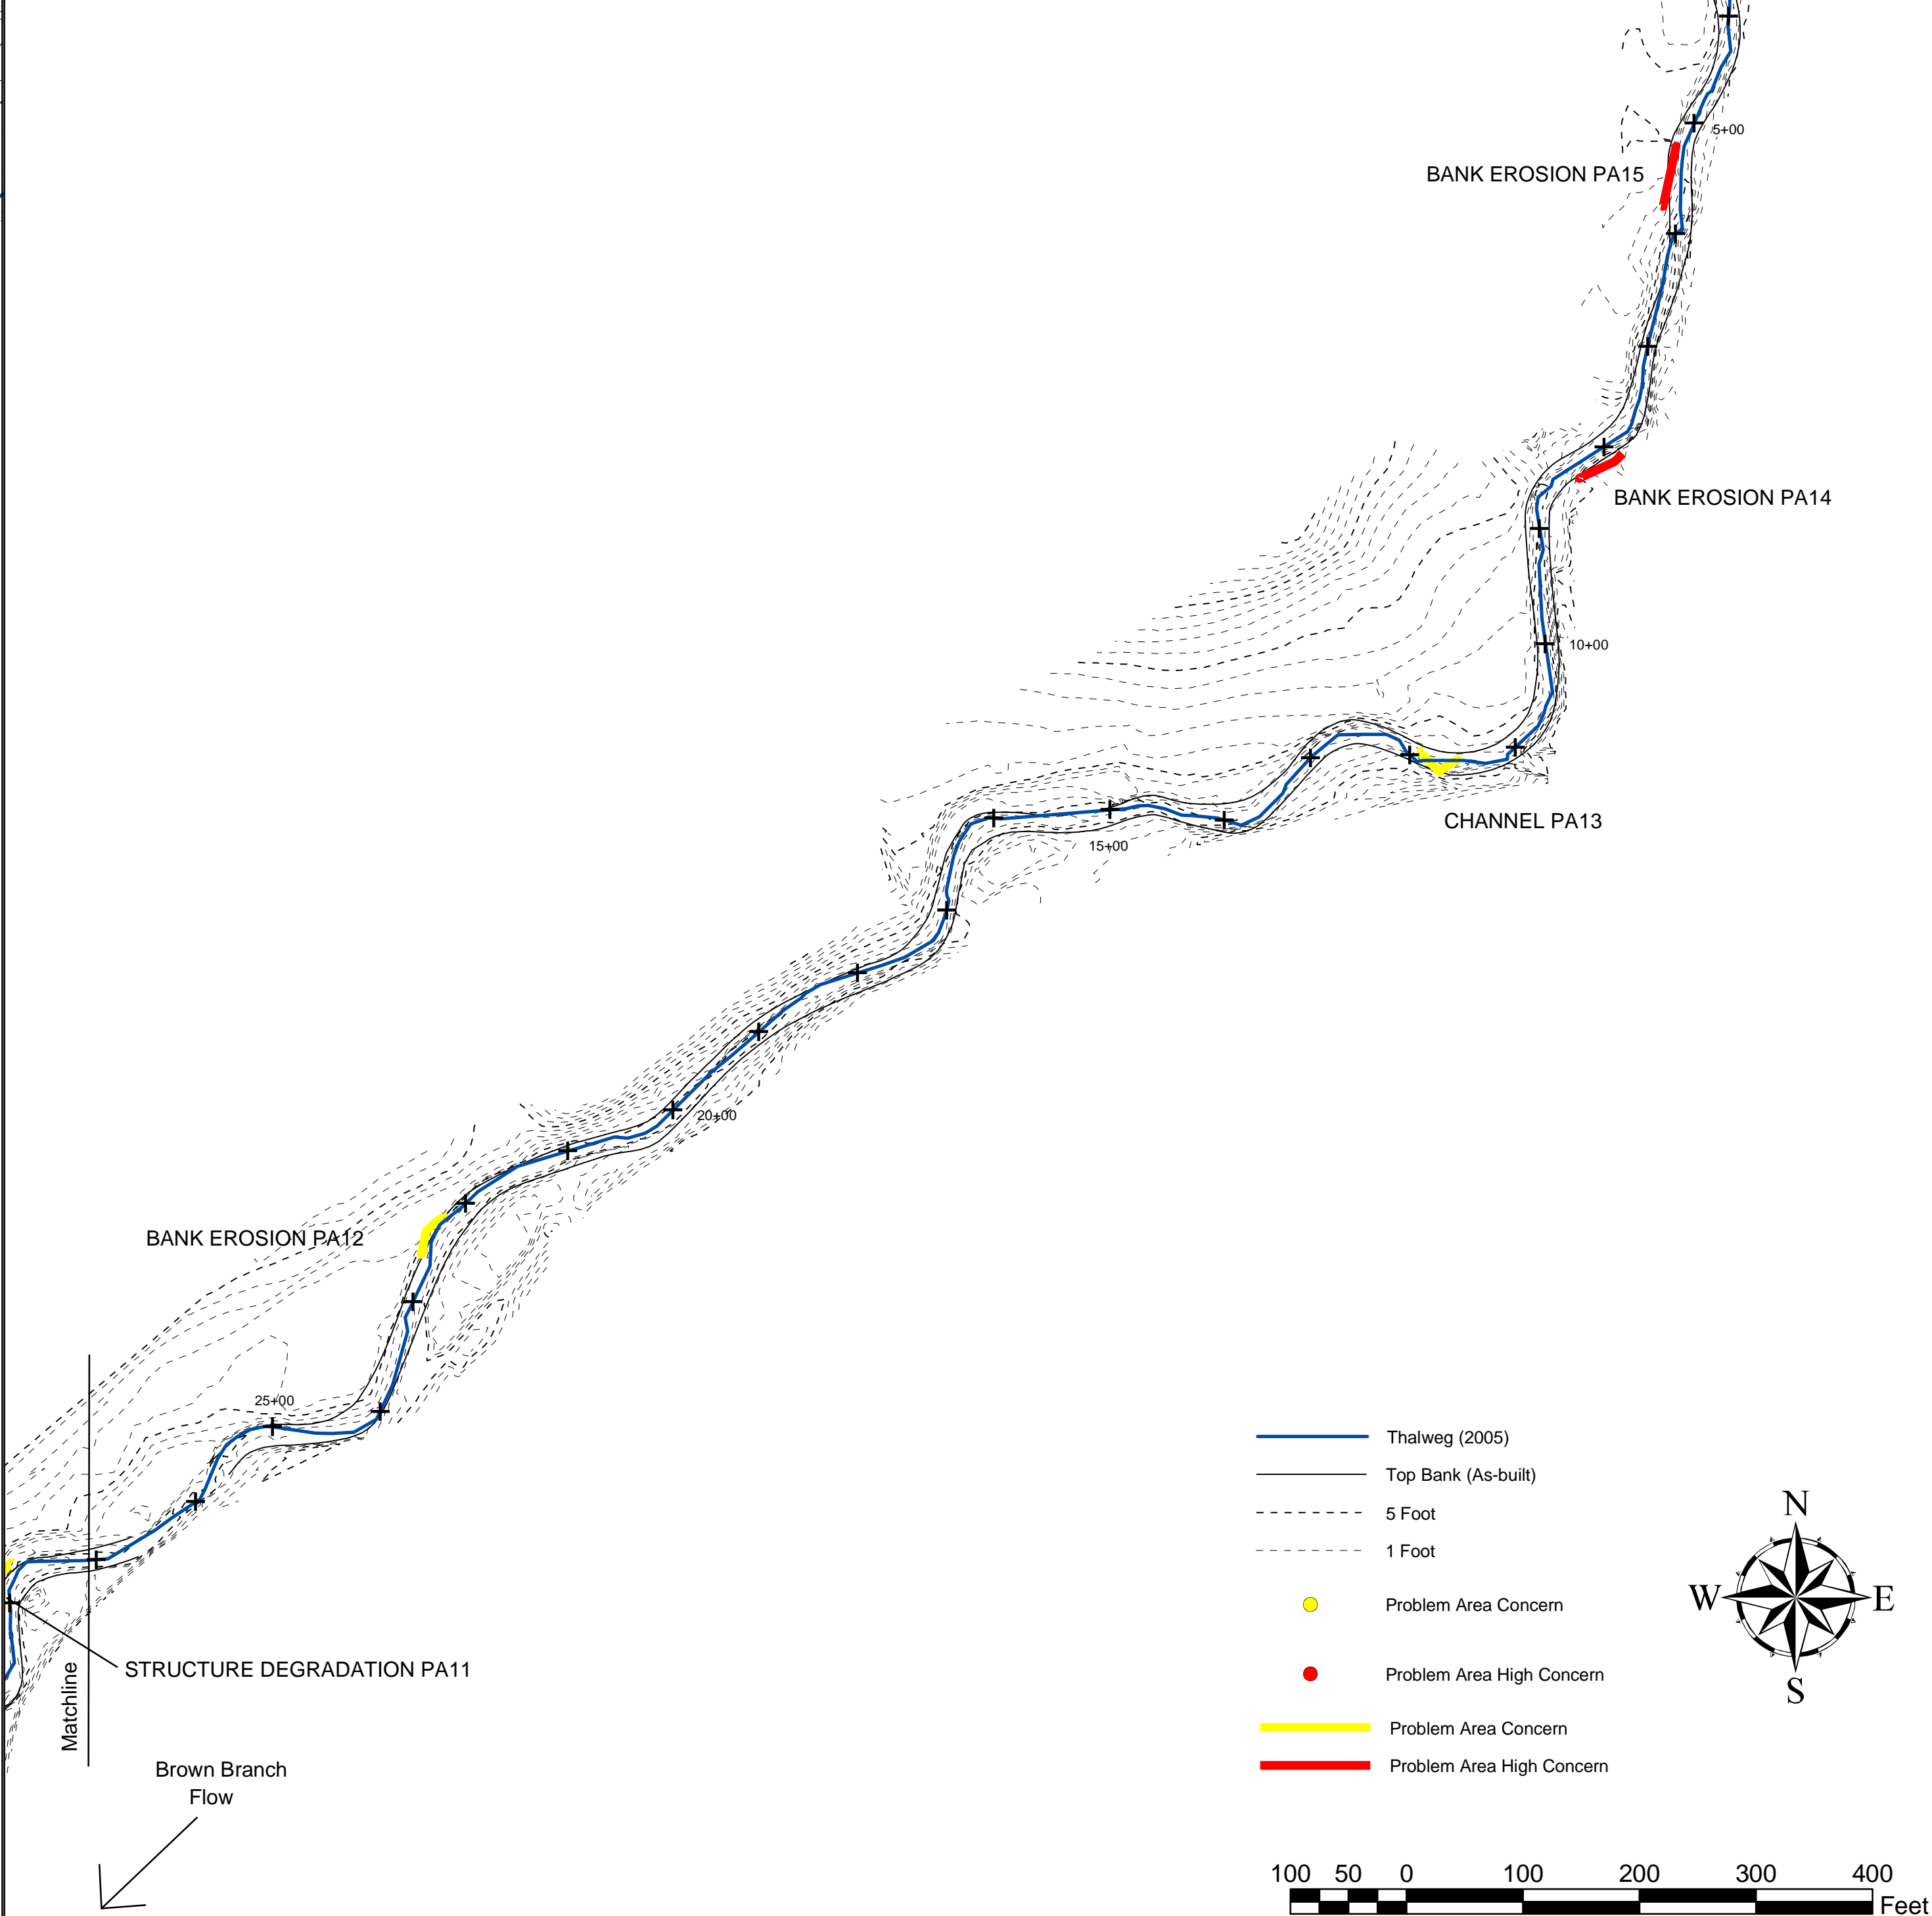
Appendix B. 1

Stream Problem Areas				
Project Number: 53				
Segment Reach: Brown Branch				
Feature Issue	Station	Suspected Cause	Photo	Severity
bank erosion	3+60	scour	PA1	yellow
bank erosion	5+00	overland flow	PA2	yellow
bank erosion	6+70	scour	PA3	yellow
channel	7+25	threaded	PA4	yellow
bank erosion	7+75	scour	PA5	yellow
bank erosion	9+00	scour	PA6	yellow
channel	10+50	threaded	PA7	yellow
bank erosion	11+00	scour	PA8	yellow
bank erosion	13+90	overland flow	PA9	yellow
bank erosion	22+00	scour	PA10	yellow
structure degradation	24+25	scour	PA11	yellow
bank erosion	29+75	scour	PA12	yellow
channel	40+25	threaded	PA13	yellow
bank erosion	44+00	scour	PA14	red
bank erosion	46+50	scour	PA15	red
bank erosion	48+75	scour	PA16	red

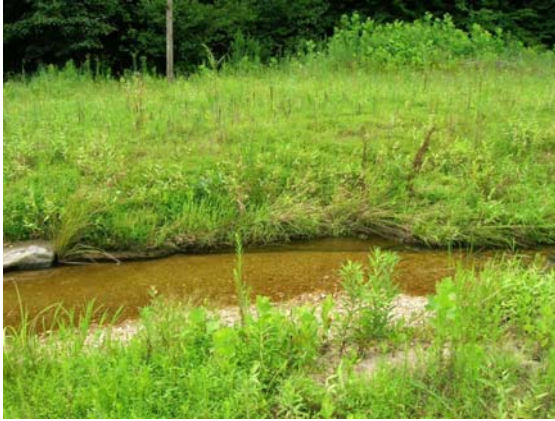
PA 1

Table IX. Stream Problem Areas Project Number: 53 Segment Reach: Brown Branch				
Feature Issue	Station	Suspected Cause	Photo	Severity
Bank erosion	3+60	Scour	PA1	Yellow
Bank erosion	5+00	Overland flow	PA2	Yellow
Bank erosion	6+70	Scour	PA3	Yellow
Channel	7+25	Threaded	PA4	Yellow
Bank erosion	7+75	Scour	PA5	Yellow
Bank erosion	9+00	Scour	PA6	Yellow
Channel	10+50	Threaded	PA7	Yellow
Bank erosion	11+00	Scour	PA8	Yellow
Bank erosion	13+90	Overland flow	PA9	Yellow
Bank erosion	22+00	Scour	PA10	Yellow
Structure degradation	24+25	Scour	PA11	Yellow
Bank erosion	29+75	Scour	PA12	Yellow
Channel	40+25	Threaded	PA13	Yellow
Bank erosion	44+00	Scour	PA14	Red
Bank erosion	46+50	Scour	PA15	Red
Bank erosion	48+75	Scour	PA16	Red
