Brown Branch Stream Restoration – Project #53 Fourth Annual Monitoring Report

Delivered to: NCDENR-Ecosystem Enhancement Program
1619 Mail Service Center
Raleigh, NC 27699-1619

Prepared by: MACTEC Engineering and Consulting, Inc.
3301 Atlantic Avenue
Raleigh, North Carolina 27604
(919) 876-0416

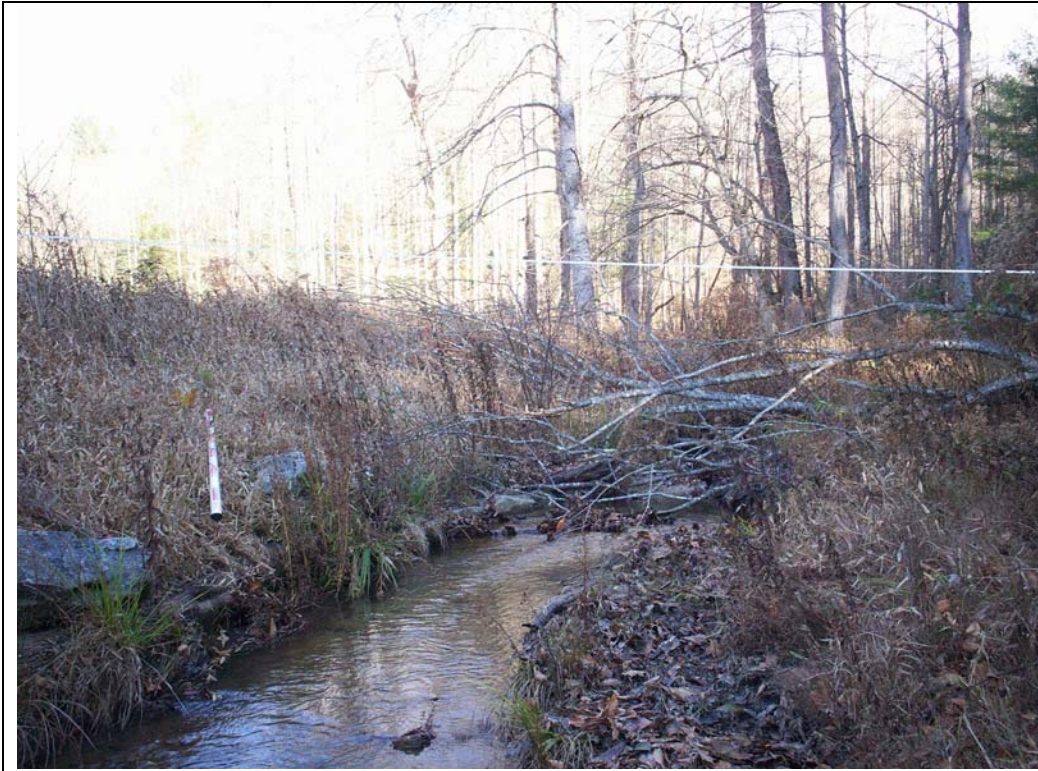
PHOTOLOG SHEET
Site: Brown Branch Problem Area
Caldwell County, North Carolina
Project No: 6470-06-1410.02
Date: October 2006
Photo #: 3
Photographed by: R.E. Spears
Description: Tree fall area. Erosion has started to impact the right bank. Recommend removing the tree.

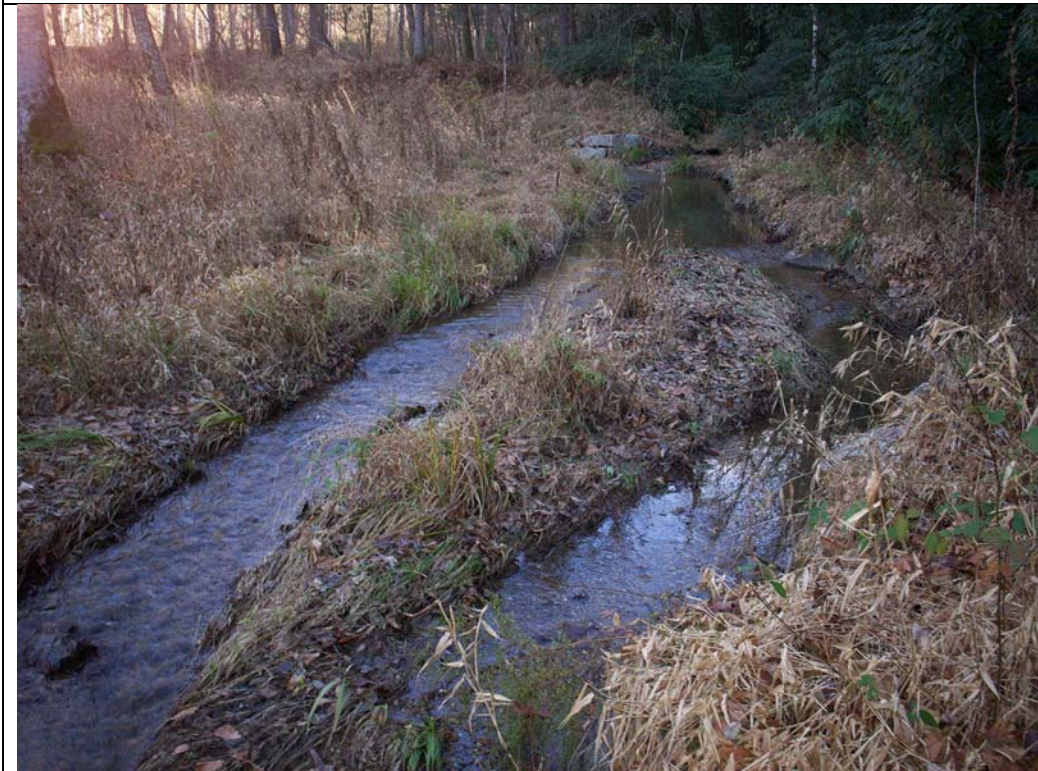
Site: Brown Branch Problem Area
Caldwell County, North Carolina
Project No: 6470-06-1410.02
Date: October 2006
Photo #: 4
Photographed by: R.E. Spears
Description: Aggradations in stream channel causing minor scour along the left bank due to stream widening and adjusting wavelength.

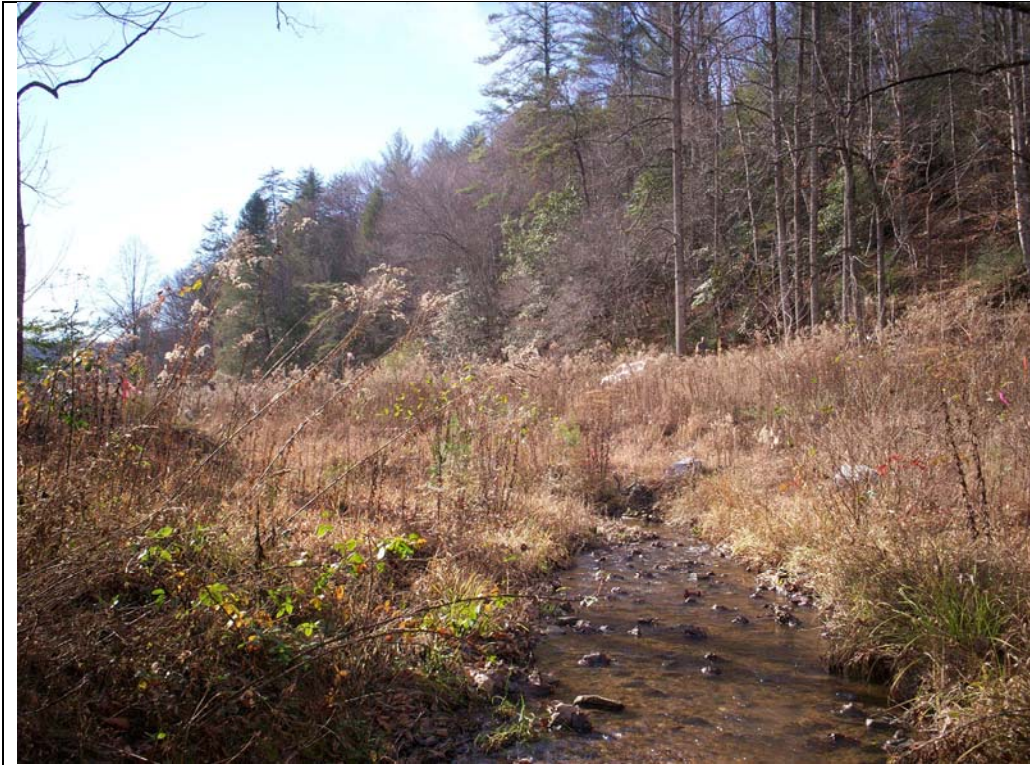
PHOTOLOG SHEET
Site: Brown Branch Problem Area
Caldwell County, North Carolina
Project No: 6470-06-1410.02
Date: October 2006
Photo #: 5
Photographed by: R.E. Spears
Description: J-hook vane severely eroded due to adjustment of stream grade in the area upstream of cross-section 3 near the pond.

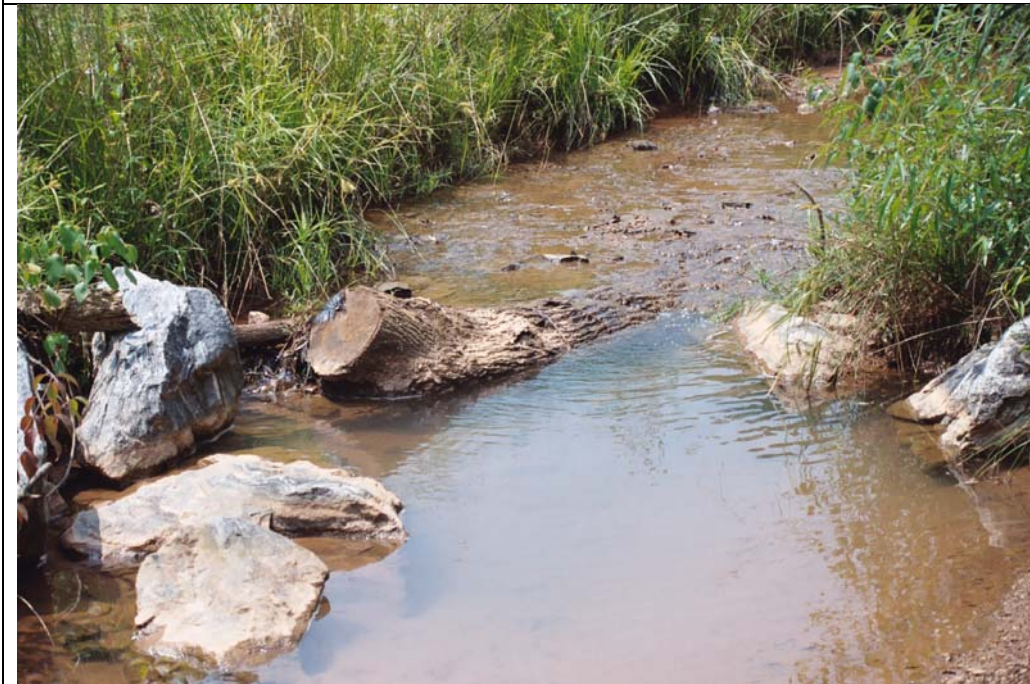
PHOTOLOG SHEET
Site: Brown Branch Problem Area
Caldwell County, North Carolina
Project No: 6470-06-1410.02
Date: May 2006
Photo #: 7
Description: Example of failed structure in stream channel bed. Stream has stabilized in this area.

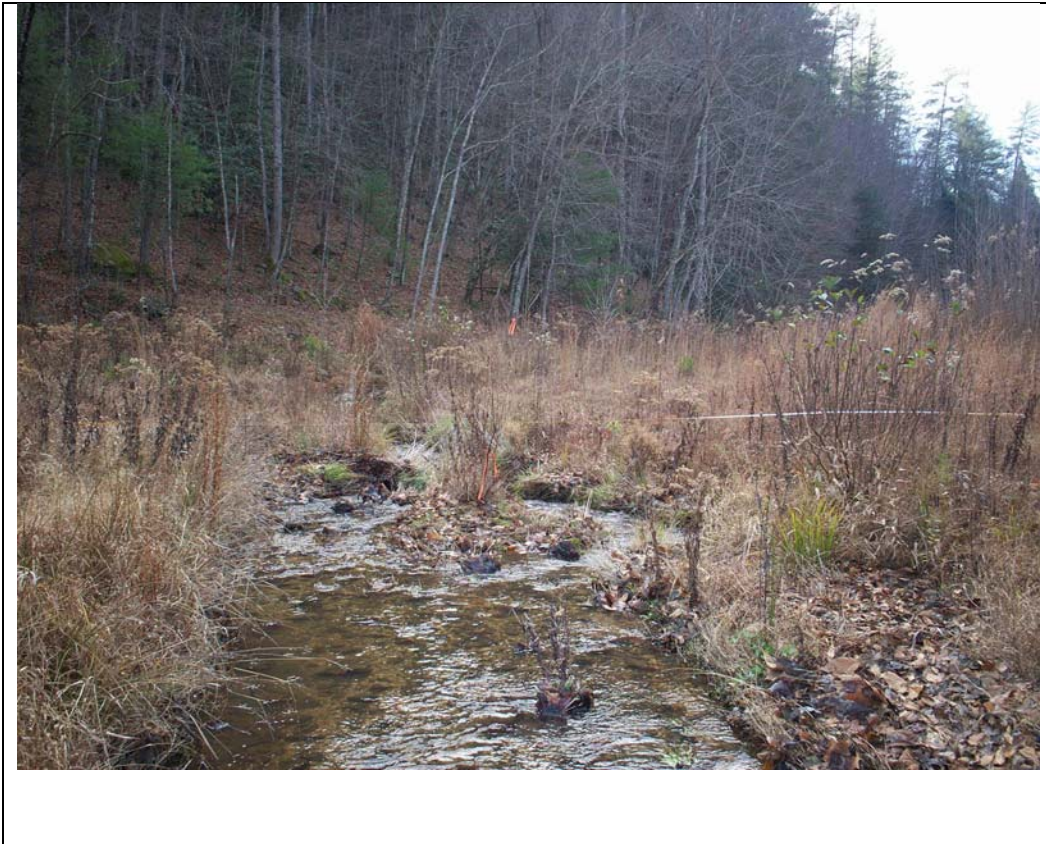
PHOTOLOG SHEET
Site: Brown Branch Problem Area
Caldwell County, North Carolina
Project No: 6470-06-1410.02
Date: October 2006
Photo #: 9
Photographed by: R.E. Spears
Description: Mid channel bar formation at cross-section 5.
