# **Brown Branch Stream Restoration – Project #53 Fifth Annual Monitoring Report**

Submitted to:

NCDENR-Ecosystem Enhancement Program  
1619 Mail Service Center  
Raleigh, NC 27699-1619

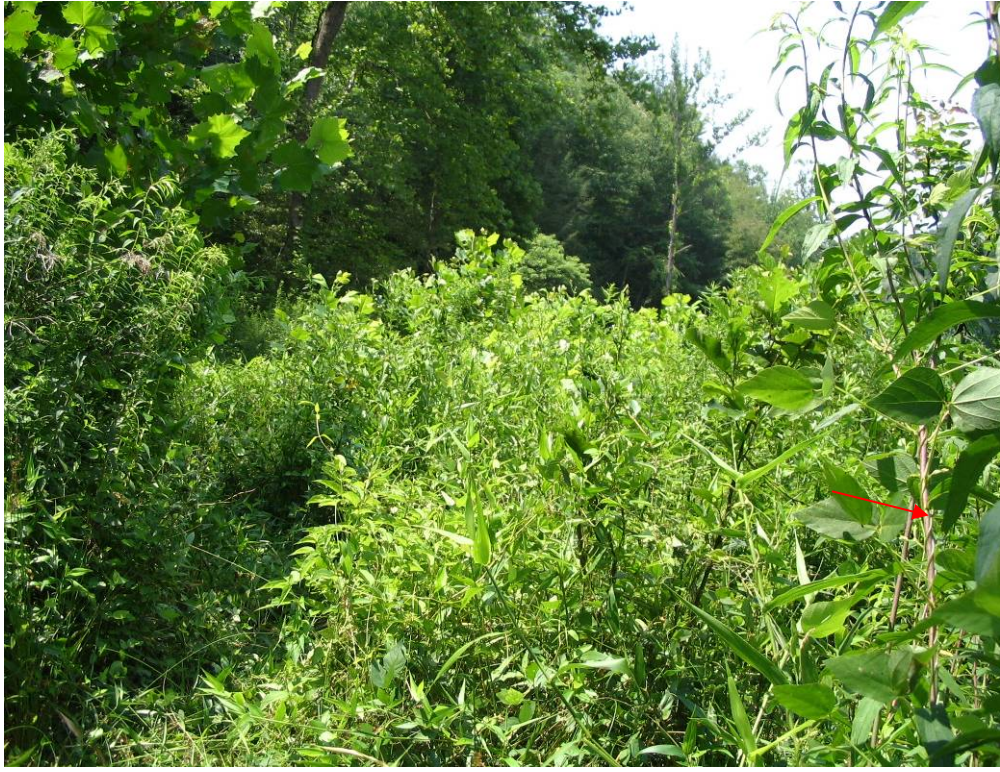
**VEGETATION PROBLEM AREA**

Problem areas, as defined in EEP's *Content, Format, and Data Requirements for EEP Monitoring Reports*, are areas either lacking vegetation or containing exotic vegetation, and are categorized as Bare Bank, Bare Bench, Bare Floodplain, or Invasive Population. Invasive species were infrequent at the site, although a moderate amount of vine strangulation was observed in vegetation plot BBP-12 due to an unknown vine, presumed to be in the Family *Fabaceae*. This same vine was also observed sporadically within a few other vegetation plots. An area of concern, an active beaver dam in the downstream portion of Brown Branch, was observed with water backed up adjacent to vegetation plot BBP-9 upstream to BBP-7. Additional observation of the beaver-influenced area is recommended, and removal of the beaver dam is warranted to ensure existing vegetation survival. Additional observation of vegetation plots for invasive plant species is also recommended.

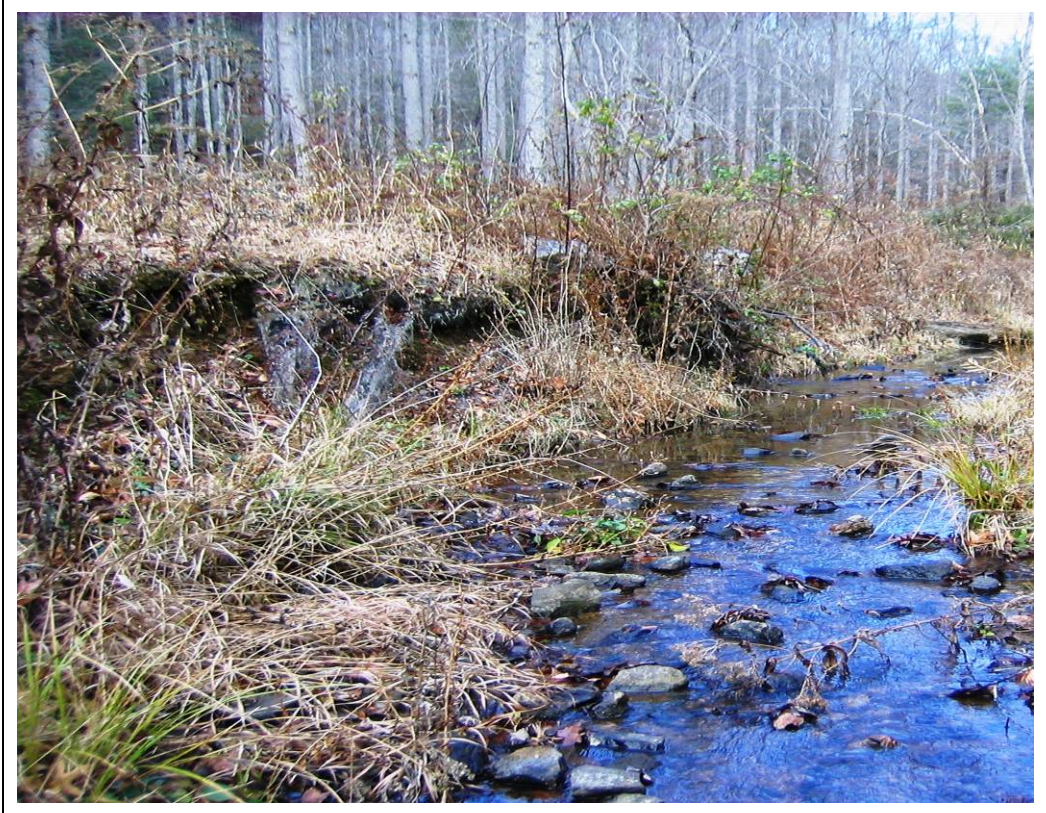
<p><b>PHOTOLOG SHEET</b></p>
	<p>Site: Brown Branch Station 3+30</p>
	<p>Caldwell County, North Carolina</p>
	<p>Project No: 6470-06-1410</p>
	<p>Date: December, 2007</p>
	<p>Photo #: 1</p>
<p>Photographed by: R. Sain</p>	
<p>Description: Photo taken facing up stream; right bank is in a stressed condition from prior erosion. Vegetation has established, not likely a long term problem.</p>

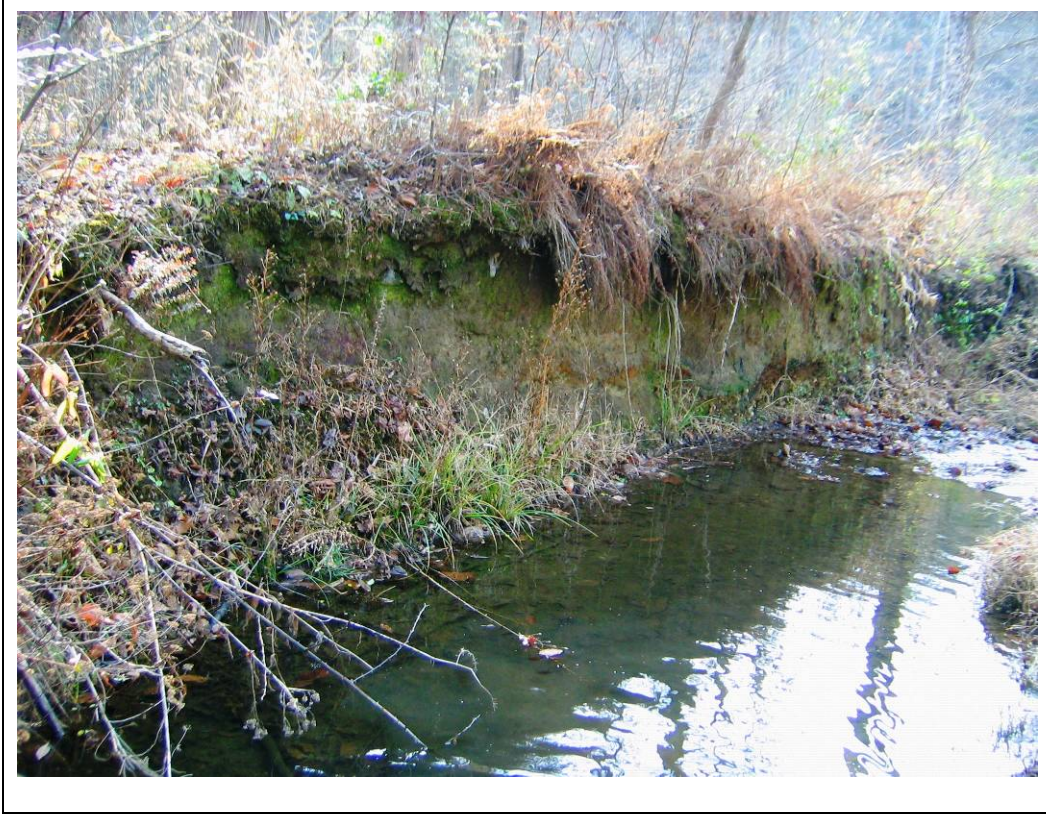
<p>Site: Brown Branch Station 5+75</p>
	<p>Caldwell County, North Carolina</p>
	<p>Project No: 6470-06-1410</p>
	<p>Date: December, 2007</p>
	<p>Photo #: 2</p>
	<p>Photographed by: R. Sain</p>
<p>Description: Photo taken facing down stream just downstream of log foot bridge; left bank appears to have failed several times.</p>

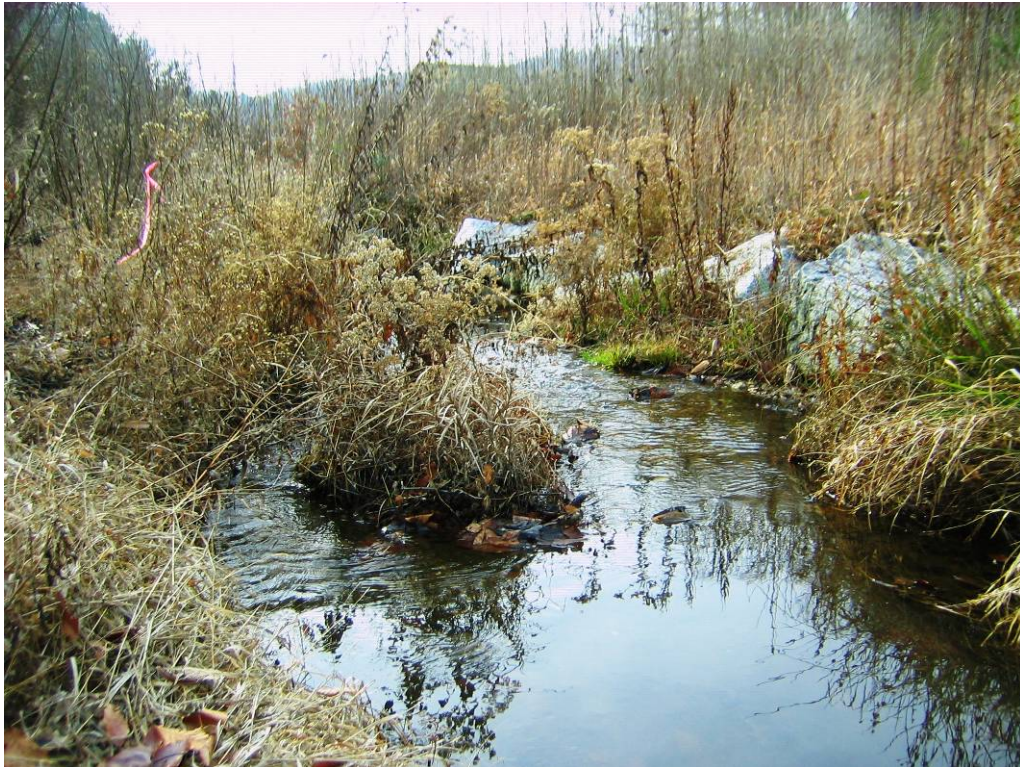
<p><b>PHOTOLOG SHEET</b></p> <p>Site: Brown Branch                  Station 33+10</p> <p>Caldwell County, North                  Carolina</p> <p>Project No: 6470-06-1410</p> <p>Date: December, 2007</p> <p>Photo #: 7</p> <p>Photographed by: R. Sain</p> <p>Description:                  Photo taken facing down                  stream; mid-channel bar and                  adjacent banks are well                  vegetated applying only                  moderate near bank stress, not                  likely to cause long term                  problems.</p>

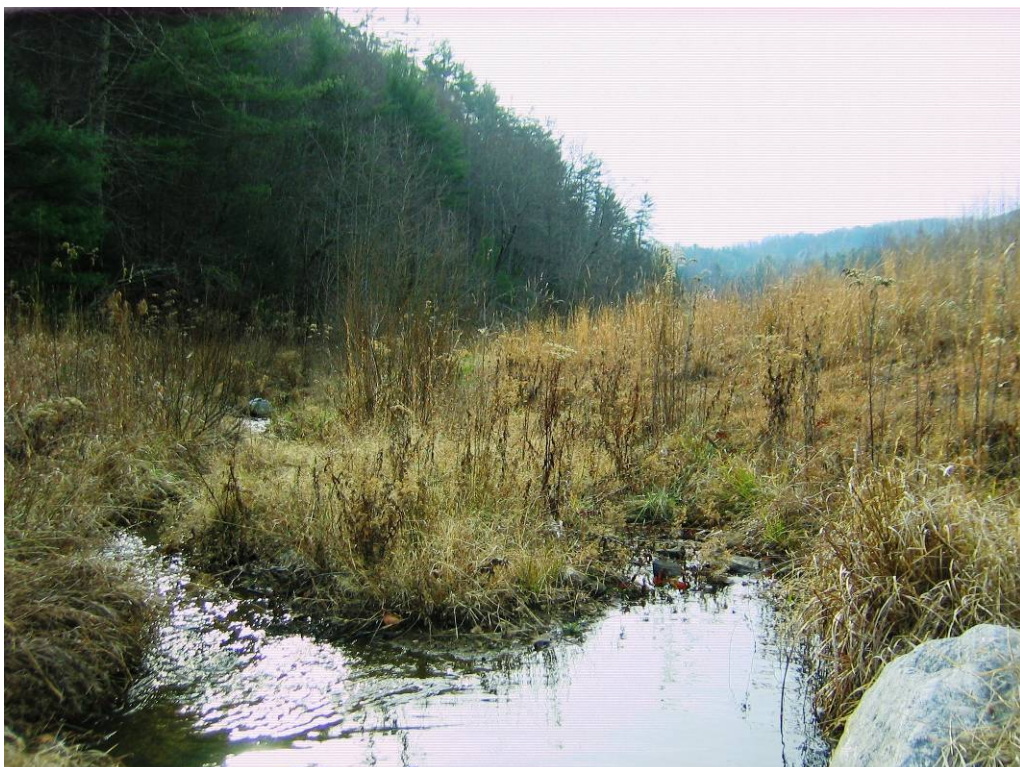
<p>Site: Brown Branch                  Station 40+00</p> <p>Caldwell County, North                  Carolina</p> <p>Project No: 6470-06-1410</p> <p>Date: December, 2007</p> <p>Photo #: 8</p> <p>Photographed by: R. Sain</p> <p>Description:                  Photo taken facing down                  stream; mid-channel bar and                  adjacent banks are well                  vegetated applying only                  moderate near bank stress, not                  likely to cause long term                  problems.</p>

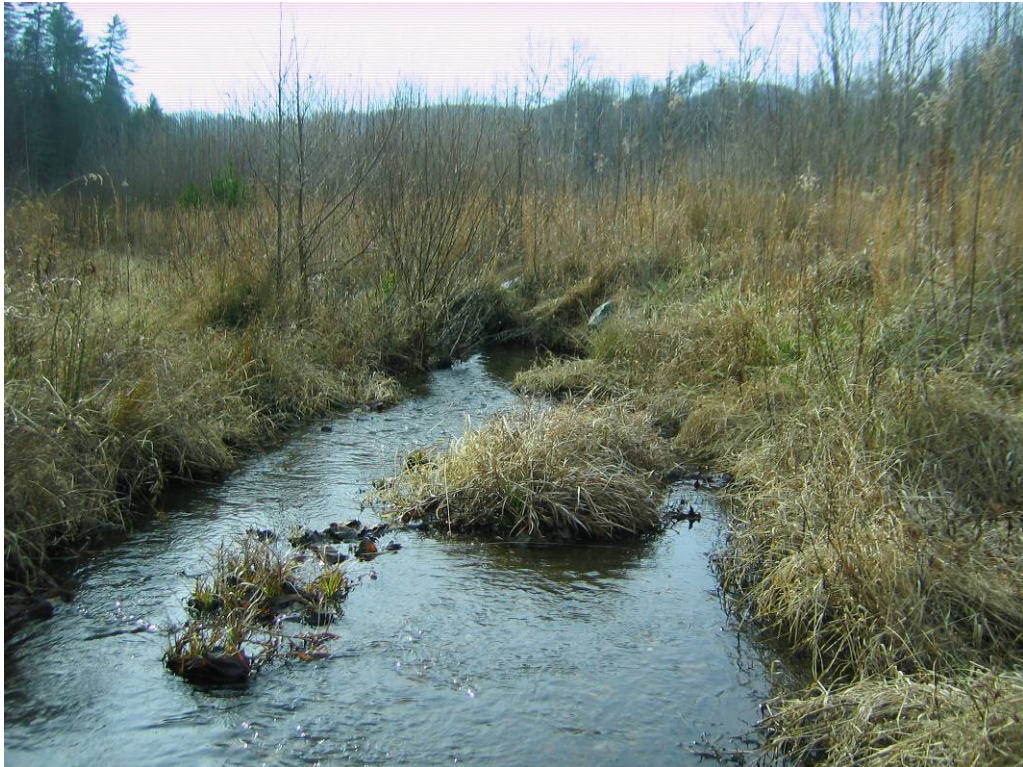
<p><b>PHOTOLOG SHEET</b></p> <p>Site: Brown Branch Station 42+25</p> <p>Caldwell County, North Carolina</p> <p>Project No: 6470-06-1410</p> <p>Date: December, 2007</p> <p>Photo #: 9</p> <p>Photographed by: R. Sain</p> <p>Description:        Photo taken facing down stream; mid-channel bar and adjacent banks are well vegetated applying only moderate near bank stress, not likely to cause long term problems.</p>

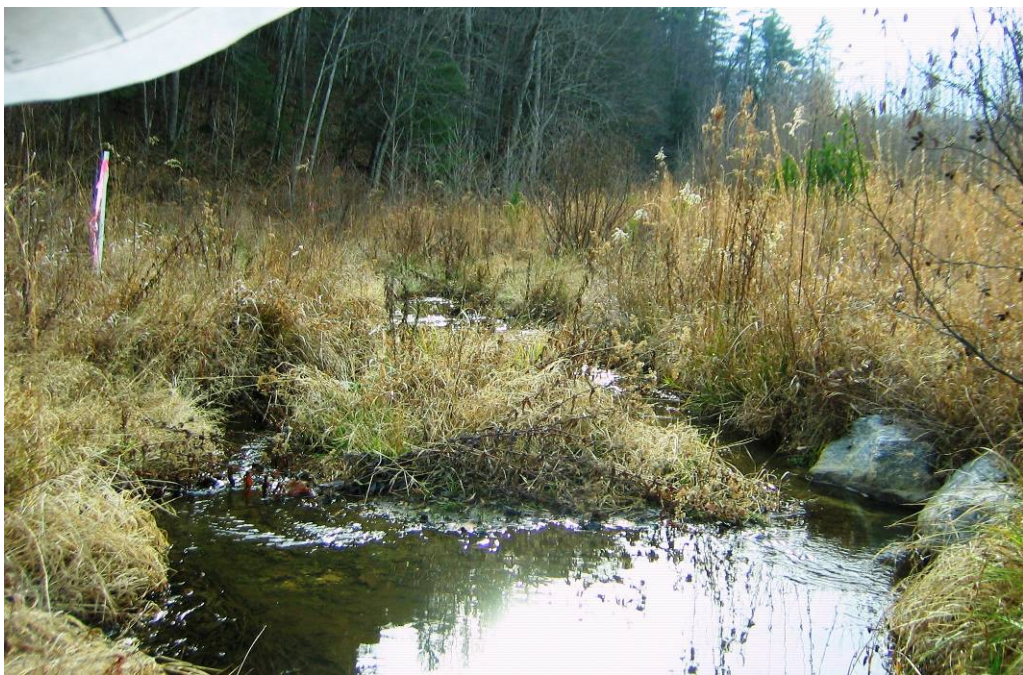
<p>Site: Brown Branch Station 42+75 and 43+20</p> <p>Caldwell County, North Carolina</p> <p>Project No: 6470-06-1410</p> <p>Date: December, 2007</p> <p>Photo #: 10 and representative of # 11</p> <p>Photographed by: R. Sain</p> <p>Description:        Photo taken facing down stream; mid-channel bar and adjacent banks are well vegetated applying only moderate near bank stress, not likely to cause long term problems.</p>
