# Brown Creek Tributaries Restoration Project Final Year 1 Monitoring Report

DMS Project ID No. 95351, DEQ Contract No. 004641

Project Info:           Monitoring Year: 1 of 7  
                              Year of Data Collection: 2015 (vegetation) and 2016 (survey)  
                              Year of Completed Construction: 2015  
                              Submission Date: January 2017

Report Prepared and Submitted by Michael Baker Engineering, Inc.

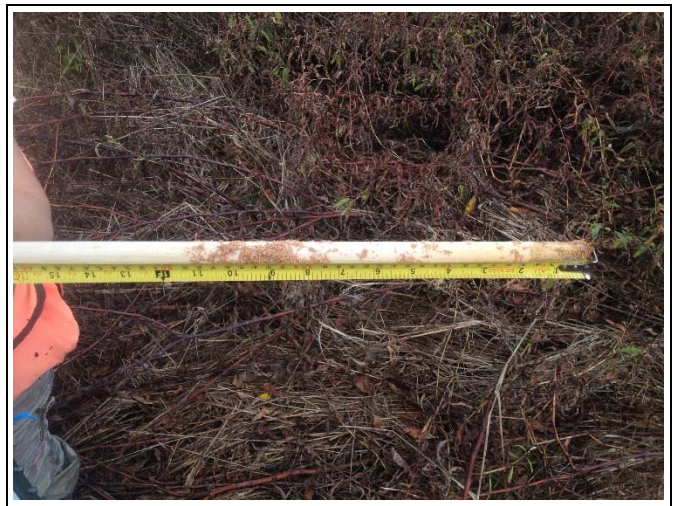
Reach HC-R2: Overbank Event of 0.94' (10/29/15)

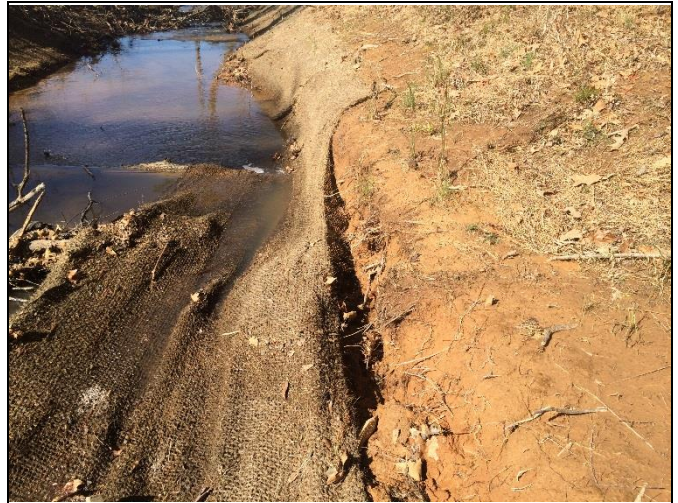
<b>SPA #</b>	<b>Feature Issue</b>	<b>Reach ID, Station Number</b>	<b>Suspected Cause</b>	<b>Photo # in Problem area Photo Log</b>
1	Log J-Hook failure	UT4-R3, 29+00	Overbank flows from fall and winter storms <sup>1</sup>	1
2	Bank erosion	UT4-R2, 37+40	Overbank flows from fall and winter storms <sup>1</sup>	2
3	Ford crossing washed out	UT4-R4, 25+30	Overbank flows from fall and winter storms <sup>1</sup>	3
4	Riffle scour	UT4-R2, 31+00	Overbank flows from fall and winter storms <sup>1</sup>	4
5	Riffle scour	UT4-R2, 28+75	Overbank flows from fall and winter storms <sup>1</sup>	5
6	Riffle scour	UT4-R2, 24+00	Overbank flows from fall and winter storms <sup>1</sup>	6
7	Bank erosion	UT4-R2, 23+10	Overbank flows from fall and winter storms <sup>1</sup>	6
8	Scour in floodplain	UT4-R2, 21+40 to 21+75	Overbank flows from fall and winter storms <sup>1</sup>	7, 8

2) Reach UT4-R2 – Bank erosion at Station 37+40

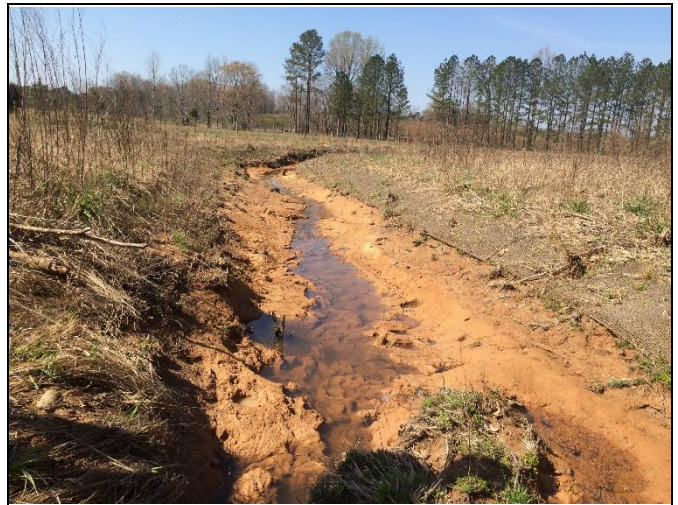
the thalweg in two of the riffles, and the banks are now being undermined. The riffles were earth/sand riffles and were therefore more vulnerable to the scouring potential of high storm flows. There were also two areas of bank scour noted for this reach as well. For UT4-R3, the cross vane located at the top of the reach at the confluence of UT4-R4b and UT4-R2 was undermined and washed out along with a portion of the adjacent bank. Additionally, the right bank of the rock ford crossing on UT4-R4b washed out. It is believed that the harsh fall and winter rainstorms of 2015 (in particular Hurricane Joaquin in early October) damaged the site before it had time to establish protective vegetation cover. All of these stream problem areas will be corrected during the summer of 2016 by Riverworks personnel. The location and photographs of the stream problem areas can be found in Appendix B.

4) Reach UT4-R2 – Riffle scour at Station 31+00

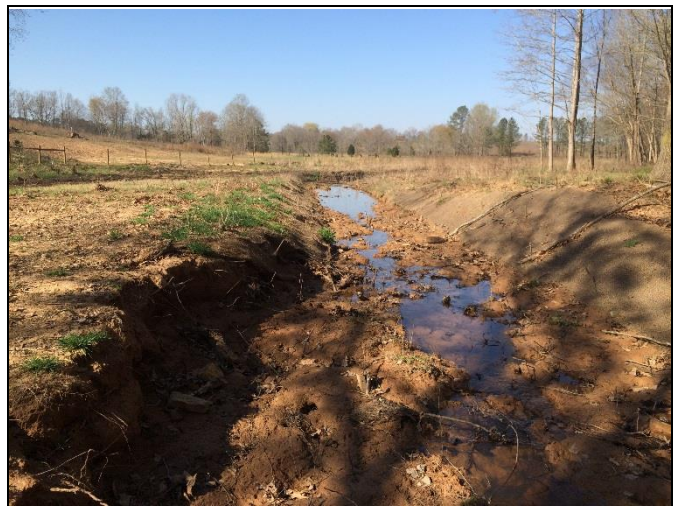
6) Reach UT4-R2 – Riffle scour at Station 24+00, and bank scour/mass wasting at Station 23+10
