Brown Creek Tributaries Restoration Project Final Year 2 Monitoring Report

DMS Project ID No. 95351, DEQ Contract No. 004641

Monitoring Year: 2 of 7
Year of Data Collection: 2016
Year of Completed Construction: 2015
Submission Date: January 2017

Report Prepared and Submitted by Michael Baker Engineering, Inc.

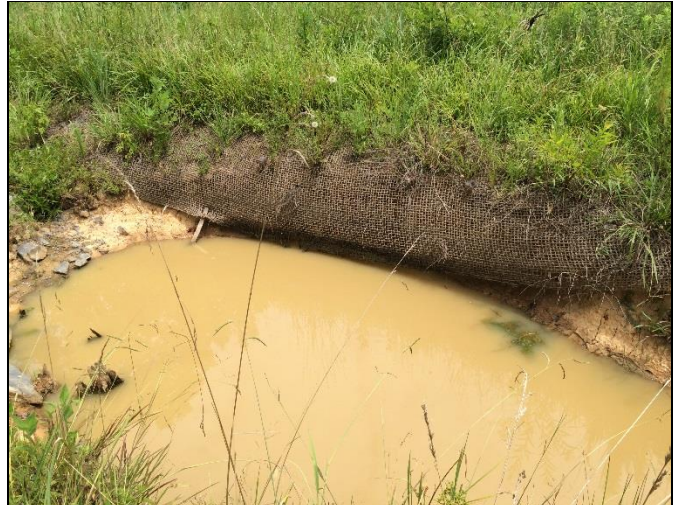
Table 5b. Stream Problem Areas (SPAs)				
Brown Creek Tributaries Restoration Project: DMS Project ID No. 95351				
SPA #	Feature Issue	Reach ID, Station Number	Suspected Cause	Photo # in Problem Area Photo Log
1	Bank scour	UT4-R2, 31+75	Storm scour ¹	1
2	Bank scour at log vane	UT4-R4b, 23+20	Storm scour ¹	2

Note:
¹Based on field visit notes and rainfall data, it is strongly believed that the overbank flows resulting from Hurricane Matthew in Oct 2016 was the primary cause of scouring observed for these areas.

1) Reach UT4-R2: Bank erosion at Station 31+75

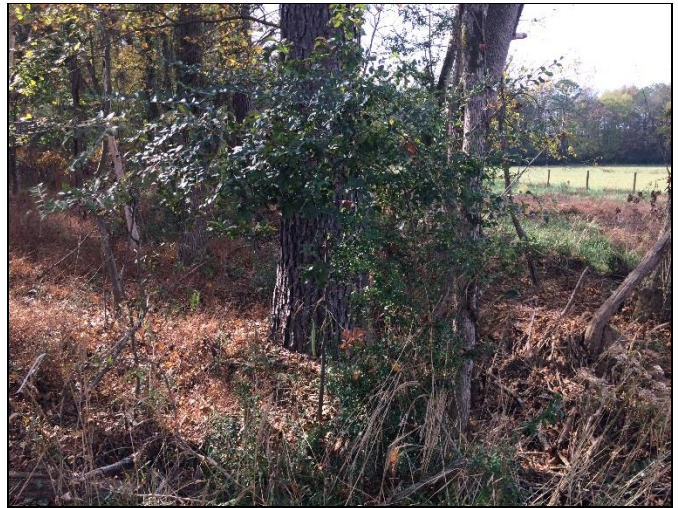
The second area of vegetative concern is the area around Vegetation Plot #7 located just downstream of the rock crossing on Reach UT4-R4b. This 0.22 acre area, while stable and vegetated with ample herbaceous growth, has a noticeably thin planted stem density. It has been noted that during storm events, the overbank flow coming from Reach UT4-R4a over the rock crossing predominantly flows into the right floodplain. After Hurricane Joaquin hit in October of 2015 (4 months after construction), some minor floodplain scouring was noticed in this area immediately downstream of the crossing, with particular impact to the still-young bareroot planted stems. Most were pushed over and/or buried in debris, some had scour around their roots, and a few had been washed away. Yet most seemed to recover the following spring and was anticipated that they would be fine. The success of Veg Plot #7 in Monitoring Year 1 seemed to suggest that to be true. It now appears that these stems were too damaged to survive long-term after all, as Veg Plot #7 did not meet its success criteria with only 202 stems surviving in Monitoring Year 2. As such, Riverworks will plant this area with supplemental bareroot stems of the same species mix as originally planted. Given that this area is now vegetated and stable, it is expected to hold up to subsequent flow from heavy storm events.

Table 6b. Vegetation Problem Areas (VPAs) Brown Creek Tributaries Restoration Project: DMS Project ID No. 95351				
VPA #	Feature Issue	Station Number	Suspected Cause	Photo # in Problem area Photo Log
1	Low stem density	UT4-R4b, station ~15+00	Storm scour on floodplain ¹	3
2	Chinese privet (<i>Ligustrum sinsense</i>)	HC-R3, station ~14+00	Resprouts	4

3) Reach UT4-R4b – Low planted stem densities around Veg Plot #7 (though area is vegetated and stable)
