Brown Creek Tributaries Restoration Project FINAL Year 3 Monitoring Report

Anson County, North Carolina

DMS Project ID No. 95351, DEQ Contract No. 004641

Monitoring Year: 3 of 7

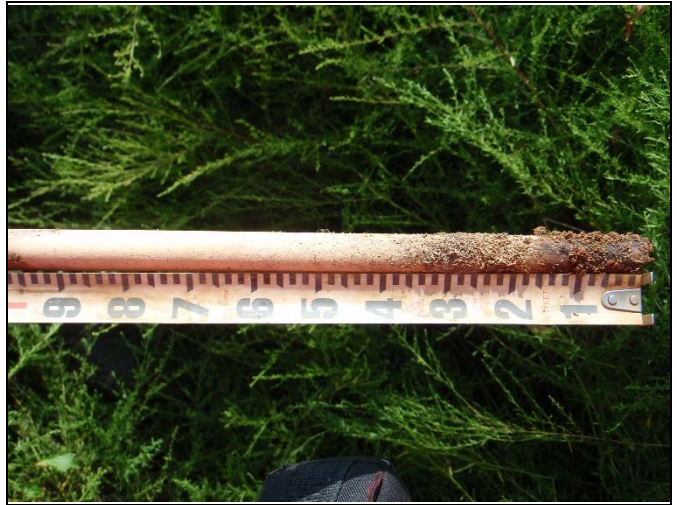
Reach HC-R2: Overbank Event of 0.33' (9/19/2017)

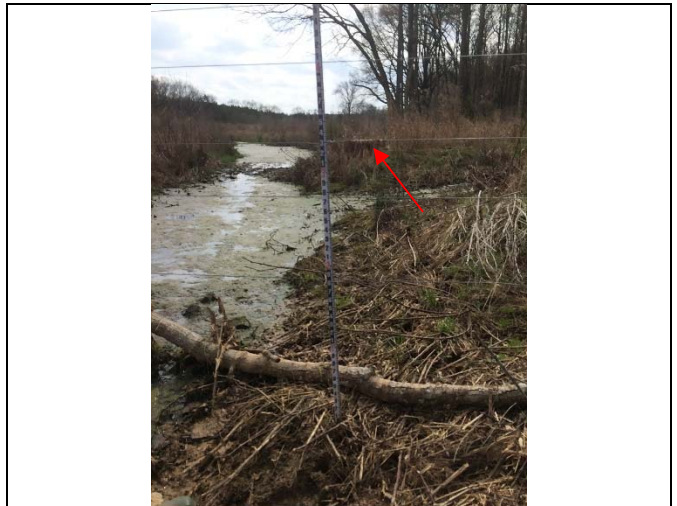
Reach HC-R1: Evidence of overbank flooding (debris caught in wires at cattle crossing ~3.3' height).

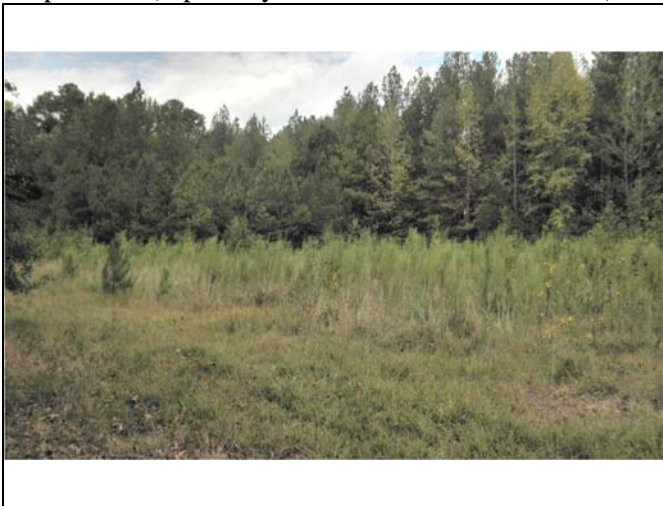
3) VPA: Reach UT4-R2, Low stem densities along portion of left bank (but area is vegetated and stable).

The other VPAs are areas of low stem densities observed in portions of the floodplain along HC-R2, HC-R3, and UT4-R2 totaling approximately 1.21 acres (about 3.6% of the total easement area of the project). They were discovered during a vegetation assessment conducted in March and April of 2017 of several areas that were suspected of potentially having thin stem densities. The area on HC-R2 has significant weed pressure from dense cocklebur (*Xanthirum strumarium*), HC-R3 appears hindered by the shade from the adjacent mature forested area, and UT-R2 may have experienced delayed mortality of stems weakened by floodplain scouring relatively soon after construction. Vegetation Plot #2 is found within the most affected portion of the area along HC-R2 and likely as a result did not meet the Year 3 success criteria. These areas will be planted during the dormant season with supplemental bareroot stems.

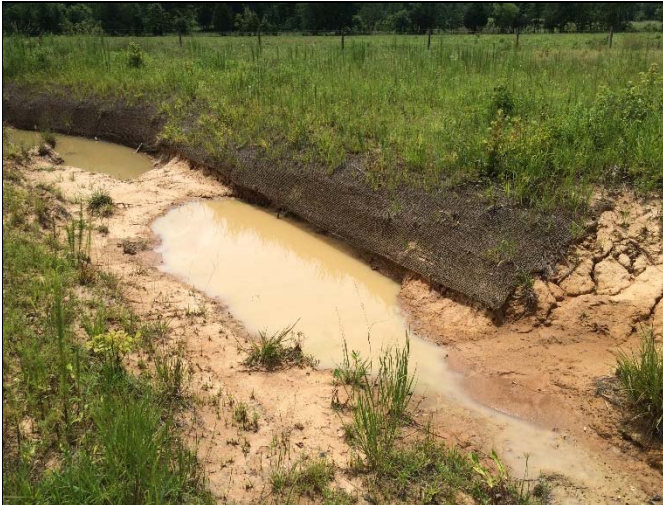
1) Reach UT4-R2: Bank Erosion, Station 31+75 (BEFORE)

In March of 2017 River Works personnel did repair two areas of concern noted previously in the Monitoring Year 2 report. They were two sections of scoured/eroded stream banks located on Reaches UT4-R2 and UT4-R4, which were regraded and had geo-lifts installed. They were subsequently planted with livestakes and all disturbed areas were re-seeded. During site visits in September of 2017, both areas appeared stable and vegetated. Additionally, a section of damaged fence was repaired along UT4-R2, and a fallen tree was removed from the upper portion of UT4-R5. The locations of each of these repaired areas can be found in the Current Conditions Plan View (Figure 2), while photographs of the repairs are shown in the Stream Maintenance and Repair photolog, both of which are located in Appendix B. Additionally, photographs of several previously repaired areas from June 2016 (as described in the Year 2 report) are also included in Appendix B. Those repaired areas have remained stable and vegetated.

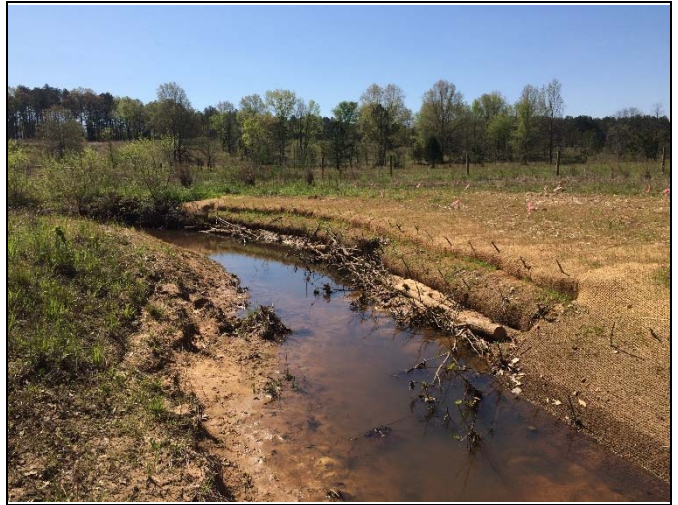
2) Reach UT4-R2: Geolift Installed March 2017 (AFTER)

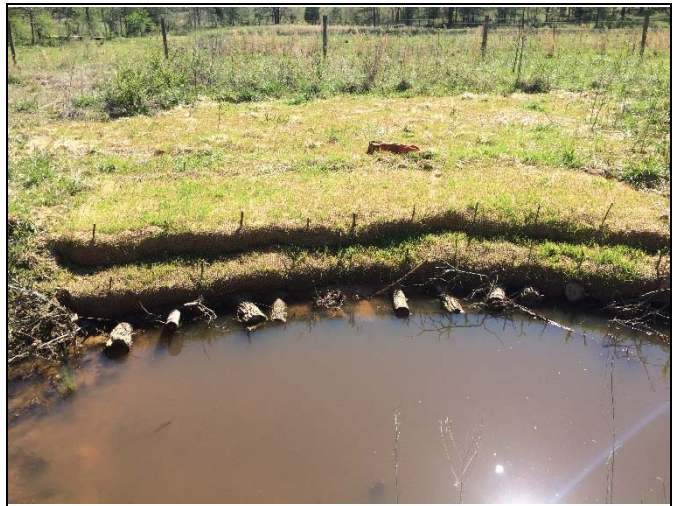
4) Reach UT4-R4b: Geolift Installed March 2017 (AFTER)

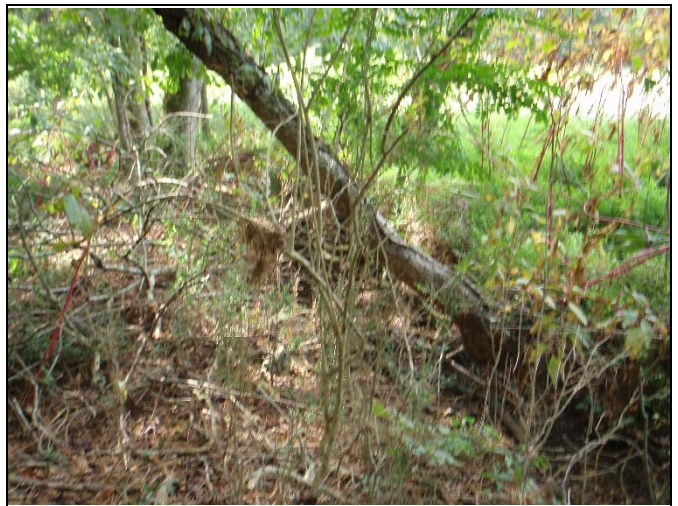
6) Reach HC-R3: Privet Treatment on Right Bank (Jan. 2017)

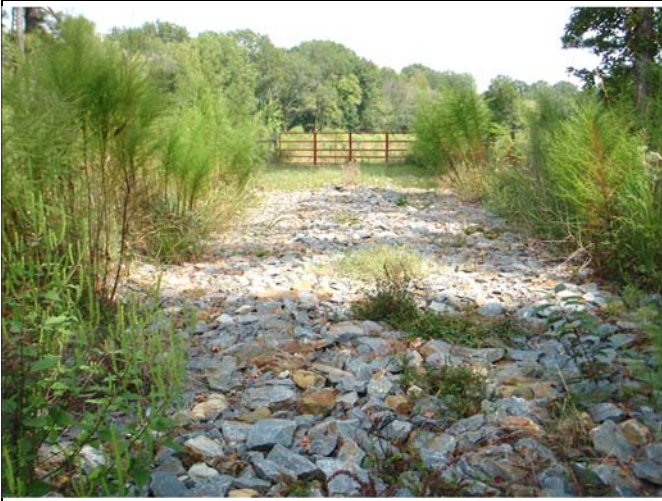
1) Reach UT4-R4b: Rock crossing, Station 25+30

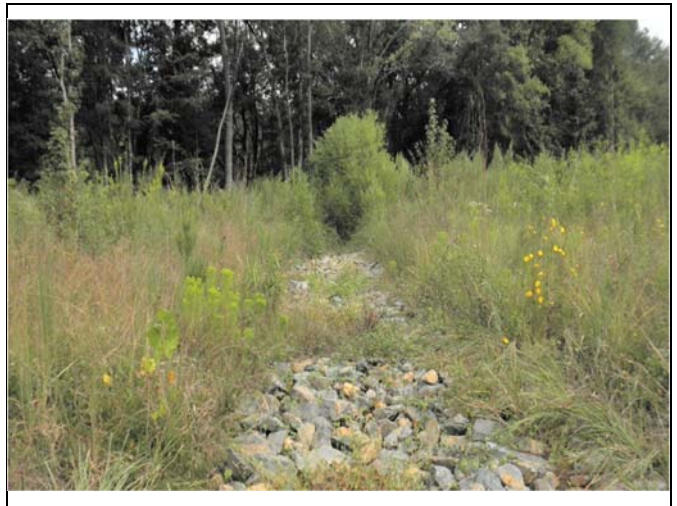
4) Reach UT4-R2: Riffle stabilized, Station 31+00

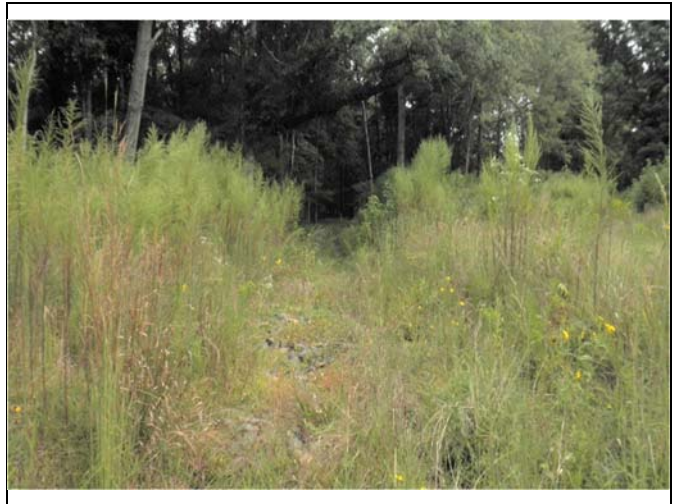
6) Reach UT4-R2: Riffle stabilized, Station 24+00

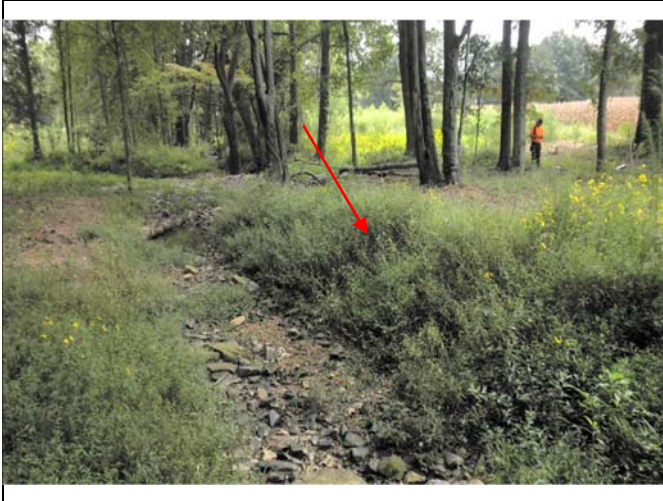
7) Reach UT4-R2: Bank regraded, Station 22+00

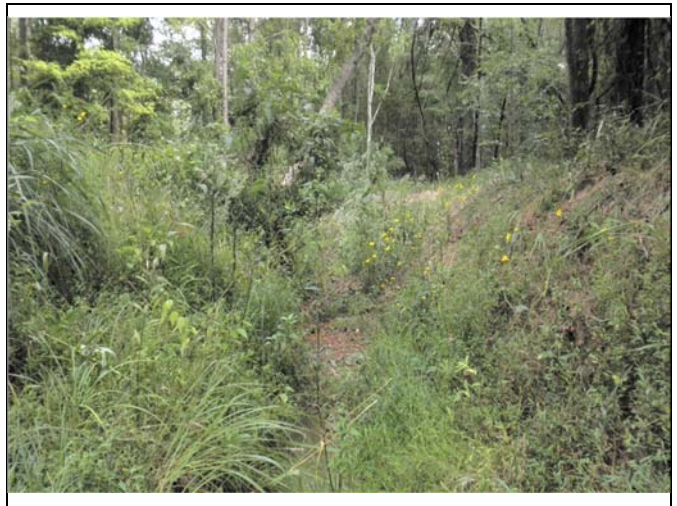
10) Reach UT4-R5a: Banks regraded, Station 11+00

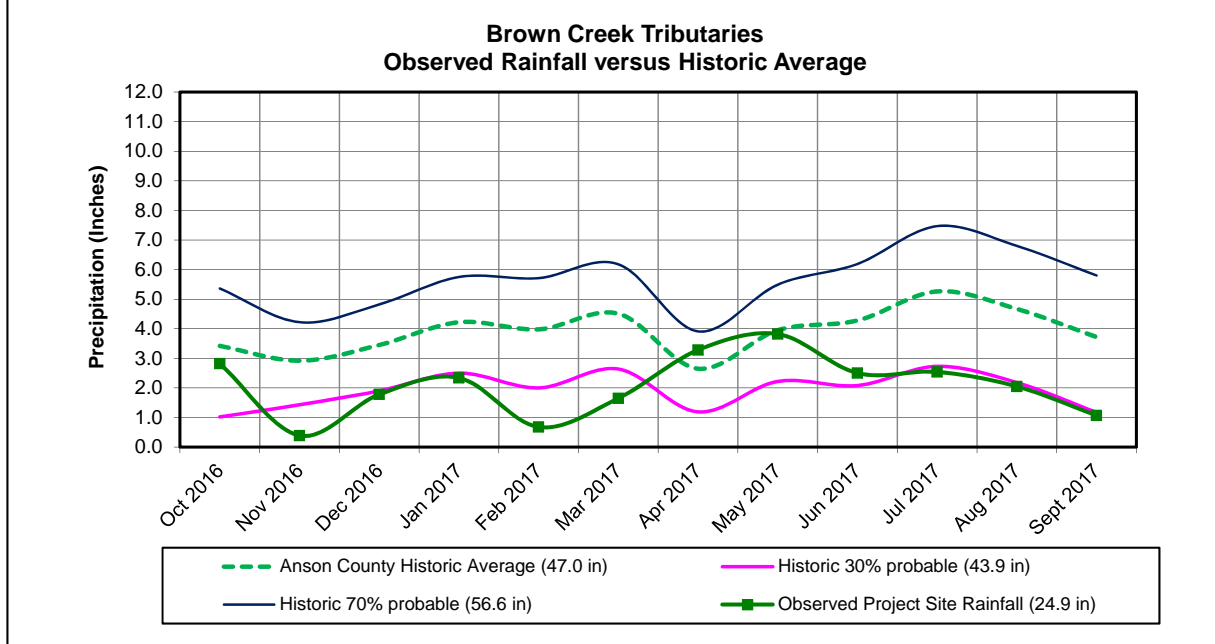
Figure 6. Observed Rainfall versus Historic Average

It should be noted that as Figure 6 in Appendix E shows, the observed monthly rainfall data for the project over the past 12 months has been quite dry as compared to historic averages. A total of just 24.9” of rainfall was observed for the site, while Anson County averages 47.0” of annual rainfall, a deficit of over 22.1”. The NCDWR drought monitoring history for Anson County also indicates that for significant periods of time over the past 12 months the County has been in Abnormally Dry (D0) or Moderate Drought (D1) conditions.

Note: Historic average annual rainfall for Anson County is 47.0", while the project site recorded a total of just 24.9" of rainfall over the previous 12 months.
