# Brown Creek Tributaries Restoration Project Final Year 4 Monitoring Report

Anson County, North Carolina

DMS Project ID No. 95351, DEQ Contract No. 004641

Submission Date: December 2018

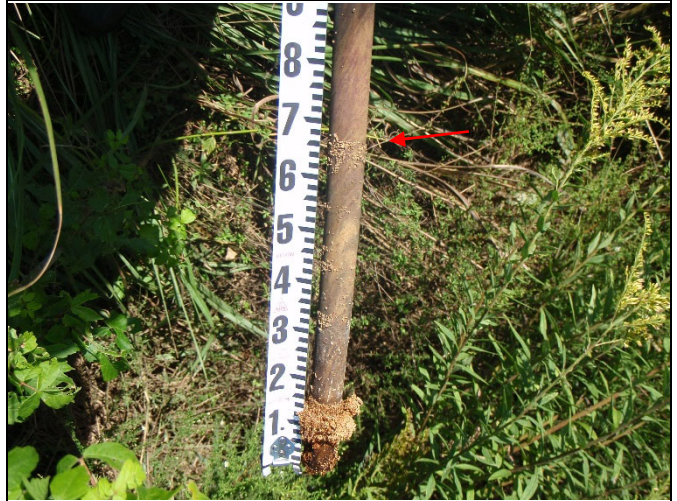
Reach HC-R2: Overbank Event of 0.67' (from Hurricane Florence, photo from 10/3/2018)

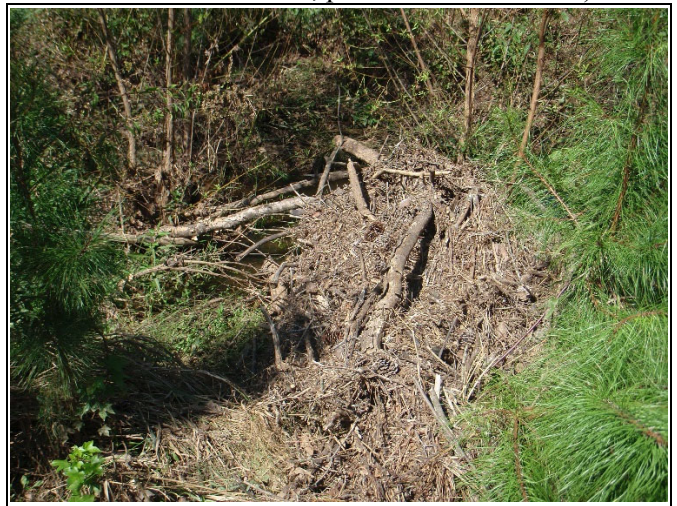
Reach HC-R1: Wrack lines and debris in floodplain

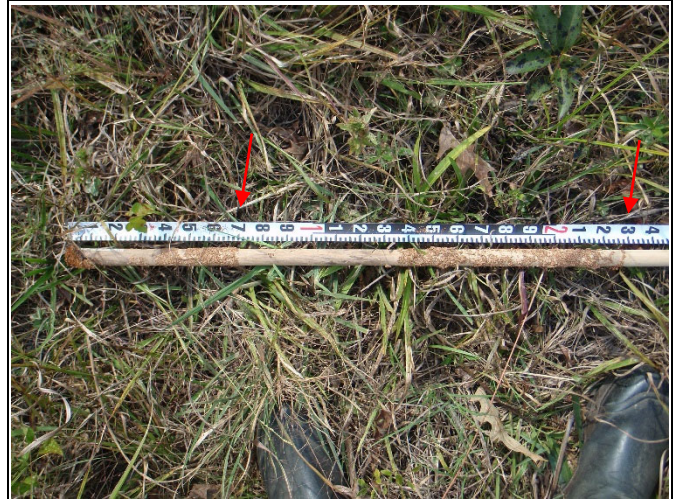
Reach UT4-R2: Overbank events of 2.26' and 0.68' (photo from 10/15/18)

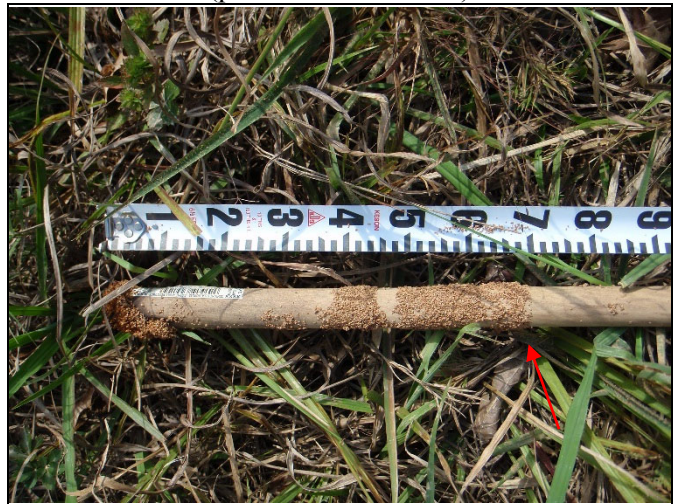
Reach UT4-R2: Overbank event of 0.68' (from Hurricane Michael on 10/11/18)

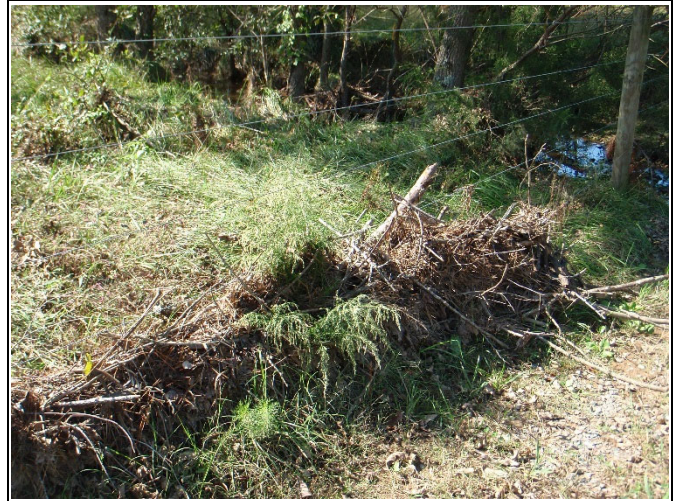
Reach UT4-R4a: Debris along fence at crossing

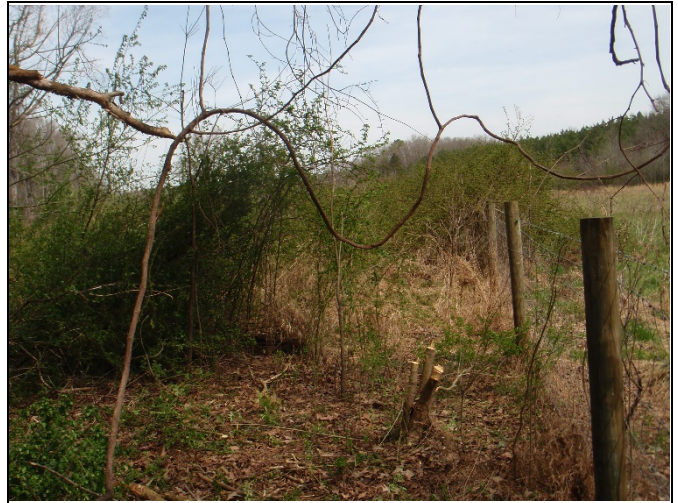
Reach HC-R1: Privet cut/sprayed, right floodplain at Station 10+00 (March 2018)

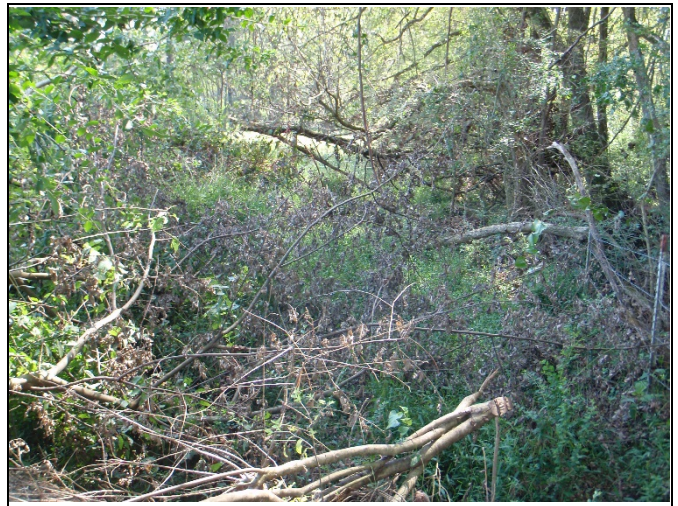
Reach HC-R1: Dead privet, Station 10+00 (Oct. 2018)

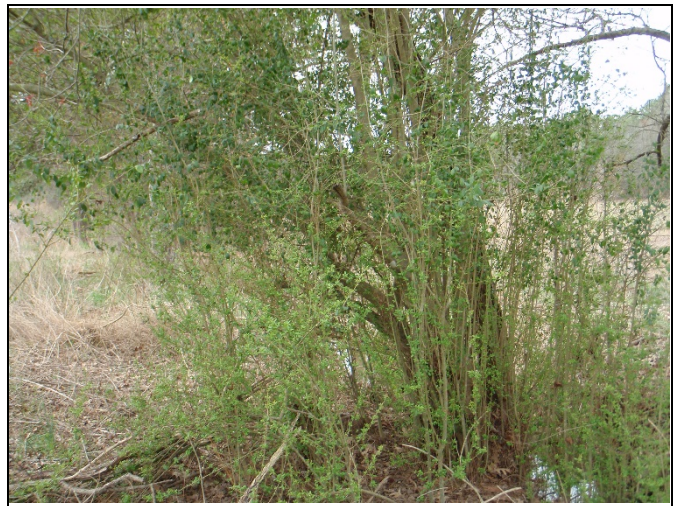
Reach UT4-R5b: Privet that was cut/sprayed (March 2018)

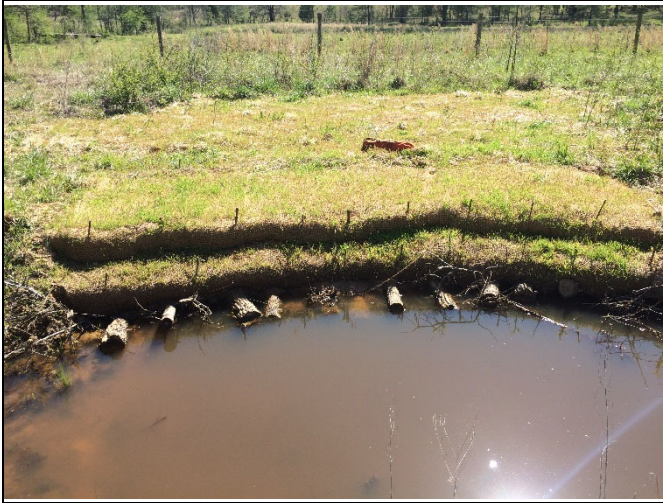
Reach UT4-R4b: Stream bank repair, Station 23+30 (post-repair in March 2017)

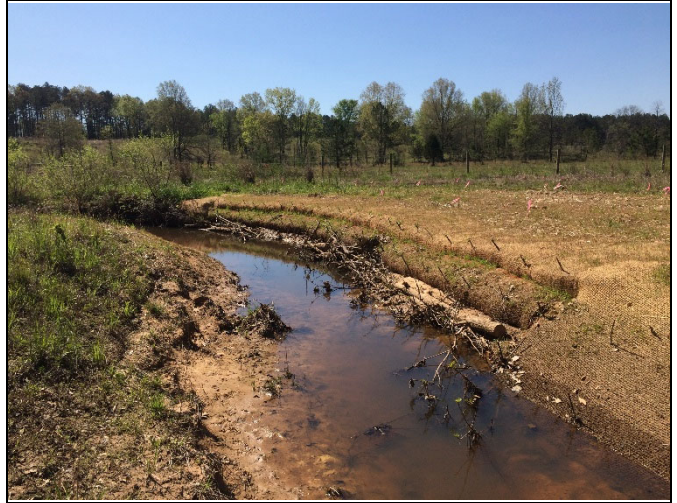
Reach UT4-R2: Stream bank repair, Station 31+75 (post-repair in March 2017)

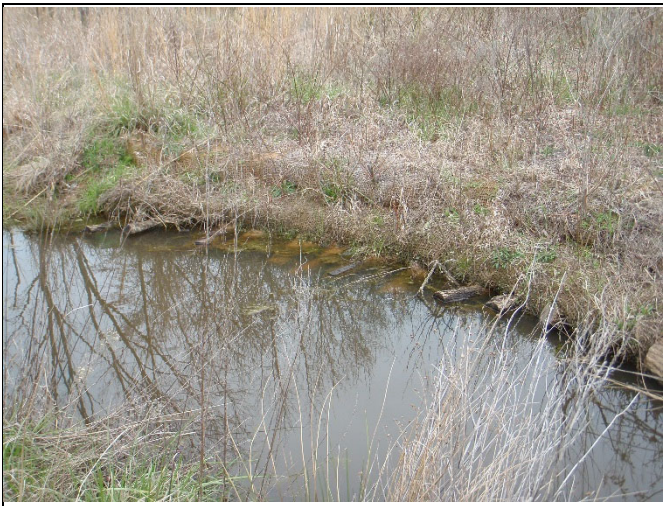
Reach UT4-R4b, Stream bank repair in March 2018

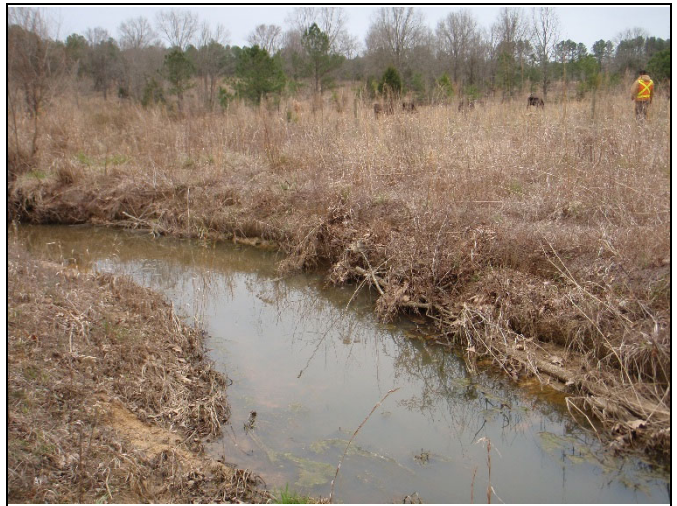
Reach UT4-R2, Stream bank repair in March 2018

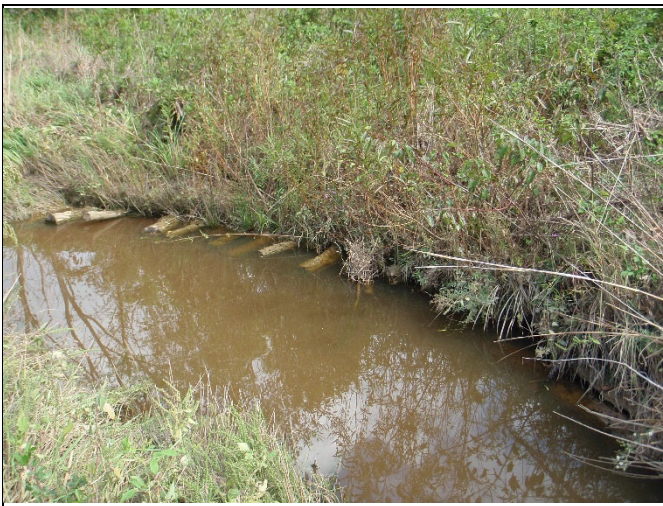
Reach UT4-R4b, Stream bank repair in Oct. 2018

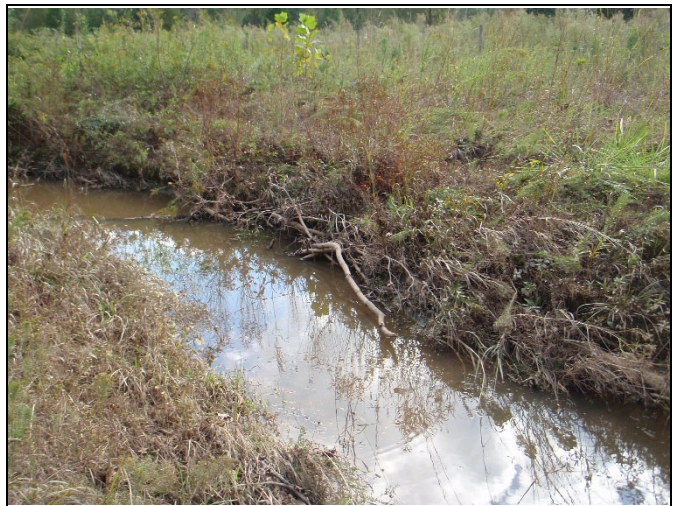
Reach UT4-R2, Stream bank repair in Oct. 2018
