Browns Summit Creek Restoration Project Year 7 Monitoring Report/Closeout Report

Guilford County, North Carolina

DMS Project ID No. 96313, DEQ Contract No. 5792

Project Info: Monitoring Year: 7 of 7
 Year of Data Collection: 2023
 Year of Completed Construction (including planting): 2017
 Submission Date: November 2023

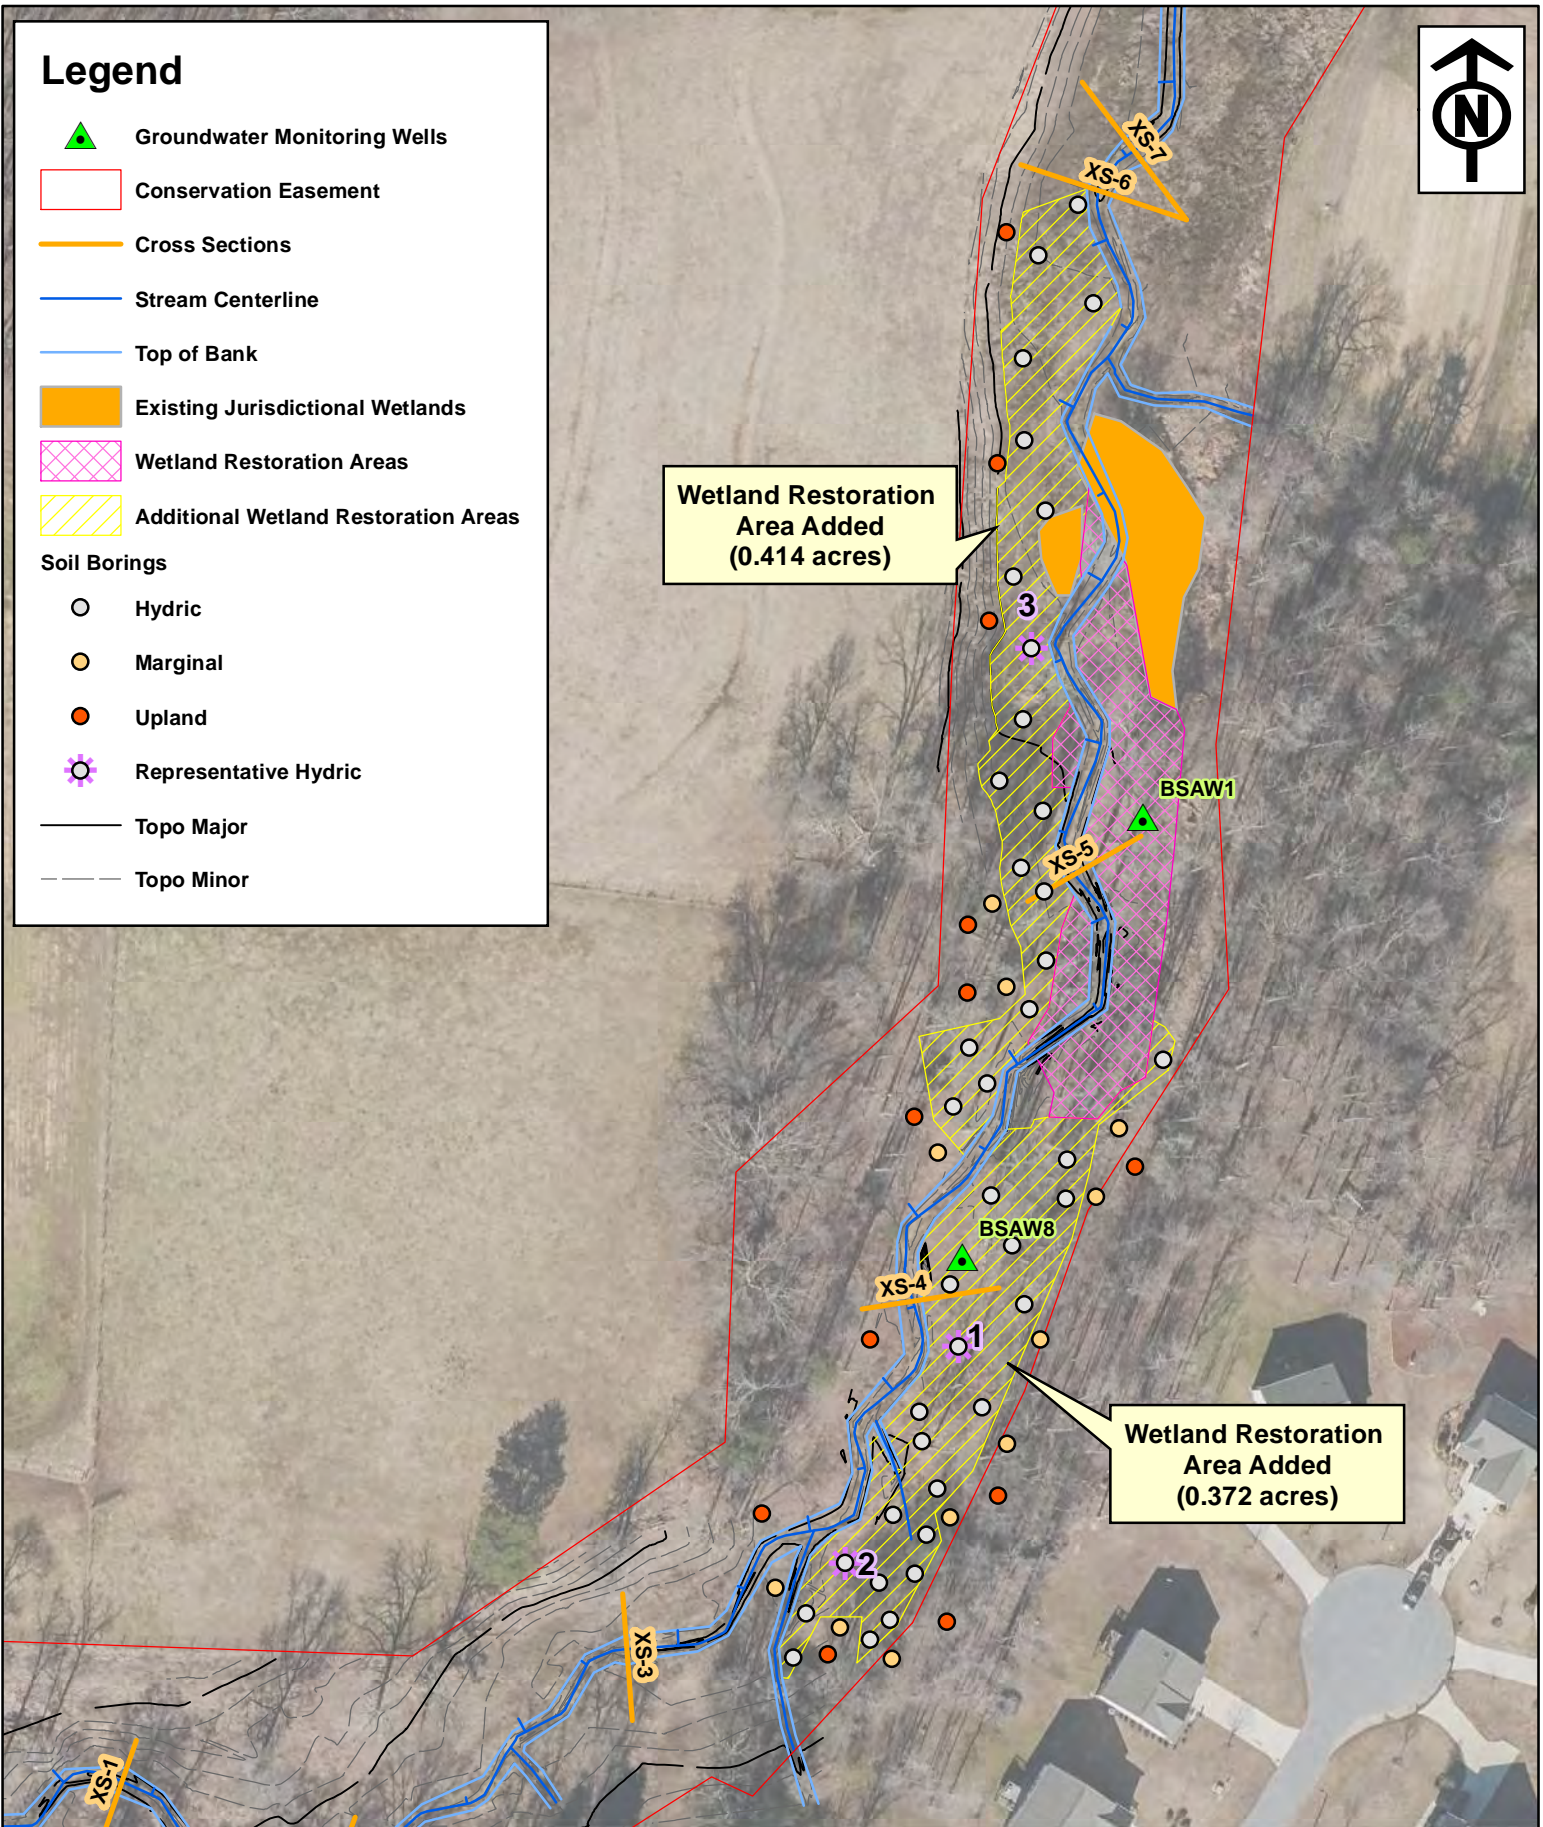
As noted above, an area of filled wetlands around monitoring well BSAW2 has not met ground water hydrology establishment criteria. As such, area around this well that was previously proposed as a restoration wetland (type 4 – filled wetland) has been removed as credit toward Riparian wetland mitigation units (1:1 ratio). Alternatively, areas identified during field investigations on November 10, 2022 were determined to qualify as having at least partially functioning restored wetlands (restoration type R-3; credit 1.5:1). Soils within these wetland restoration areas were hydric and the areas expressed wetland hydrology indicators such as surface water, saturation, iron deposits, water-stained leaves, hydrogen sulfide odor and oxidized rhizospheres along living roots. Additionally, likely-hydrophytic vegetation was also noted including sedges (*Carex lurida*), black willow (*Salix nigra*), green bulrush (*Scirpus atrovirens*), American sycamore (*Platanus occidentalis*), and Smooth alder (*Alnus serrulata*). These areas identified on the November 10, 2022 field visit were deemed to qualify for a wetland restoration ratio of 1.5:1 toward WMUs. Table 1 summarizes the net gain of 0.08 WMUs after Wetland Boundary Readjustment.

Wetland Restoration Area Added (0.414 acres)

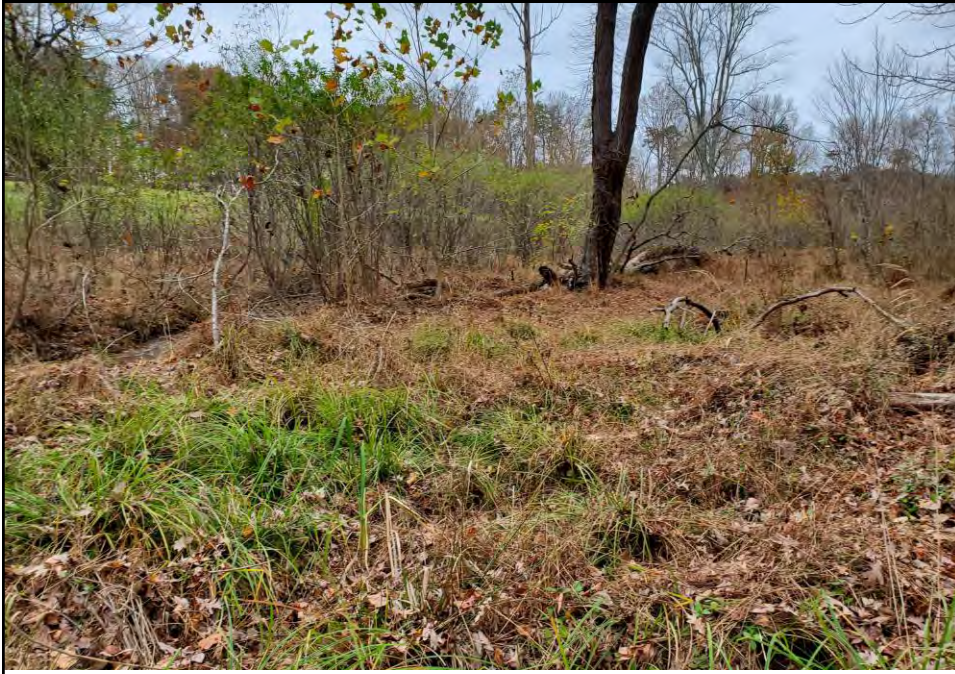
Photo 1. A view North along added wetland restoration area.

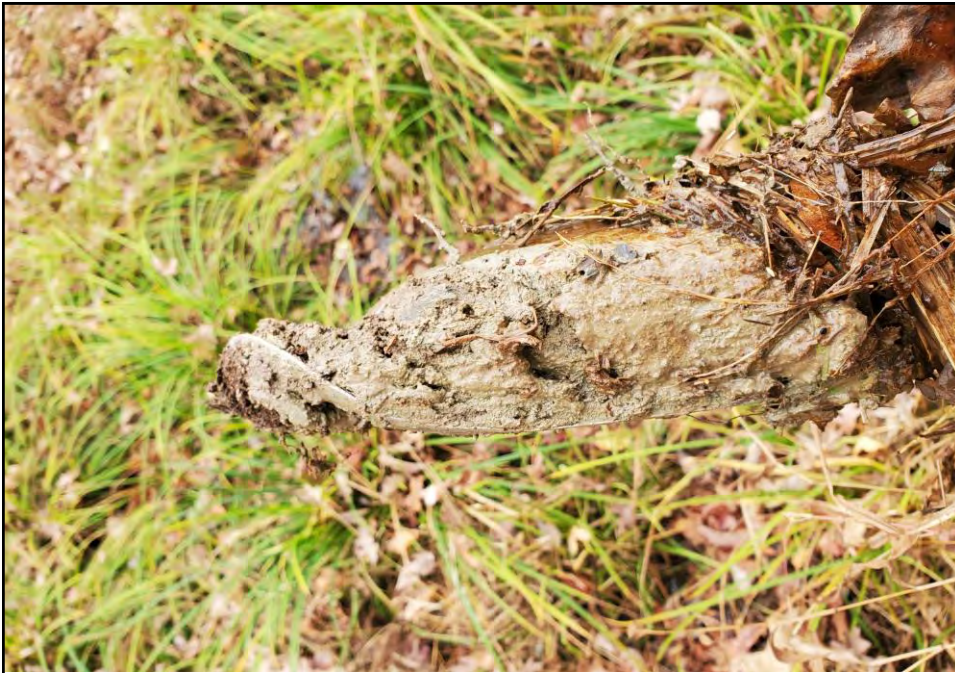
Photo 2. Hydric Soil present throughout added wetland restoration area.

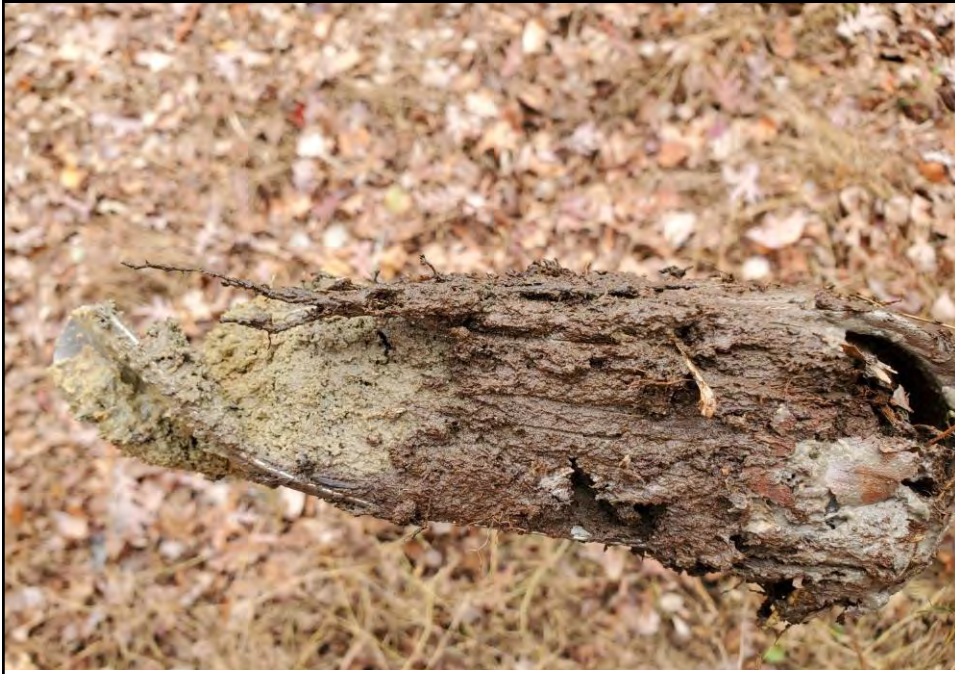
Photo 3. Hydric Soil present throughout added wetland restoration area.

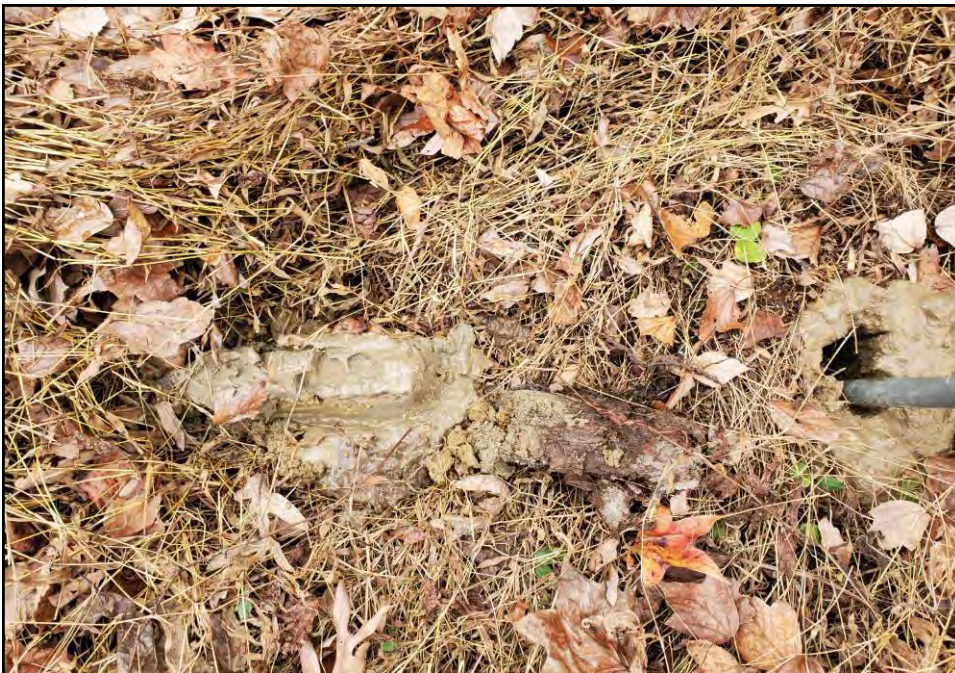
Photo 4. Hydric Soil present throughout added wetland restoration area.

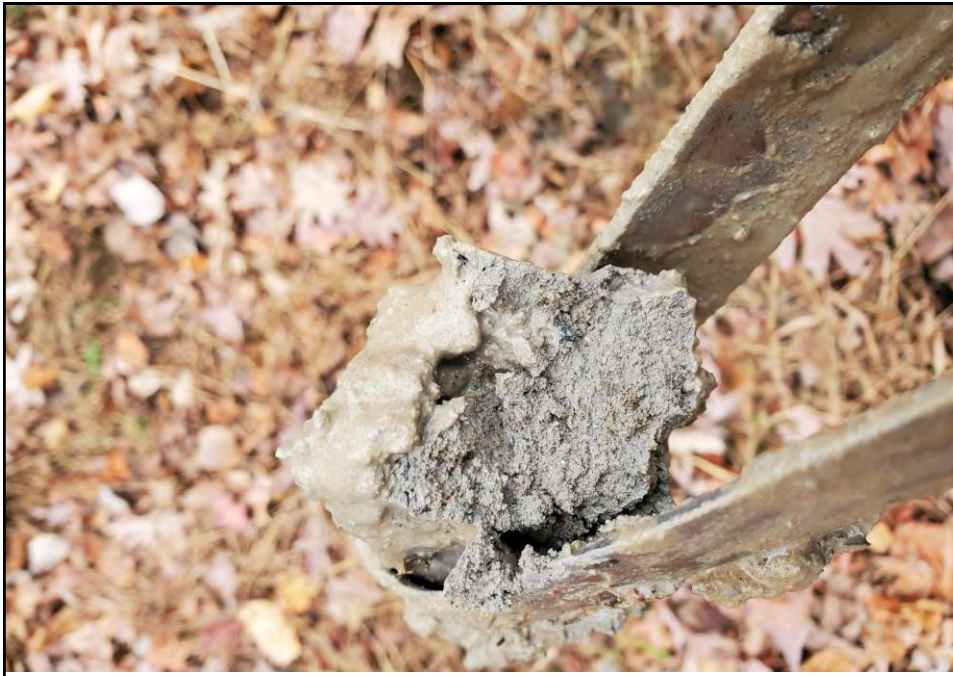
Photo 5. Hydric Soil present throughout added wetland restoration area.

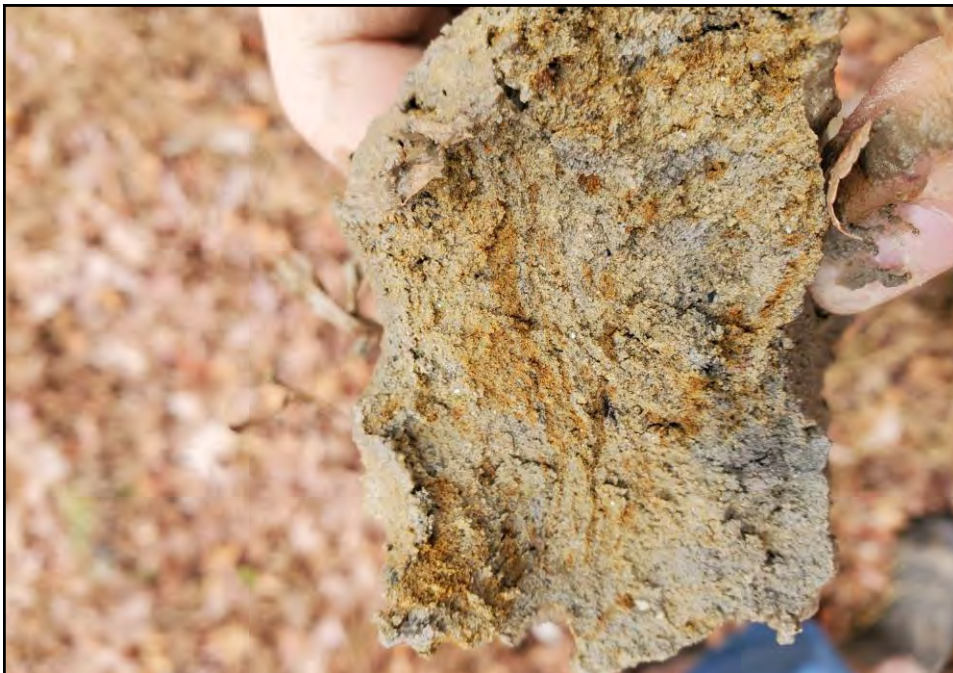
Photo 6. Hydric Soil present throughout added wetland restoration area.

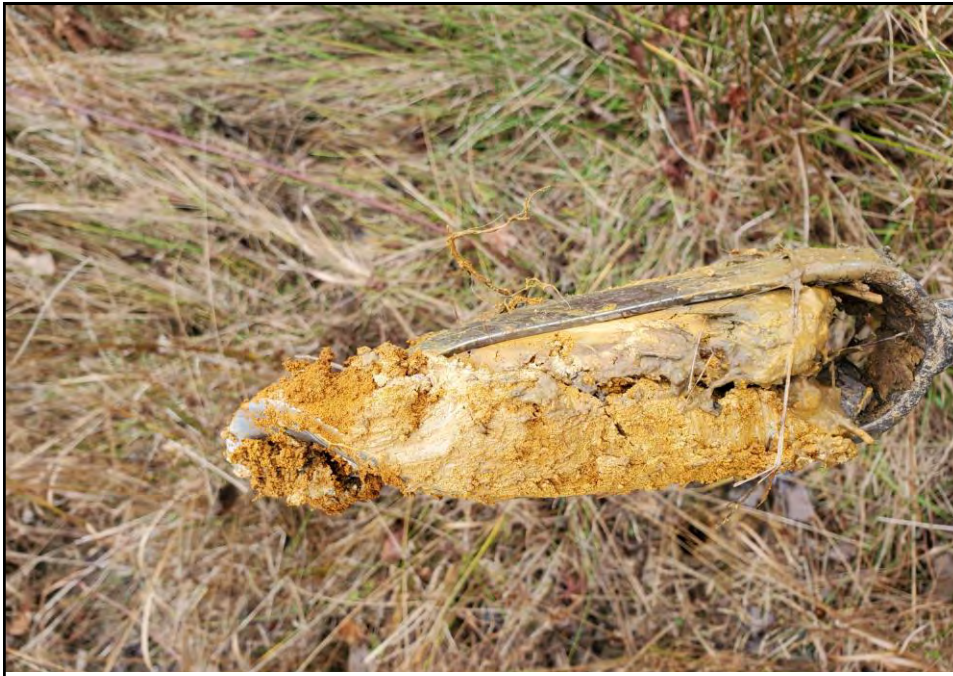
Photo 7. Hydric Soil present throughout added wetland restoration area.

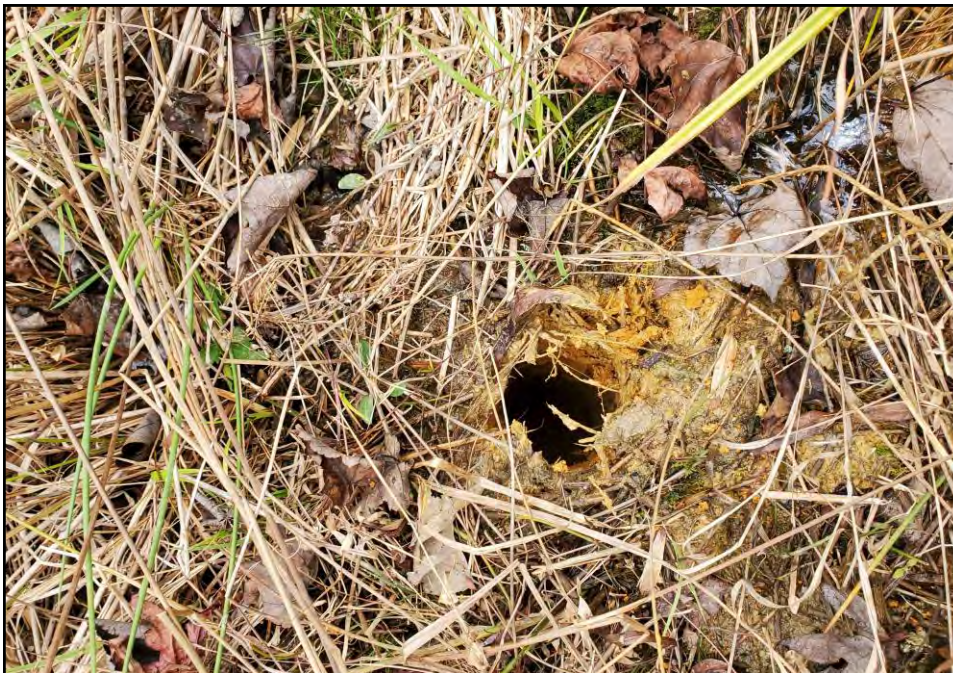
Photo 8. Hydric Soil present throughout added wetland restoration area.

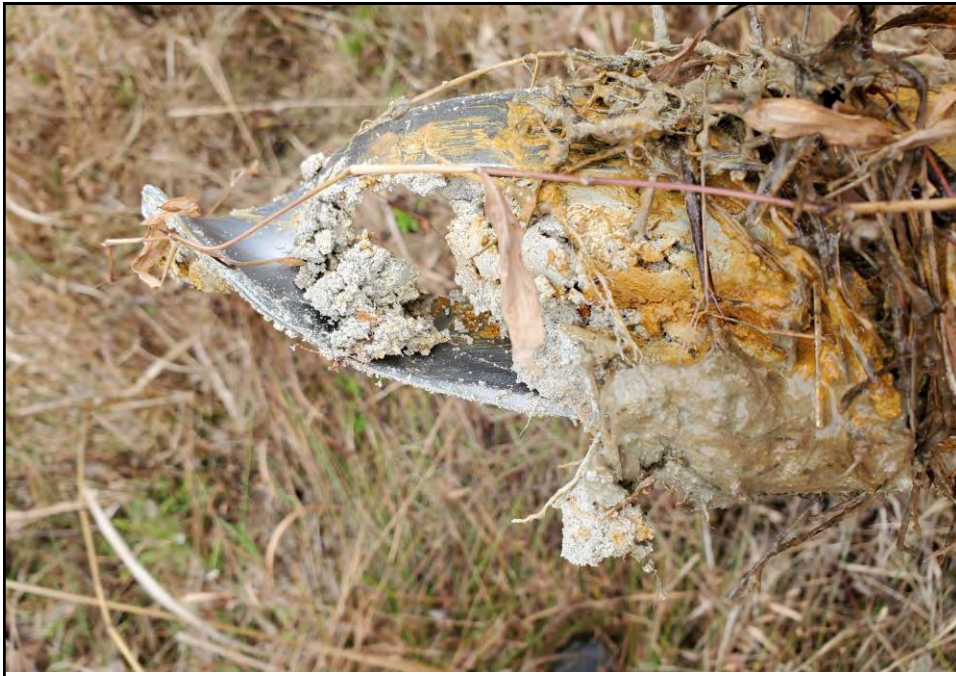
Photo 9. Hydric Soil present throughout added wetland restoration area.

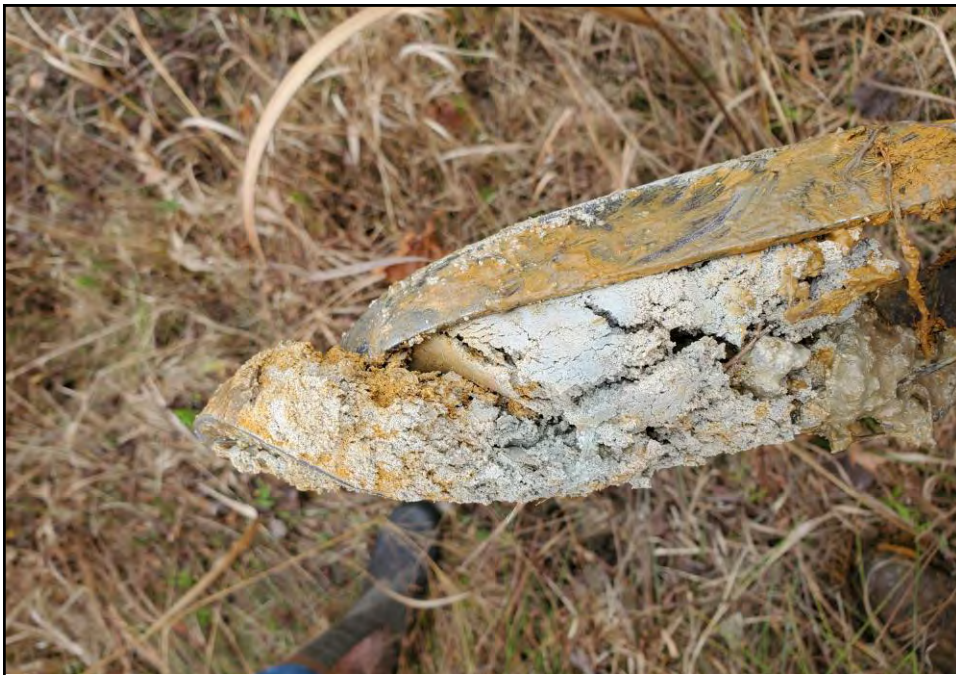
Photo 10. Hydric Soil present throughout added wetland restoration area.
