Browns Summit Creek Restoration Project Year 1 Monitoring Report

Guilford County, North Carolina

DMS Project ID No. 96313, DEQ Contract No. 5792

Project Info: Monitoring Year: 1 of 7
 Year of Data Collection: 2017
 Year of Completed Construction (including planting): 2017
 Submission Date: January 2018

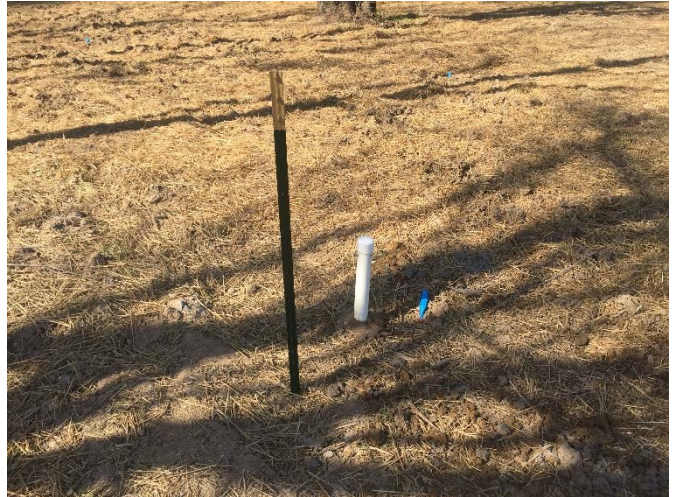
Wetland Well 2 – Reach 2, Station 47+00 March 9, 2017

Response: The automated collector was not acquiring data properly, upon re-inspection approximately one month into the monitoring season, the logger was re-set and began acquiring data.
