## Browns Summit Creek Restoration Project Year 2 Monitoring Report

Guilford County, North Carolina

DMS Project ID No. 96313, DEQ Contract No. 5792

Project Info:            Monitoring Year: 2 of 7  
                                 Year of Data Collection: 2018  
                                 Year of Completed Construction (including planting): 2017  
                                 Submission Date: December 2018

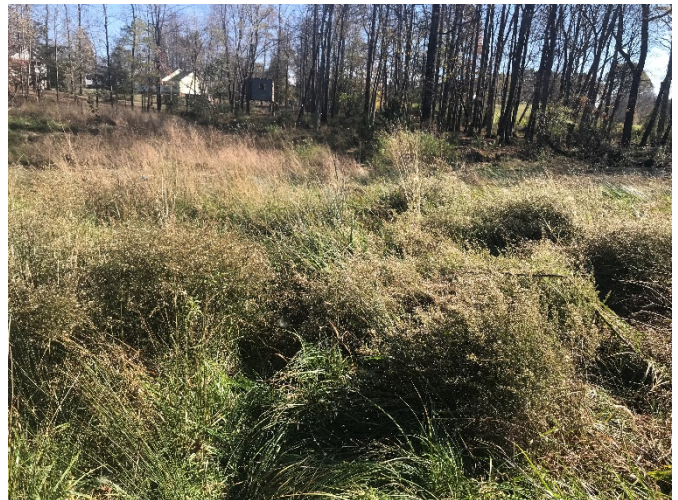
Vegetation Plot 12

During Year 2 monitoring, all plots except one meet the planted acreage performance categories (Appendix B and C). Due to the high flows pushing think herbaceous vegetation over, plot 12 trees may not have survived. This area will be evaluated for replanting once the frost has set the herbaceous layer back. The average density of total planted stems, based on data collected from the fourteen monitoring plots following Year 2 monitoring in November of 2018, was 541 stems per acre not including volunteer species. Thus, the Year 2 vegetation data demonstrate that the Site is on track to meet the minimum success interim criteria of 320 trees per acre by the end of Year 3. Additionally, there were three areas within the conservation easement of invasive species vegetation observed during the Year 2 monitoring. These areas totaled to 1.26 acres and have been shown on the CCPV Appendix B. We have made note of these areas and plan to start treatments in January 2019 until the growing season starts in March.

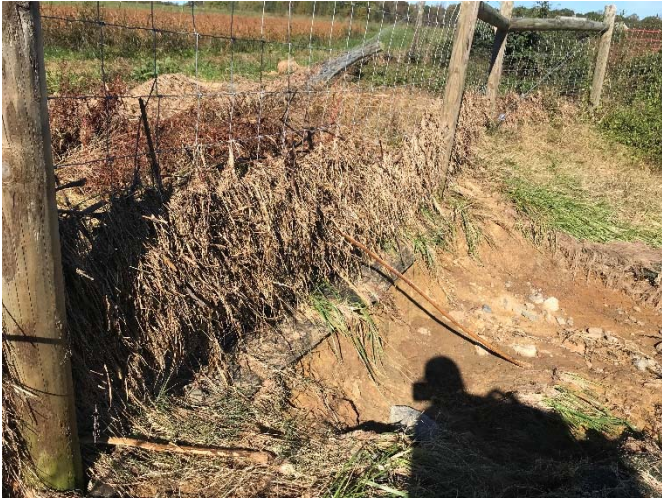
SPA 1 – Reach 6, Station 10+25

The Year 2 monitoring survey data of seventeen cross-sections indicates that the Site is geomorphically stable and performing at 100 percent for all the parameters evaluated. Certain cross-sections (located in Appendix D) have shown minor fluctuations in their geometry as compared to their as-built conditions; however, visually the site has remained stable with very little fluctuation. The as-built (MY0) cross section survey was conducted by the construction contractor's sub and has not provided the level of detail that is normally provided. Therefore, the fluctuations shown on the MY0 and MY2 overlay graphs found in Appendix D is much more pronounced than what is actually observed in the field. MY1 and MY2 is a better representation of the cross-section surveys. Moving forward the cross-section survey will be to the appropriate level of detail as is reflected in the MY1 cross-sections. These fluctuations do not represent a trend towards instability based off visual field evaluations. All reaches are stable and performing as designed. The data collected are within the lateral/vertical stability and in-stream structure performance categories. Hurricane Florence washed out the uppermost riffle on R6 and shifted some stone around on the step-pool structure below the BMP as indicated on the CCPV in Appendix B. This has been noted as a Stream Problem Area (SPA) and will be repaired in January 2019.

**Response: Changes have been made in the final report. All SPA and VPA are scheduled to be treated and repaired beginning January 2019.**
3. Section 4.1, page 5: The report states that that BSAW2 did not meet hydrologic success of 12% in years 1 and 2. Baker should keep a watch on this well and maybe do a little investigative work through out that wetland area to determine potential causes. Good thing is that it is trending up. 3.2% in MY1 and 6.8% in MY2.
