Browns Summit Creek Restoration Project Year 3 Monitoring Report

Guilford County, North Carolina

DMS Project ID No. 96313, DEQ Contract No. 5792

Project Info: Monitoring Year: 3 of 7
 Year of Data Collection: 2019
 Year of Completed Construction (including planting): 2017
 Submission Date: December 2019

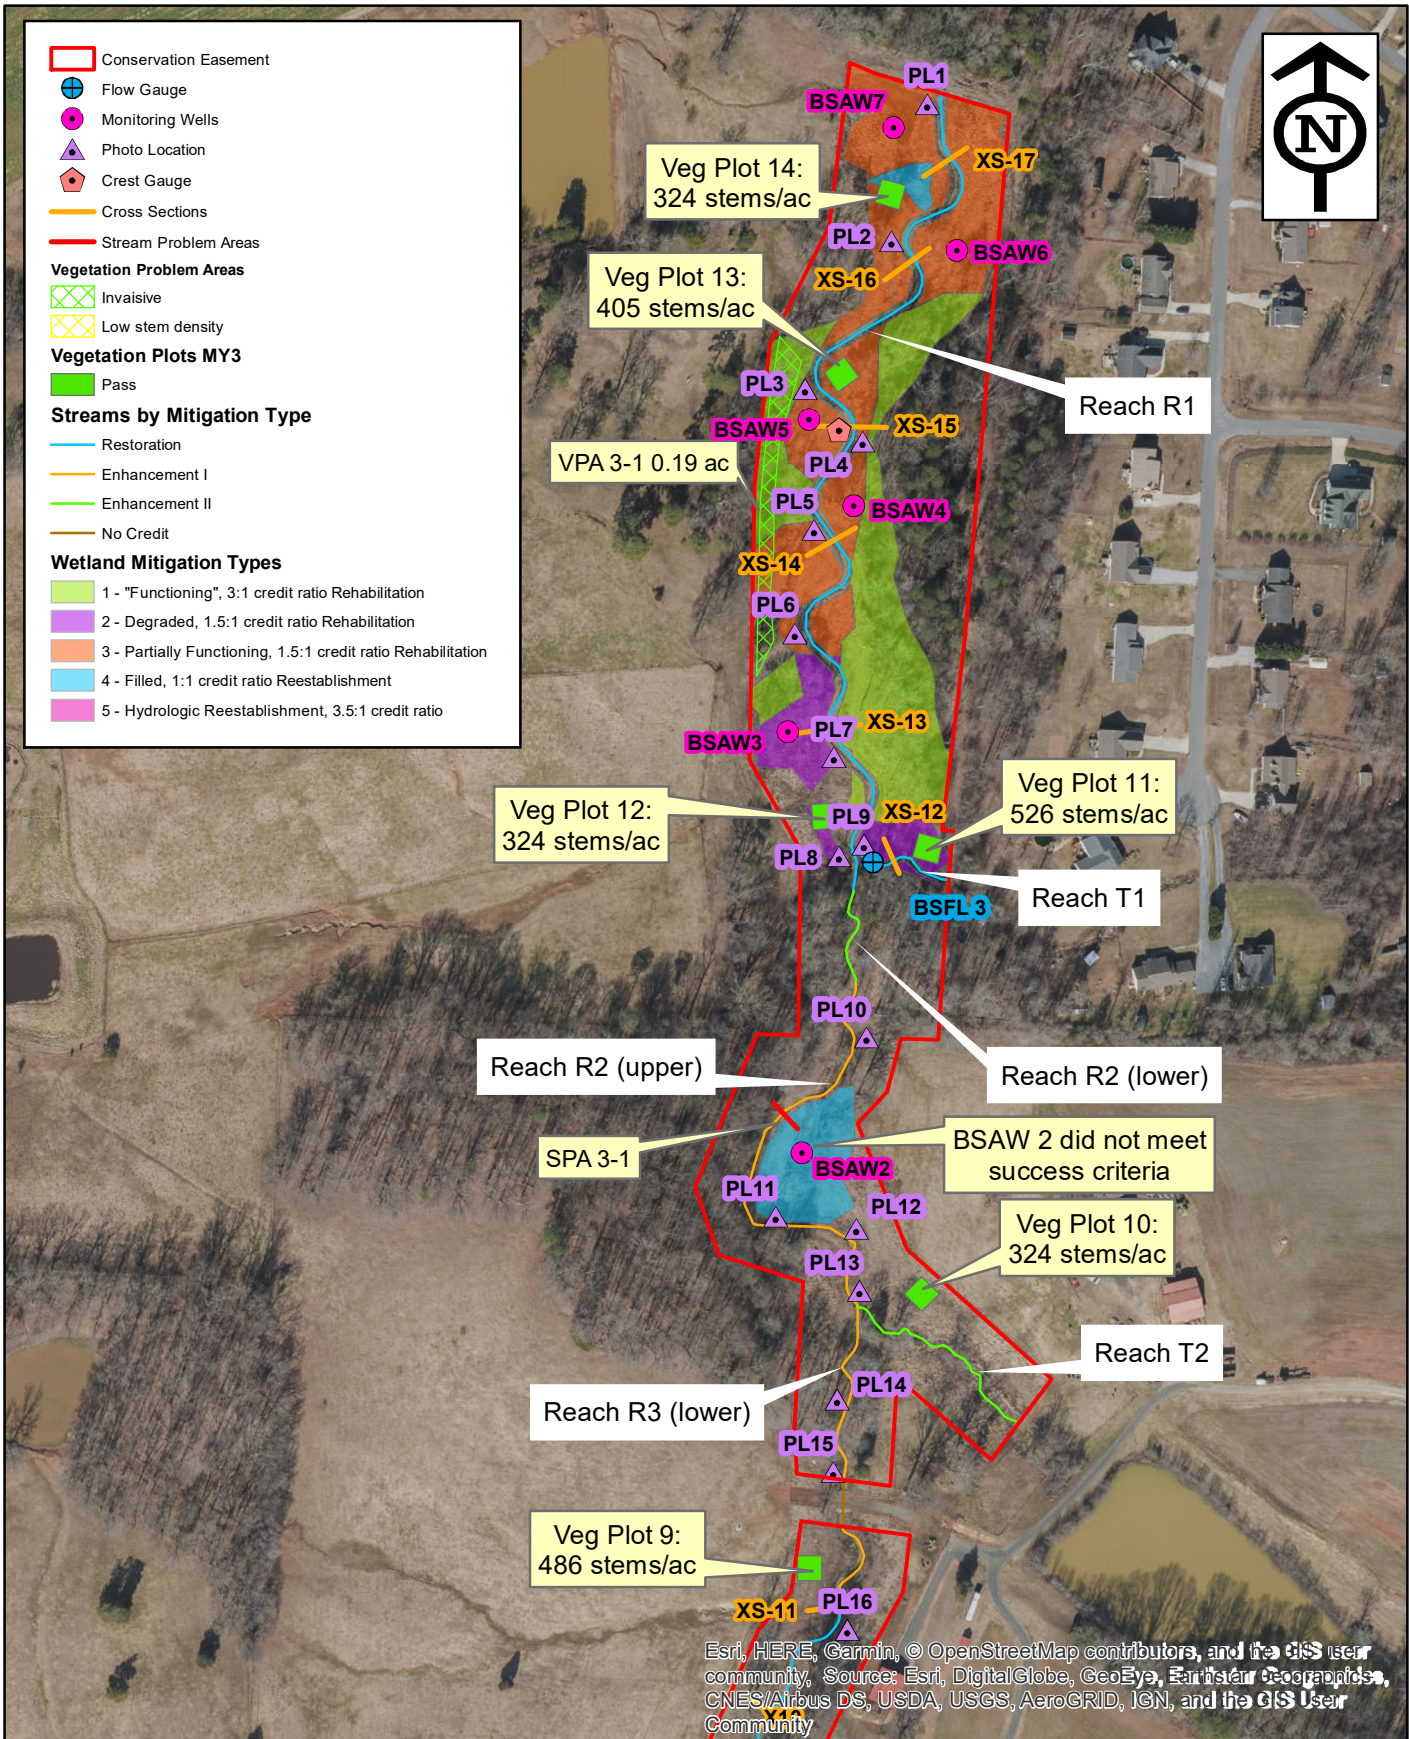
Figure 4.1
Current Conditions
Plan View
Browns Summit Site
(DMS #96313)

Response: Figures 4.1 and 4.2 have been revised to show wetland mitigation type, a note detailing that BSAW2 did not meet success criteria and veg problem areas broken down to distinguish the two different types.

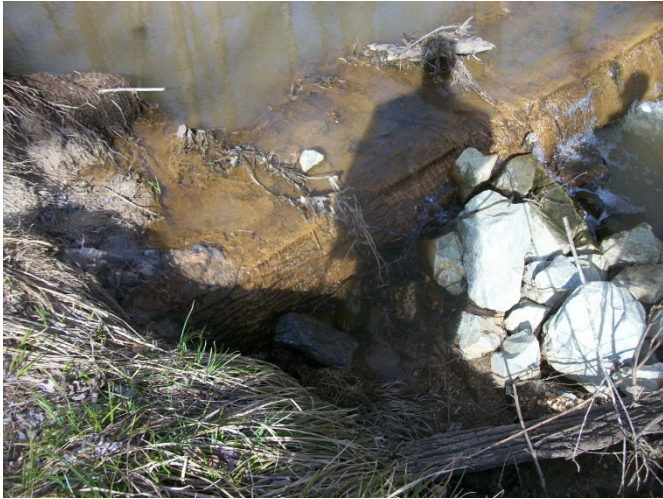
SPA 3-1 – Reach 2, Station 47+50 (March 12, 2019)

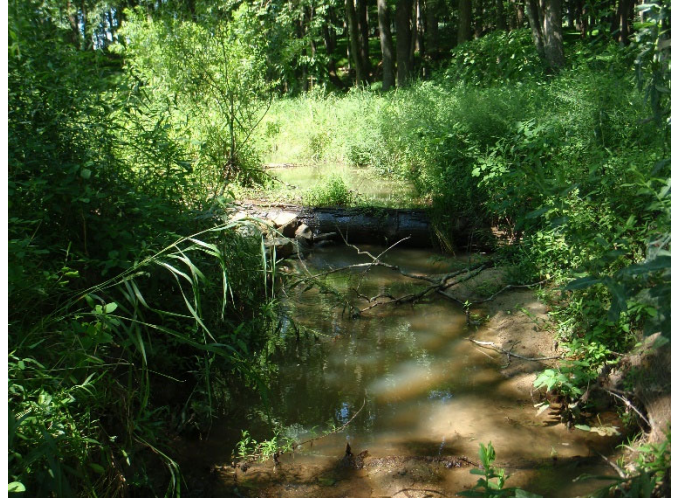
SPA 3-1 – Reach 2, Station 47+50 (March 12, 2019)

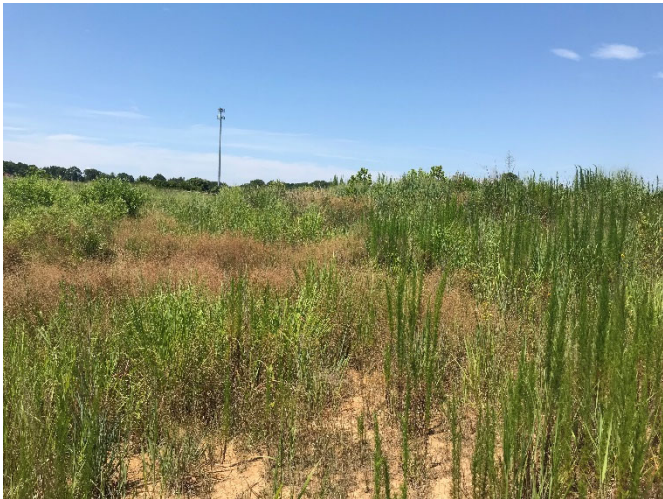
VPA 3-2 – Reach 5, Left Bank (July 3, 2019)

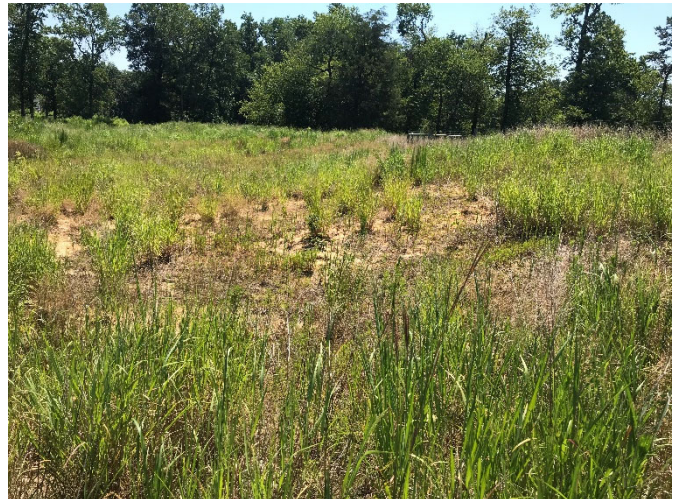
VPA 3-3 – Reach 5, Right Bank (July 3, 2019)

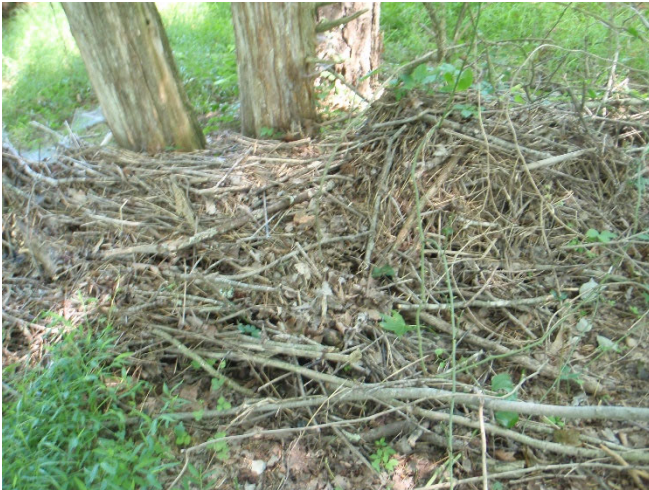
Wrack Line Showing High Flow (7/3/2019)

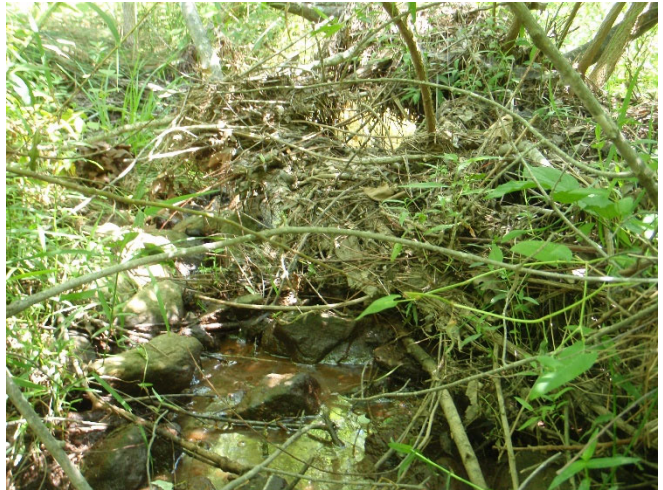
Wrack Line Showing High Flow (7/3/2019)
