Browns Summit Creek Restoration Project Year 4 Monitoring Report

Guilford County, North Carolina

DMS Project ID No. 96313, DEQ Contract No. 5792

Project Info: Monitoring Year: 4 of 7
 Year of Data Collection: 2020
 Year of Completed Construction (including planting): 2017
 Submission Date: December 2020

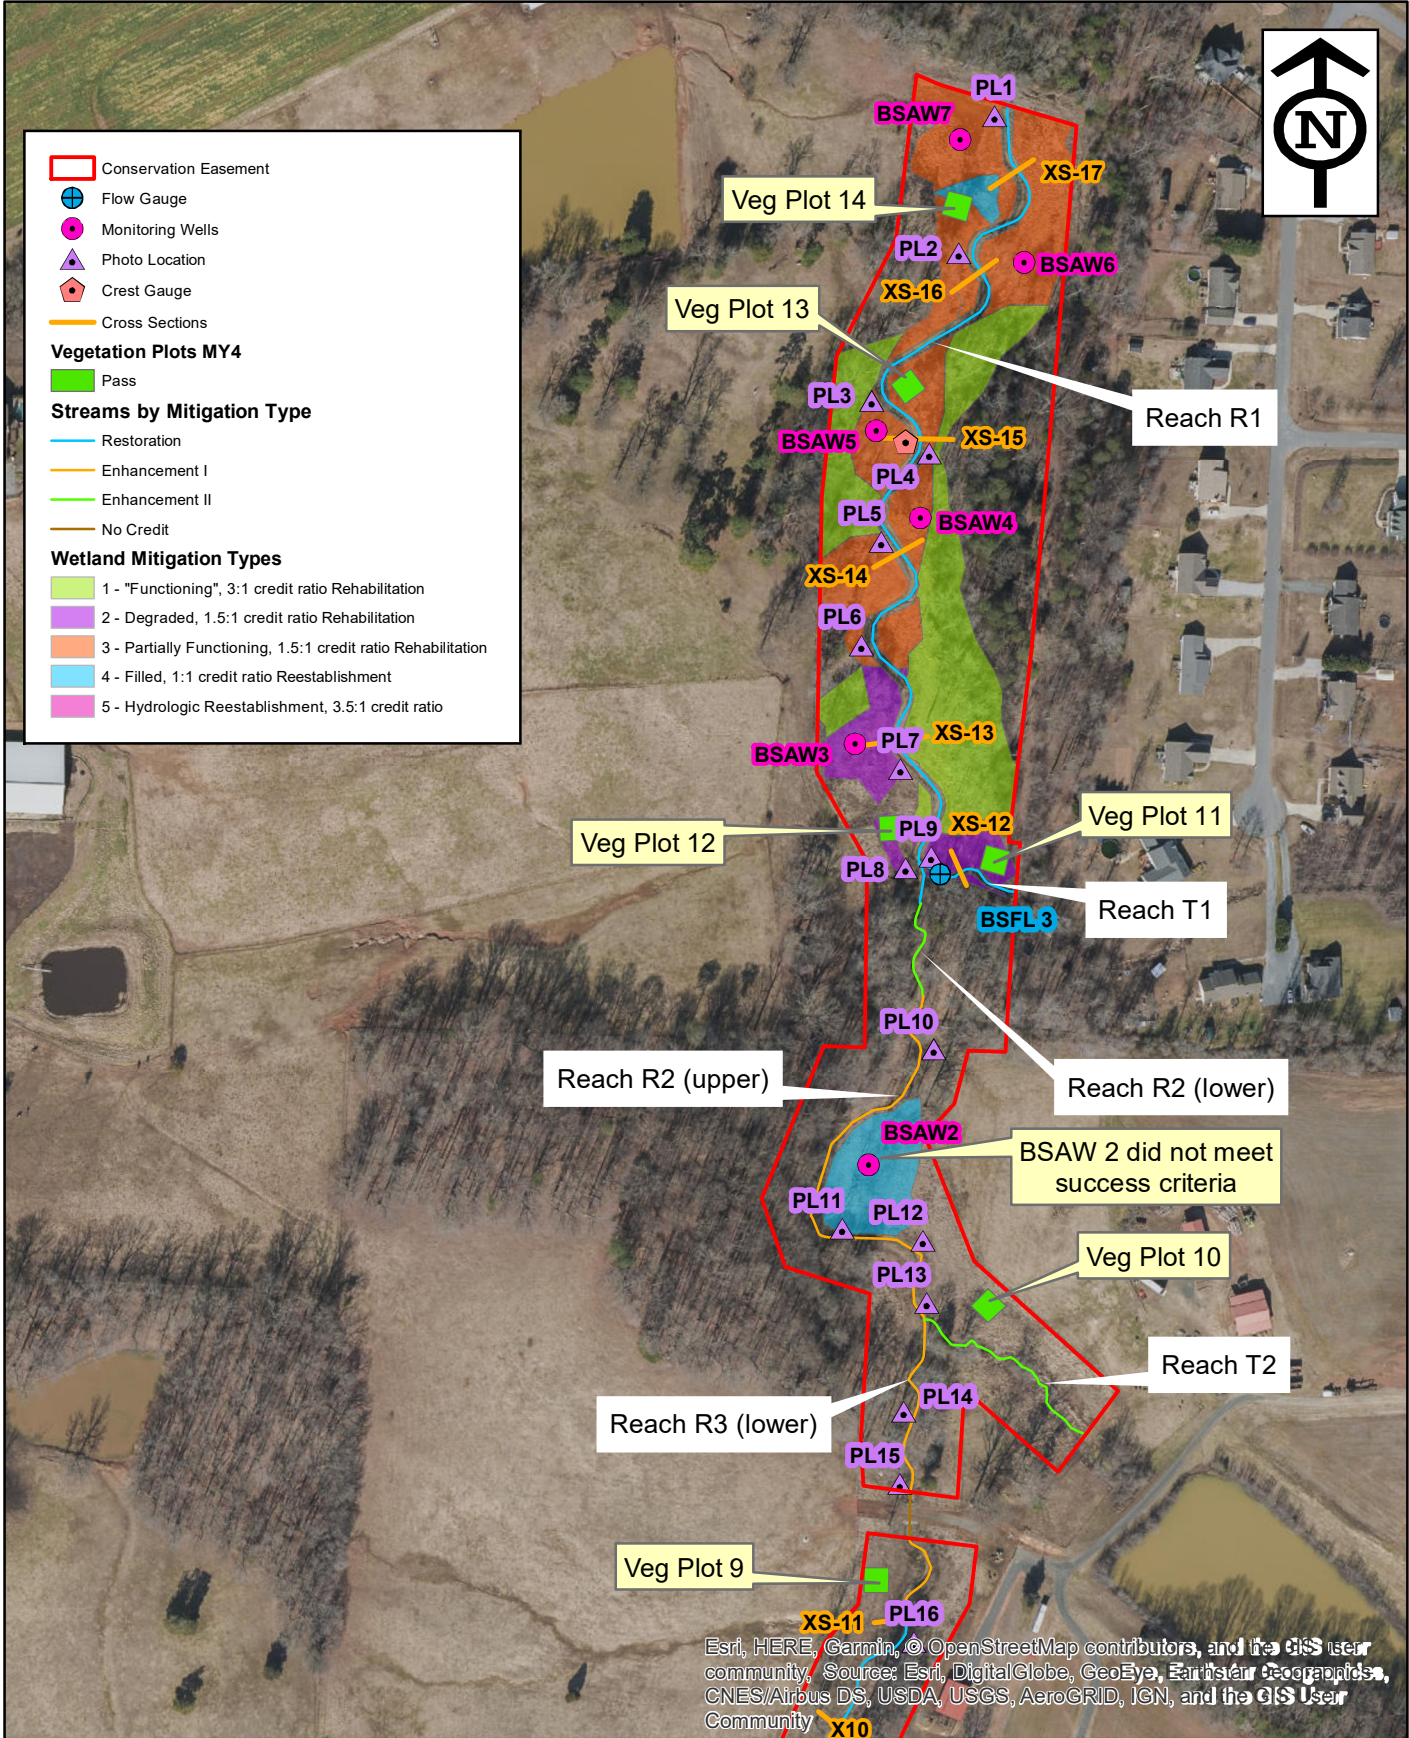
Figure 4.1
Current Conditions
Plan View
Browns Summit Site
(DMS #96313)

Response: BSAW8 (MW8) has been added to the CCPV along with a written description located in the executive summary.

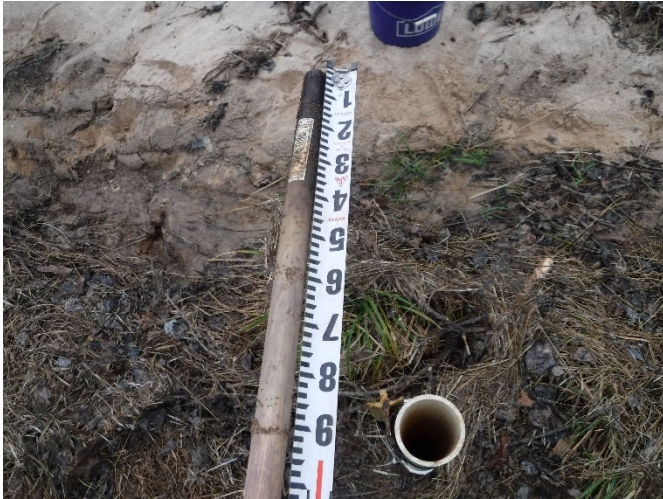
During Year 4 monitoring, the R1 crest gauge documented two post-construction bankfull event from February 2020 at 0.91 feet and second event in November of 2020 at 1.49 feet. The site had already meet the bankfull flow requirement of two bankfull events within two separate monitoring years in previous monitoring years (MY1 and MY2).

Manual Crest Gauge – Reading 1/24/2020 (.91')

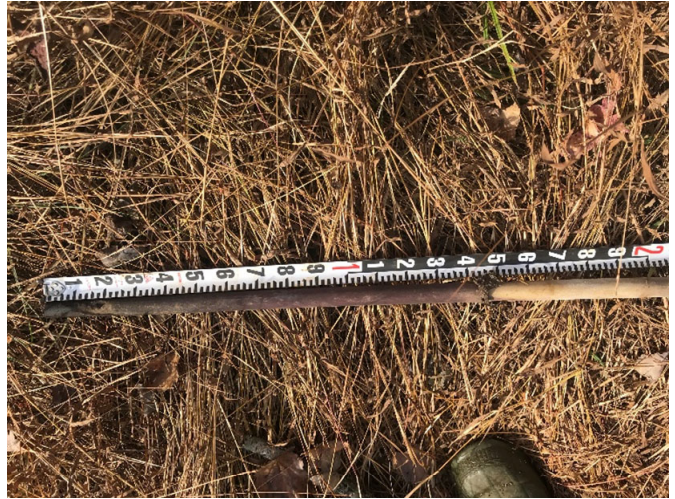
Manual Crest Gauge – Reading 11/6/2020 (1.49')

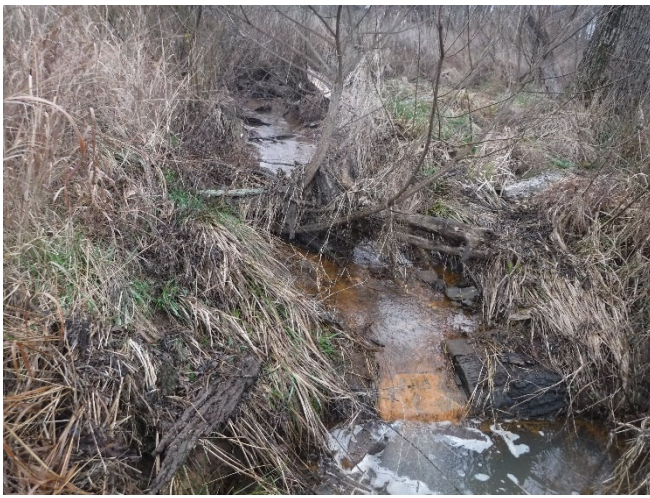
Wrack Line Showing High Flow (3/3/2020)

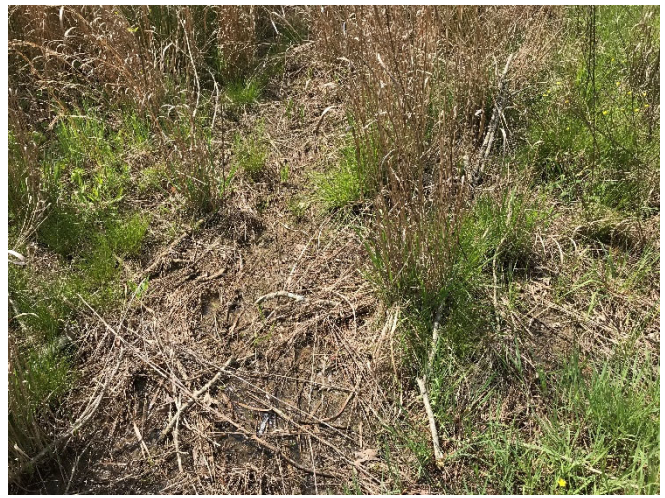
Wrack Line Showing High Flow (4/21/2020)

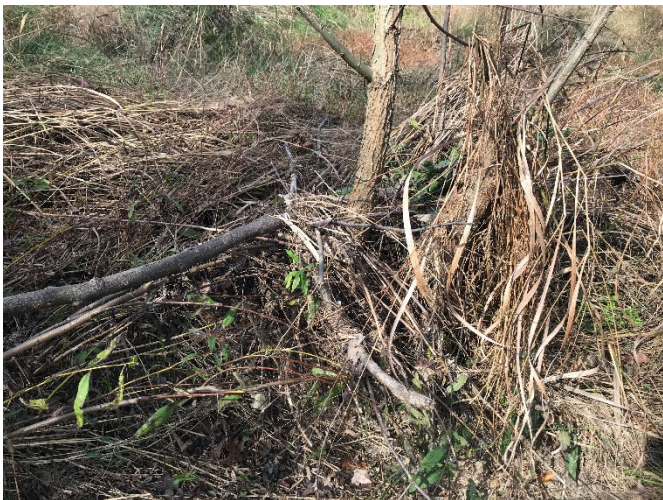
Wrack Line Showing High Flow (11/6/2020)
